## #22 Vilas Co Sucker Creek Culvert

Project Title Sucker Creek Bridge Replacement					Current Funded Miles 499.6/37.2	New Miles (if applicable) 0
County Vilas	Township 40 N	Range 10	Section 4	1/4 1/4 SE	1/4 NW	GPS Coordinates: Lat. _____ Long. _____

# Trail Bridge Inspection

Vilas 39

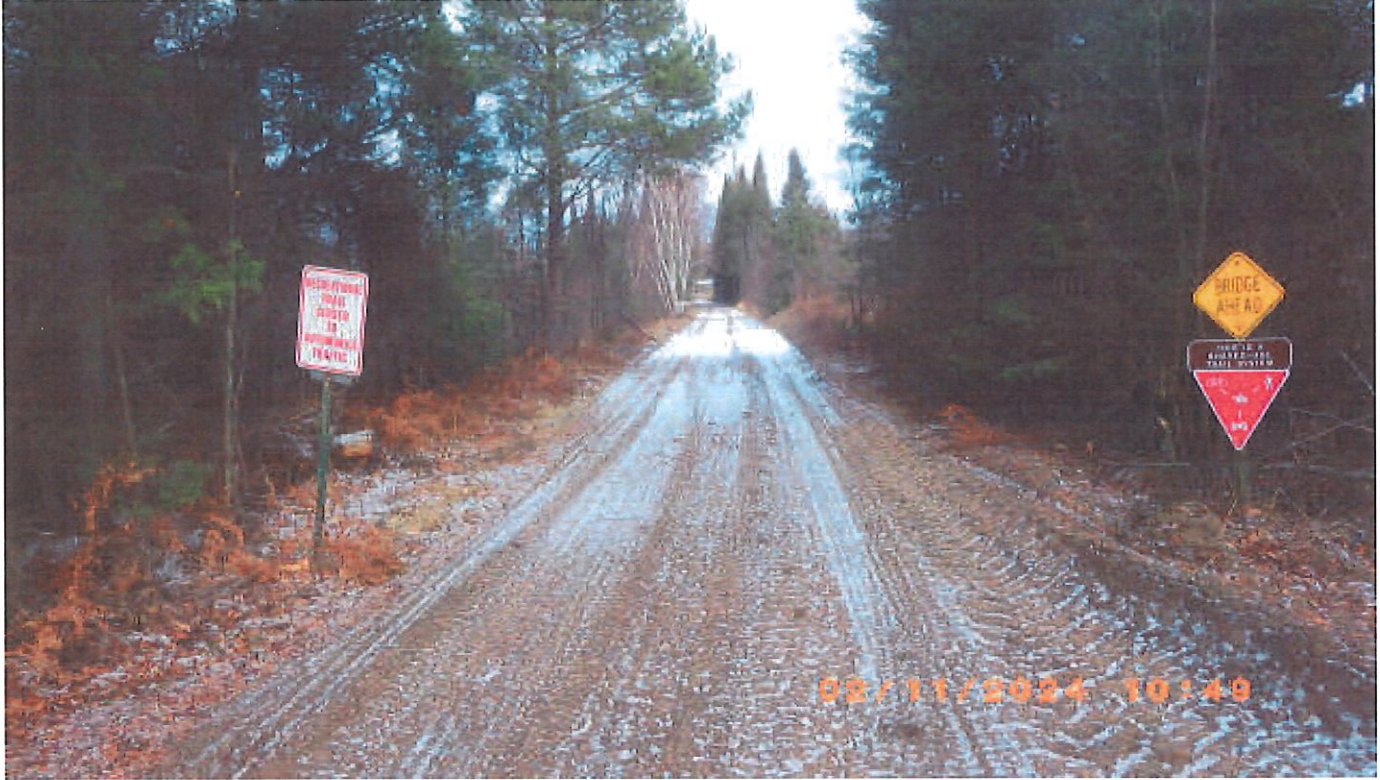
All signs have CS2 map cracking or minor damage.

South bridge ahead / other signs

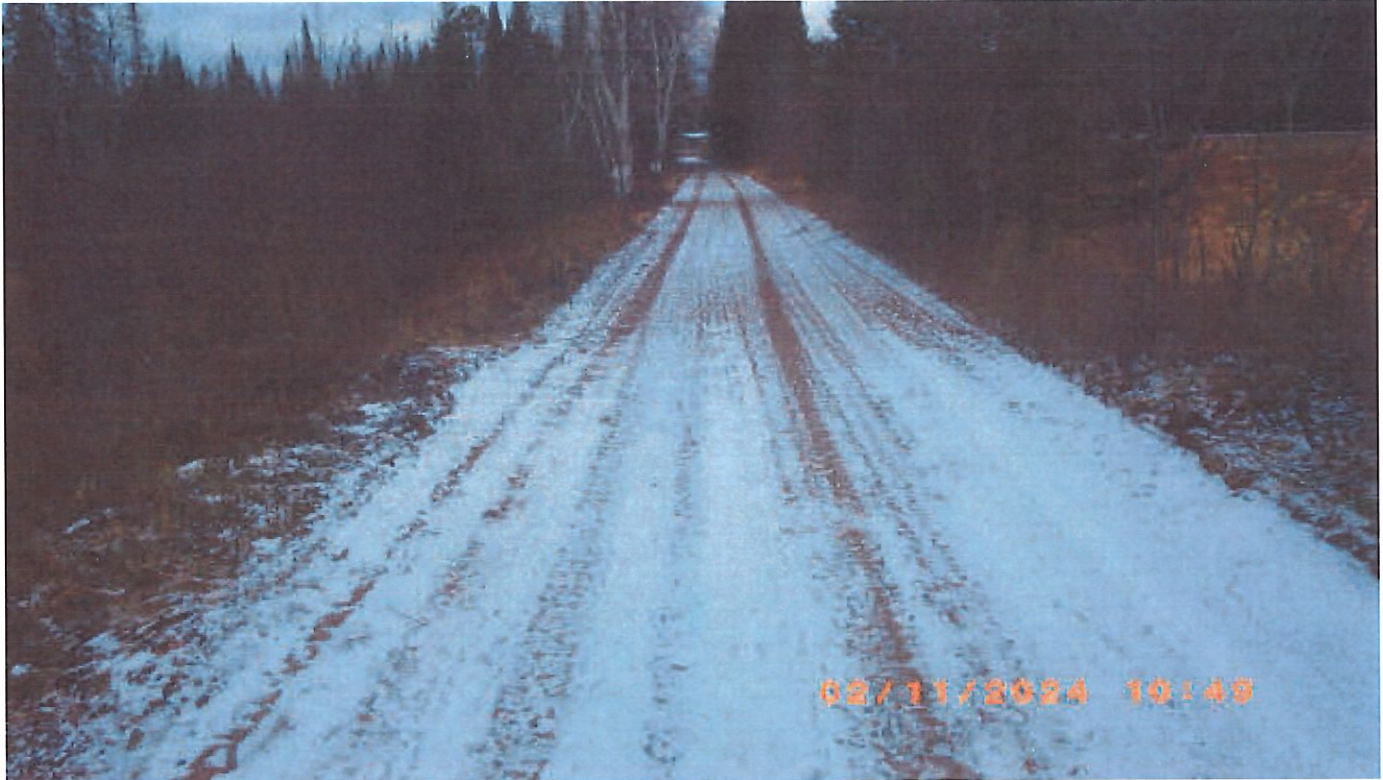
Roadway above structure has CS3 wheel ruts.

CS3 Roadway over structure

Inspect on a regular schedule of 48 months.  
Monitor the spalls on the West end of the structure.  
Maintain proper drainage above the structure on the roadway.  
CUT BRUSH AROUND THE ENTIRE STRUCTURE ANNUALLY

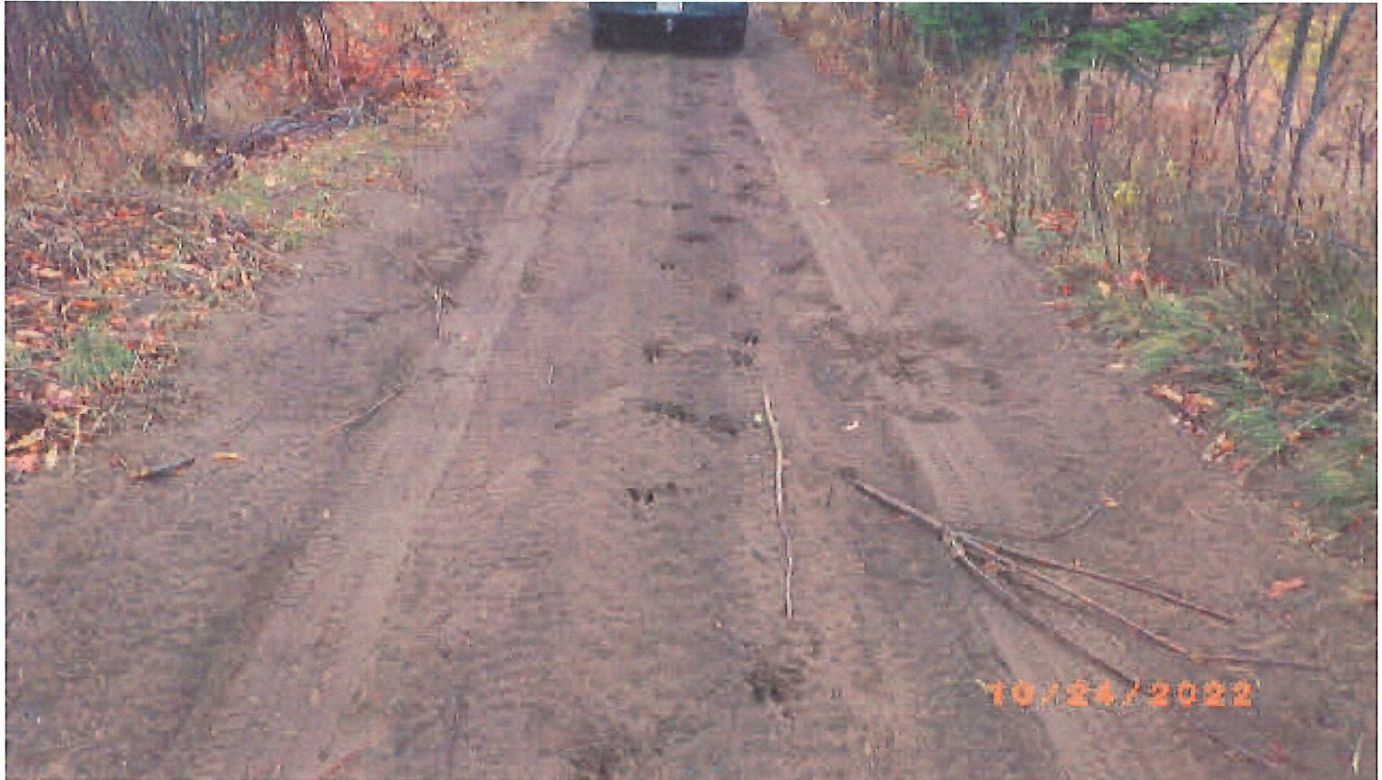
2022 CS3 road way over structure.

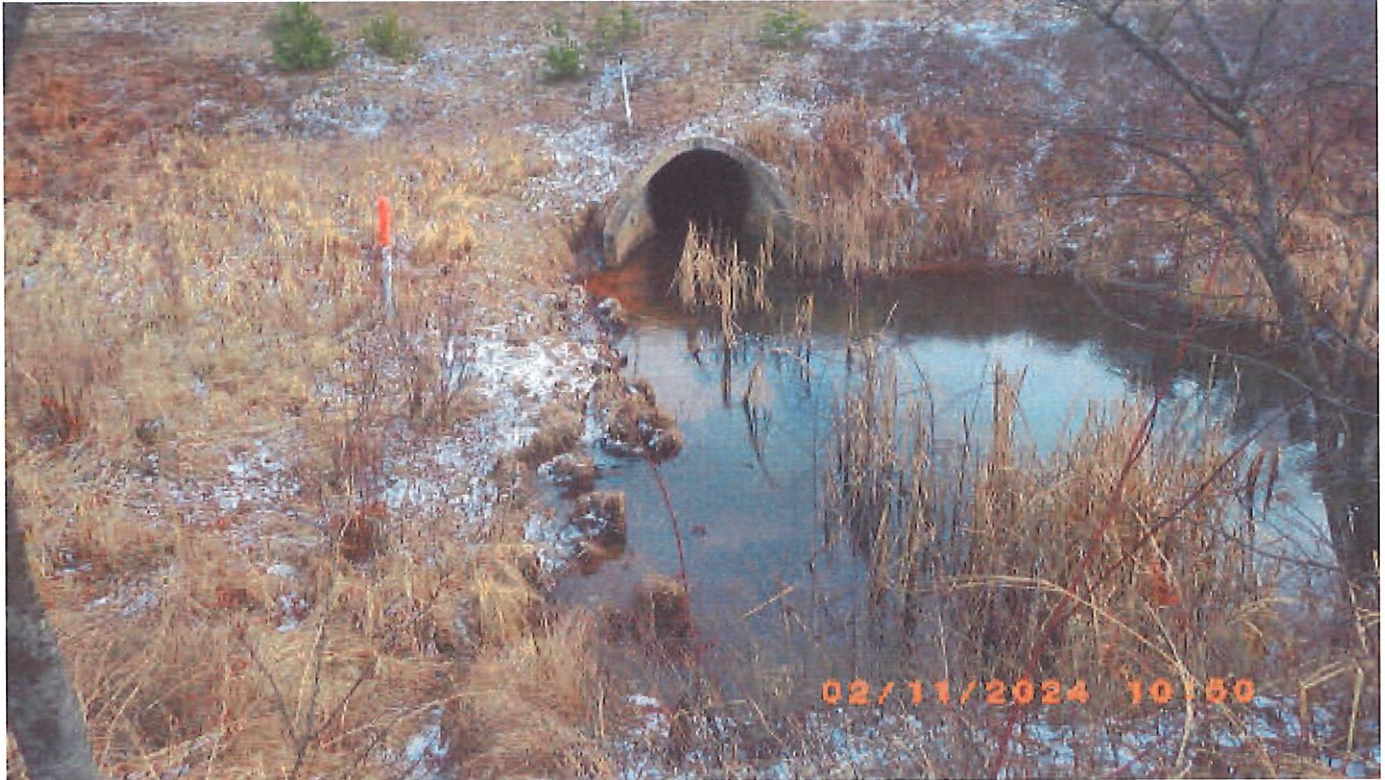
The box has CS2 scaling on the wetted perimeter. There is moderate spalling at the top of the east end of box. Channel has a highway culvert and low head dam immediately upstream.

Looking upstream (highway culvert)

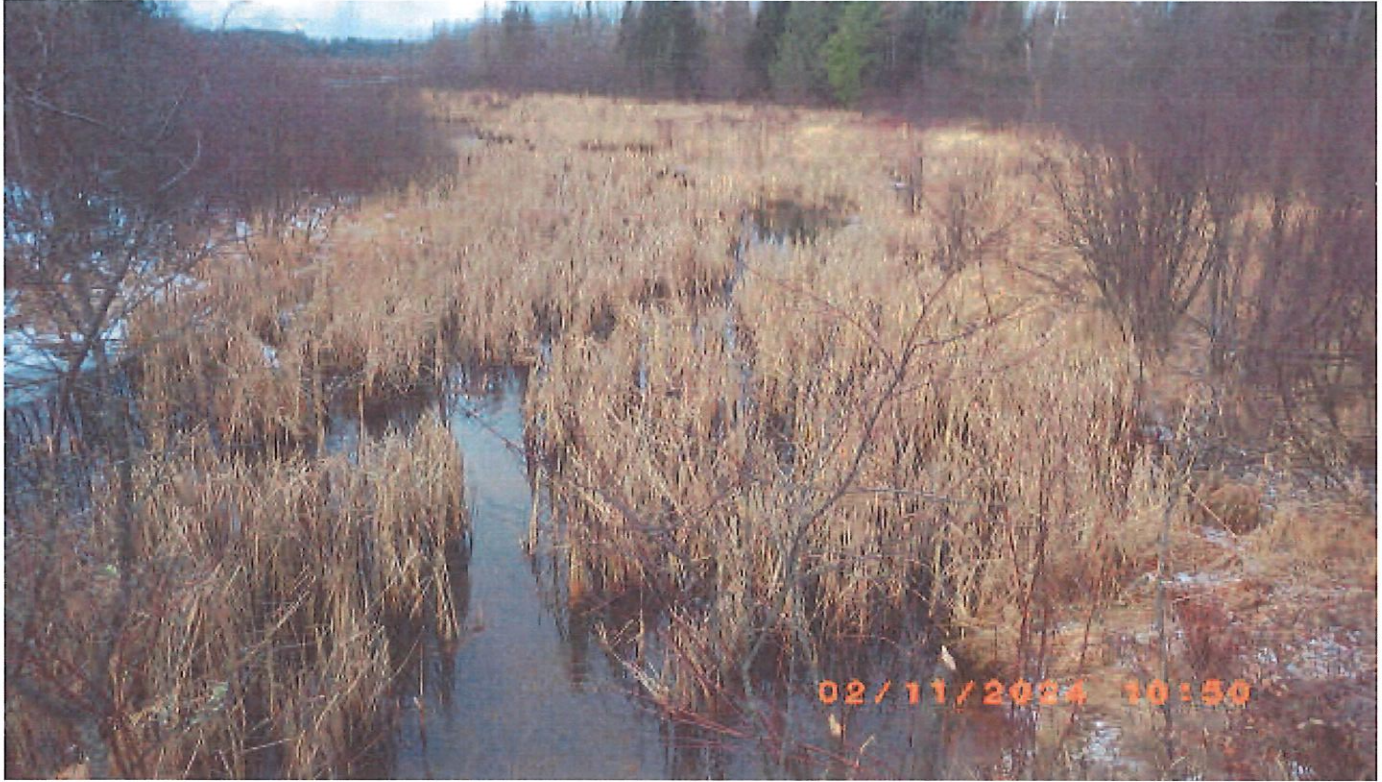
Looking downstream

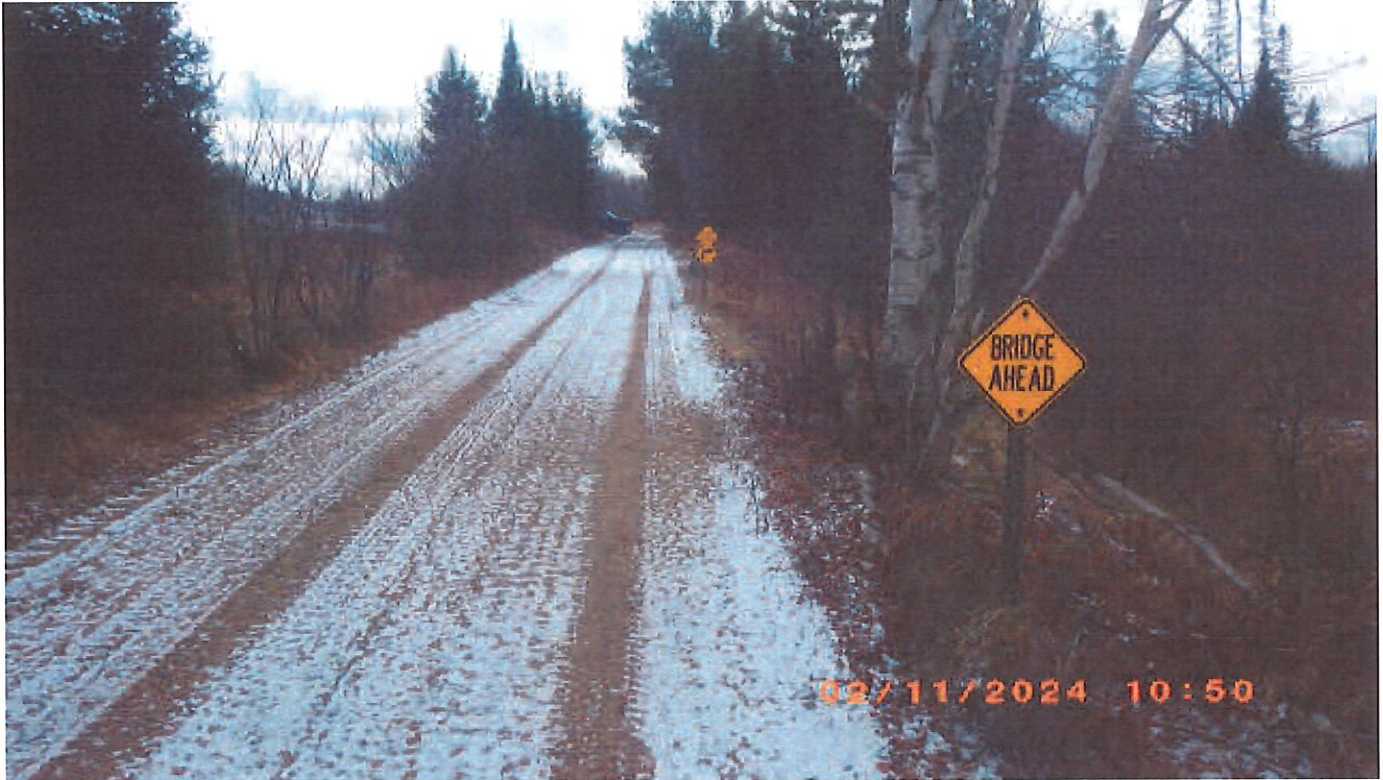
North bridge ahead sign

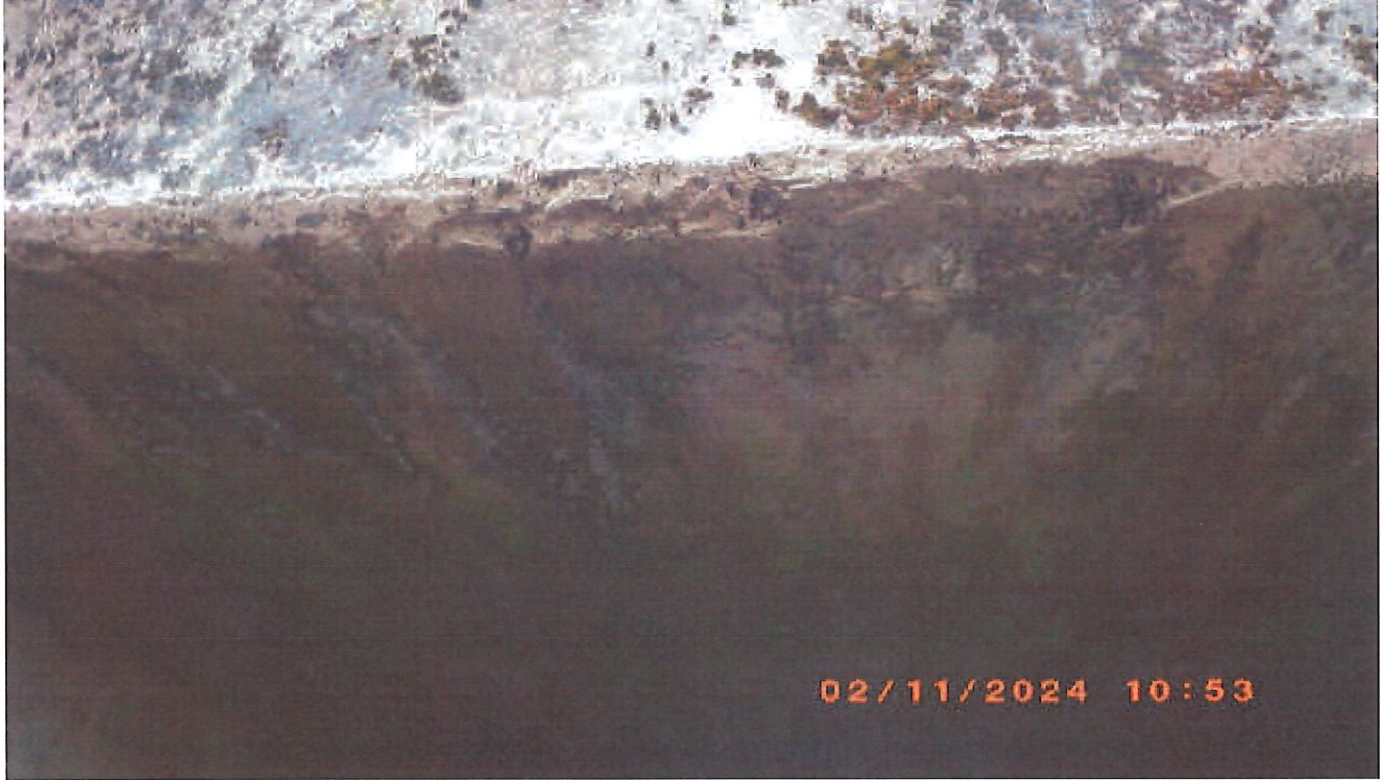
Spall on top of box, east end

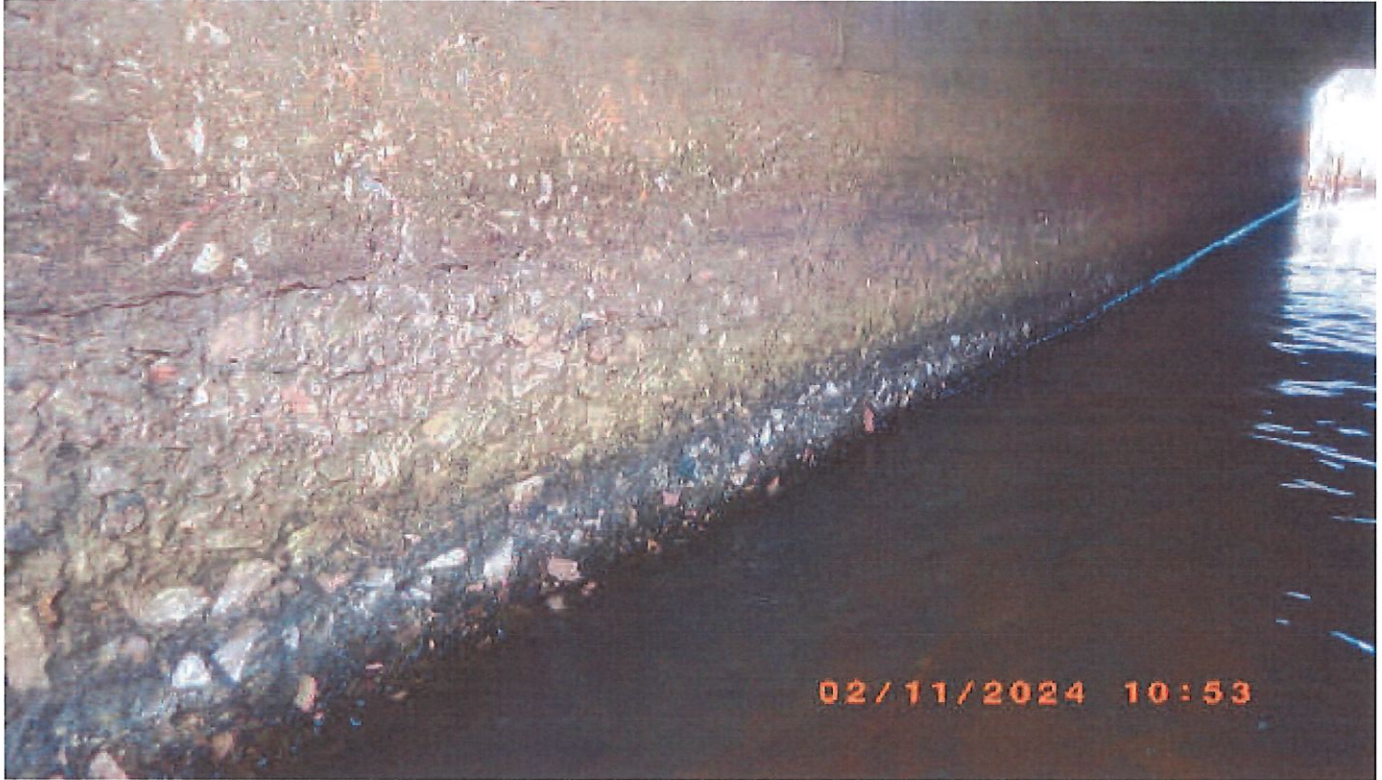
CS2 scaling on wetted perimeter of box

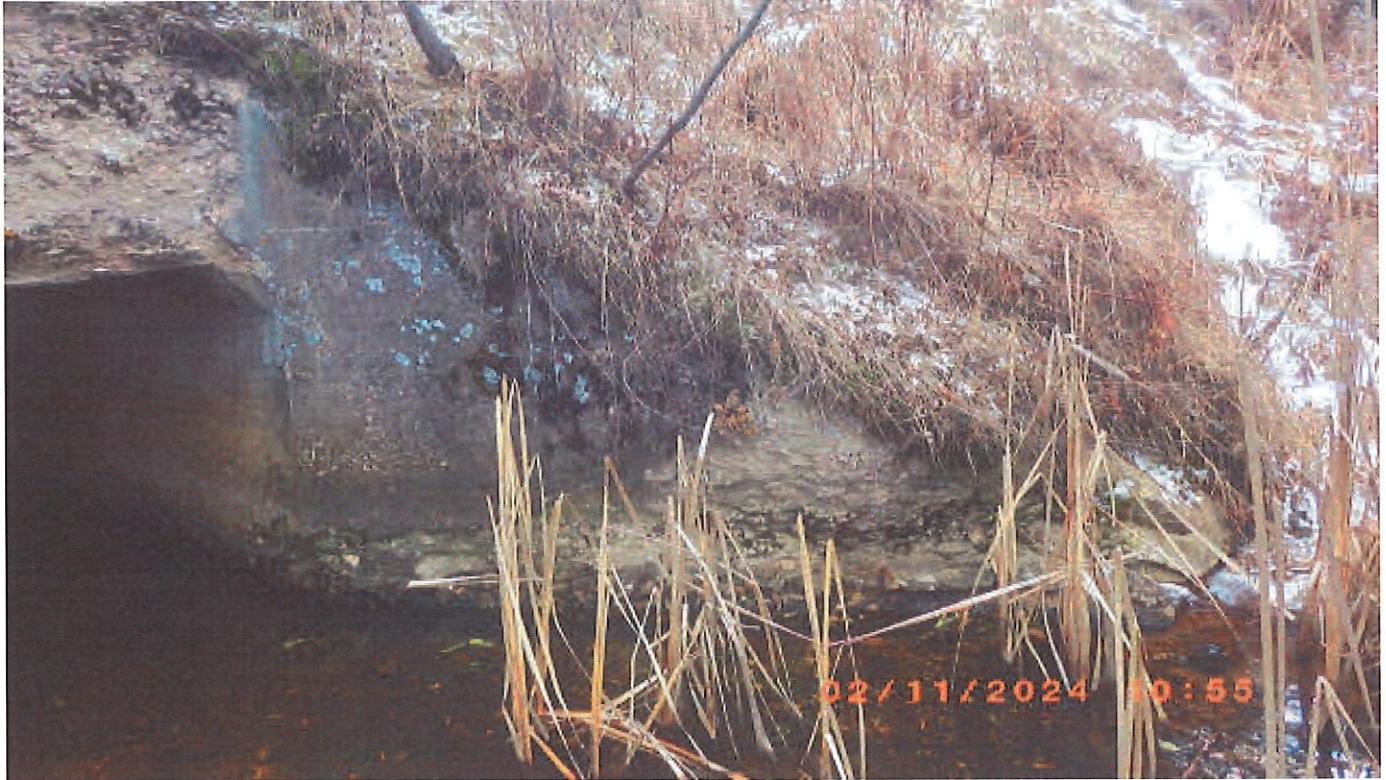
West end of the box culvert and wingwalls have extensive spalls. Borderline CS4, with the amount of section loss. NW wingwall is missing 1/2 of its thickness.

SW wingwall

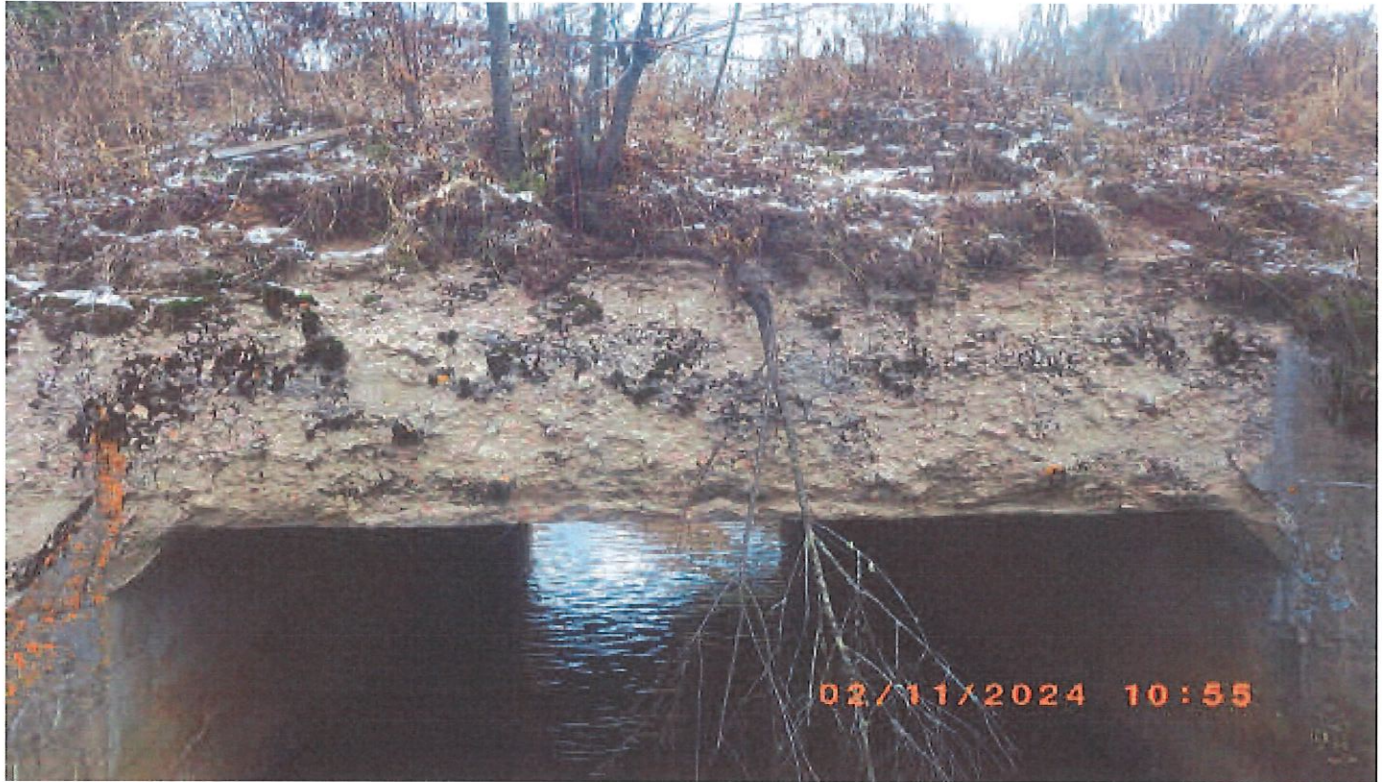
Top of box / headwall, west side

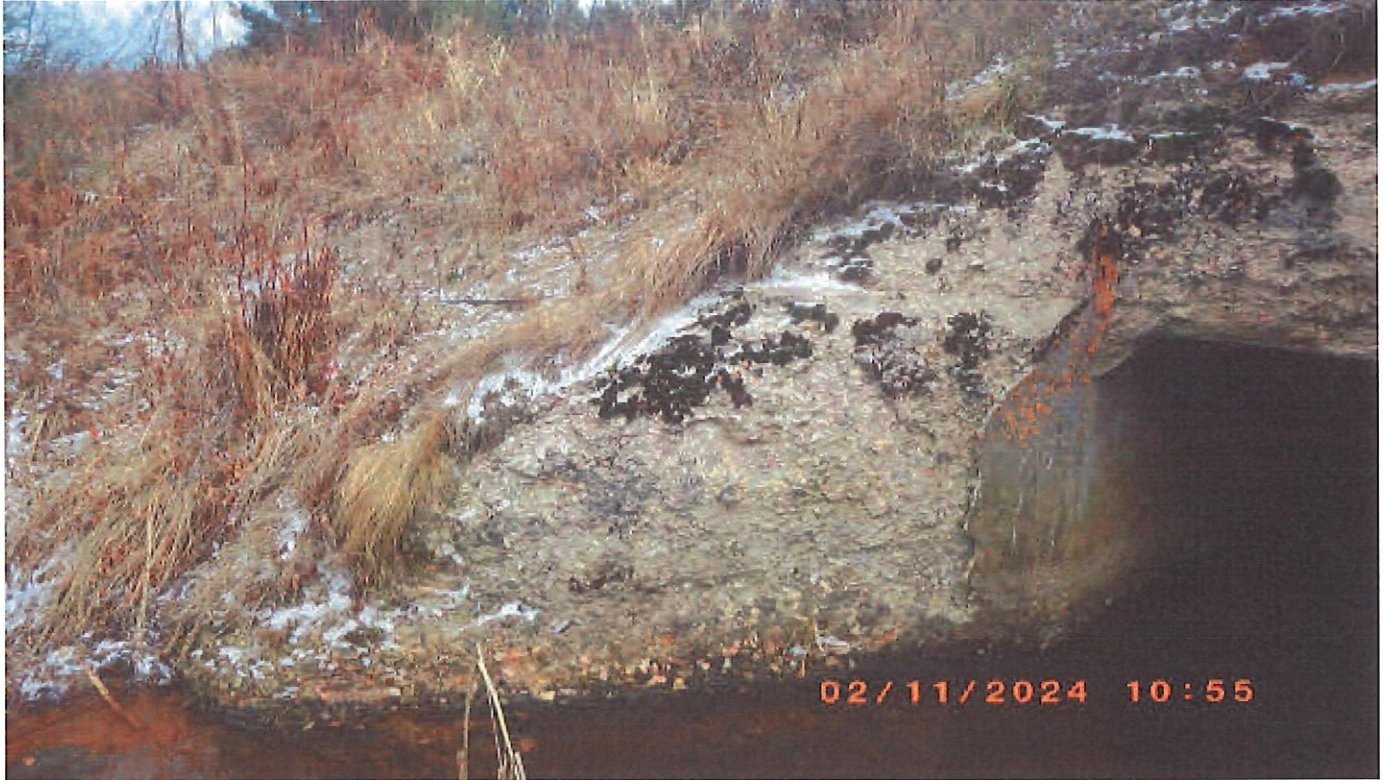
NW wingwall

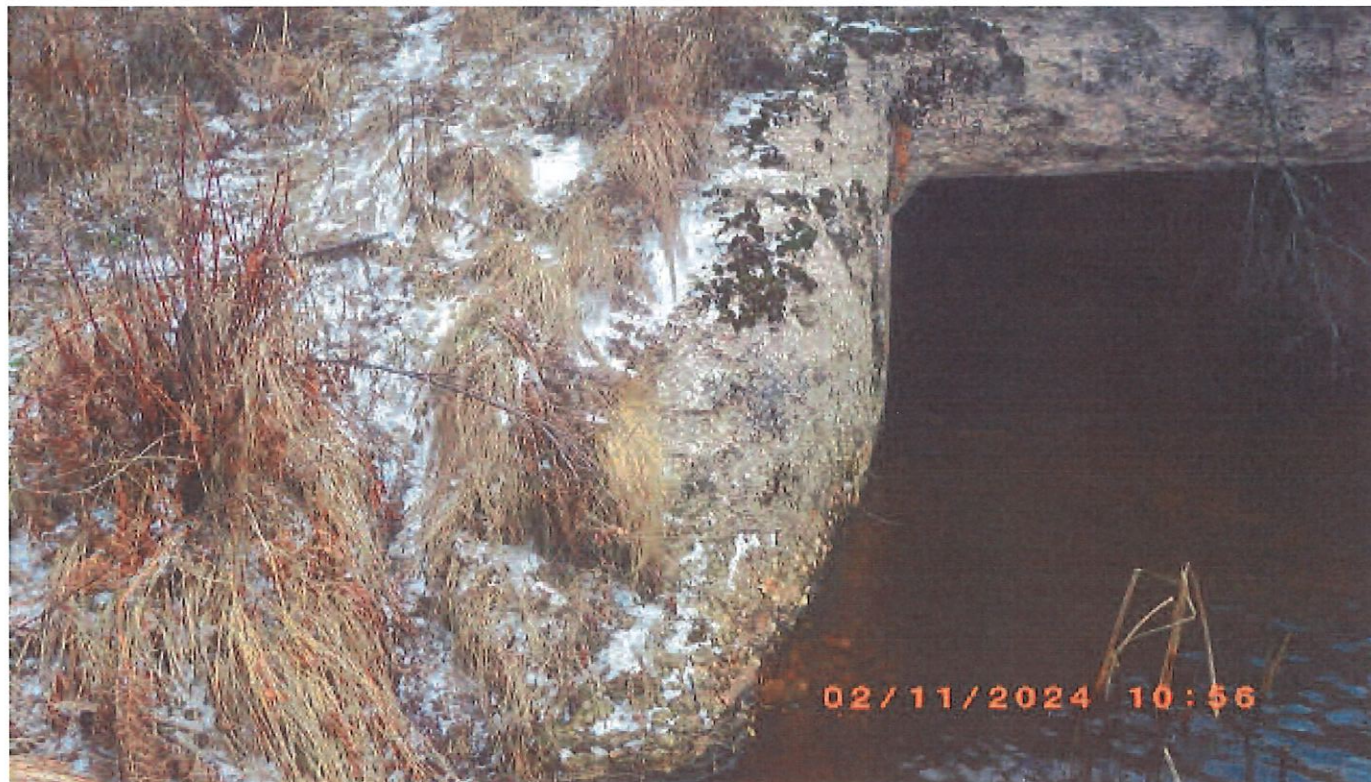
NW wingwall section loss
