#38 Oconto Bridge 23 Redeck

Motorized Recreation Grant Application

Inspection Report for

Oconto Co. Rec. Trail over Oconto River

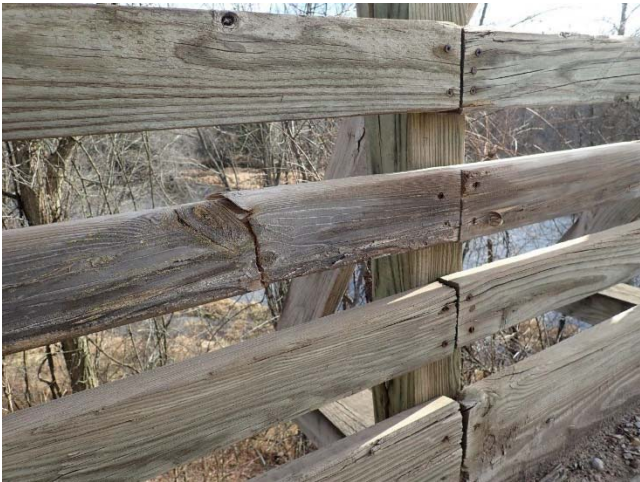
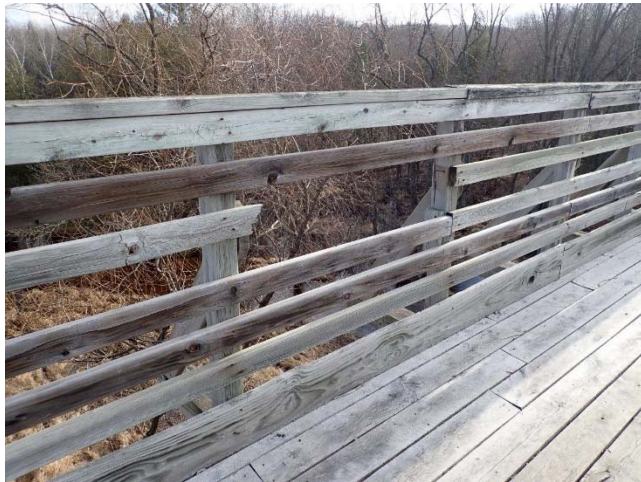
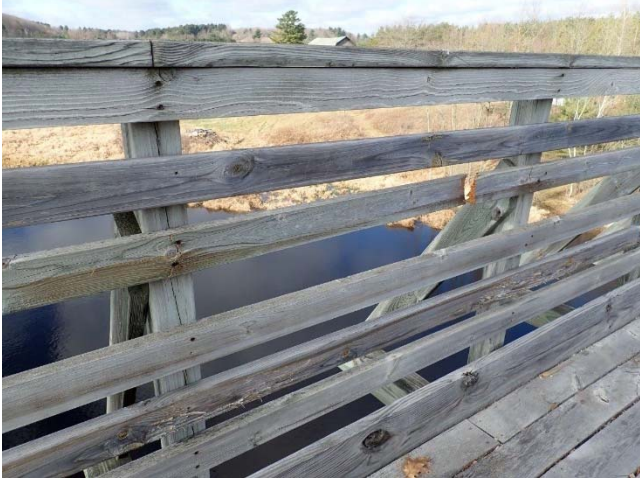
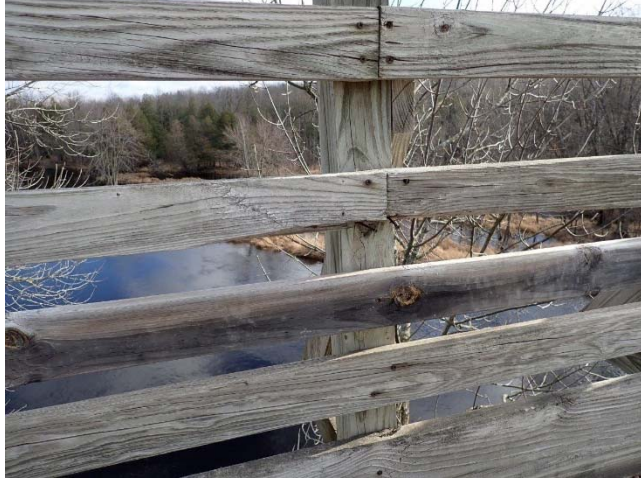
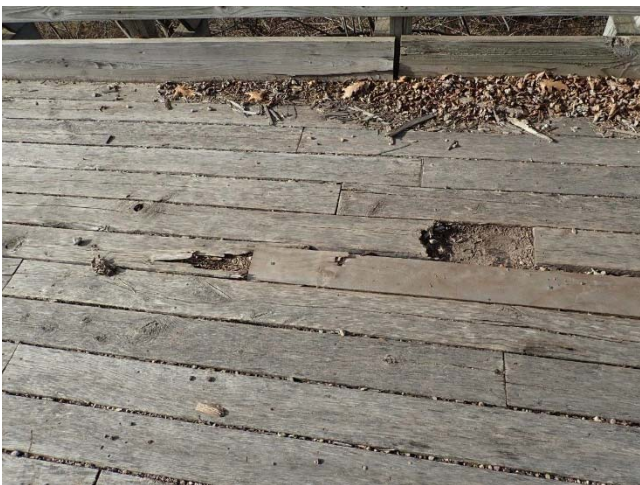
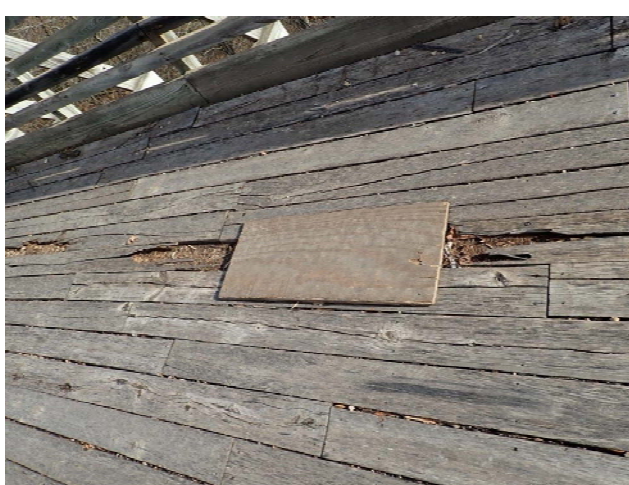
332		Timber Bridge Railing	LF	1064	1051	5	8	
-----	--	-----------------------	----	------	------	---	---	--

1900	Distortion				5	8	
--	------	------------	--	--	--	---	---	--

Railing shows signs of age but also has several damaged or decaying locations.

Item	Priority	Recommended by	Status	Status Change
Misc – Cut Brush	high	Epley, Brian (9712)	identified	
Plants and trees growing on piers need to be removed. Consider patching/filling joints to prevent future growth.				
Deck – Repair Railing	medium	Epley, Brian (9712)	identified	
replace broken and missing railing				
Deck – Patching	medium	Epley, Brian (9712)	identified	
replace broken and missing deck boards, replace previous repairs made with plywood

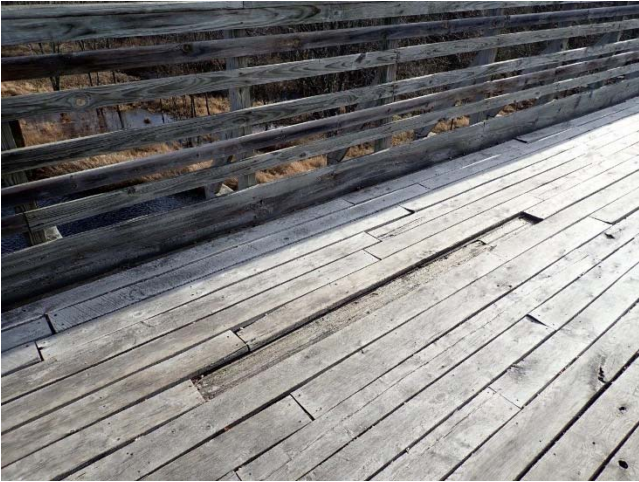
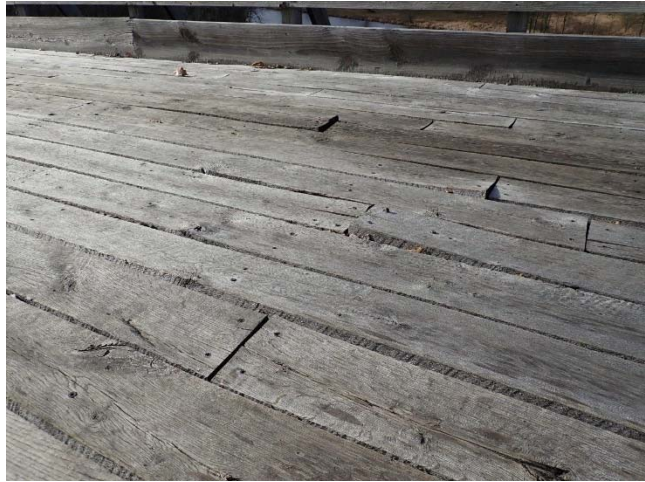
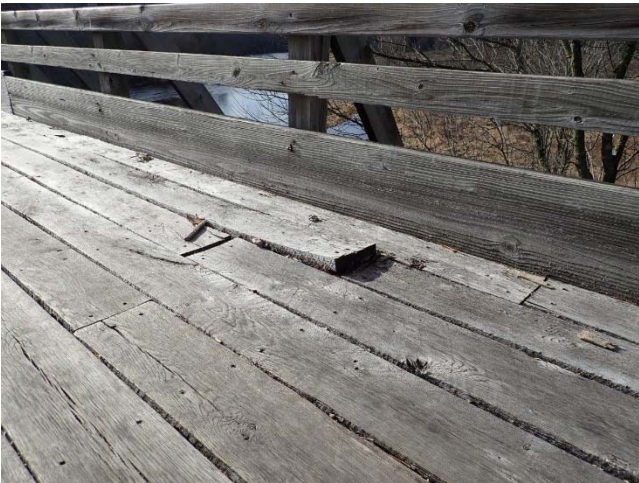
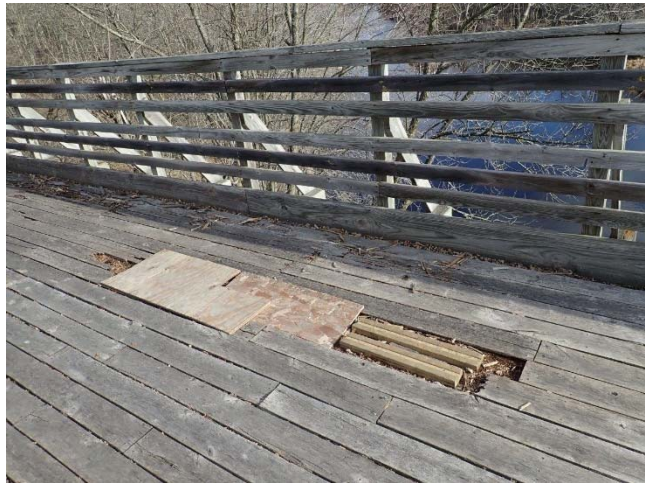
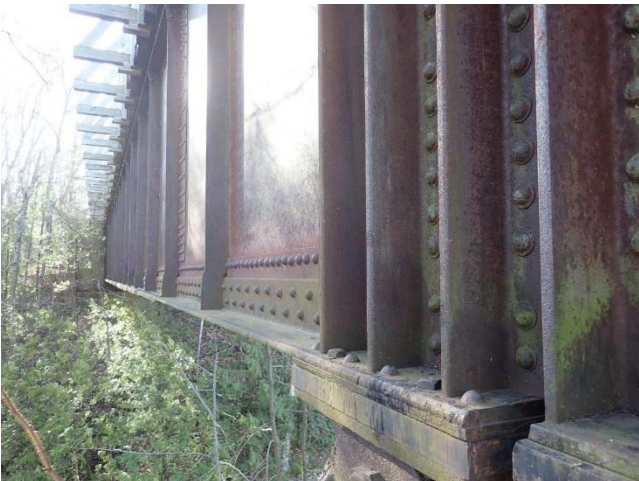
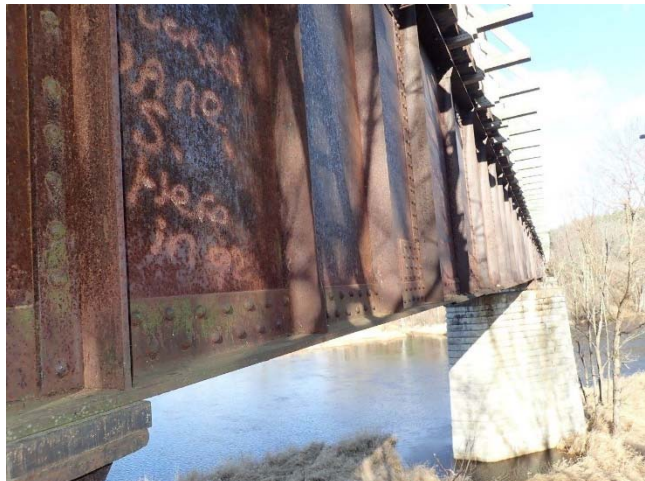
Element Inspection (x) Check Elements Inspected						Quantity in Condition States			
Ck	Elem.	Def.	Description	Unit	Total	1	2	3	4
	31		Timber Deck	SF	5320	5320			
Comments: unable to inspect bottom of deck, floor beams are tight together									
	510		Wearing Surfaces (Other)	SF	5320	5142	127	51	
Comments:									
	8912		Deterioration/Distortion – Wearing Surface				127	51	
Comments:									
	107		Steel Open Girder/Beam	LF	1056		1056		
Comments: 2 girders, built up sections with plates, angles, cover plates, and stiffeners. All connections are riveted.									
	1000		Corrosion				1056		
Comments: Freckled rust throughout, but no section loss was noted.									
	8516		Painted Steel	SF	31680				31680
Comments:									
	3440		Effectiveness	SF					31680
Comments: The majority of the steel is unprotected, what appears to be left of the paint is largely ineffective									
	210		Reinforced Concrete Pier Wall	LF	25		25

Wearing surface is aging but mostly intact. Several locations need proper replacements or repairs.

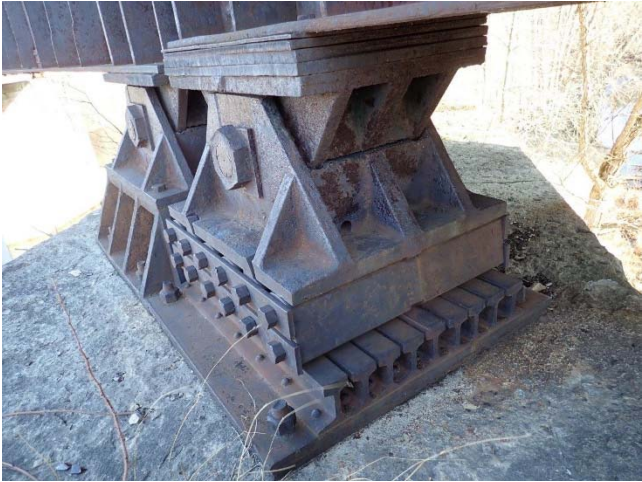
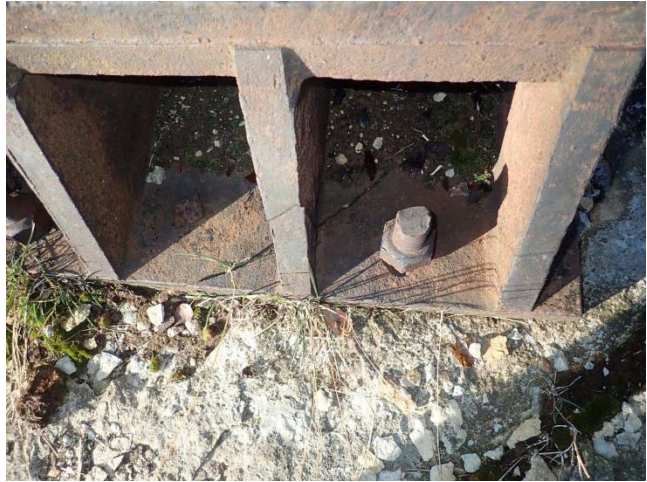
Comments: The east bearing at pier three has a crack throught the base plate and extending up through one of the vertical sections. With the lighter loads experienced by the bridge, this defect is not a significant concern.

Cracked bearing at pier 3, east side

Removal of all decking materials down to steel girders and replace and widen to 12' width and install new railings.
Repair crack in brearing located on pier 3. Repair cracks in concrete on pier tops to prevent further break down from vegative growth.

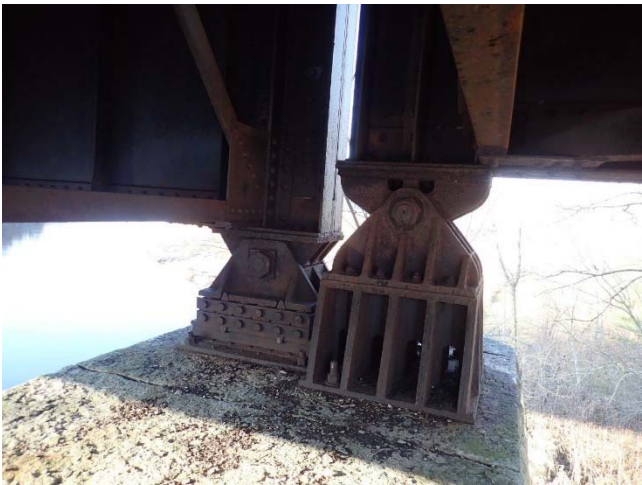
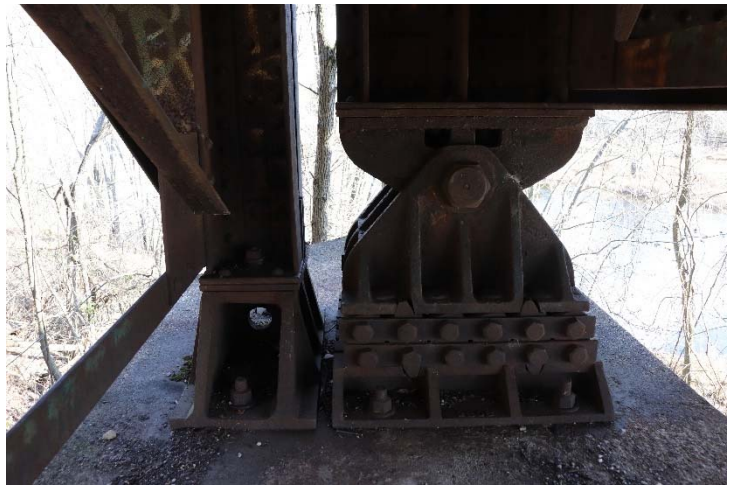
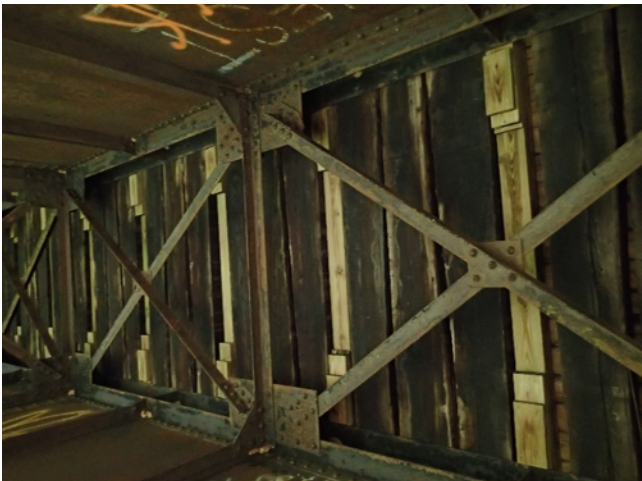
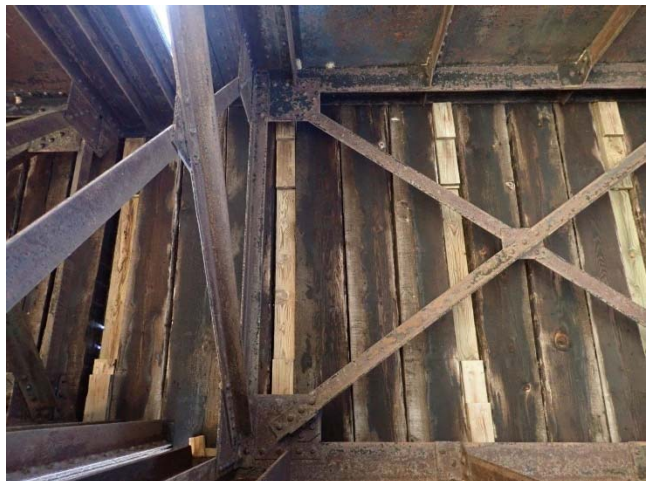
Bearings

Comments: The bearings have light freckled rust that does not appear to affect the operation of the bearings.

Comments: The bearings have light freckled rust.

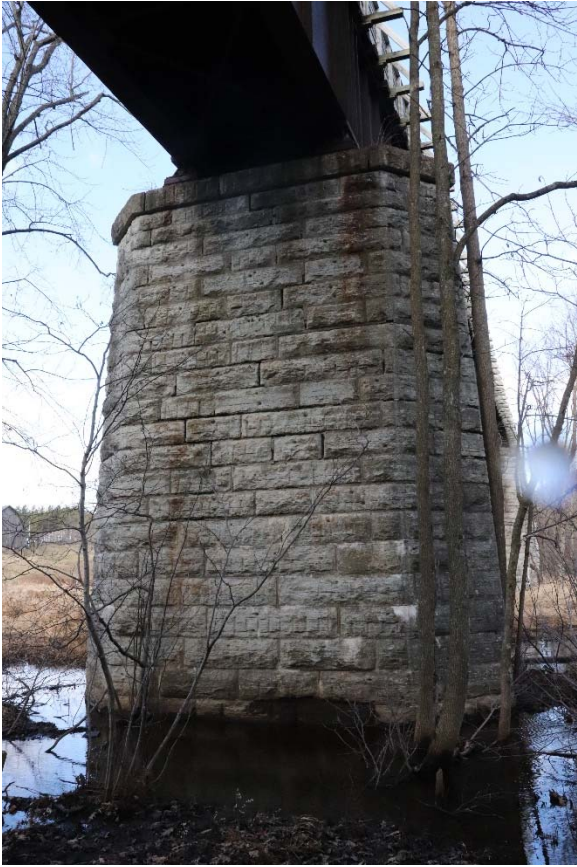
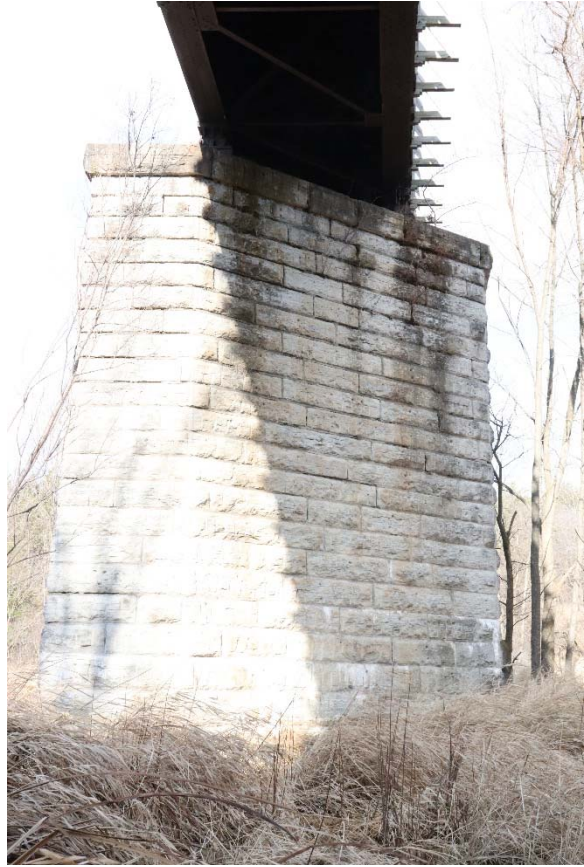
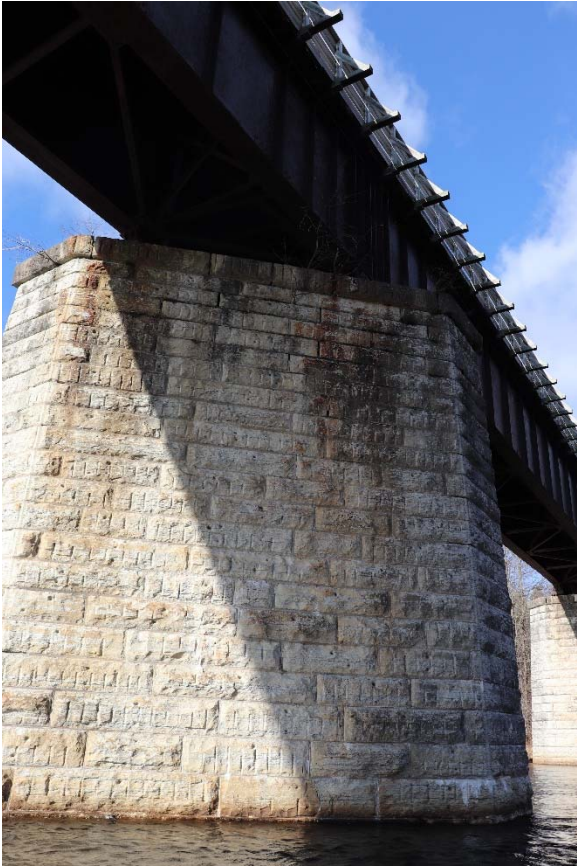
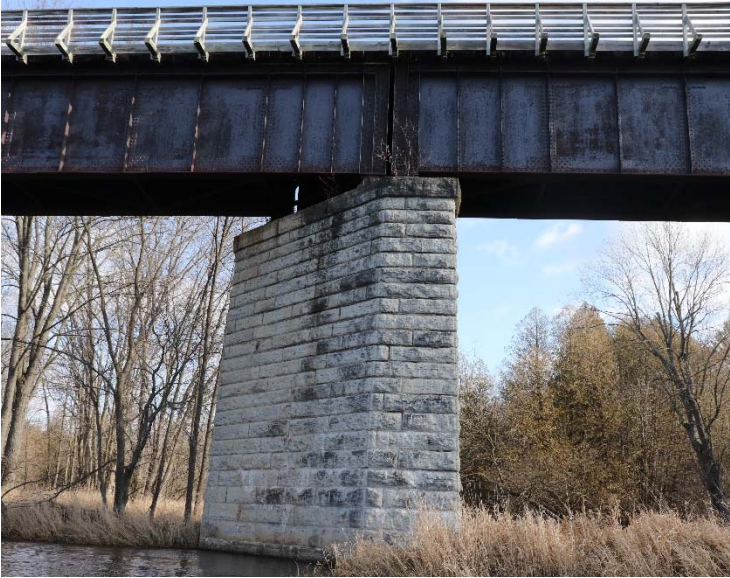
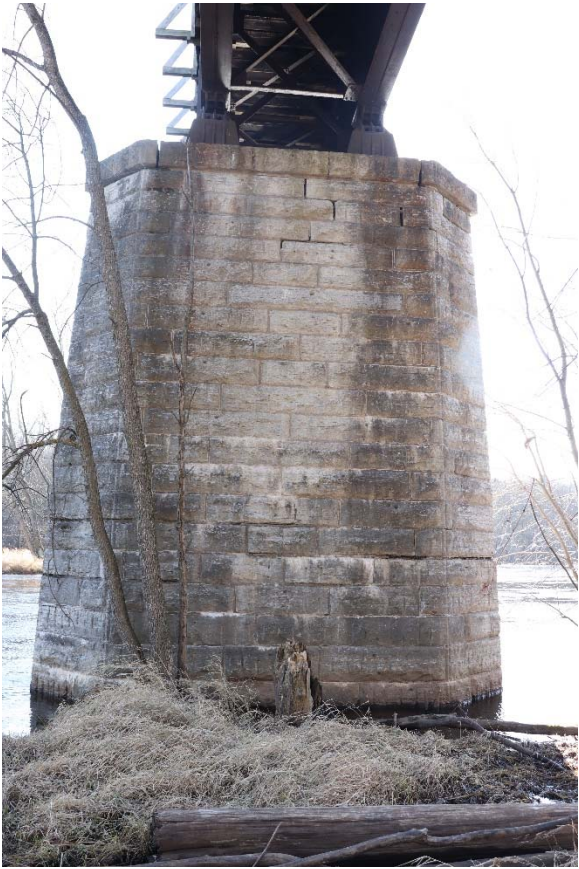
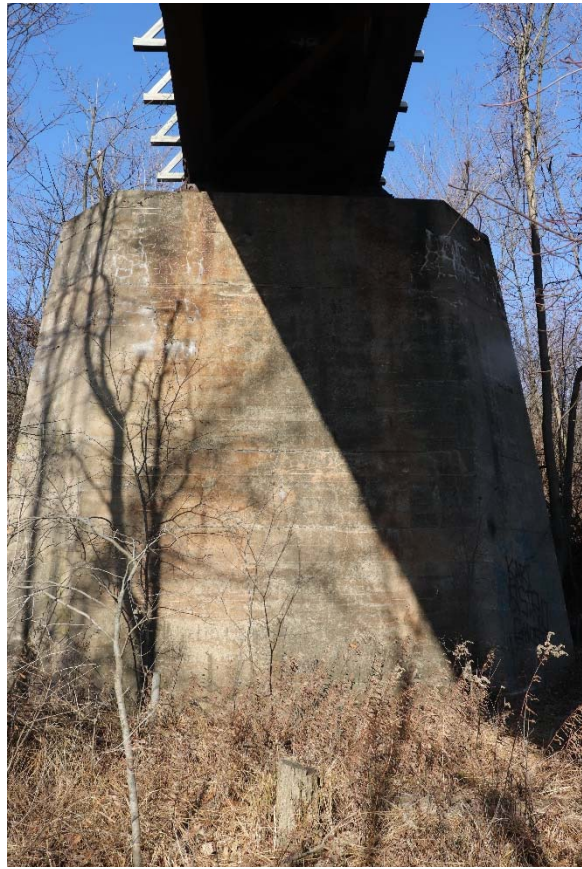
Comments: Pier 5 - Square									
	1130		Cracking (RC)/ Efflorescence				25		
Comments: Minor miscellaneous cracking throughout, some light to moderate efflorescence.									
	213		Masonry Pier Wall	LF	108		108		
Comments: Piers 1 & 4 - Square - 25', Piers 2 & 3 - Skewed - 29'									
	1610		Mortar Breakdown				108		
Comments: There are minor issues with joints breaking down and vegetation growing out of gaps, mainly in the caps. Vegetation must be removed. Consider filling gaps.									
	215		Reinforced Concrete Abutment	LF	38		38		
Comments: S. Abut - 20', N. Abut. 18'									
	1130		Cracking (RC)/ Efflorescence				38		
Comments: Minor miscellaneous cracking throughout, some light to moderate efflorescence. Concrete behind the girders at the north abutment is scaling.									
	311		Movable Bearing	EA	10		10
