#7 Oneida Tomahawk River Bridge Redecking

Trail Bridge Inspection

Tomahawk River (S)

Bridge Inspection Report

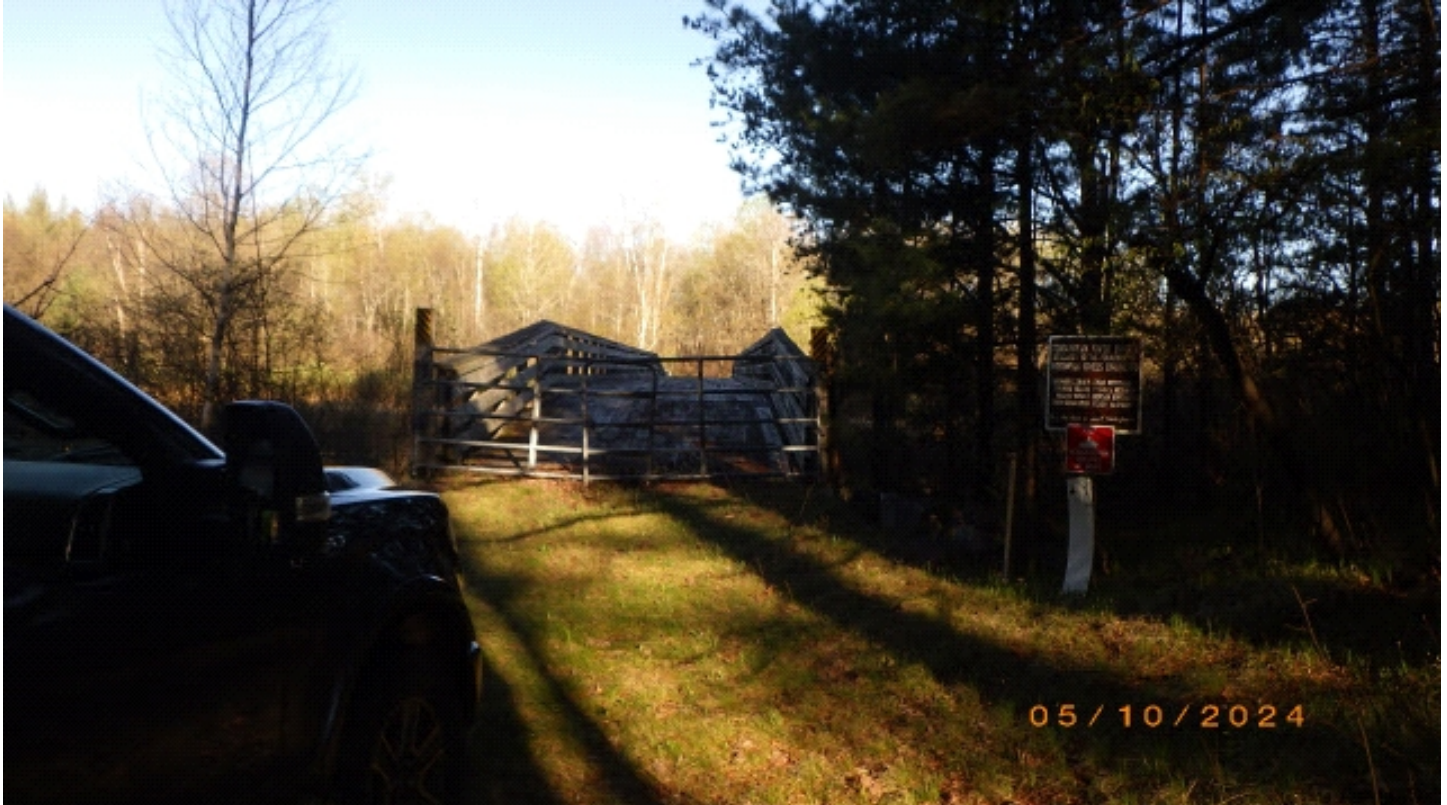
Looking West

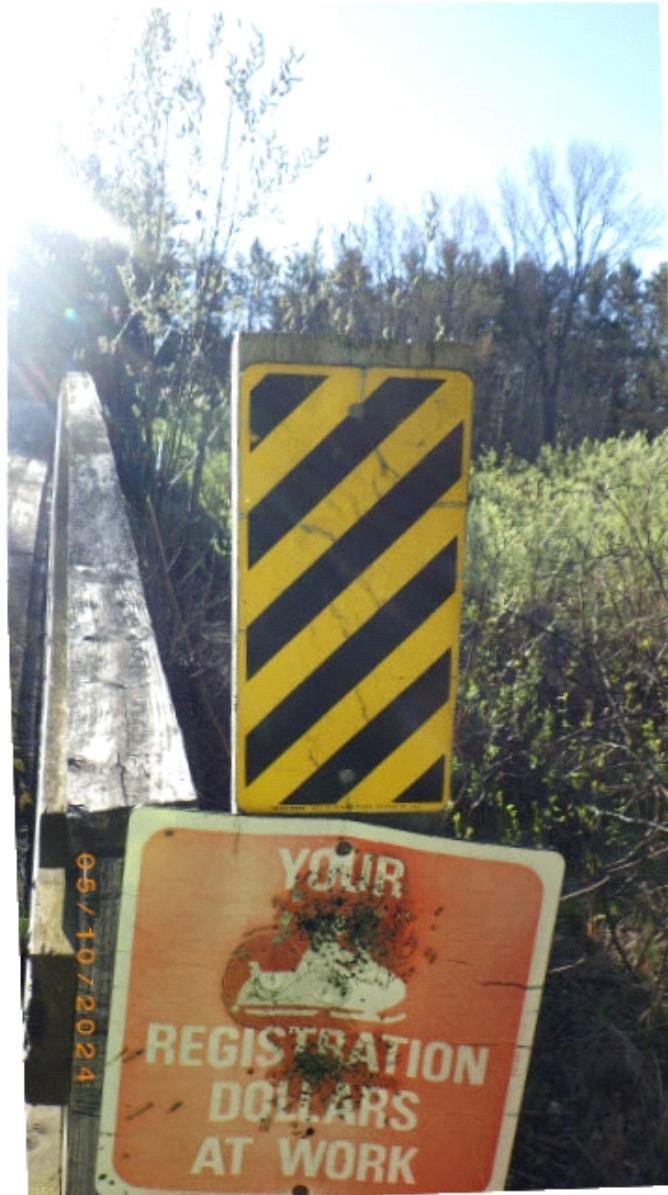
All 4 object markers have CS2 scratches.

CS2 Object Marker SW

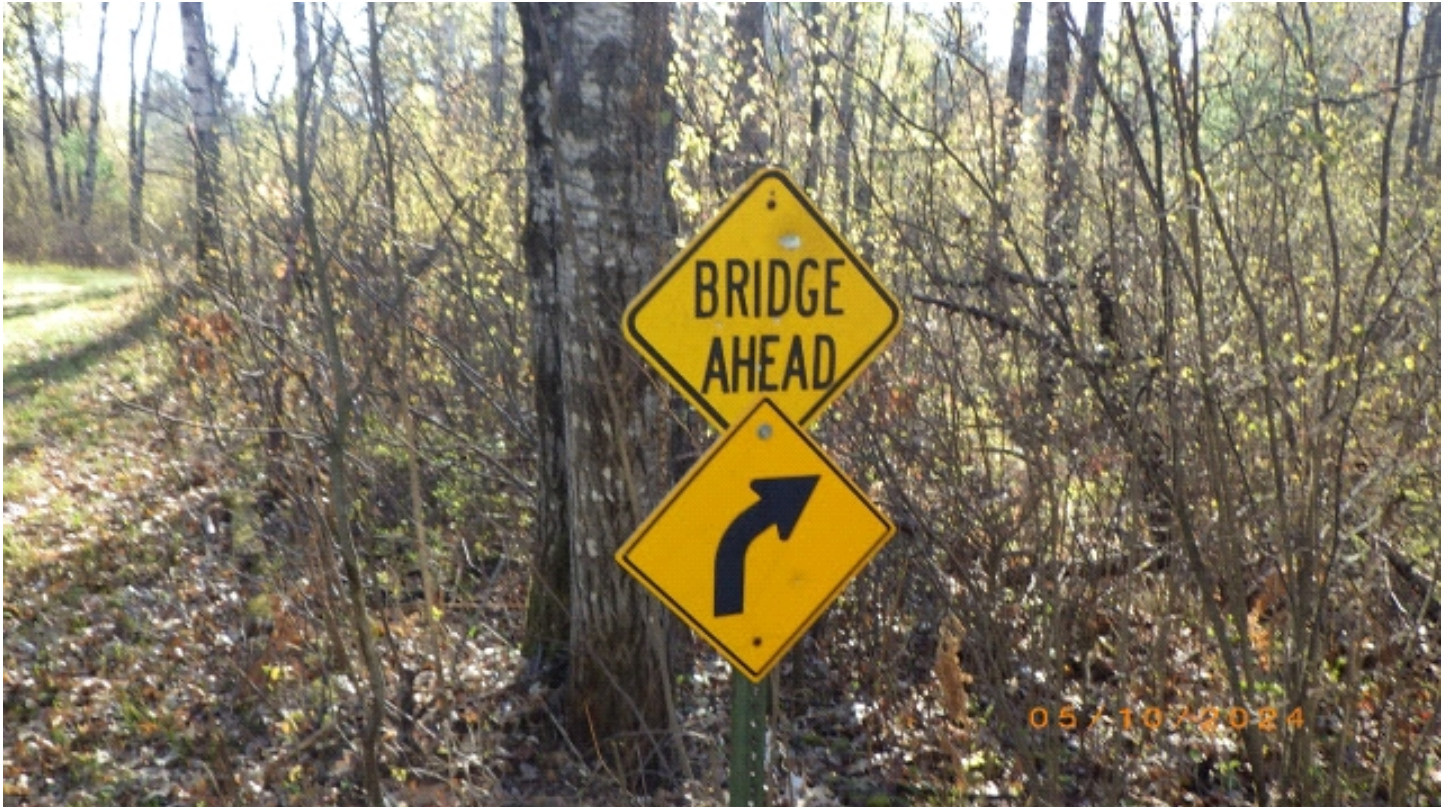
West Bridge ahead is CS2 with minor damage, East CS1.

CS2 Bridge Ahead sign, West End.

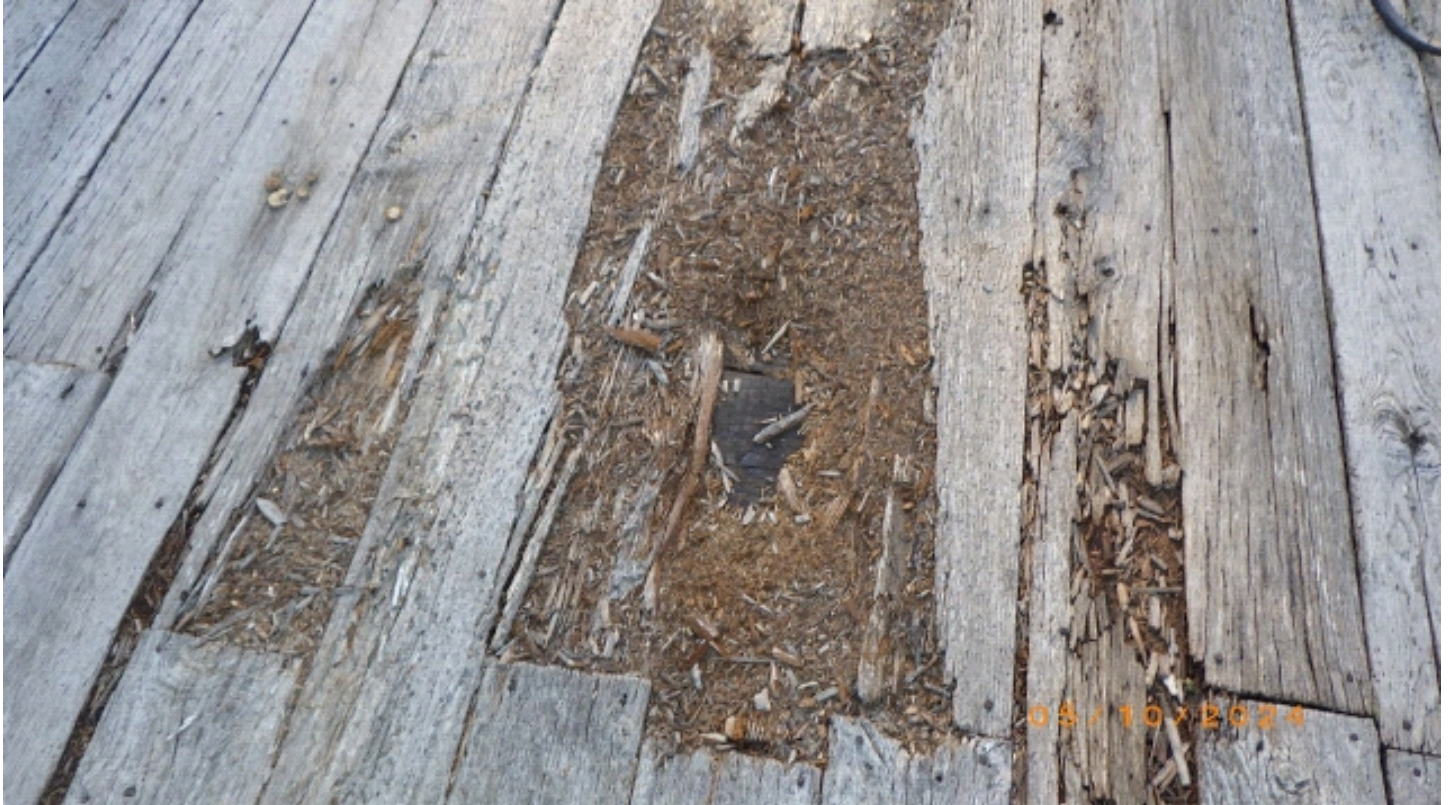
The wearing surface is past any useful life or use.

CS4 Wearing surface, typical.

***Replace the wearing surface, it is not doing anything but having screws poking out, in 2024.

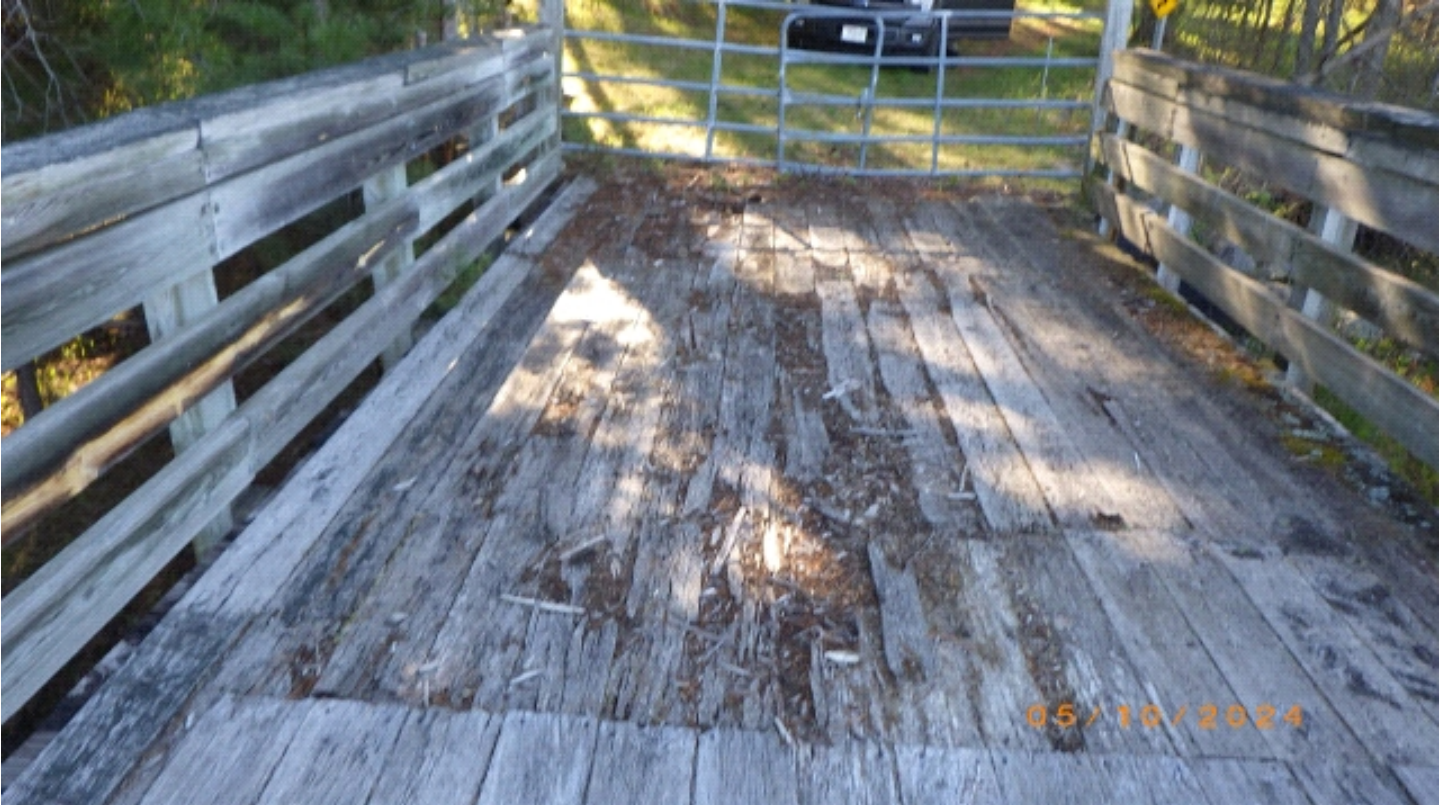
CS4 wearing surface, typical.

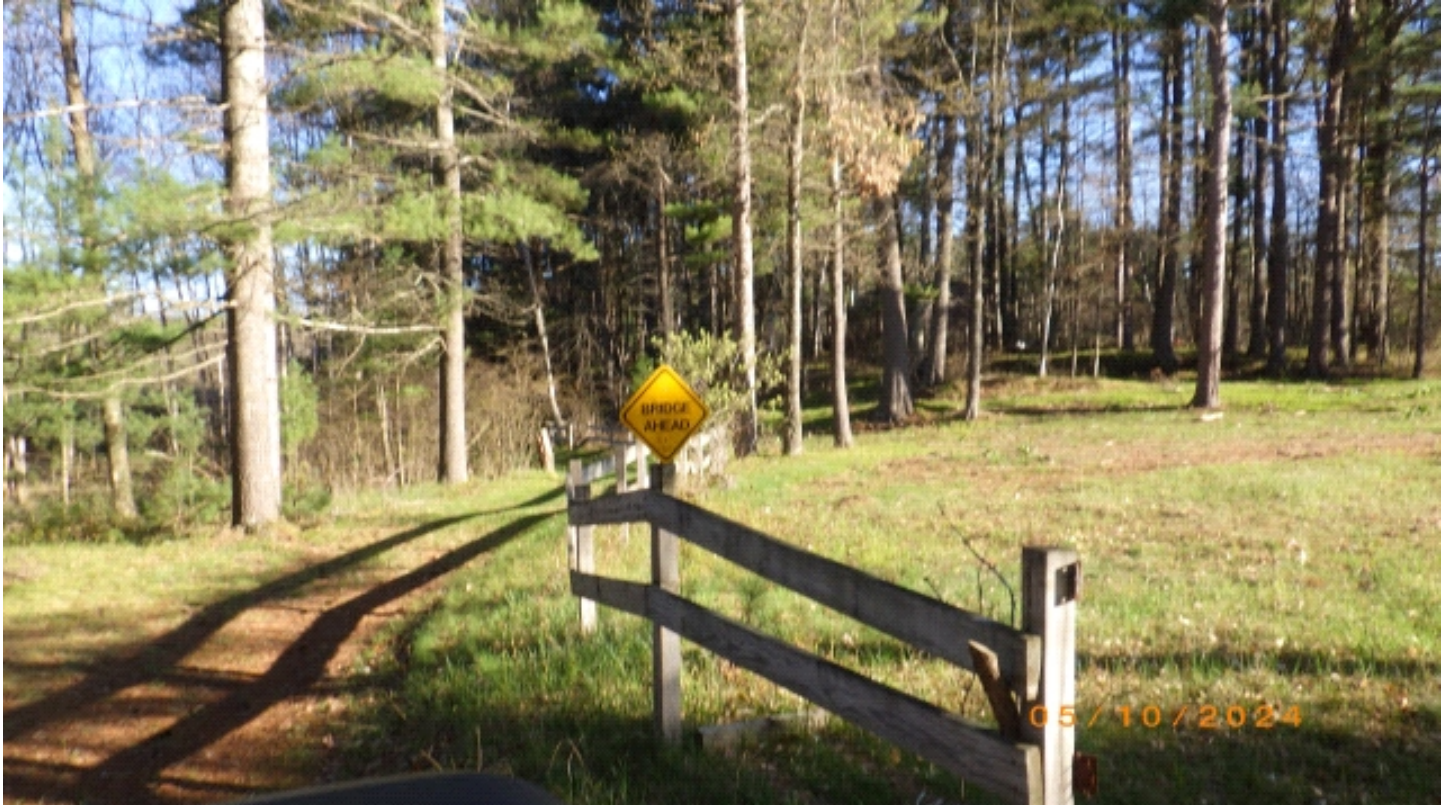
East Bridge Ahead Sign.

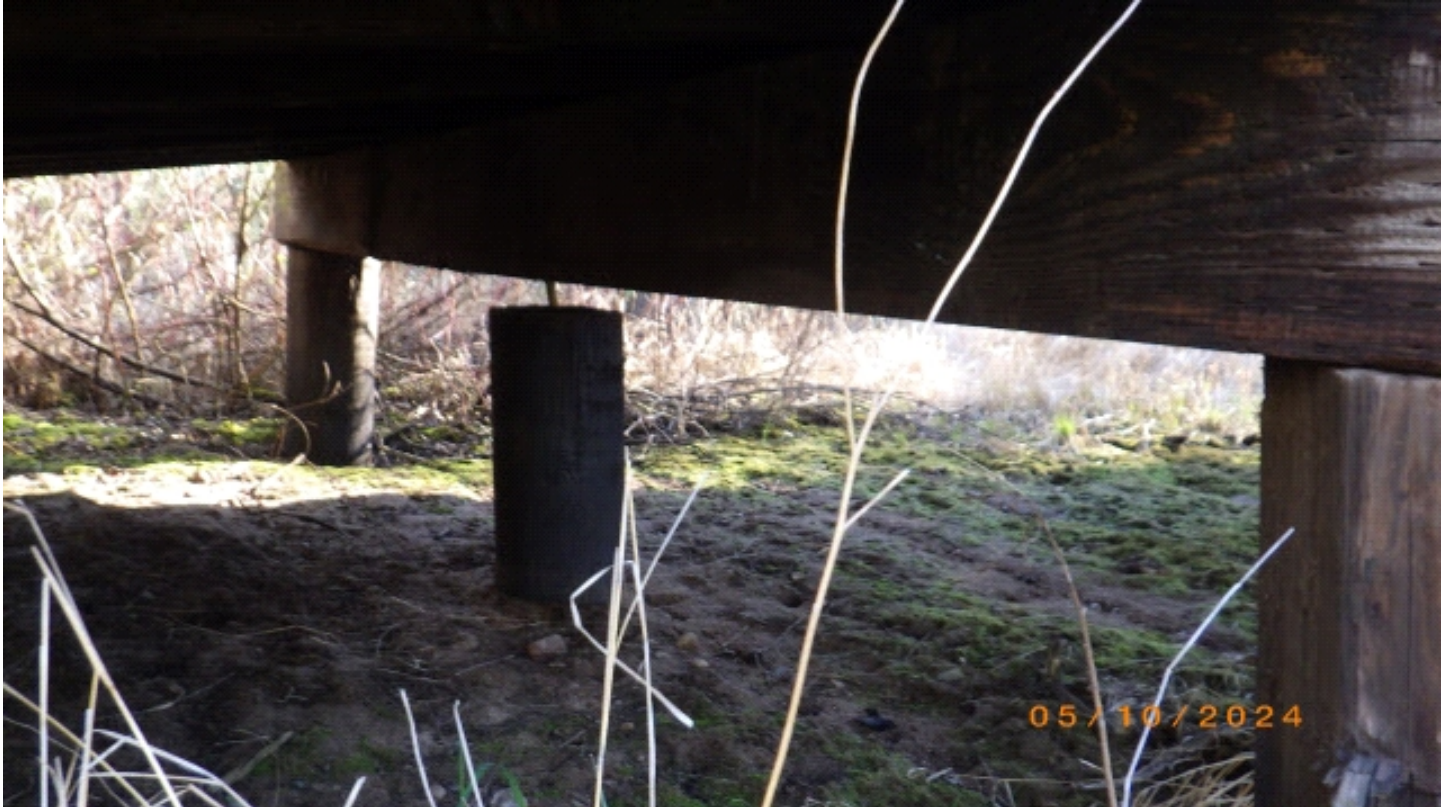
P1, and P2 have gaps on the middle piles the space should be filled to prevent damage to the pile cap.

P1 and P2 gap at middle pile, fill space to protect pile cap under load.

Wedge piles on P1 and P2.

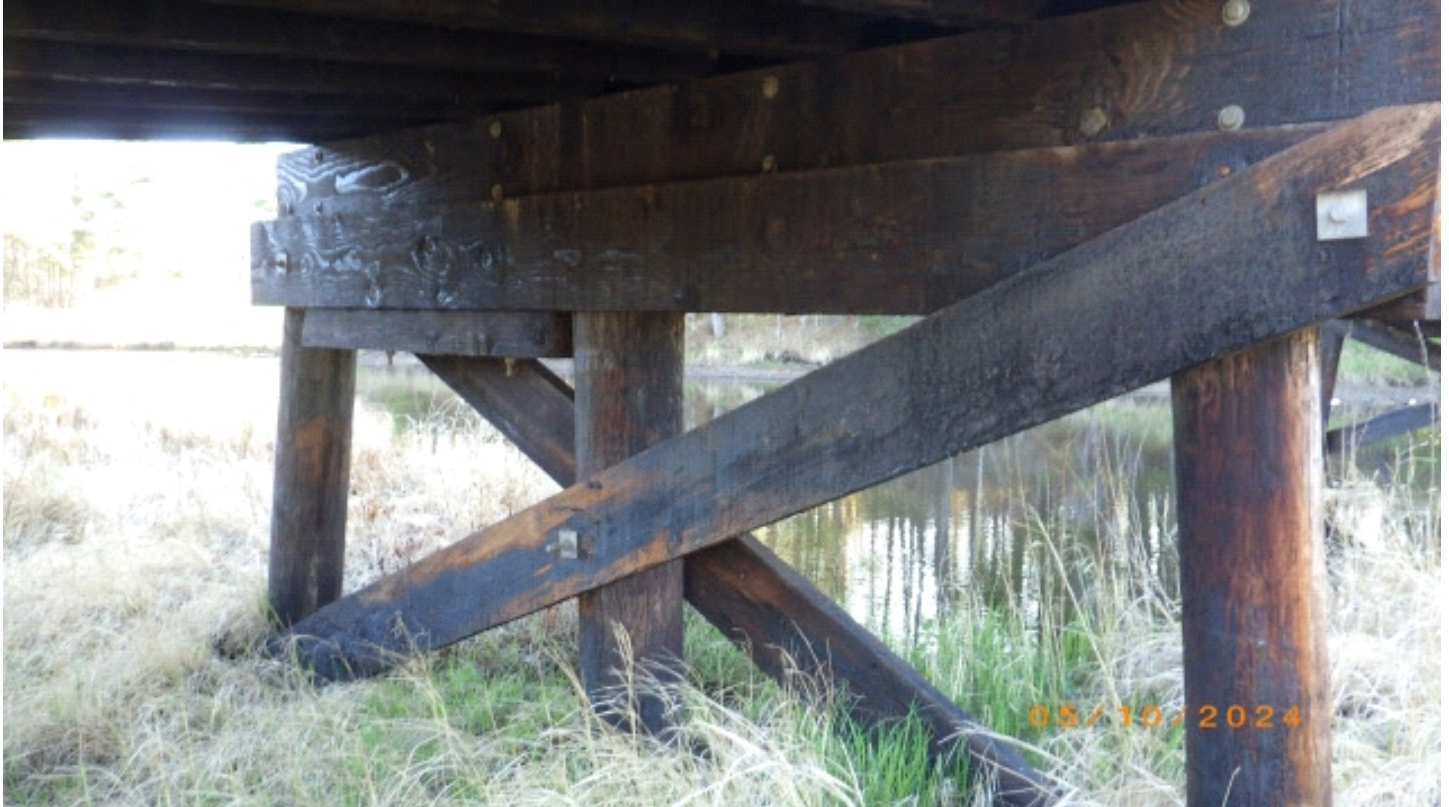
Piers are 3 piles, approx 12 inch diameter, pile caps (Cracks and Checks) with cross bracing. All CS2.

Pier along channel, typical.

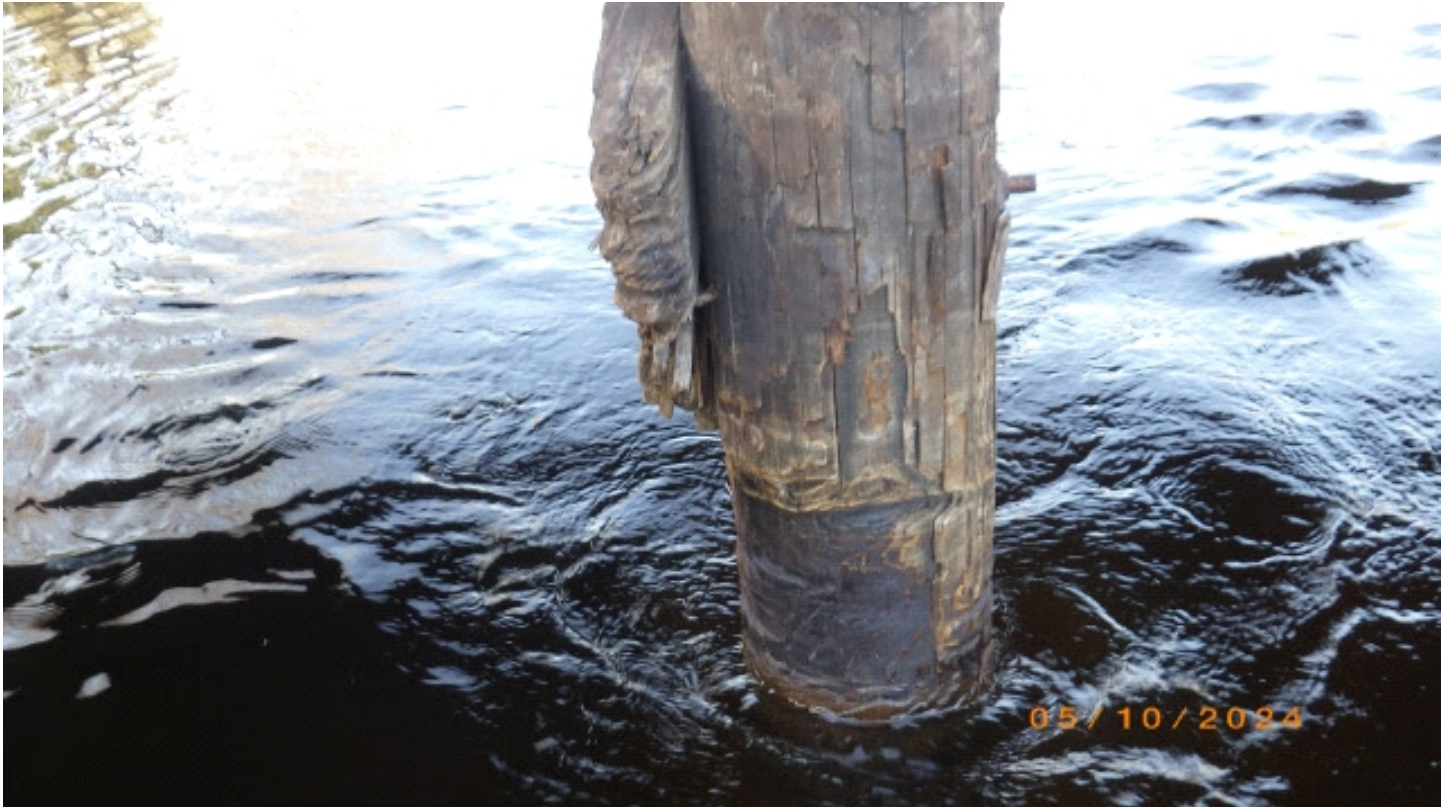
There is wear on the upstream piles in the channel from debris build up

Wear from Ice and Debris on upstream pile in channel, typical.

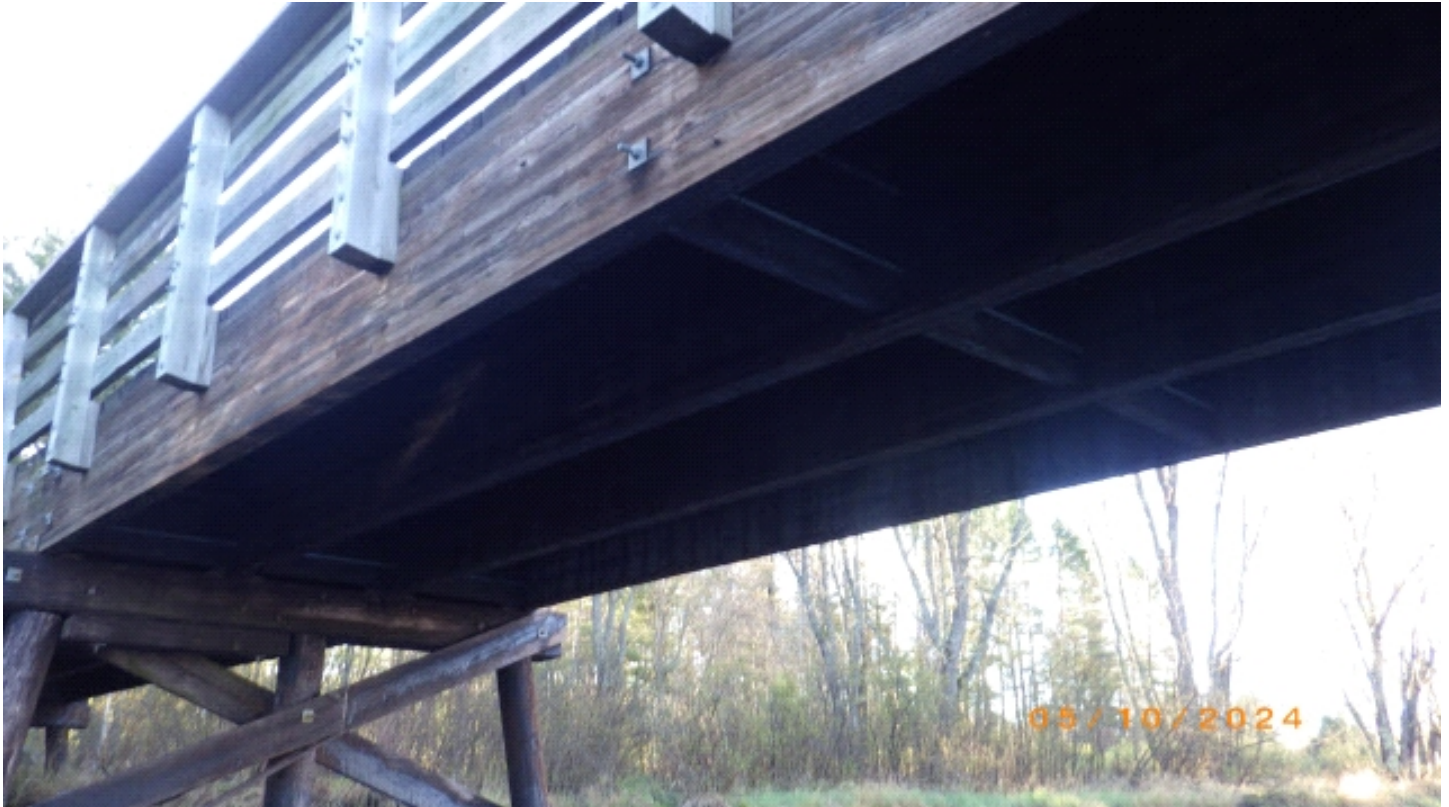
Middle spans are 4 girder glulams, the exterior girders are weathered on the exterior, CS2.

Glulam Span, typical.

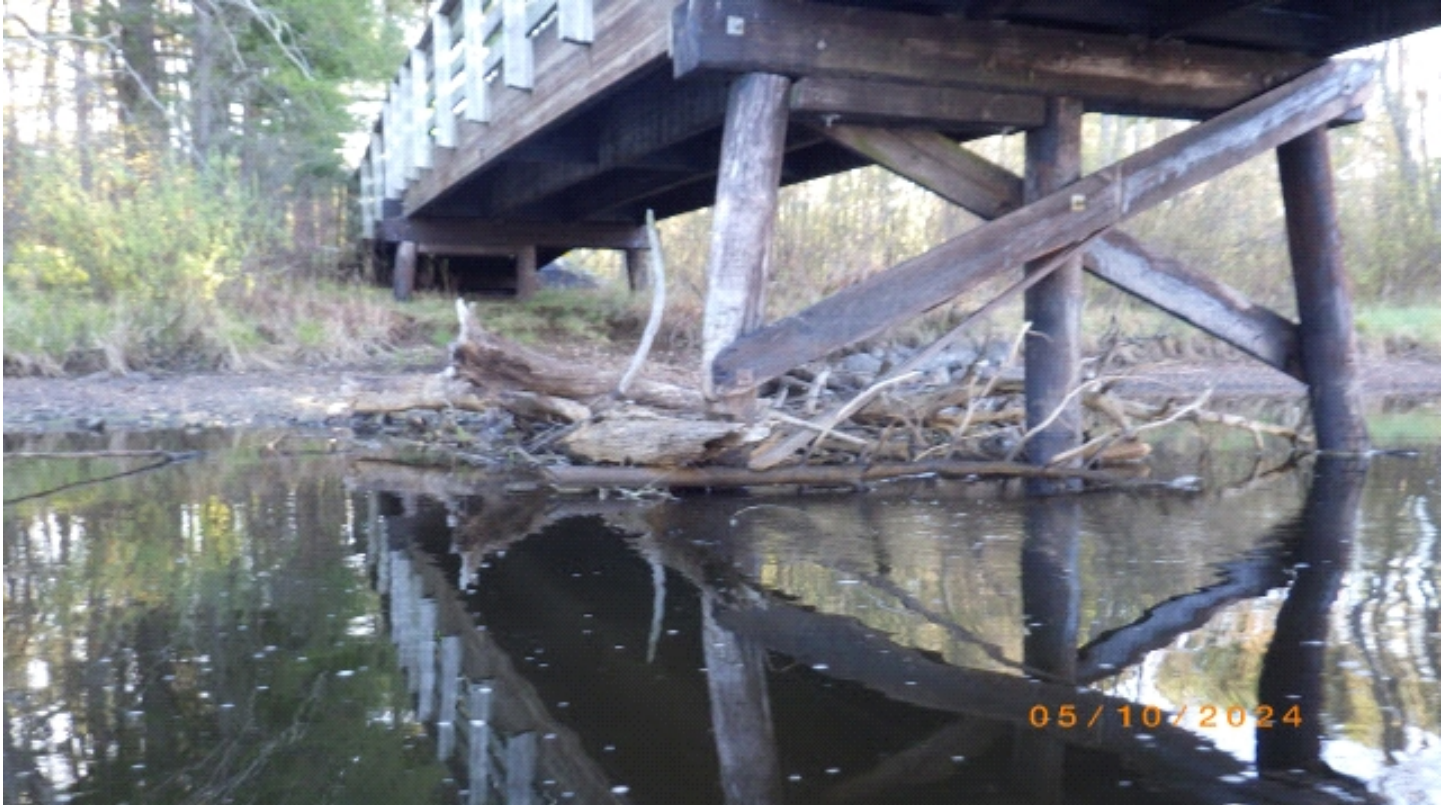
Significant debris in channel along P5. This can be very serious if not removed.

Remove debris on P5, cause scour of the channel which can be catastrophic.

Remove channel debris at P5.

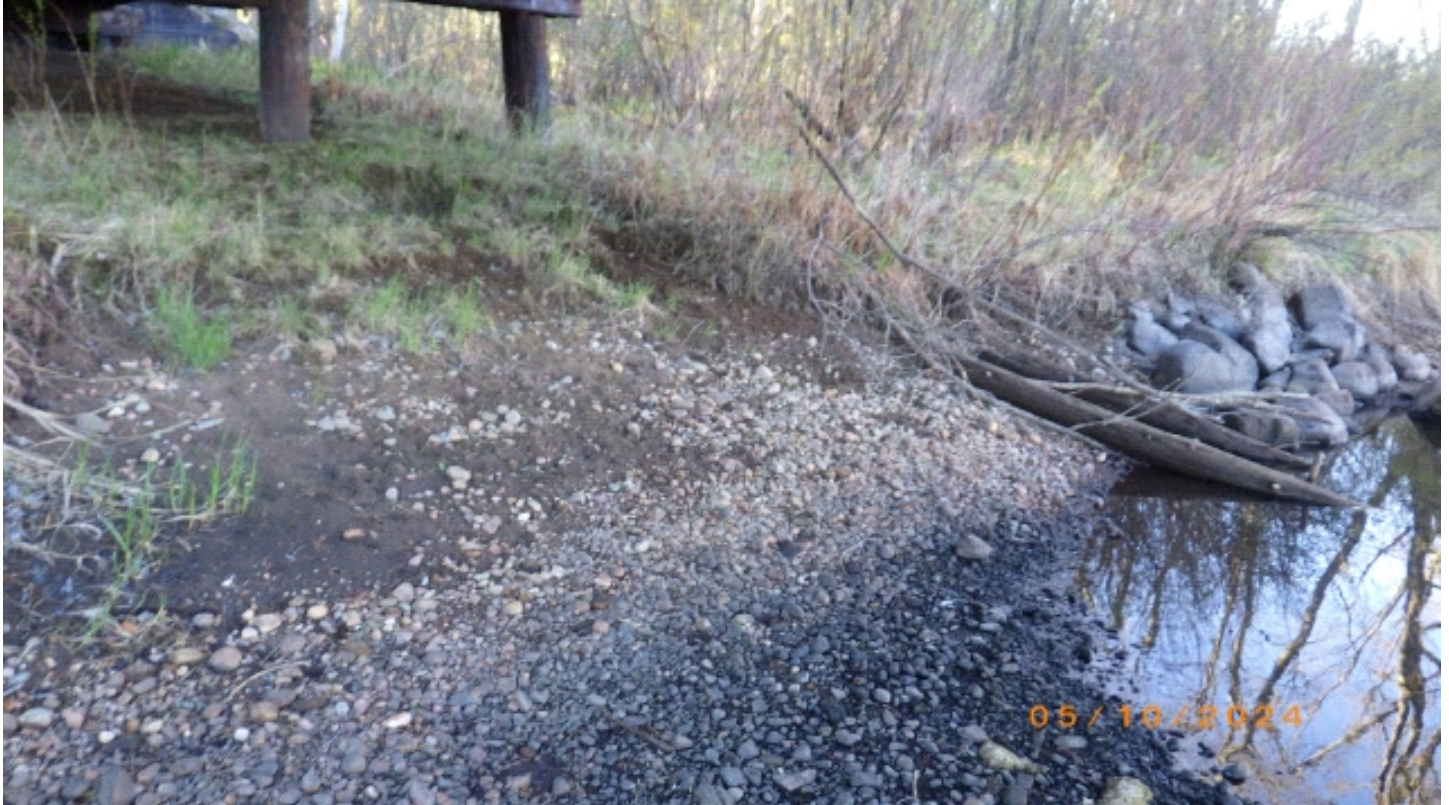
Add more riprap to protect the channel slope.

Add rip rap to East side of the channel.
