### #33 Douglas Olson Meadow Dam Culvert

## Motorized Recreation Grant Application

Project Title Douglas County trail 7 Culvert replacement					Current Funded Miles 355	New Miles (if applicable)
County Douglas	Township 41 N	Range 11	Section 6	¼ ¼ ¼	GPS Coordinates: Lat. _____ Long. _____

# OLSON MEADOWS FLOWAGE FF 16.22 2020 DAM SAFETY INSPECTION

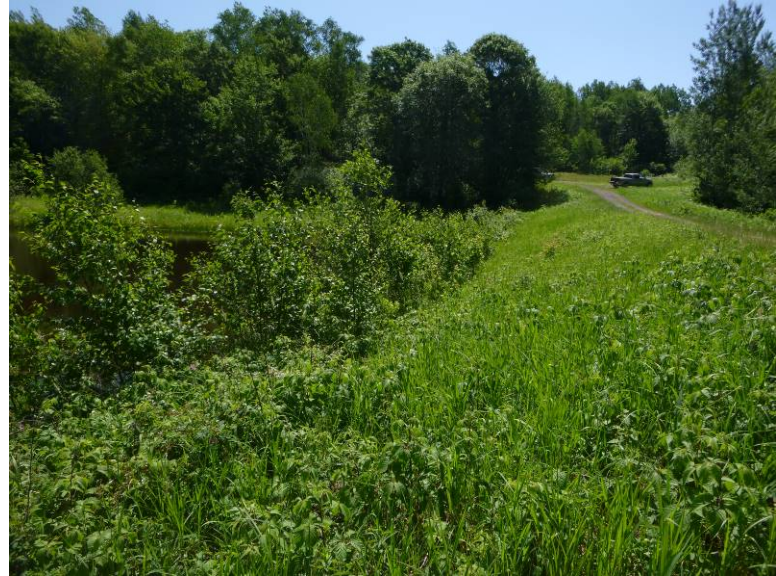
- 2004 inspection noted seepages on toe of dike @ 40-75' left, 100' left, and 220' right of structure.
- 2011 inspection no flow noted.
- 2020 inspection no flow noted.
- 2020 inspection noted woody growth requires removal.

Woody growth on US embankment requires removal.

- Woody growth requires removal on the upstream side of the embankment.
- A joint in the CMP outlet pipe is rusted through (perforated) and requires repair.

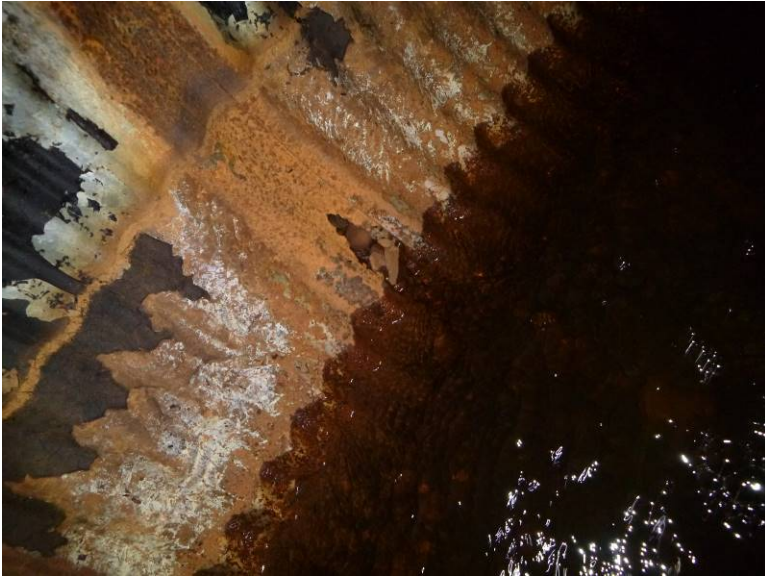
1. The CMP riser and CMP outlet pipe show no signs of perforations, but the outlet pipe joints are showing some signs of leakage and corrosion.
  - 2004 no perforations noted.
  - 2011 no perforations noted.
  - 2020 perforated joint noted approximately 20' in from outlet of pipe.

OUTLET CONTROL STRUCTURE IS IN OVERAL GOOD CONDITION. THE 48" CMP PIPE HAS ONE AREA THAT IS RUSTED THROUGH (SEE ATTACHED PHOTOS. THE DAMAGE IS APPROX. 20' IN FROM THE DOWNSTREAM END OF THE PIPE. THE DAMAGE DOES NOT POSE AN IMMEDIATE THREAT TO THE DAM, BUT DOES REQUIRE MAINTENANCE.

Rust damaged pipe. Approx. 20' in from outlet.

It is the recommendation of Long Island Engineering LLC to repair the perforated joint in the CMP outlet pipe within 5 years.

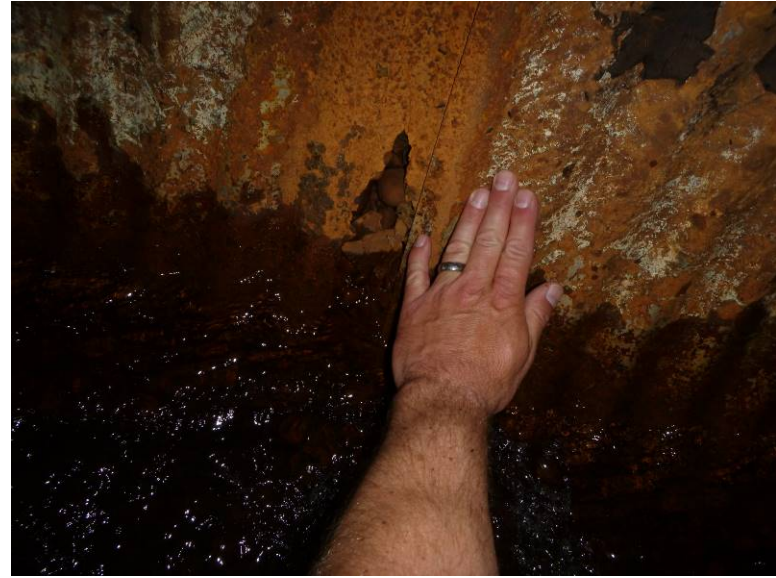
Same rust damage.

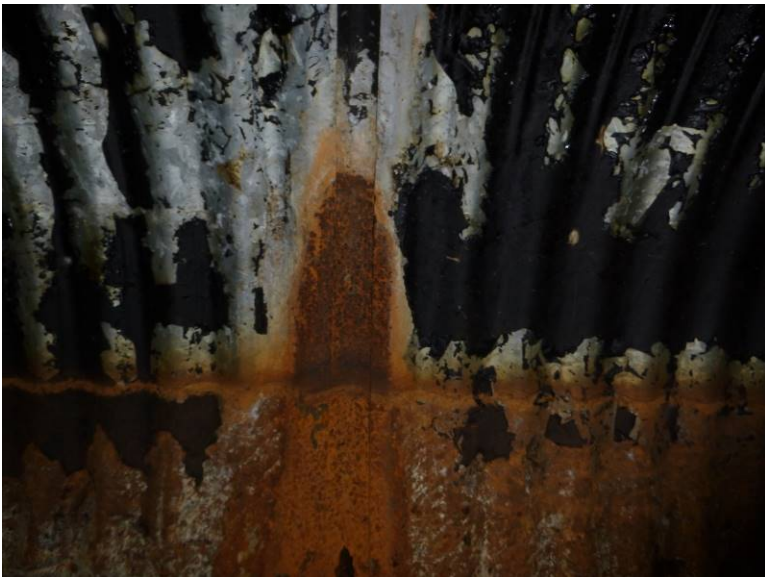
Same rust damage. Damage is at joint of two pipes. The banding is rusted through.
