**A-02 Tri Co (Cheese Country) Bridge #40**

Project Title Cheese Country Trail Bridge #40 Replacement					Current Funded Miles		New Miles (if applicable)	
County Green	Township 01 N	Range 6	Section 5	¼ ¼ SE	¼ SW	GPS Coordinates: Lat. 42.580256 Long. -89.809841

Bridge ID / Structure No.  <b>Bridge #40</b>	<b>Inspection Date:</b>	11.20.2025
	<b>Inspection TL:</b>	Nate Miller, PE
	<b>NBI Project No:</b>	2503501

Inspection Report for  
**Bridge #40**  
Cheese Country Trail over Pecatonica River

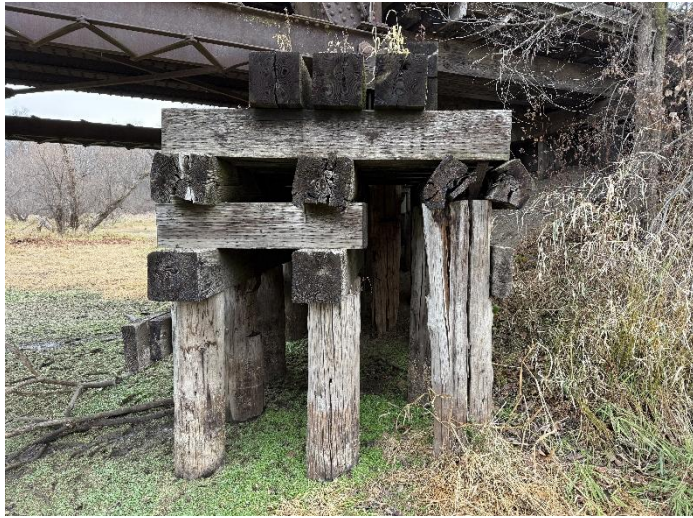
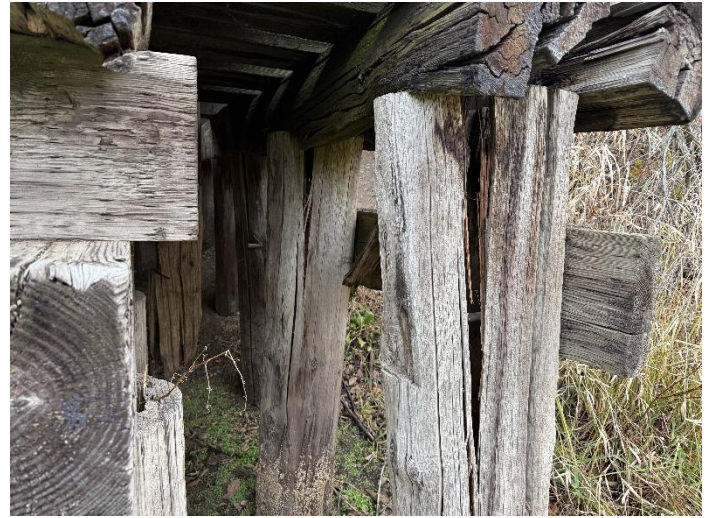
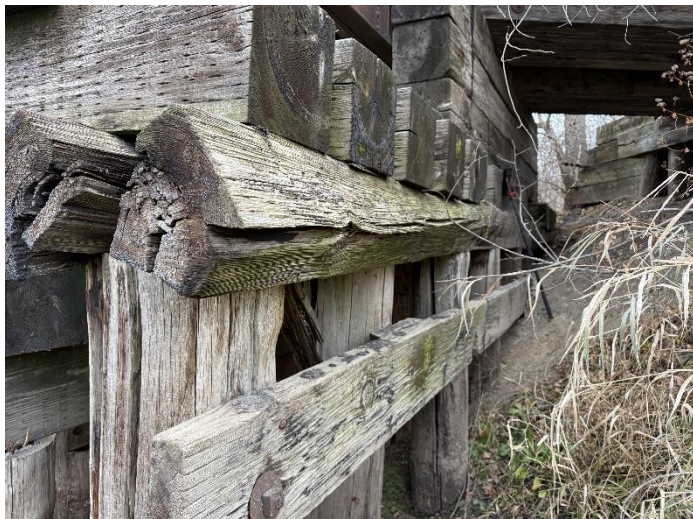
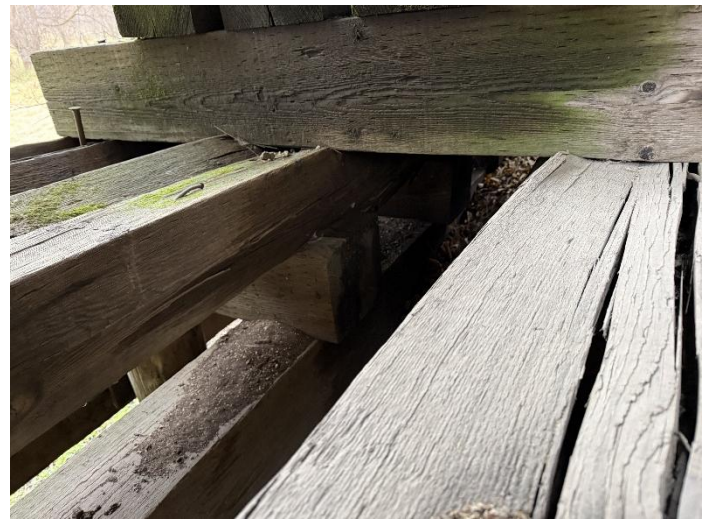
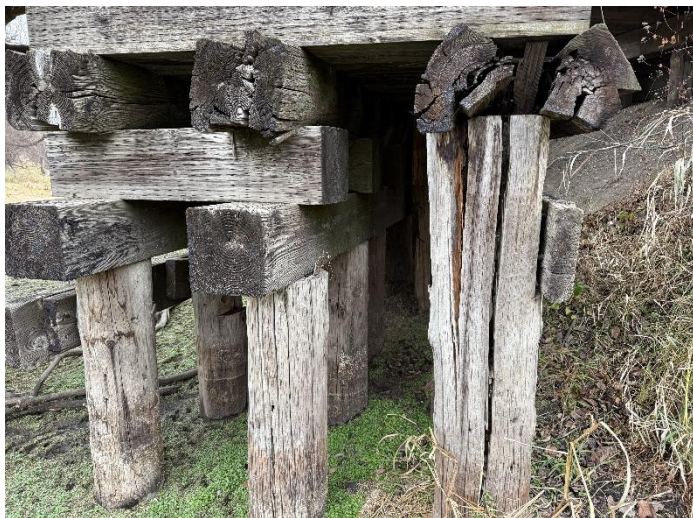
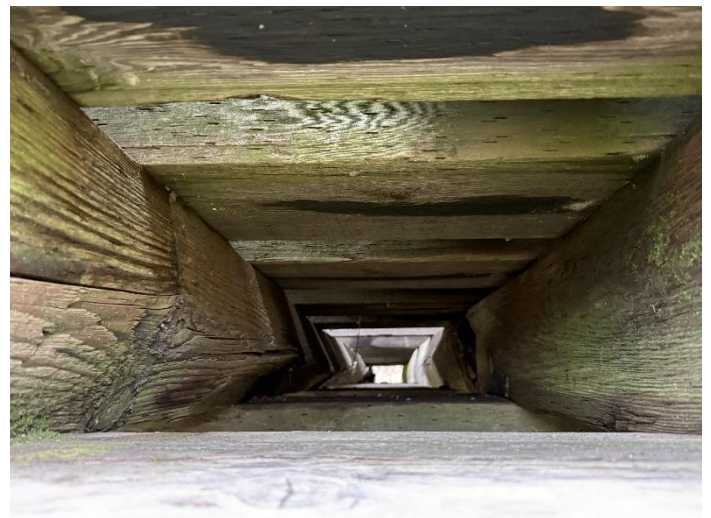
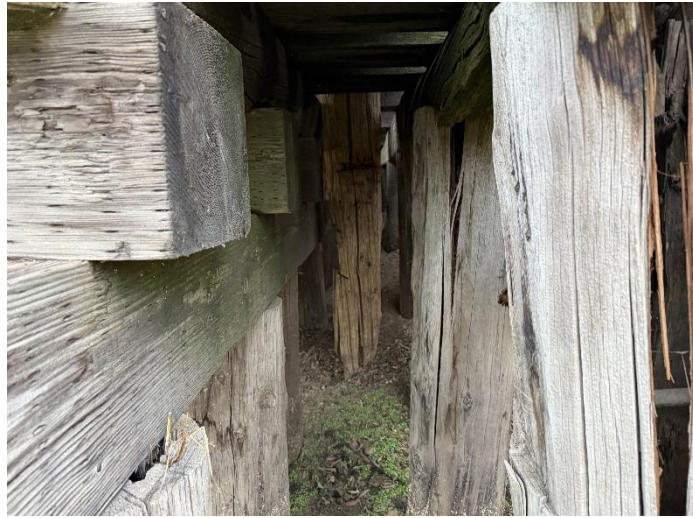
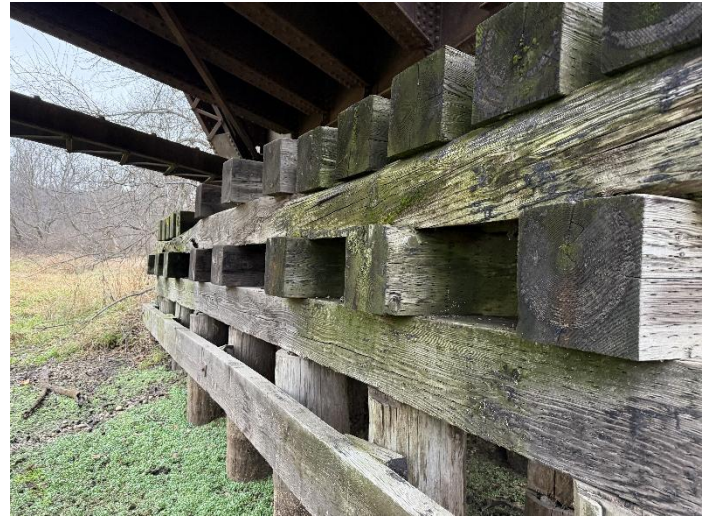
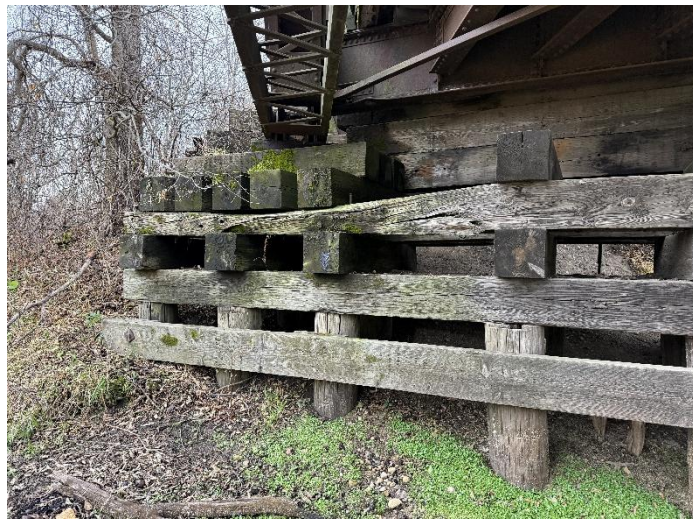
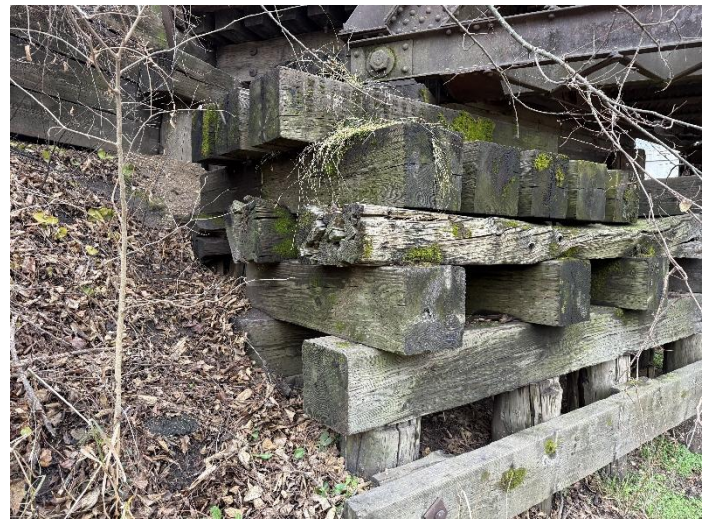
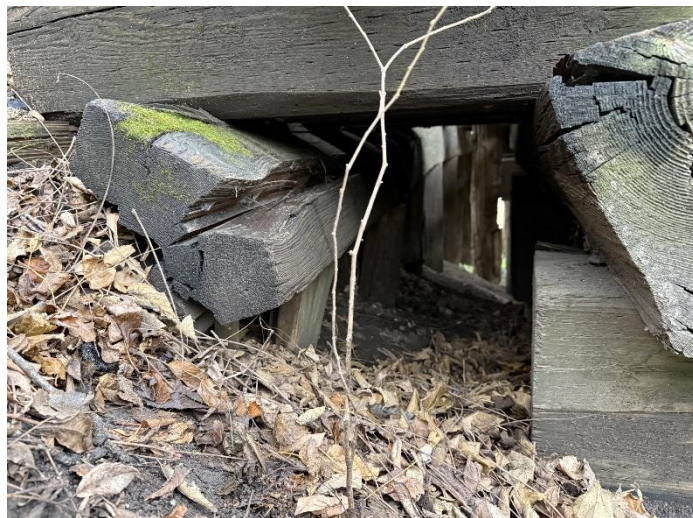
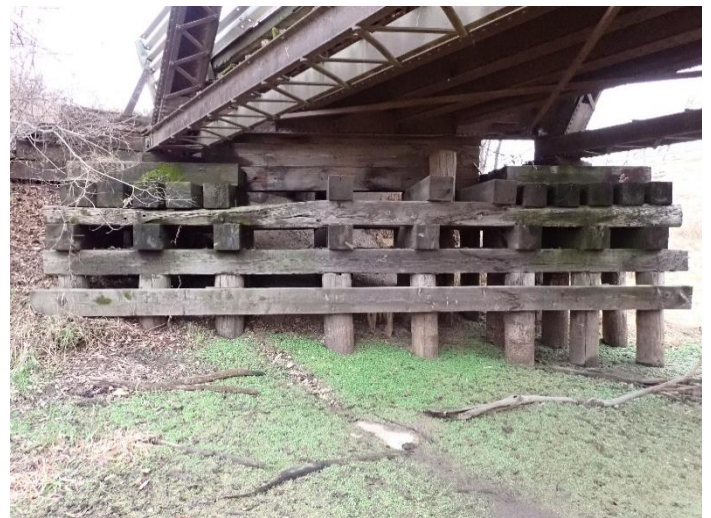
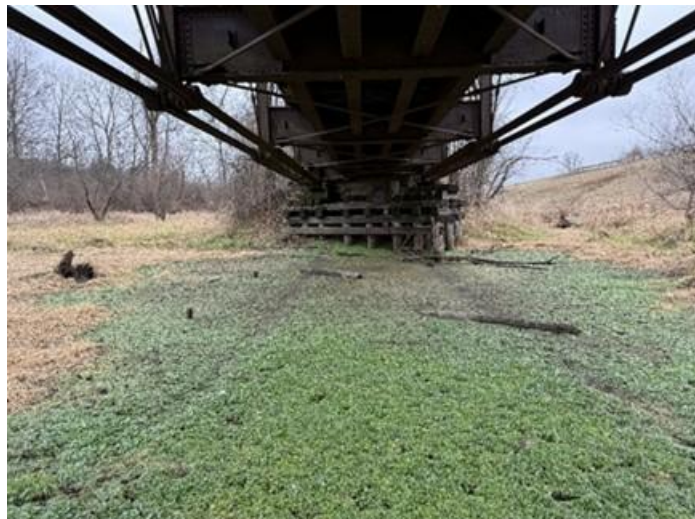
1. Driven timber piles with timber cribbing/pile caps.
2. **Decayed timber components throughout with readily evident signs of crushing. Multiple piles and caps are completely split/crushed. Pier is unstable.**

Photo 7 – Pier W4 Looking North.

Photo 8 – Pier W4 Looking North.

Photo 9 – Pier W4 Looking North.

Photo 10 – Pier W4 Looking North-Cribbing.

Photo 11 – Pier W4 Looking North.

Photo 12 – Pier W4 Looking North-Cribbing.

Photo 13 – Pier W4 Looking North-Piles.

Photo 14 – Pier W4 Looking North-Front Face.

Photo 15 – Pier W4 Looking West-North Bearing.

Photo 16 – Pier W4 Looking West-North Bearing.

Photo 17 – Pier W4 Looking South.

Photo 18 – Pier W4 Looking West.

Photo 33 – Pier W4 Looking East.

- a. Comprehensive concrete/masonry repair of the west abutment, and piers W1 and W2.
- b. Complete replacement of piers W3, W4, and the east abutment.

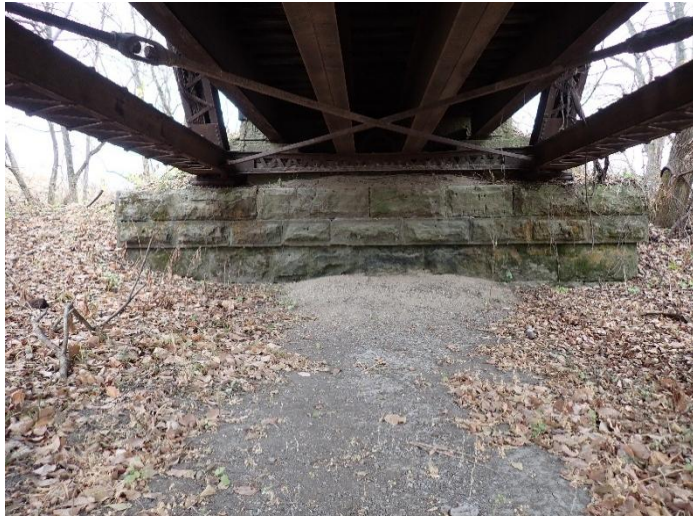
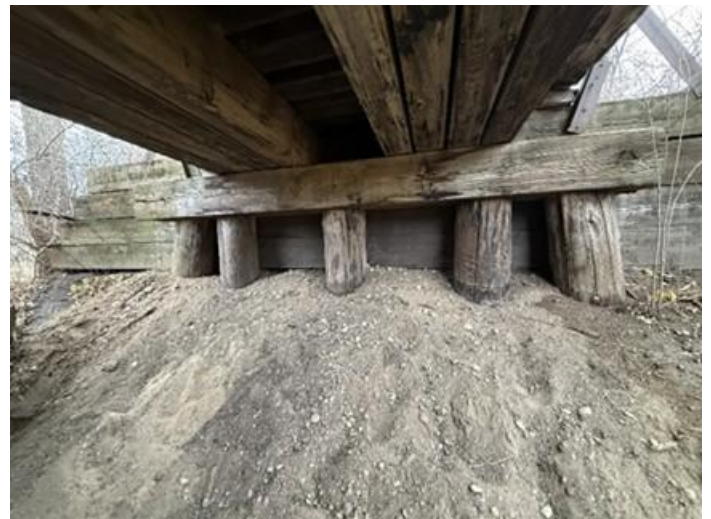
1. Stone block masonry abutment. **Unknown bearing conditions.**
2. General masonry deterioration throughout with widespread areas of missing mortar in joints.

Photo 19 – West Abutment.

Photo 34 – West Abutment.

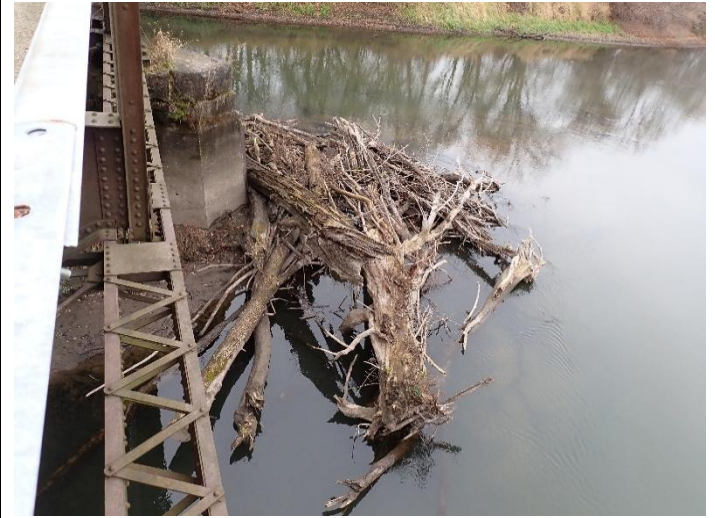
- 1. Streambed Scour: Unable to verify scour conditions on upstream end of Pier W1 due to flood debris accumulation. Remaining substructure units beyond channel flow during inspection.

Photo 20 – Pier W1 – Upstream (North) End.

- c. Complete additional inspections of pier W1 after removal of built-up flood debris to assess the physical and scour conditions of, and adjacent to, the pier not readily accessible during this inspection.
- d. Complete an unknown foundation/scour analysis.

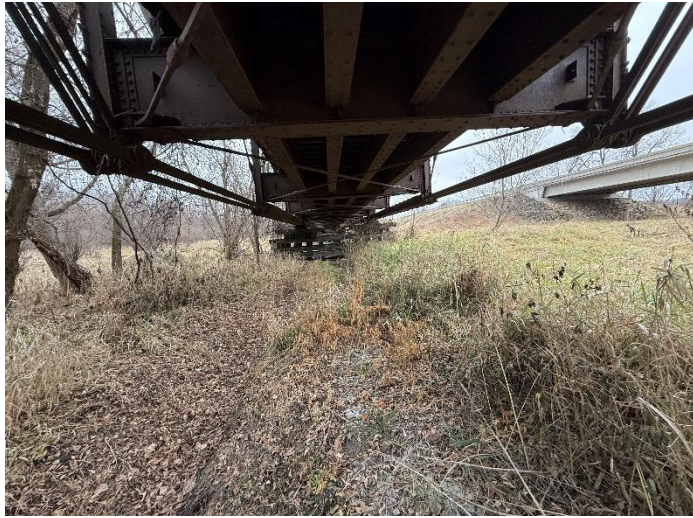
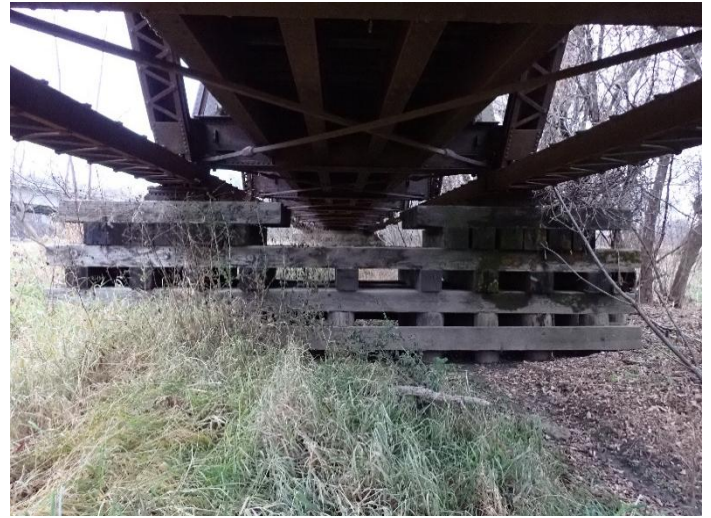
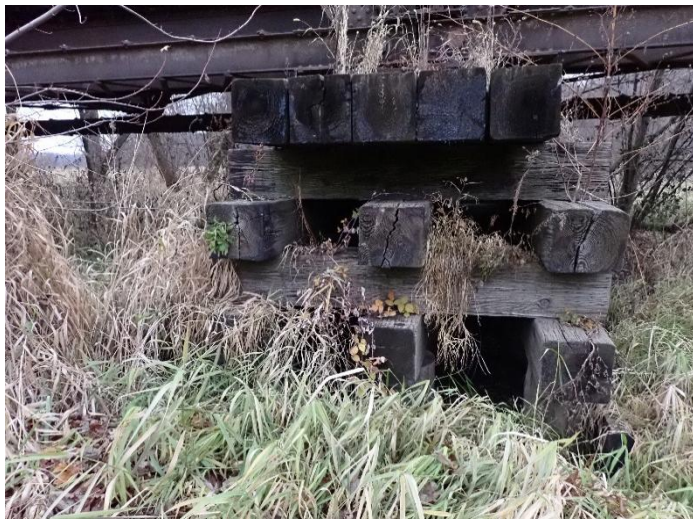
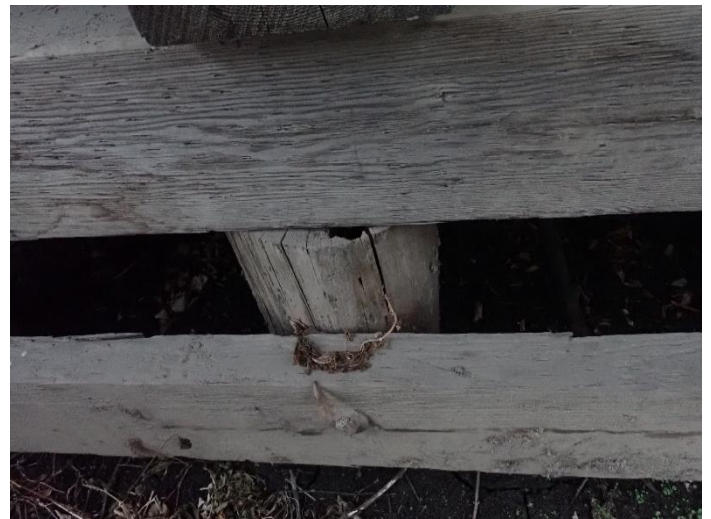
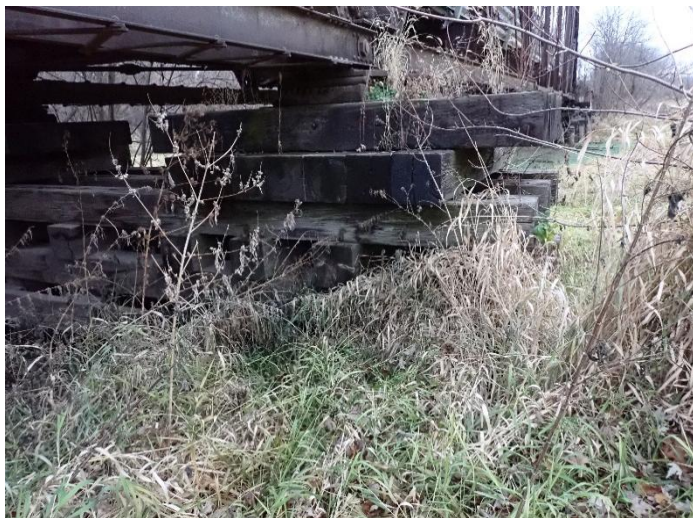
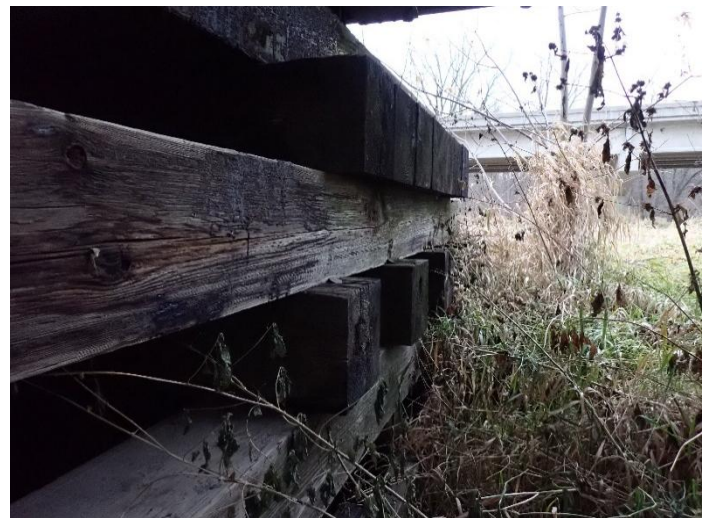
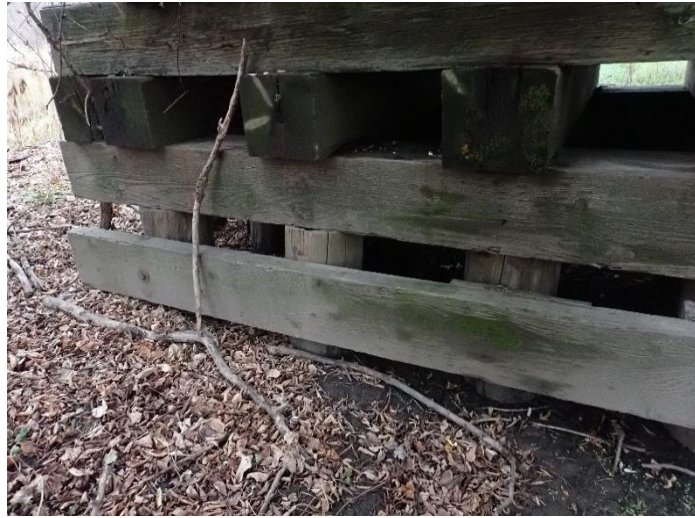
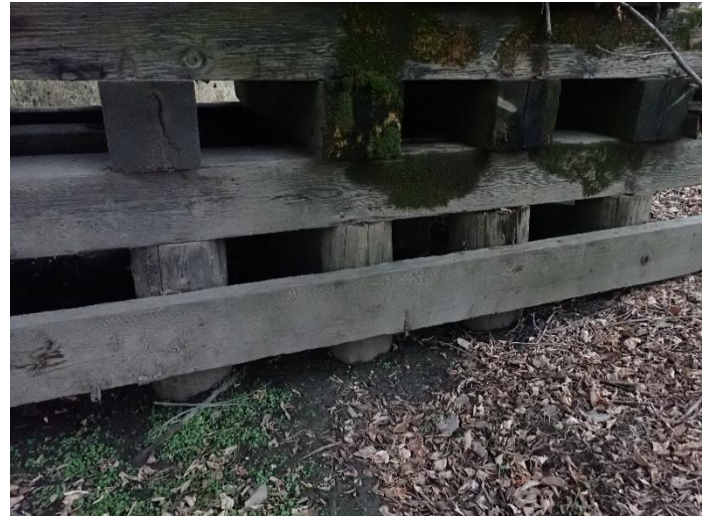
1. Driven timber piles with timber cribbing/pile caps.
2. Decayed timber components throughout with initial signs of crushing.
3. Caps are decayed 75%-90% throughout with widespread cracking and splitting. Components generally appear hollow when sounded with soft/easily dented outer shells. Decay and splitting is more pronounced at the ends of cribbing.
4. Piles: Bearing piles sound hollow with an estimated 75%-90% loss of section.

Photo 25 – Pier W3 Looking East.

Photo 26 – Pier W3 Looking West.

Photo 27 – Pier W3 Looking North.

Photo 28 – Pier W3 Looking West.

Photo 29 – Pier W3 Looking East.

Photo 30 – Pier W3 Looking South.

Photo 31 – Pier W3 Looking East.

Photo 32 – Pier W3 Looking West.

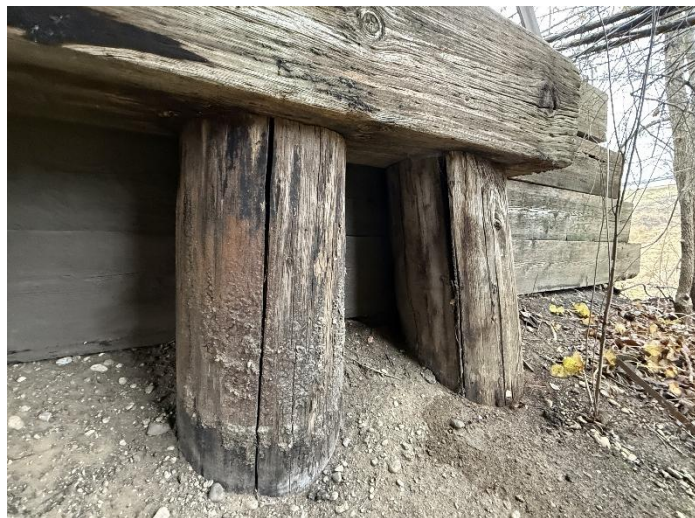
1. Driven timber piles, timber pile caps, and timber backwall plank.
2. Decayed timber components throughout with no readily evident signs of crushing.
3. Caps are decayed 75%-90% throughout with widespread minor checking and generally appear hollow when sounded. More advanced decay throughout north half of cap with full depth vertical splitting of cap.
4. Piles: Bearing piles sound hollow with an estimated 75%-90% loss of section. Multiple piles split vertically.

Photo 35 – East Abutment-Piles S2-S1.

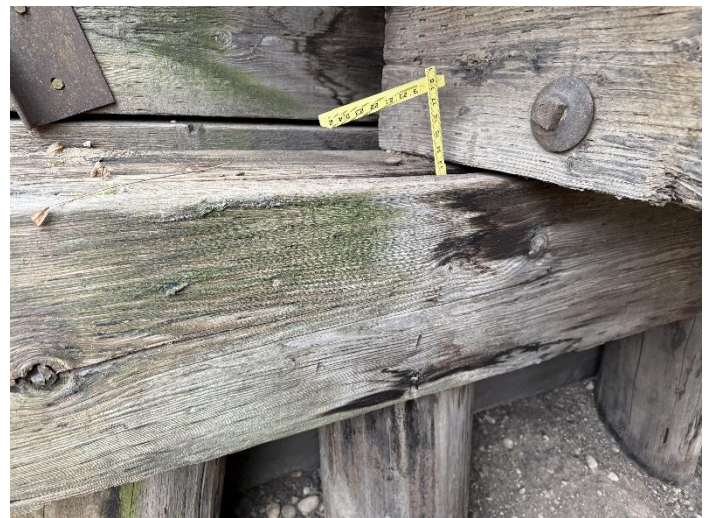
Photo 36 – East Abutment-North End.

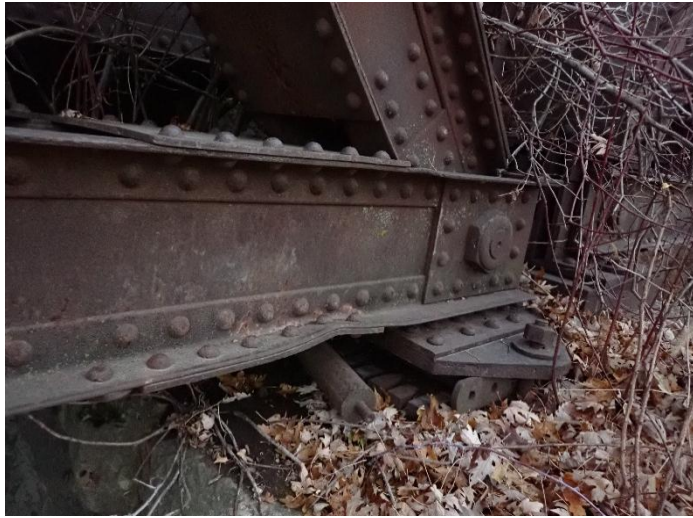
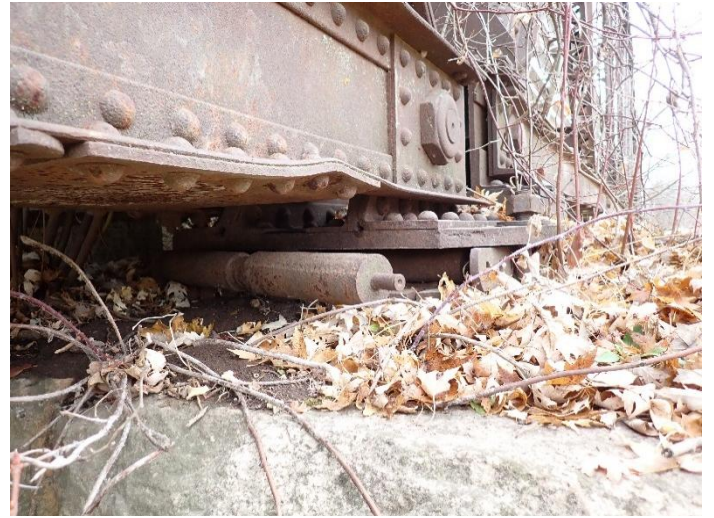
1. Spans W1-W4: (16) Roller baskets at truss bearings.
2. Corrosion of bearing assemblies restricts movement.
3. Decayed timber cribbing resulting in loss of bearing area.
4. Multiple roller unseated from bearing assemblies.

Photo 37 – Span W2-SE. Bearing Over Pier W2.

Photo 38 – Span W2-SE. Bearing Over Pier W2.

Remove debris from all bearings.  
 Repair of damaged bearing assemblies and corrosion mitigation should be considered as part of a comprehensive rehabilitation plan.

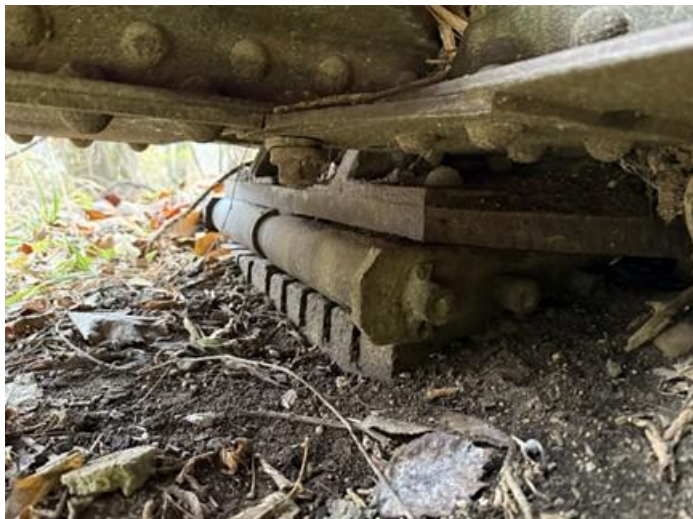
Photo 39 – Span W1-S. Bearing Over W. Abutment.

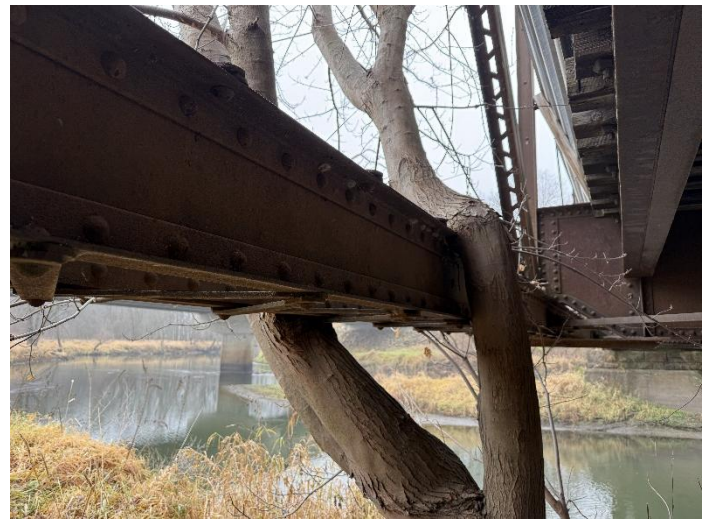
Element	Defect	Description	OUM	Total	Quantity in Condition State					
					1	2	3	4		
Superstructure	120	<b>Superstructure-Steel-Truss</b>	4	LF	875		564	311		
		<i>Spans W1-W4: Riveted Steel Through Truss</i>								
		1000	STL-Corrosion	LF			282	220		
			CS2: Surface corrosion throughout with widespread areas of freckled rust. CS3: Areas of pack rust with deformation and pitting of built-up members, most prevalent in vertical members- Assume 25% of +/- length.							
		1020	Connection	LF			282	88		
			CS2: Widespread areas of pack rust with no distortion. Connections are in place and functioning as intended. CS3: Isolated areas of pack rust with deformation with of connections between faying surfaces of eye bars-Assume +/- 10% of length.							
		1900	Distortion	LF						
			Members generally appear properly aligned with no readily visible signs of distortion.							
		7000	Damage	LF					3	
			CS2: Widespread areas of damaged flanges and bent lattice bars throughout lower chords. CS2: Tree growing around Span W2/S. Truss L4-L5. No readily visible deformation. CS3: Span W2/S. Truss L4-L5 damaged/bent near displaced bearing

Photo 40 – Span W2-South Truss L4-L5.

- a. Removal of trees and vegetation growing through trusses-continued growth of tree around lower chord of south truss in span W2 will likely result in permanent damage to truss.
  - b. Complete additional NSTM/NDT inspections of truss spans.
  - c. Complete replacement of timber beams in span W5.
-

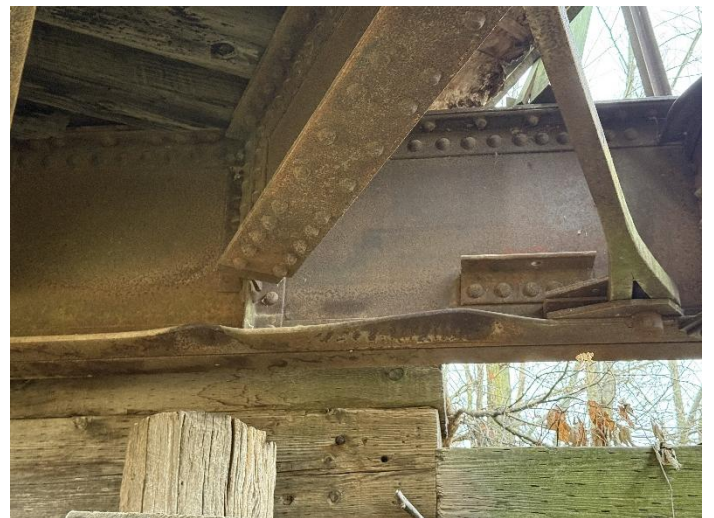
152		<b>Superstructure-Steel-Floor Beam</b>	4	LF	405		160	245	
			<i>Spans W1-W4: [27 Rows] Transverse Steel Floor Beams-Riveted Sections</i>							
	1000	STL-Corrosion	LF			80	200			
		CS2: Surface corrosion throughout with widespread areas of freckled rust. CS3: Widespread areas of section loss (pitting) at web stiffeners and near stringer connections and near truss connections-Assume +/-50% of length.								
	1020	Connection	LF			80	40			
		CS2: Widespread areas of pack rust with no/initial signs of distortion. Connections are in place and functioning as intended. CS3: Isolated areas of pack rust with deformation with of connections-Assume +/- 10% of length.								
	1900	Distortion	LF							
		Members appear properly aligned with no readily visible signs of distortion.								
	7000	Damage	LF					5		
		CS2: Widespread areas of damaged flanges throughout floor beams. CS3: Span W4/FB7 bottom flange bent/distorted (5-LF).

Photo 42 – Span W4-Floor Beam 7 (East).

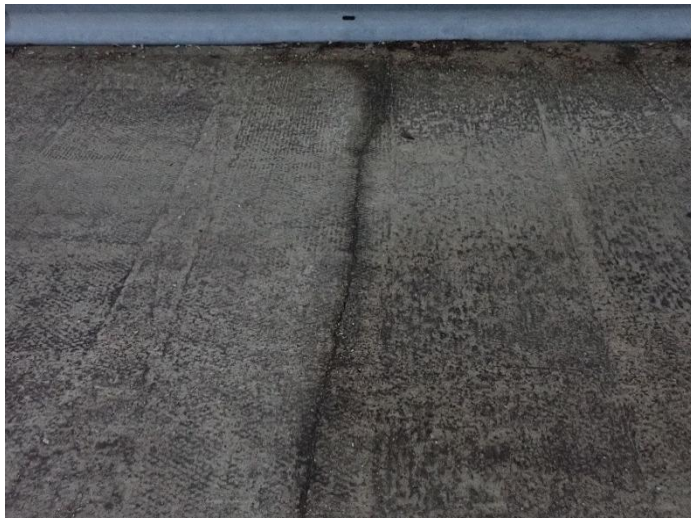
1. Concrete slab (wearing surface) over timber crossties(deck).
2. Moderate wear of concrete throughout wearing surface, most pronounced along wheel lines. Multiple unsealed moderate/wide width transverse cracks throughout concrete slab.
3. Timber crossties decayed and split at ends. Signs of decay throughout all timber components. Timber preservative treatment is no longer effective.

Photo 43 – Deck.

No feasible rehabilitation options to extend longevity of component. Complete replacement of deck system should be considered as part of a comprehensive rehabilitation plan.
