A-04 Tri Co/Cheese Country Bridge #28

Project Title Cheese Country Trail Bridge #28 Replacement					Current Funded Miles	New Miles (if applicable)
County Lafayette	Township 01 N	Range 4	Section 2	¼ ¼ UN	¼ UN	GPS Coordinates: Lat. 42.588625 Long. -89.990923

Inspection Report for

Cheese Country Trail over Tributary to Pecatonica River

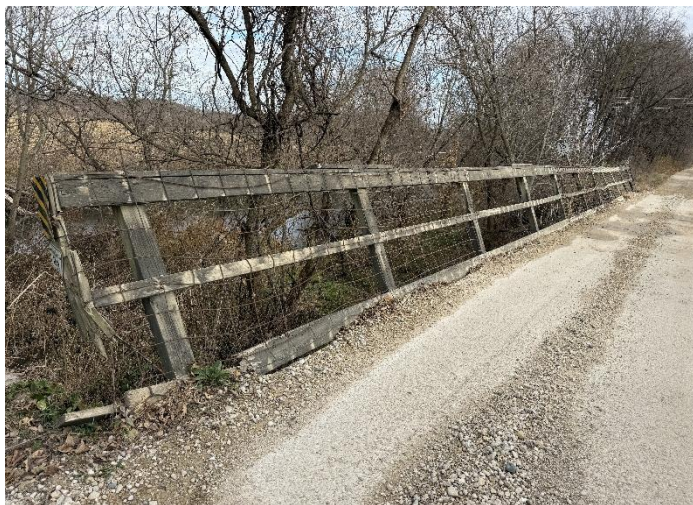
Photo 5 – North Railing.

1. Hog panel fencing supported by dimensional timber rails with angled timber posts.
2. Initial signs of incipient decay of timber components. Timber preservative treatment appears marginally effective.
3. Widespread areas of moderate to severe damage to timber curbs and rails. Widespread areas of damaged/missing hog fencing.
4. Southwest rail post cracked/broken.

Repair damaged bridge rail components.

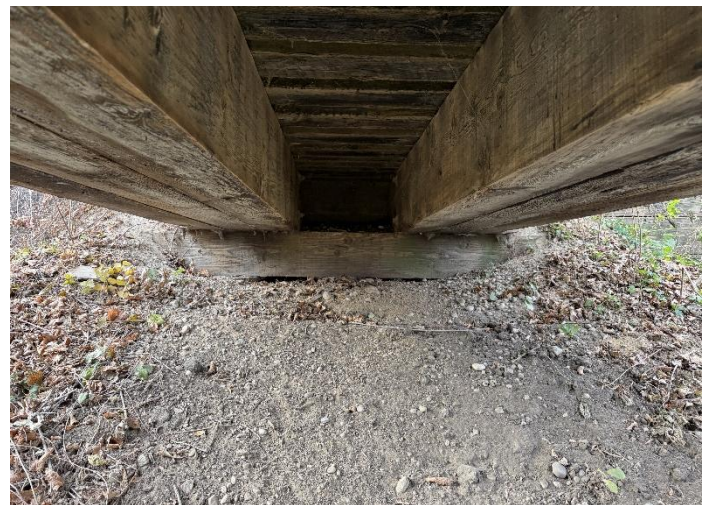
Photo 6 – West Abutment.

1. Driven timber piles, timber pile caps, and timber backwall plank.
2. Decayed timber components throughout with no readily evident signs of crushing.
3. Caps are decayed +/- 50% throughout with widespread minor checking and generally appear hollow when sounded. Isolated areas of more advanced decay and splitting at ends.
4. Piles: Exposed bearing piles are starting sound hollow with an estimated 50%-75% loss of section.

No feasible rehabilitation options to strengthen or extend longevity of component.

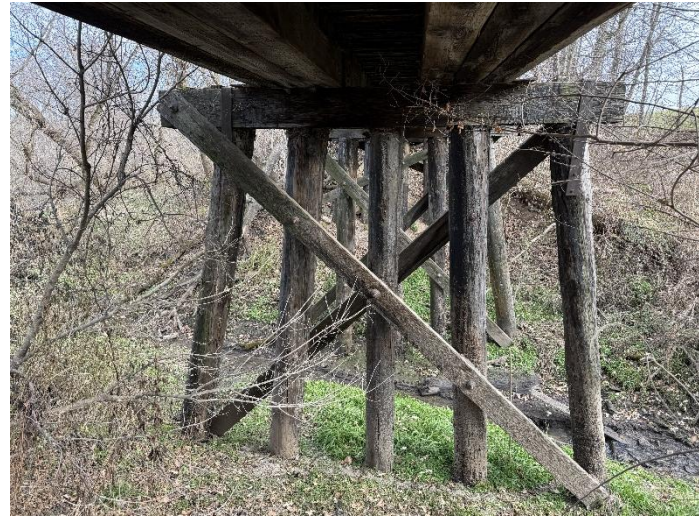
Photo 7 – Pier W2 Looking East.

1. Driven timber piles and timber pile caps.
2. Decayed timber components throughout with potential signs of initial overload distress (brooming/springy pile shells) at base of isolated piles.
3. Caps are decayed 50%-75% throughout with widespread minor checking and generally appear hollow when sounded. Isolated areas of more advanced decay and splitting at ends. Full depth vertical splitting of caps in piers W2 & W4.
4. Piles: Bearing piles sound hollow with an estimated 50%-90% loss of section.
5. Pier piles and caps are highly susceptible to overload damage.

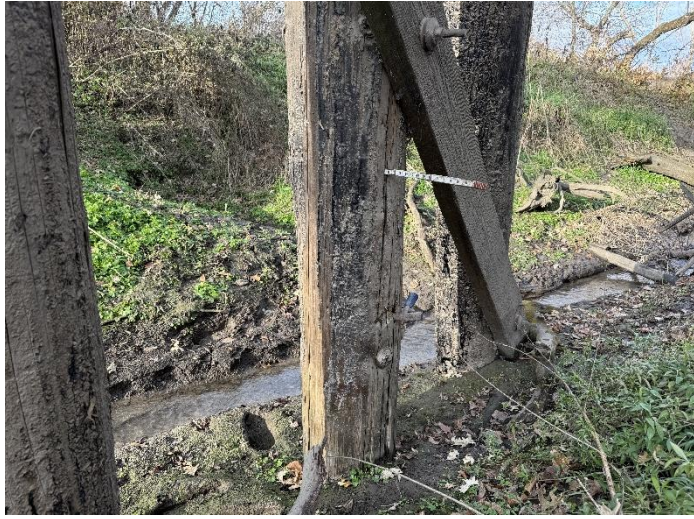
Photo 13 – Pier W3-Pile S4.

Pier(s)	235	Substructure-Timber-Pile Cap Pier	3	LF	60			14	46	
		<i>Timber Pile Cap - Timber pile bent pier.</i>								
		TBR-Decay/ Section Loss/ Abrasion/ Wear		LF				14	46	
	1140	CS3/CS4: Caps sound hollow throughout length estimated 50%-75% decay/section loss throughout length with +/- 75%-90% at ends. Prominent horiz. and vert. checking (>0.08") throughout. No signs of crushing. Visual only above 7ft. Pier W1/W3-Full depth vertical split through full length of cap (CS4: 30-LF). Pier W2/W4-Partial depth vertical split at ends of cap (CS4: 16-LF).								
	Protective Coatings: CS4: Timber preservative treatment ineffective.									
	228	Substructure-Timber-Pile-Pier	3	EA	20			10	10	
		<i>Timber Piles - Timber pile with backwall plank abutment.</i>								
		TBR-Decay/ Section Loss/ Abrasion/ Wear		EA				10	10	
	1140	[5] Bearing piles per pier. Visual only above 7ft. CS3/4: Piles sound hollow with prominent vertical checking/splitting throughout. Pile shells soft/easily damaged. No definitive signs of crushing. (1)-1" Deep Loose Shakes. (2)-Potential signs of initial overload distress; brooming/springy pile shell. Pier W1-Estimated % Decay: S1-75%_S2-75%_S3-75%_S4-75%_S5-75% Pier W2-Estimated % Decay: S1-75%_S2-75%_S3-50%_S4-75%_S5-50% Pier W3-Estimated % Decay: S1-90%(2) _S2-50%_S3-75%(1)_ S4-90%(2) _S5-50% Pier W4-Estimated % Decay: S1-75%(1)_S2-75%_S3-75%_S4-75%_S5-75%

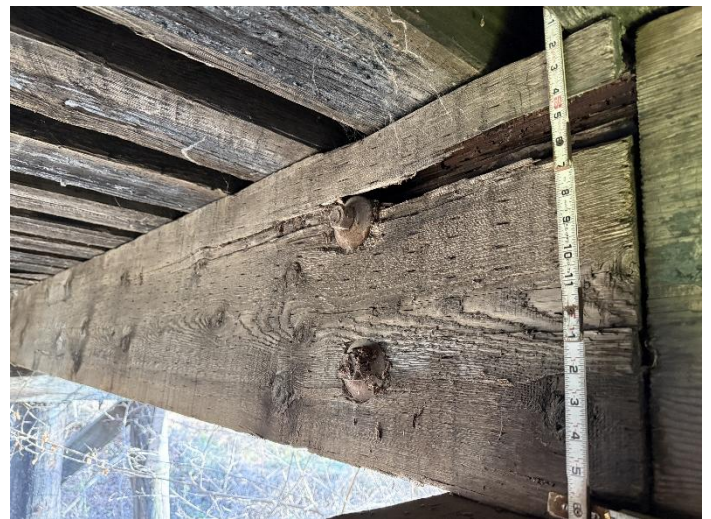
Photo 16 – S. BM-N.F.-Span 2 Over Pier W1 Looking W.

1. (2) lines of timber beams each comprised of (3) through-bolt connected laminations.
2. Beams are decayed +/- 75% throughout with widespread prominent checking and generally appear hollow when sounded. Isolated areas of more advanced decay and signs of horizontal shear cracking.
- 3. Readily evident signs of crushing over the west abutment and Pier W1.**
4. Beams are highly susceptible to overload damage.

Element	Defect	Description	OUM	Total	Quantity in Condition State					
						1	2	3	4		
Superstructure	111		Superstructure-Timber-Open Girder/ Beam <i>2 beam lines of 3-ply timber beams.</i>	2	LF	164			147	17	
		1140	TBR-Decay/ Section Loss/ Abrasion/ Wear CS3: All beams decayed and sound hollow with an estimated 75% loss of section. CS4: Isolated areas of more advanced decay estimated 90% loss of section over piers (See Damage - 7000).		LF				74		
		1150	TBR-Checks/ Shakes/ Cracks/ Splits/ Delamination CS3: Prominent checking/horizontal shear cracking(+/- 1/4") throughout length of beams. CS4: Isolated areas of splitting/crushing. (See Damage - 7000).		LF				73		
		1020	Connection Through-bolts appear intact and functioning as intended.		LF						
		1900	Distortion Beam appear properly aligned with no readily visible signs of distortion.		LF						
		7000	Damage Beams showing signs of overload damage (crushing): CS4: Span 1 (over w. abut.): South Beam (7-lf) / North Beam (5-lf). Span 2 (over pier W1): East Beam (5-lf).		LF					17

No feasible rehabilitation options to strengthen or extend longevity of component.

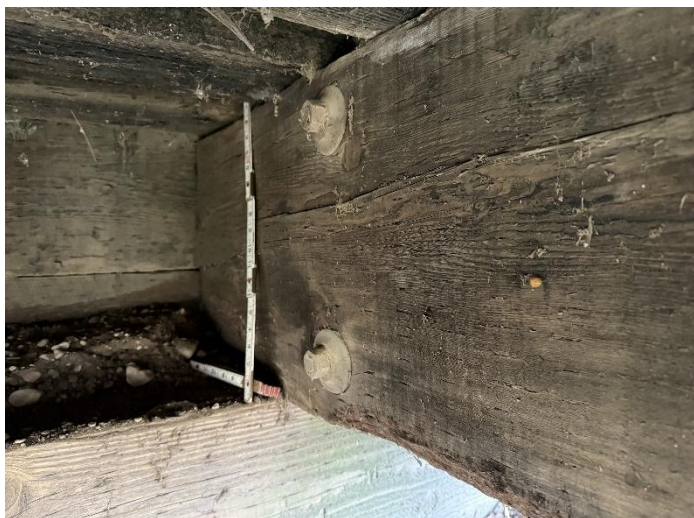
Photo 17 – N. Beam-S. Face Over West Abutment.

- Decayed timber components throughout are susceptible to overload damage.
- **Beams showing signs of overload damage (crushing) over the west abutment.**
