A-05 Tri Co/Cheese Country Bridge #47

Project Title Cheese Country Trail Bridge #47 Replacement					Current Funded Miles	New Miles (if applicable)
County Green	Township 01 N	Range 7	Section 4	¼ ¼ SE	¼ SW	GPS Coordinates: Lat. 42.5593442 Long. -89.675092

Bridge ID / Structure No.  <b>Bridge #47</b>	<b>Inspection Date:</b>	11.24.2025
	<b>Inspection TL:</b>	Nate Miller, PE
	<b>NBI Project No:</b>	2503501

Inspection Report for  
**Bridge #47**  
Cheese Country Trail over Honey Creek

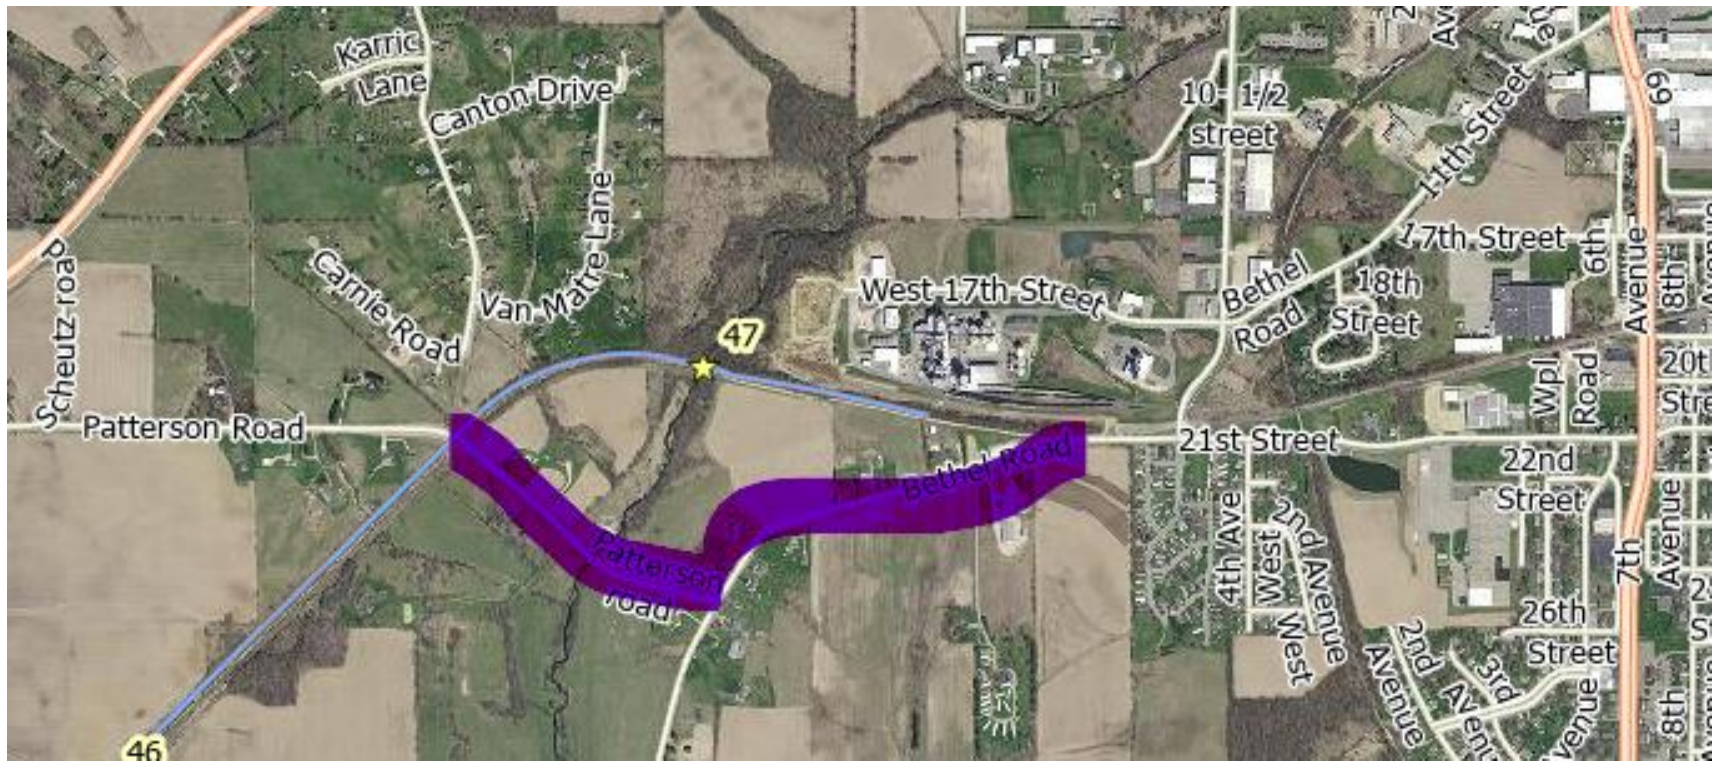
Trail re-route because of #47 closure.

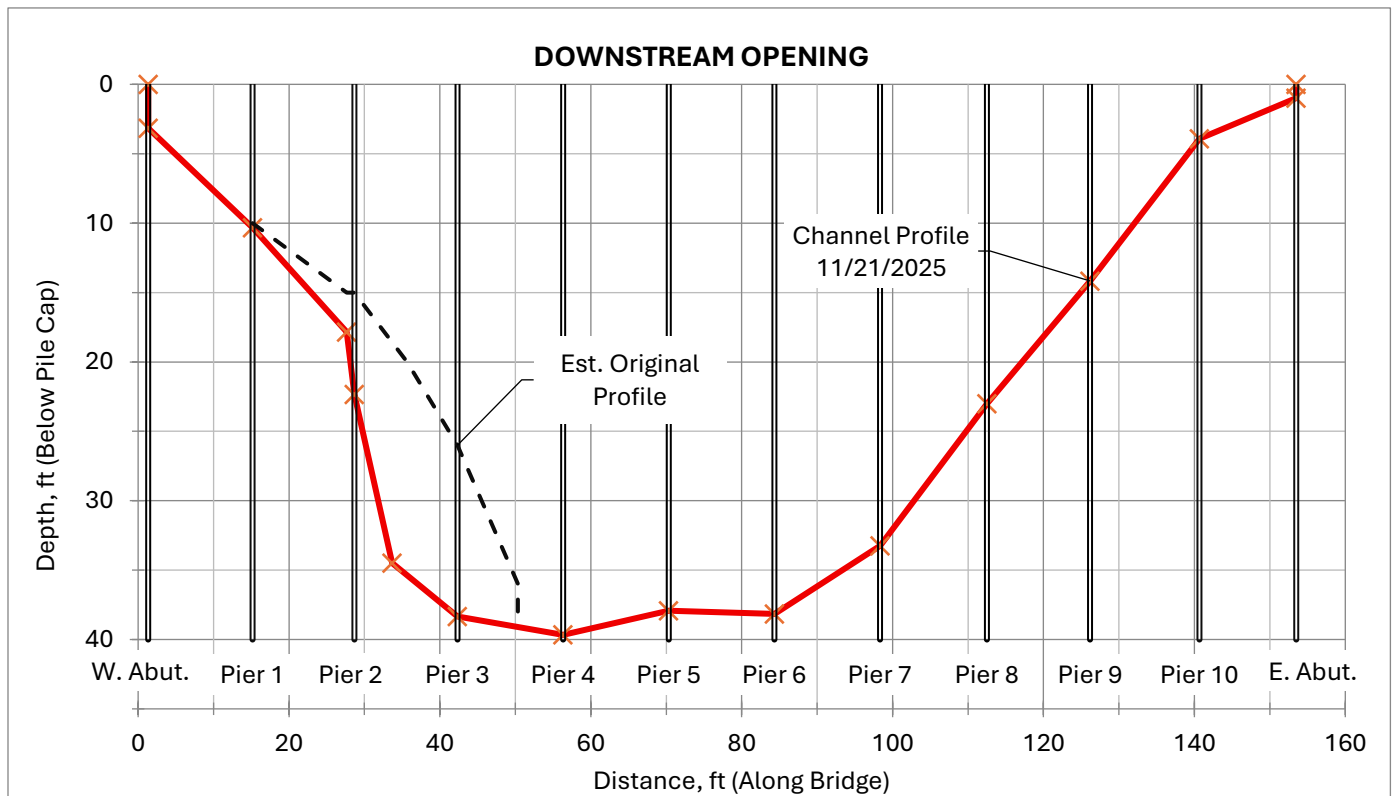
**Figure 1. Downstream Channel Profile-Full Bridge Length**

2. No information has been provided to establish the original channel profile. Locations shown below have been approximated based on observed conditions, location of pier bracing, and the presence of a cast-in-place concrete block in the channel. The original channel profile may vary considerably from illustrated representation which has been included for reference purposes only.

3. Pile tip elevations are unknown and have been shown to a depth of 40 feet below the top of pile caps. This should be considered as the maximum possible depth of penetration due to the presence of readily visible bedrock in the streambed. Pile tip elevations likely vary throughout the bridge and shallower pile elevations should be assumed. The tapered driven tip of Pile S2 in Pier W7 is exposed, indicating negligible remaining embedment, and therefore includes a tip elevation shallower than is shown in Figure 1, below (see Photo 49).

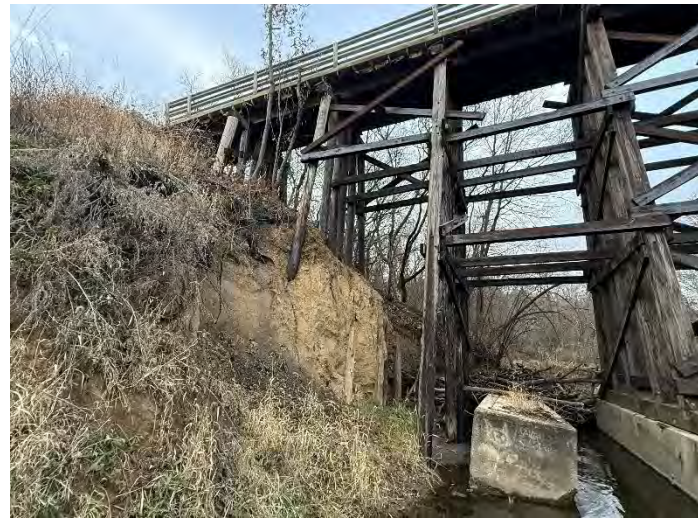
Photo 7 – West Embankment Looking North.

1. Embankment Erosion: **The west embankment is in a state of imminent failure.** Severe erosion at the toe of the west embankment has caused a 15ft-20ft vertical embankment to be retained by remnants of a critically decayed timber wall. *See included channel profile sketches included as Figures 1-3, included with this report.* Erosion at Pier W7 has exposed the tapered pile tip of Pile W2.
2. Drift: Flood debris caught on upstream face of piers.
3. Channel Change: Waterway flows through spans W4-W6 and around Piers W3-W6.
4. Adequacy of Opening: No readily visible signs of overtopping.

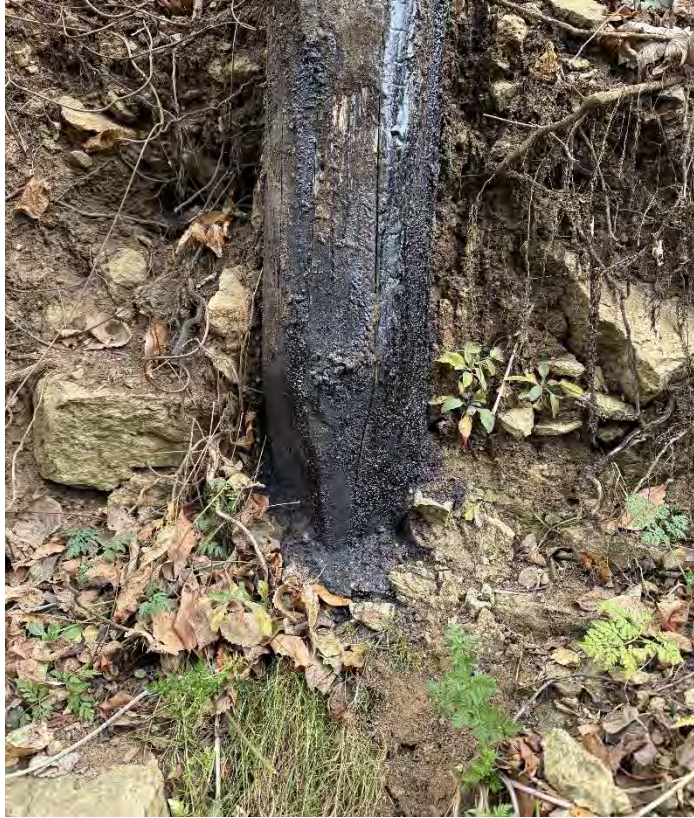
Photo 49 – Pier W7-Pile S2.

1. Piers W1-W3 and W7-W10: Driven timber piles with timber pile caps.
2. Piers W4-W6: Poured concrete footings with timber sill beams under timber pile bents with timber pile caps.
3. **The west embankment is in a state of imminent failure which could destabilize Pier W2 and cause a full, or partial collapse of the bridge.**
4. Decayed timber components throughout with signs of crushing.
5. Multiple caps are severely decayed and are splitting/separating.
6. The bottom sill beams are severely decayed with the sill crushing in Pier W6.
7. Piles are decayed with significant section losses throughout with multiple piles visibly hollow and split. Pile S5 in Pier W7 is starting to crush. The tapered driving tip of Pile S2 in Pier W7 is exposed, indicating negligible pile embedment.
