A-06 Tri Co/Cheese Country Bridge #32

**Motorized Recreation Grant Application**

Project Title Cheese Country Trail Bridge #32 Replacement					Current Funded Miles	New Miles (if applicable)
County Lafayette	Township 01 N	Range 5	Section 6	¼ ¼ UN	¼ UN	GPS Coordinates: Lat. 42.586527 Long. -89.950638

<b>Bridge ID / Structure No.</b>		<b>Bridge 32</b>		<b>Inspection Date:</b>	05.19.2025
				<b>Inspection TL:</b>	Nate Miller, PE
				<b>NBI Project No:</b>	2503500
<b>Inventory Data</b>	Location Desc: Cheese Country Trail 1,500' East of Larse Road (West of Sargent Road)				
Feature On:	Cheese Country Trail	Feature Under: Unnamed Wetland/ Marsh Area			
Orientation	Traffic Direction: EB – WB	Channel Flow: Upstream: N Downstream: S			
<b>Structure Type</b>	No. Spans: 4	Wearing Surface: 1" Crushed Stone			
Deck	8" Concrete over 7.5" Square Cross Ties				
Superstructure	3-Ply 17.5"x9.5" Timber Beams	No. Beam Lines: 2			
Substructure	Abutments: Timber Pile Bent	A01 Height: 5.5'	A02 Height: 3.6'		
	Pier(s): Timber Pile Bent	P01 Height: 9.2'	P02 Height: 9.4'	P03 Height: 8.7'	
<b>Geometric</b>	Deck Length (O-O): 62.0'	Span Length(s): 14.5', 15.5', 14.5', 15.0'			
	Width (O-O): 12.0'	Width (C-C

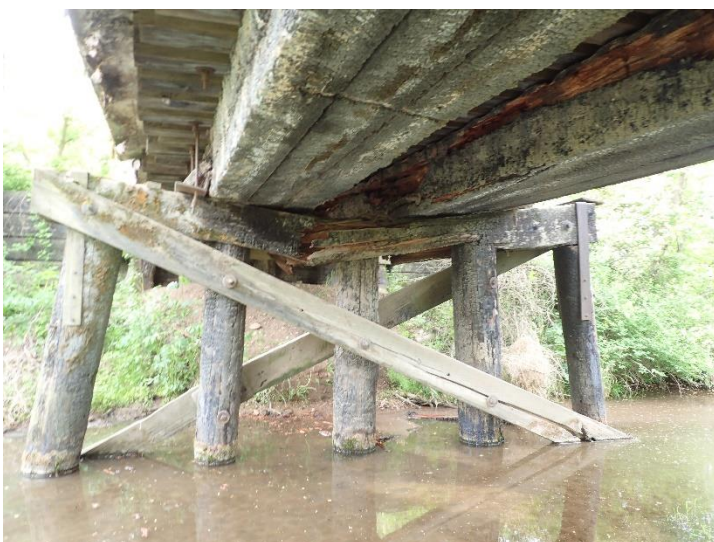
Photo 8 – Pier E1 Looking East

1. Scour Susceptible: No		
2. Caps: Advanced decay of pile caps with >90% loss of section. Readily evident signs of overload distress in east pier cap (vertical crushing). Outermost 1/2" fire damaged.

Underside of bridge looking east. Pier cap crushed in east pier.
