A-07 Tri Co/Cheese Country Bridge #35

Inspection Report for

**Bridge #35**

Cheese Country Trail over Small Stream

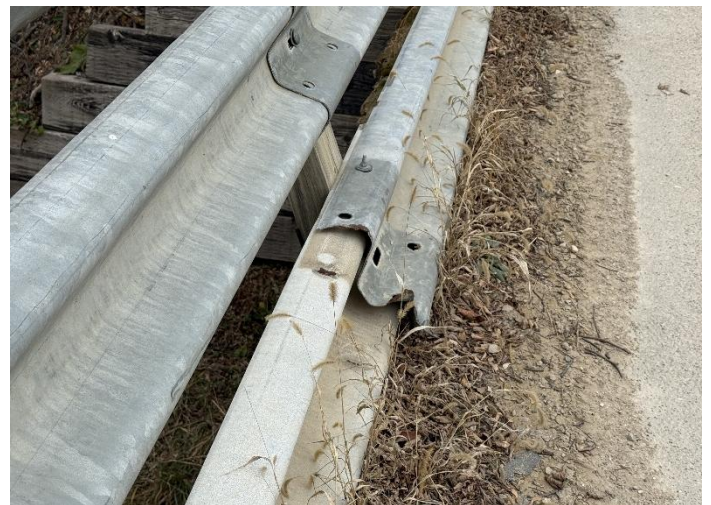
Photo 6 – North Rail Looking East.

1. (3) rows of W-beam bridge rail supported by angled timber posts.
2. Initial signs of incipient decay of timber components. Timber preservative treatment appears marginally effective.
3. Widespread areas of moderate damage to w-beam curb rails.
4. Damaged ends of w-beam curb extend into traveled way.

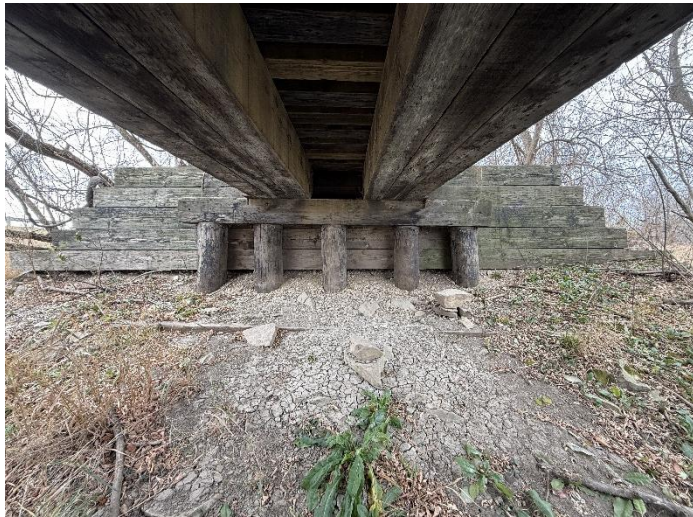
Photo 9 – West Abutment.

- Erosion at both abutments has undermined the backwall plank.

1. Driven timber piles, timber pile caps, and timber backwall plank.
2. Decayed timber components throughout with no readily evident signs of crushing.
3. Caps are decayed +/- 75% throughout with widespread minor checking and generally appear hollow when sounded. Isolated areas of more advanced decay and splitting at ends. Full depth vertical splitting with minimal separation throughout length of both caps.
4. Piles: Bearing piles are starting sound hollow with an estimated 75% loss of section.

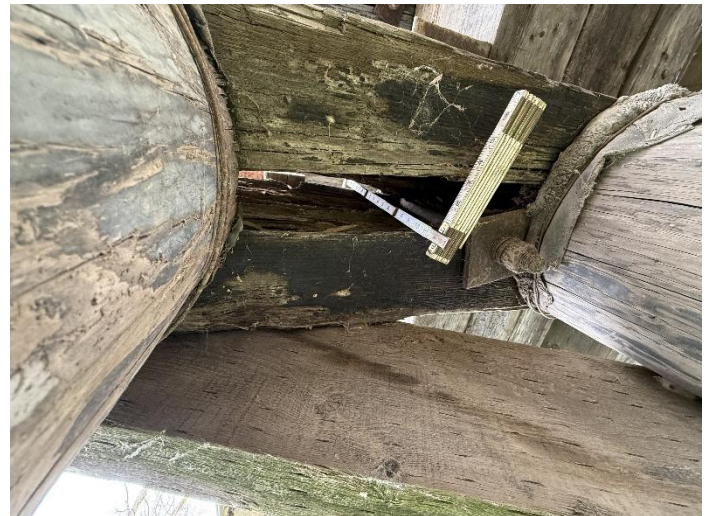
Photo 12 – West Pier Cap-Piles W5-W4.

- The pile cap in the west pier is severely decayed, has split vertically across the length of the cap, separated 3”, and is crushing over the adjacent piles.

1. Driven timber piles and timber pile caps.
2. Decayed timber components throughout with **readily evident signs of splitting/crushing of the west pier cap.**
3. Caps are decayed 75%-90% throughout with widespread minor checking and generally appear hollow when sounded. Isolated areas of more advanced decay and splitting at ends.
4. Piles: Exposed bearing piles are starting sound hollow with an estimated 75% loss of section. Piles split vertically.

- **Owner notified of Critical Finding: Bridge should be immediately closed to all traffic.**

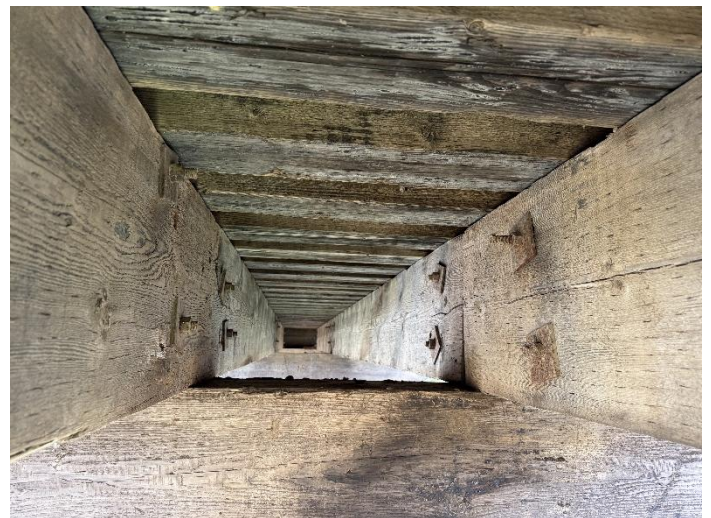
Photo 18 – Underside Near East Pier Looking West.

1. (2) lines of timber beams each comprised of (3) through-bolt connected laminations.
2. Beams are decayed 50%-75% throughout with widespread prominent checking and generally appear hollow when sounded. Isolated areas of more advanced decay and signs of horizontal shear cracking.
3. No readily evident signs of crushing.
4. Beams are highly susceptible to overload damage.

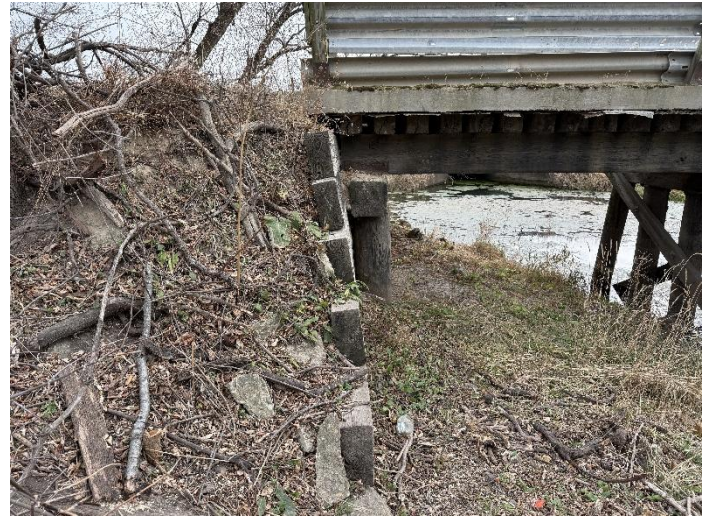
Photo 20 – East Abutment Looking South.

1. Embankment Erosion: Erosion of natural earth embankments has undermined the backwall plank in both abutments.
2. Drift: No significant deposits in channel.
3. Channel Change: Standing water/stagnant pool fills the center span and around both piers.
4. Adequacy of Opening: No readily visible signs of overtopping.
