A-11 Tri Co/Cheese Country Bridge #45

Inspection Report for

Bridge #45

Cheese Country Trail over Allen Road

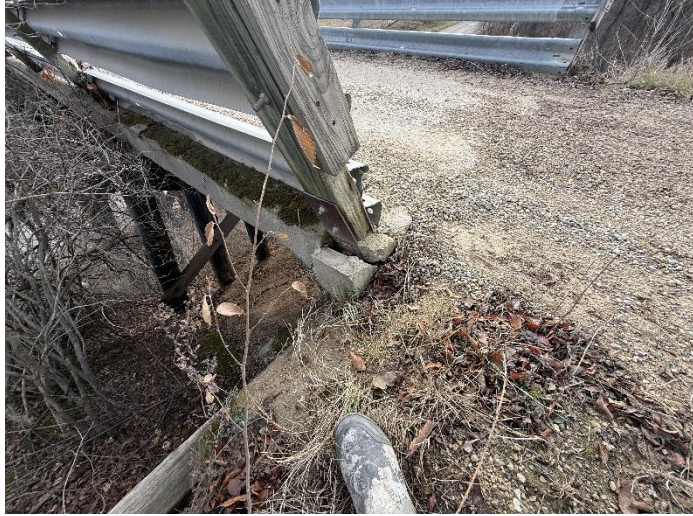
Photo 7 – Northwest Corner of Deck.

1. (3) rows of W-beam bridge rail supported by angled timber posts.
2. Initial signs of incipient decay of timber components. Timber preservative treatment appears marginally effective.
3. Widespread areas of minor damage to w-beam rails. Ends of curb rails damaged.
4. Northwest rail post anchorage/deck embedment failed.

Repair damaged rail post anchorage.
