A-12 Tri Co/Cheese Country Bridge #41

Inspection Report for

Bridge #41

Cheese Country Trail over Skinner Creek

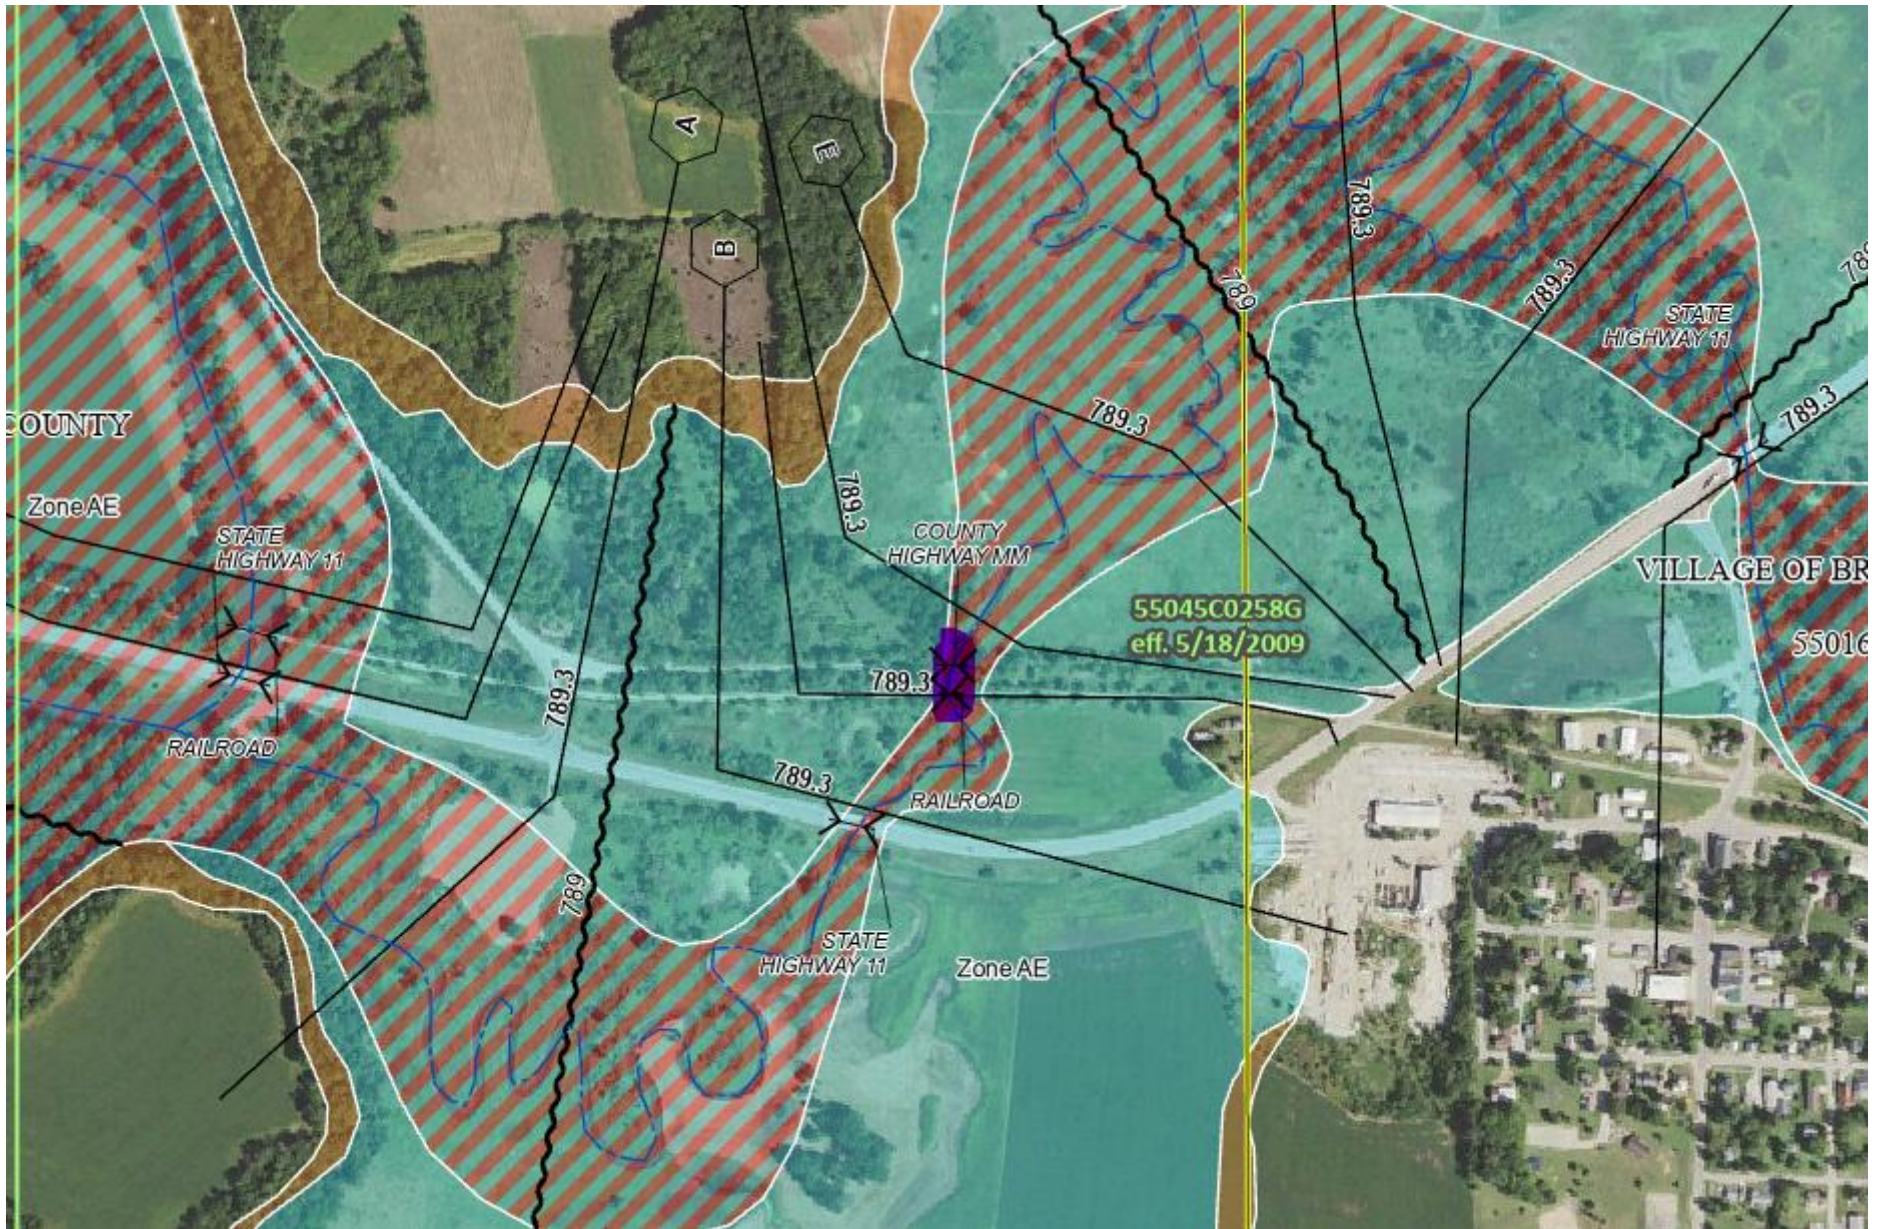
Trail re-route (2 choices) if bridge 41 would have to close.

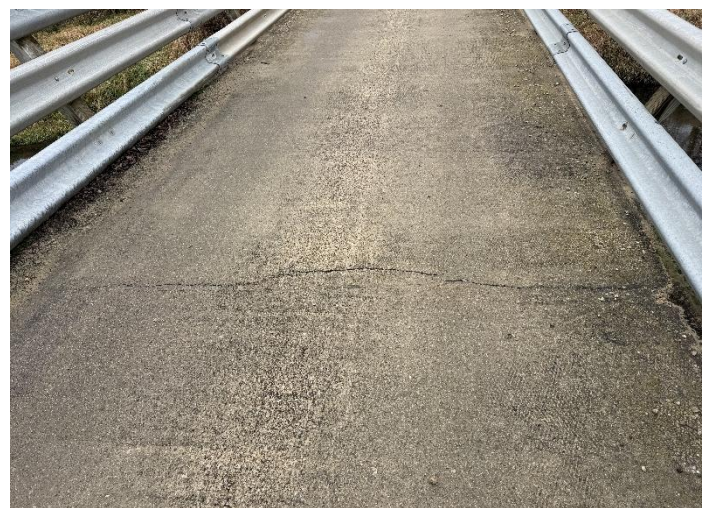
Photo 6 – Deck Looking South.

1. Concrete slab (wearing surface) over timber crossties(deck).
2. Minor wear of concrete throughout wearing surface, most pronounced along wheel lines. Multiple unsealed moderate/wide width transverse cracks throughout concrete slab.
3. Timber crossties decayed and split at ends. Signs of decay throughout all timber components. Timber preservative treatment is no longer effective.

No feasible rehabilitation options to extend longevity of component.

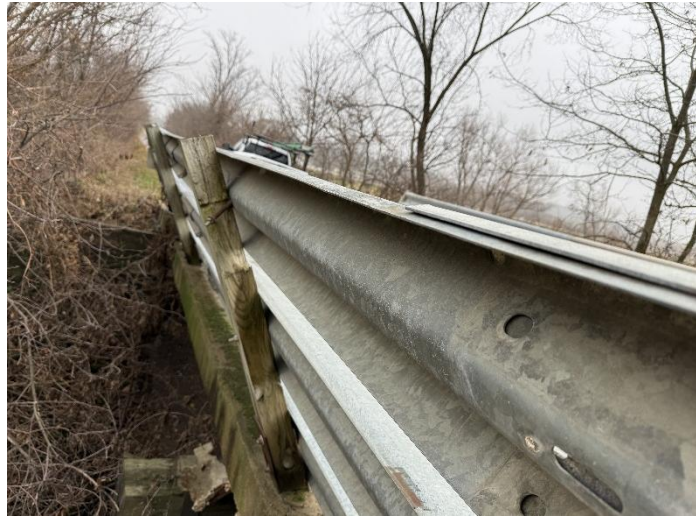
Photo 7 – North Rail Looking East.

1. (3) rows of W-beam bridge rail supported by angled timber posts.
2. Initial signs of incipient decay of timber components. Timber preservative treatment appears marginally effective.
3. Isolated areas of minor damage to w-beam curb rails.
4. Post in north railing cracked/broken.

Repair damaged rail post.

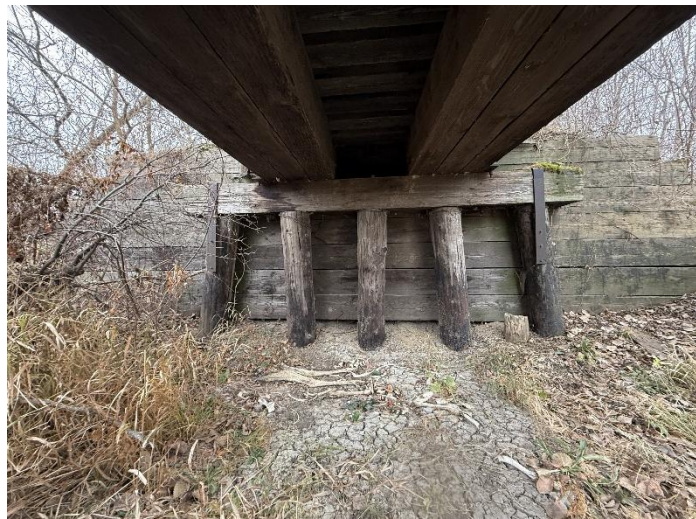
Photo 9 – West Abutment.

1. Embankment Erosion: Erosion of natural earth berms at west abutment has undermined backwall plank.
2. Drift: No significant deposits in channel.
3. Channel Change: Waterway flows through spans W2 & W3 and around Piers W2 & W3. Upstream channel migrating west. Downstream channel bends to the east to flow through roadway bridge.
4. Adequacy of Opening: No readily visible signs of overtopping.

Maintenance/Repair Recommendations
 Installation of channel protection would reduce likelihood of future erosion/scour issues. Channel armoring may not be feasible, and/or recommended, given the expected longevity of the structure and current observed conditions.

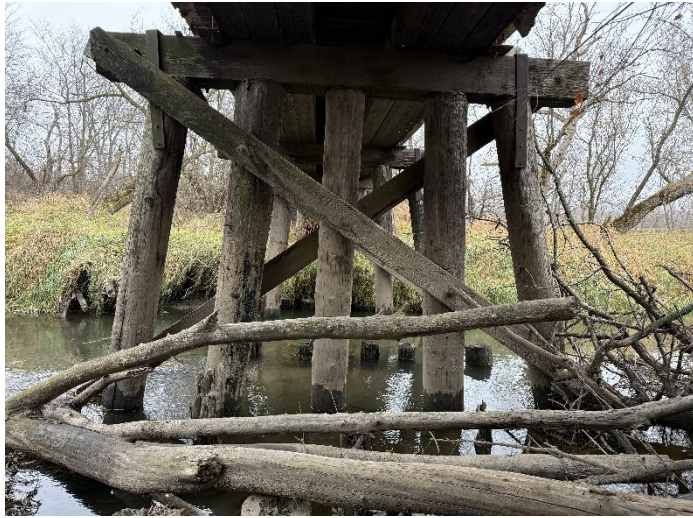
Photo 13 – Pier W2 Looking East.

1. Streambed Scour: Soft/silty streambed is prone to scour. 2ft-3ft of local scour observed at Piers W2 & W3.

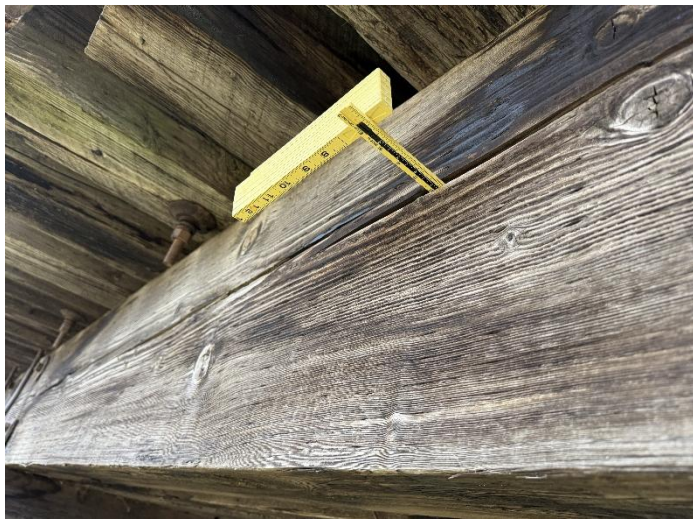
Photo 27 – Span W5-South Beam.

1. (2) lines of timber beams each comprised of (3) through-bolt connected laminations.
2. Beams are decayed +/- 75% throughout with widespread prominent checking and generally appear hollow when sounded. Isolated areas of more advanced decay and signs of horizontal shear cracking.
3. No readily evident signs of crushing.
4. Beams are highly susceptible to overload damage.

No feasible rehabilitation options to strengthen or extend longevity of component.
