A-13 Forest Co NST Peshtigo Bridge Replacement

Trail Bridge Inspection

Peshtigo River

Bridge Inspection Report

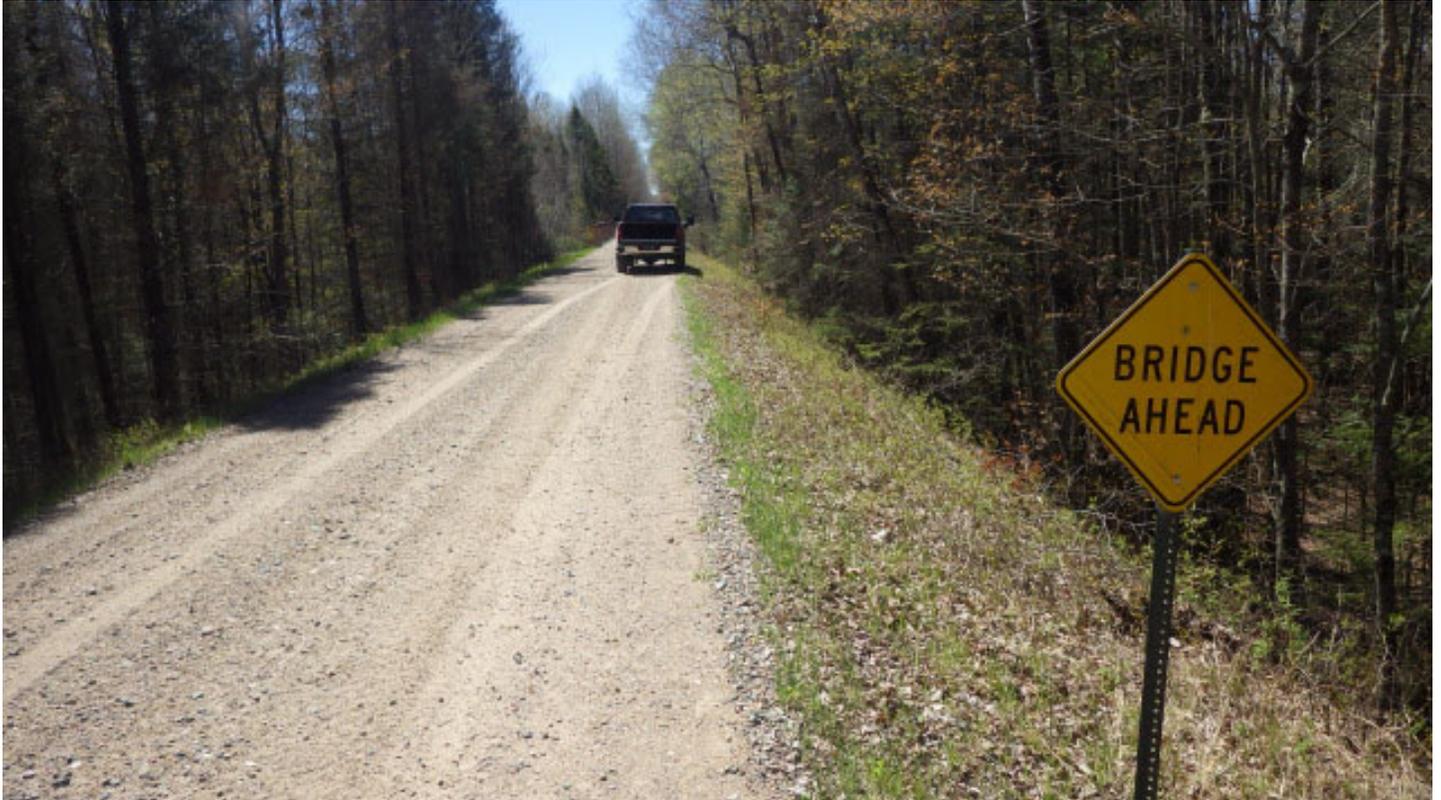
North bridge ahead sign

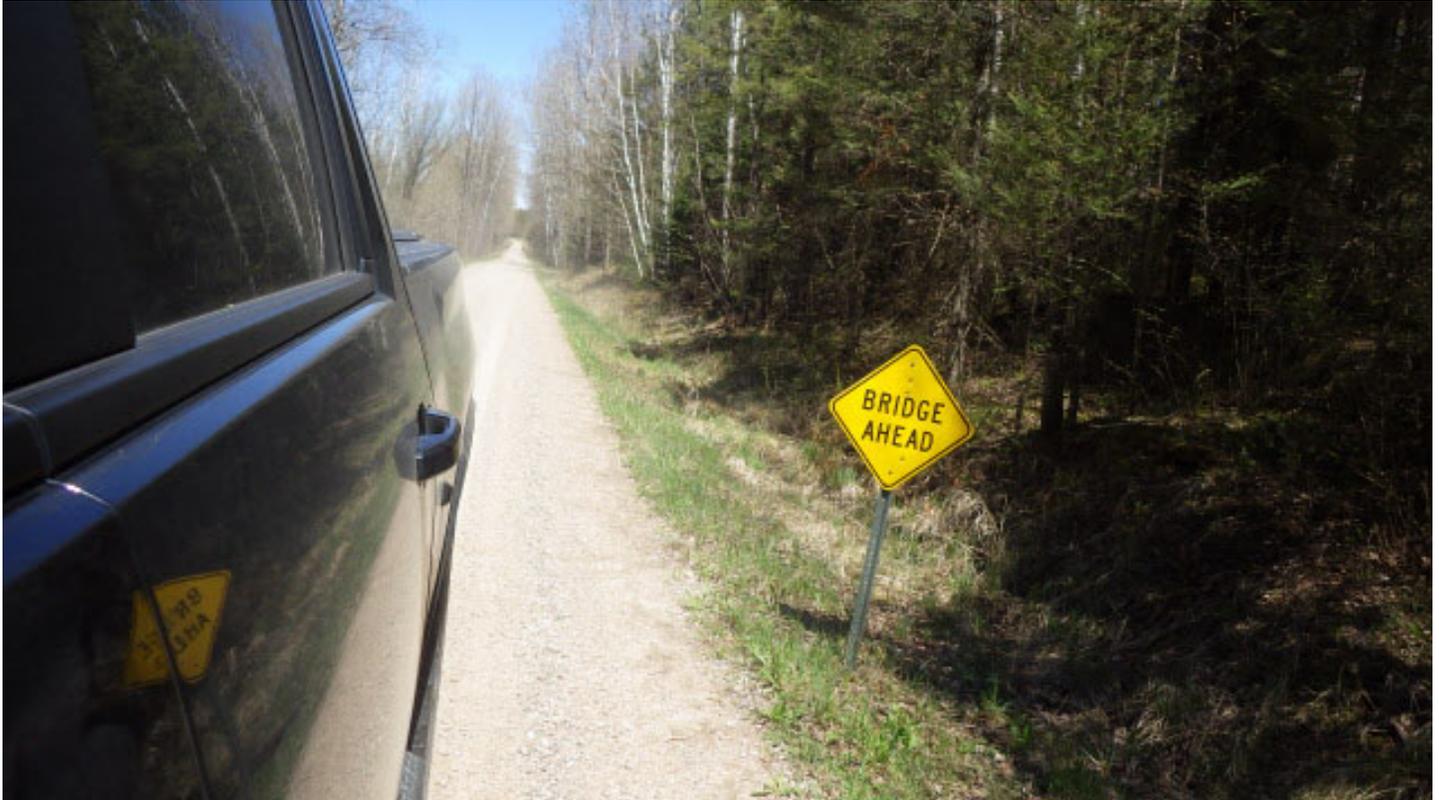
South bridge ahead sign

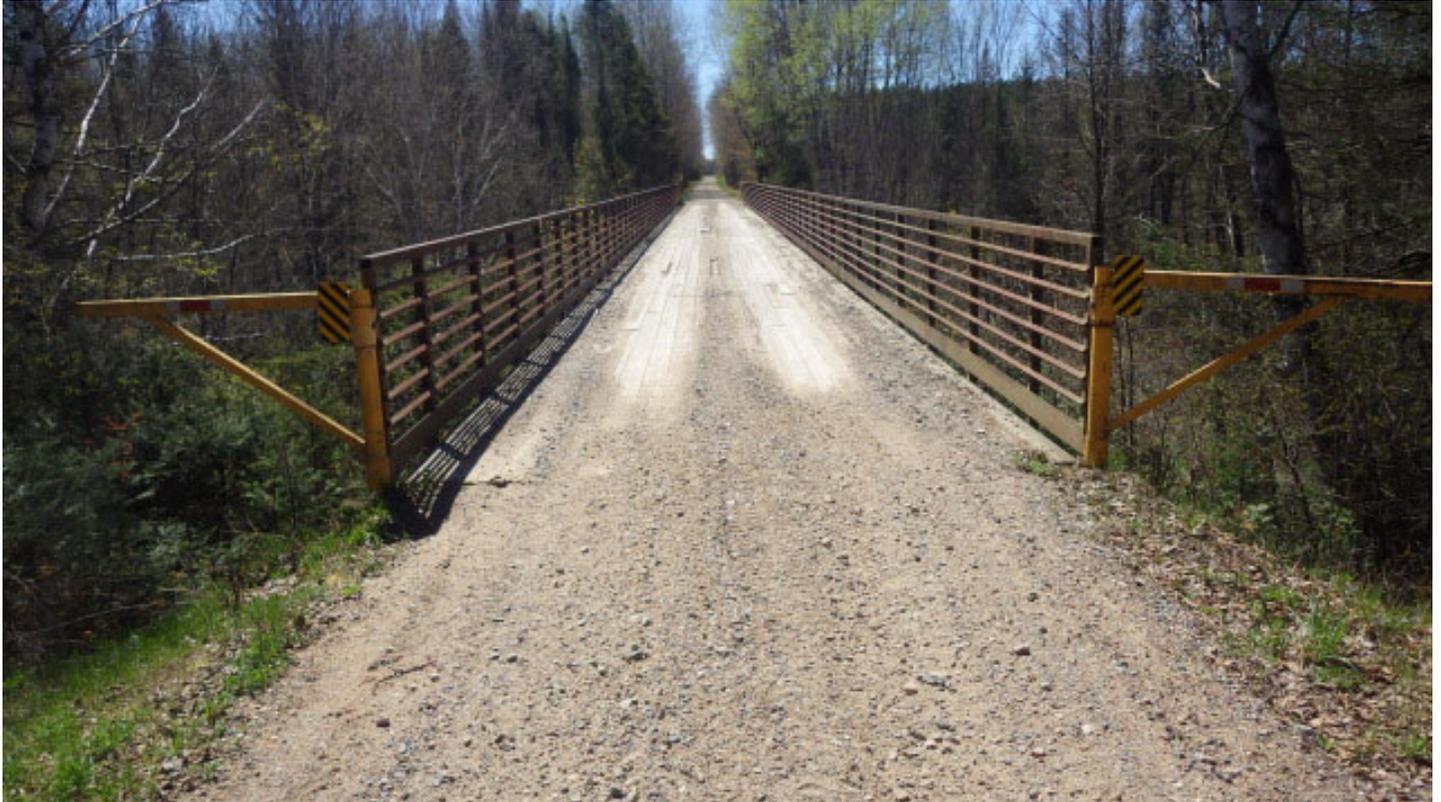
Approaches are in good condition. Object markers are in place and serviceable. Both bridge ahead signs are in place and serviceable.

North approach

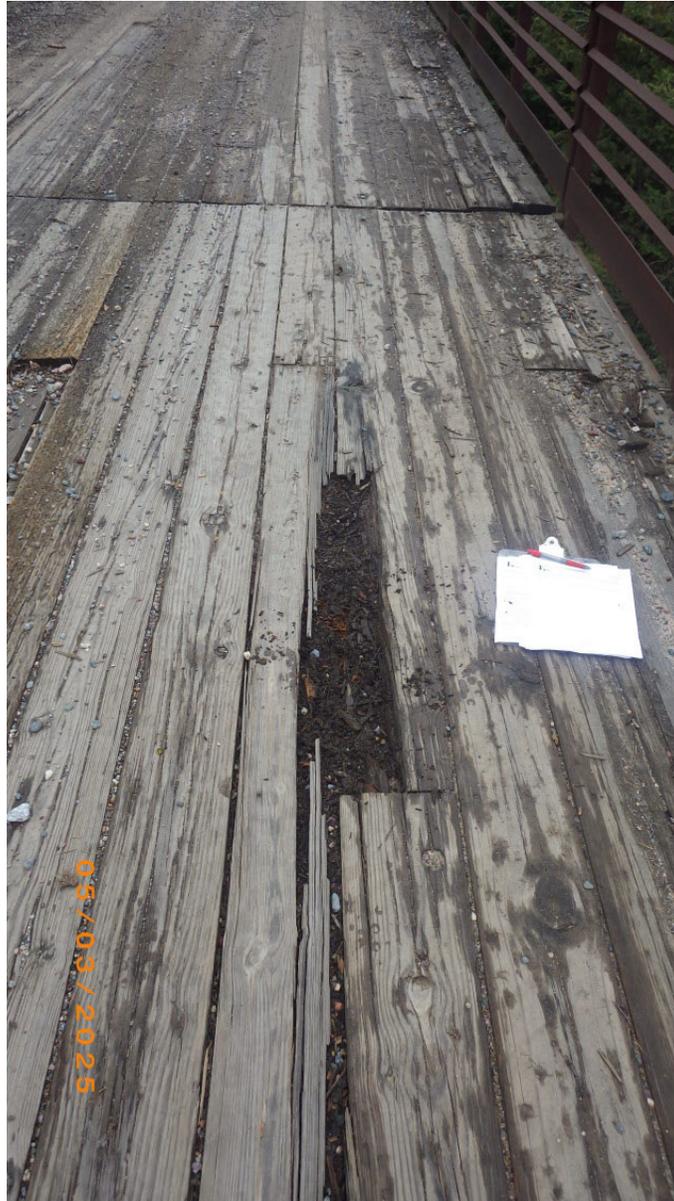
Minor gravel on deck. Scattered wear plank ends sticking up 1"+. 10-20 rotten wear planks. Both wear plank and structural deck underneath rotten through in two locations. First is a 1 SF hole at the center of the bridge and the second is a 1' x 3' hole along the east edge in span 7. The surrounding areas in these regions are rotten on the underside.

Missing / rotten wear planks

Replace entire deck with copper naphthenate treated timber planks

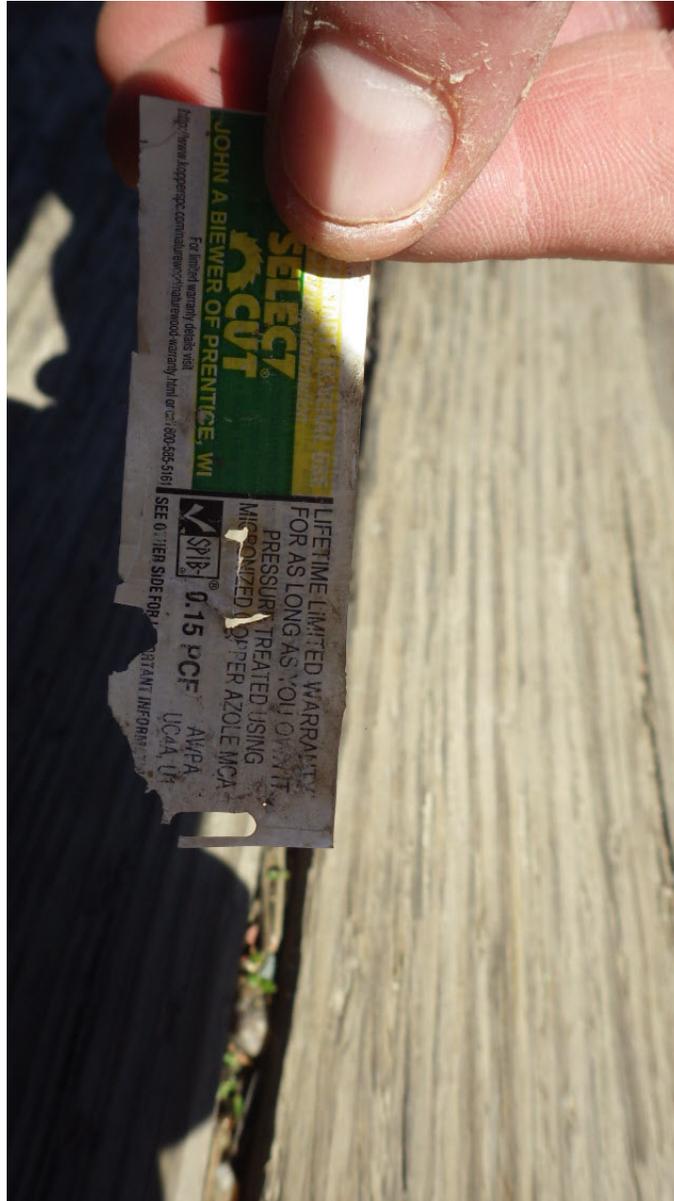
Decking is MCA treated to UC4A which is insufficient for structural applications

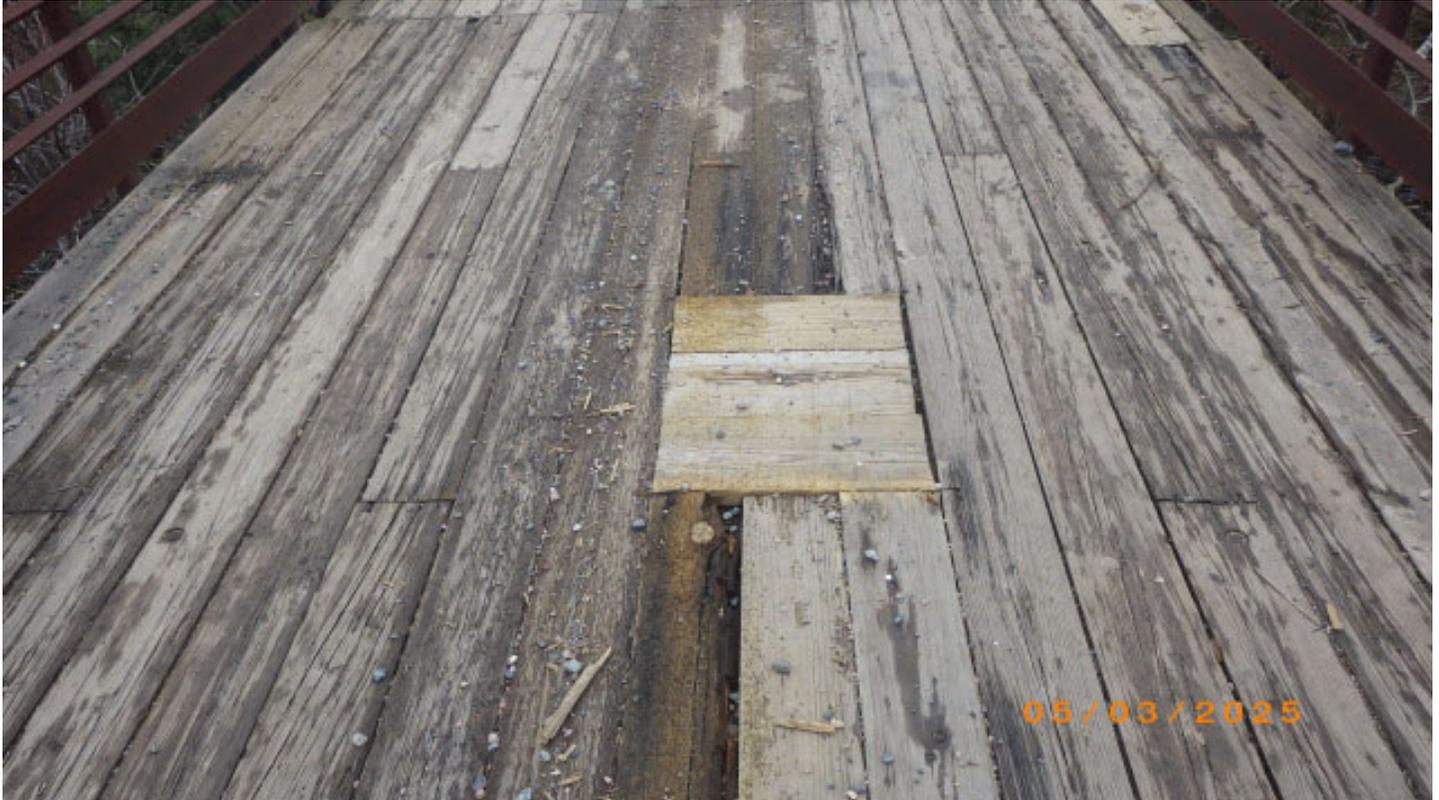
Patched hole near center of bridge

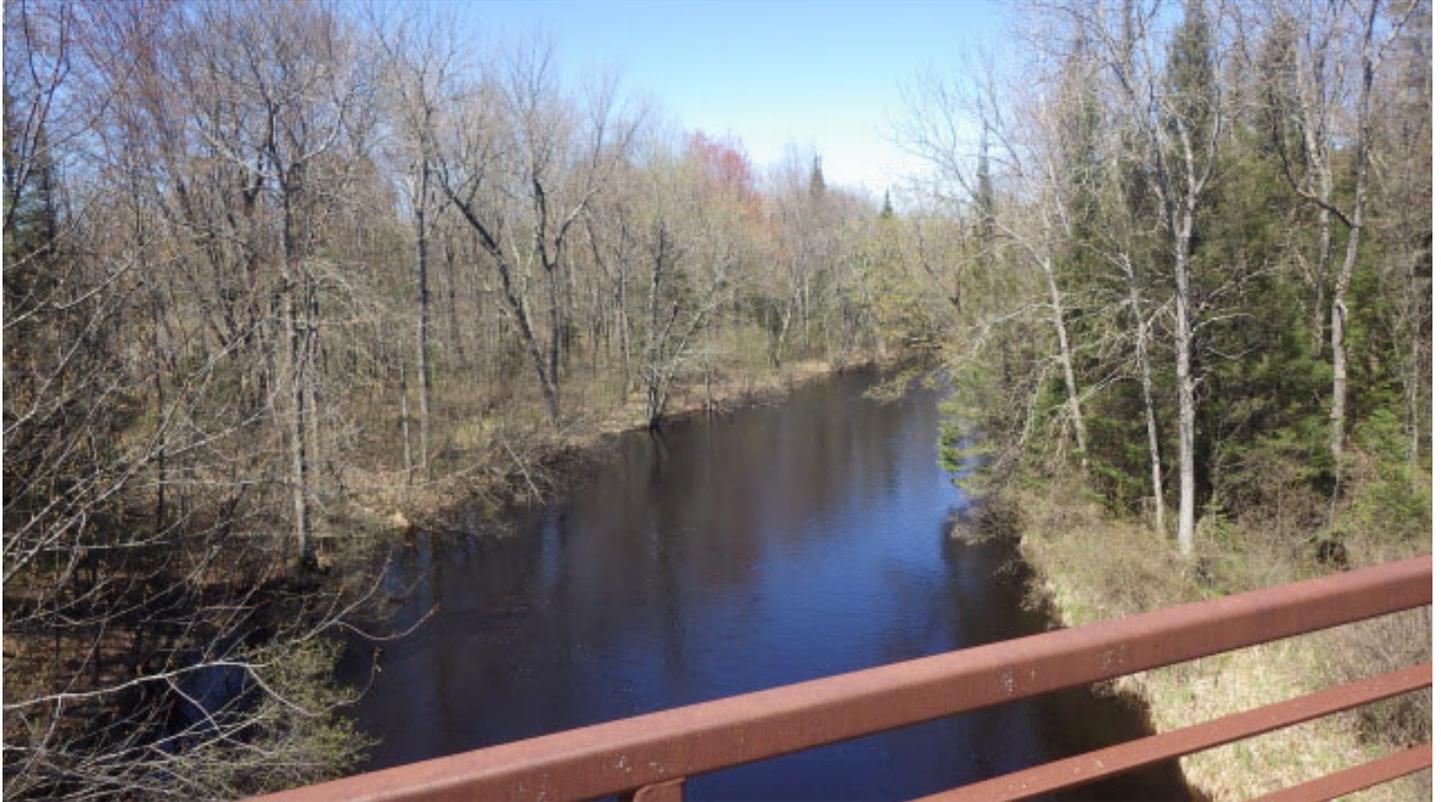
Channel is in good condition with lots of trees and brush in floodplain under bridge.

Channel looking upstream

Cut brush around / under bridge

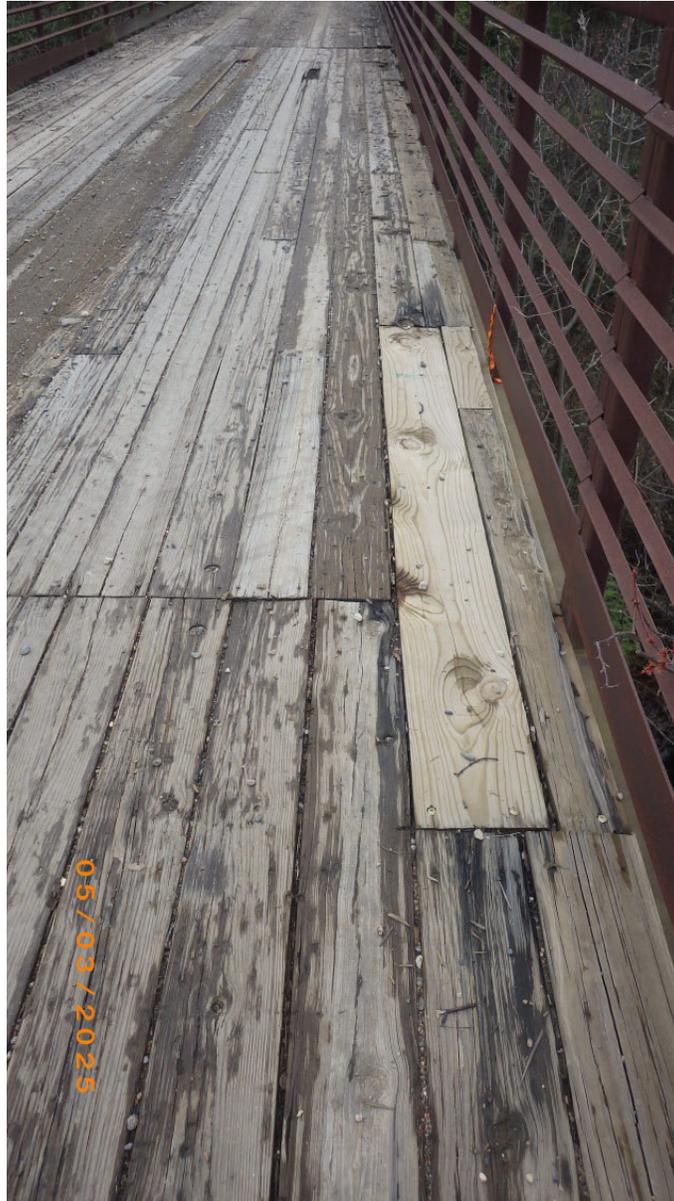
Patched hole at east edge of span 7

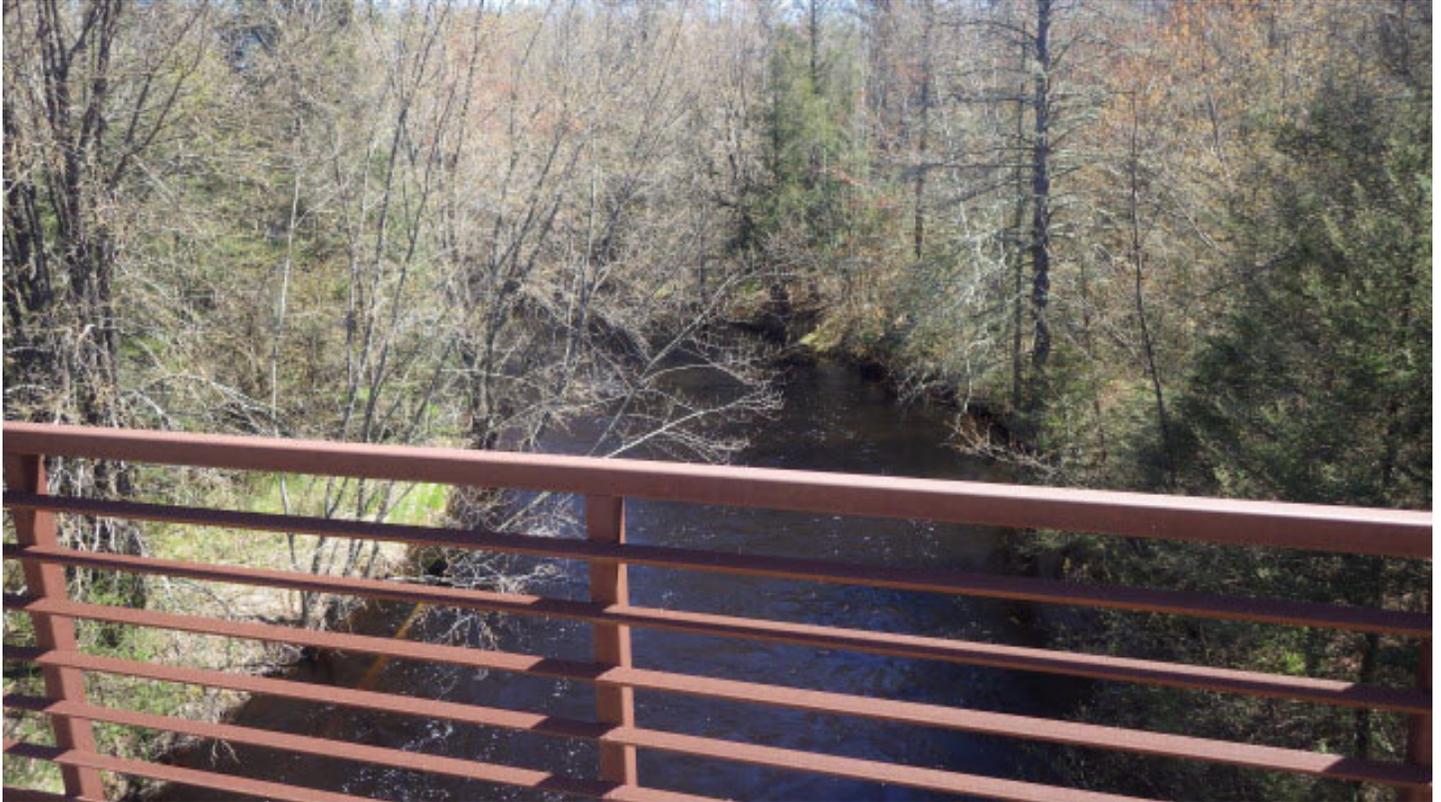
Channel looking downstream

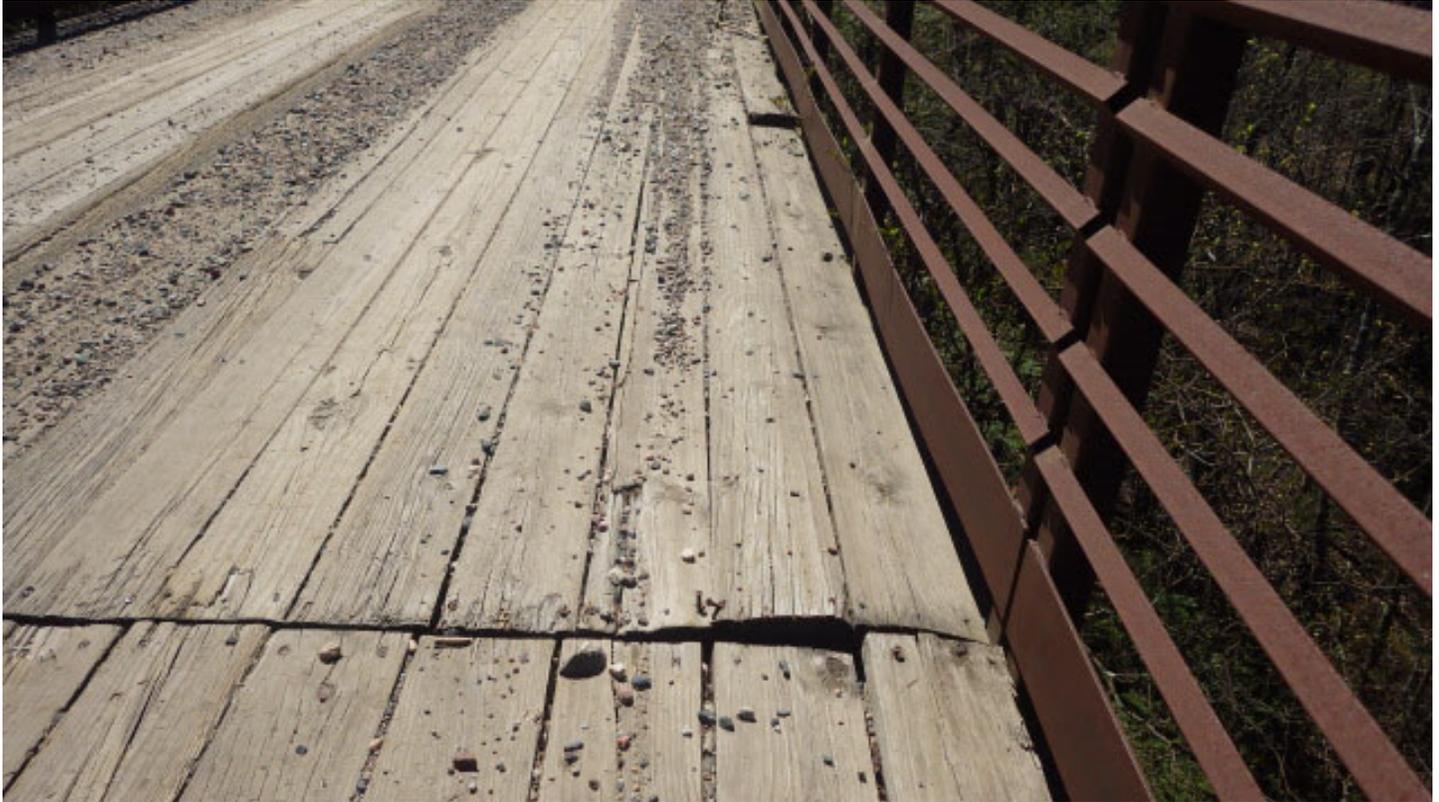
Running planks with ends sticking up 1"+

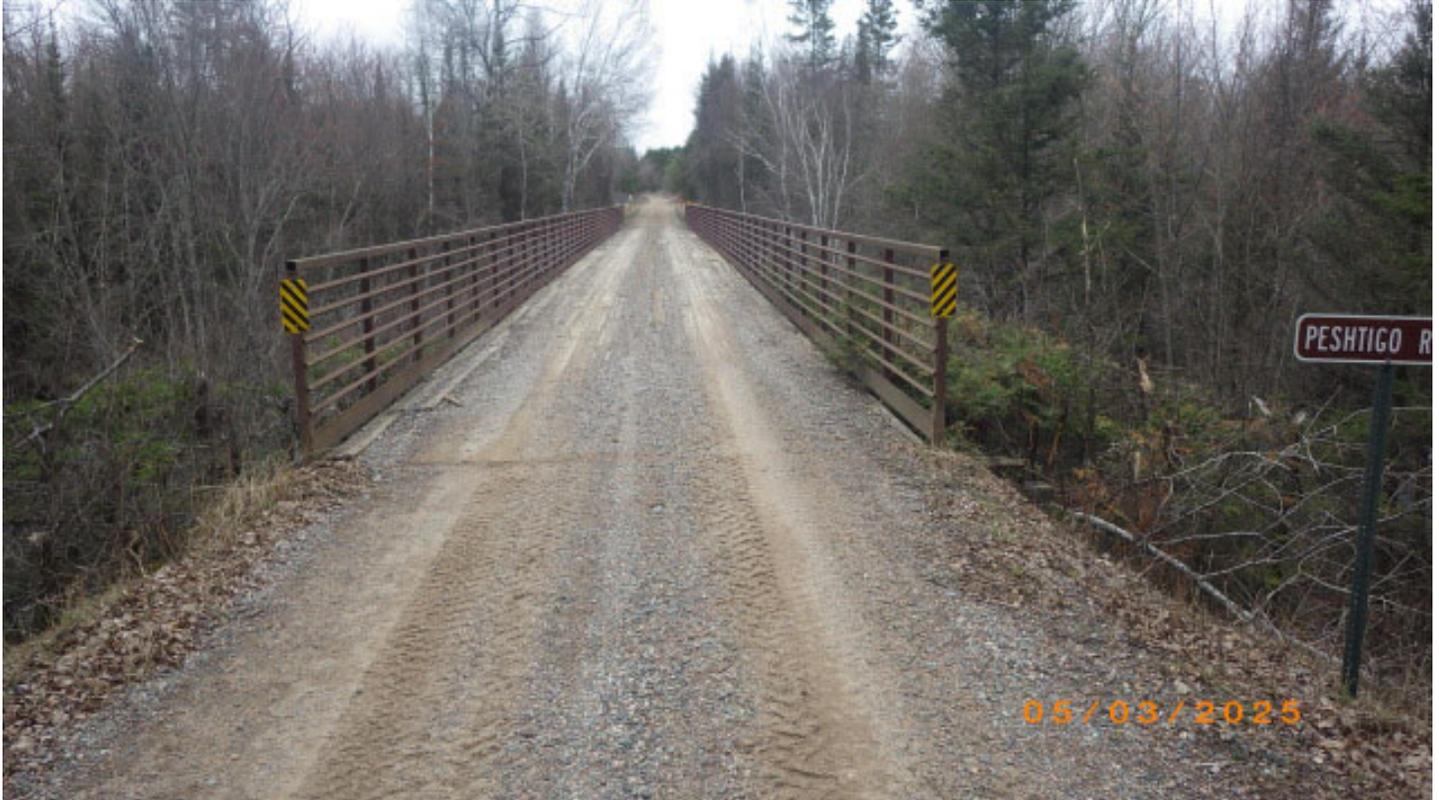
South approach

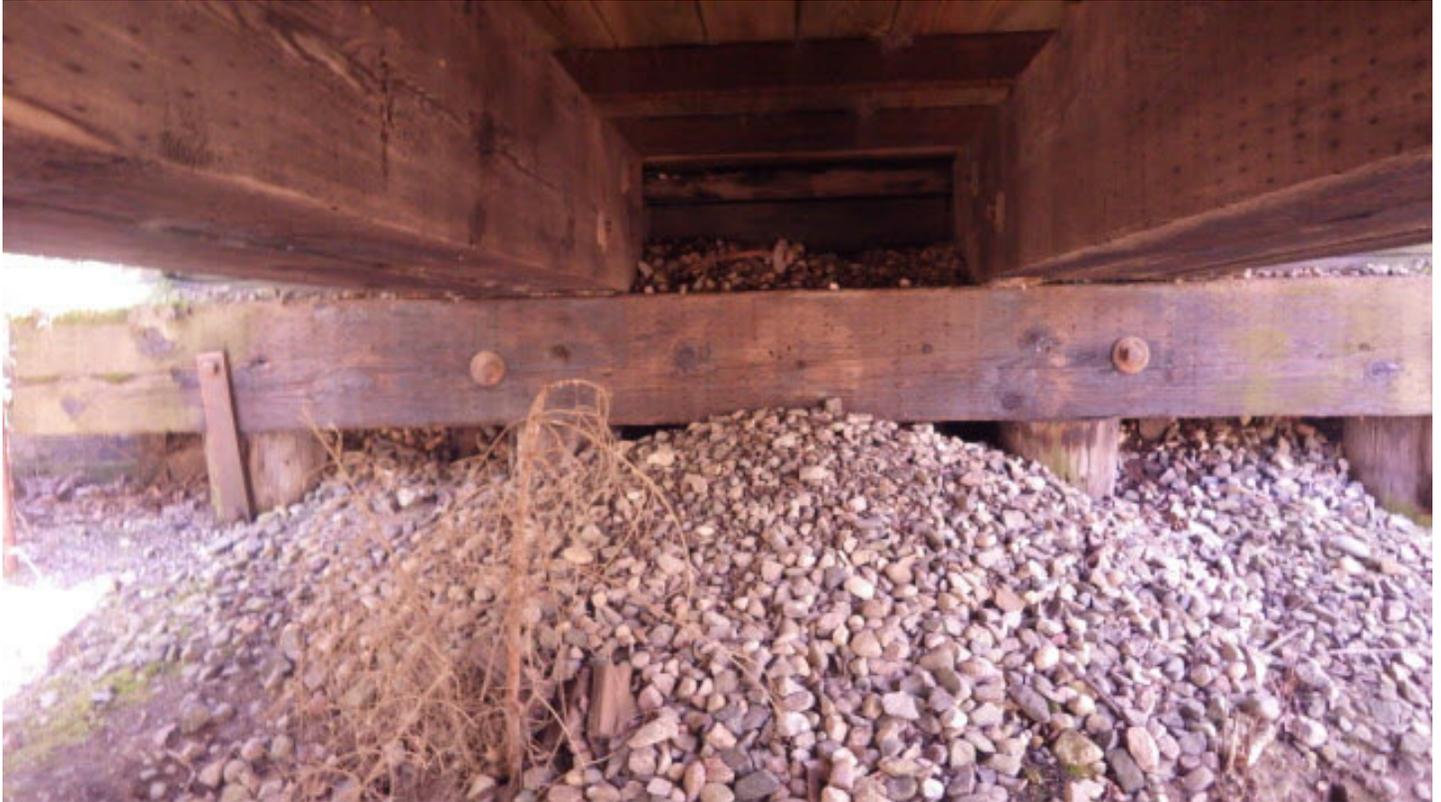
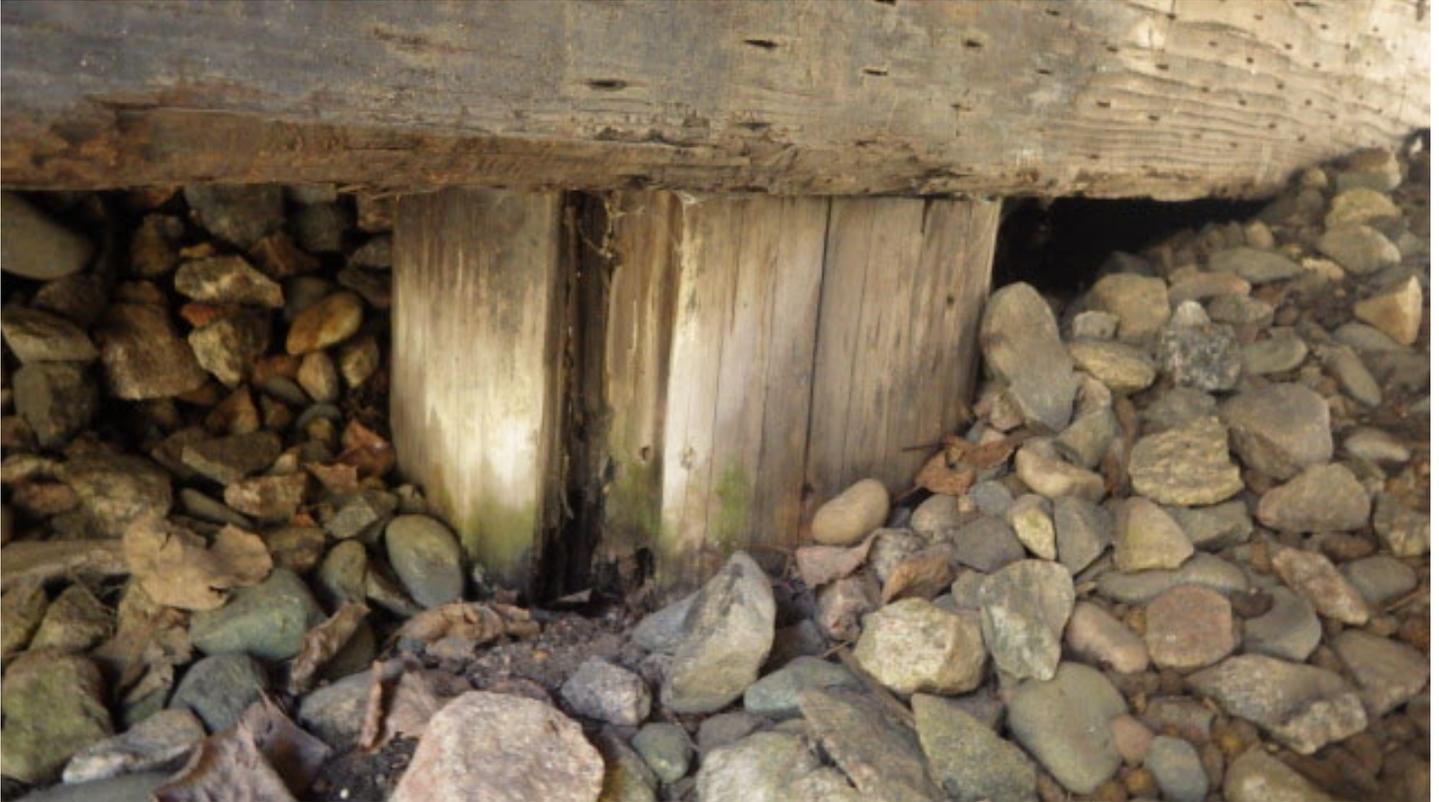
South abutment has rotten piling. Bent #1 pile cap is rotten / crushing. Bent #2 center pile is hollow. Concrete pier #3 has a very large CS3 spall on the upstream and top edge, widespread CS3 cracking with rust stained

South abutment rotten piling

****Replace bridge in next 1-3 years****

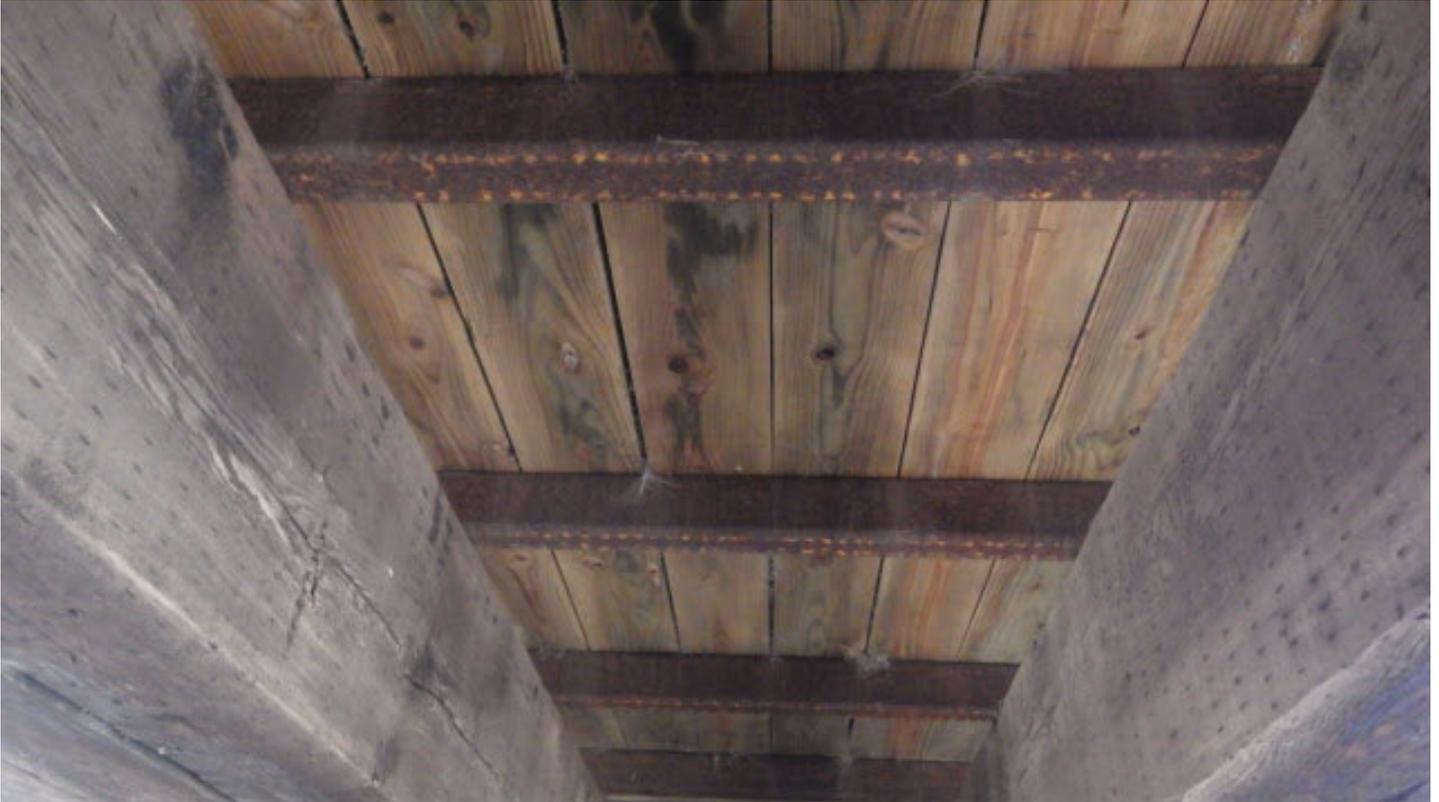
typical underside of deck, scattered black mold.

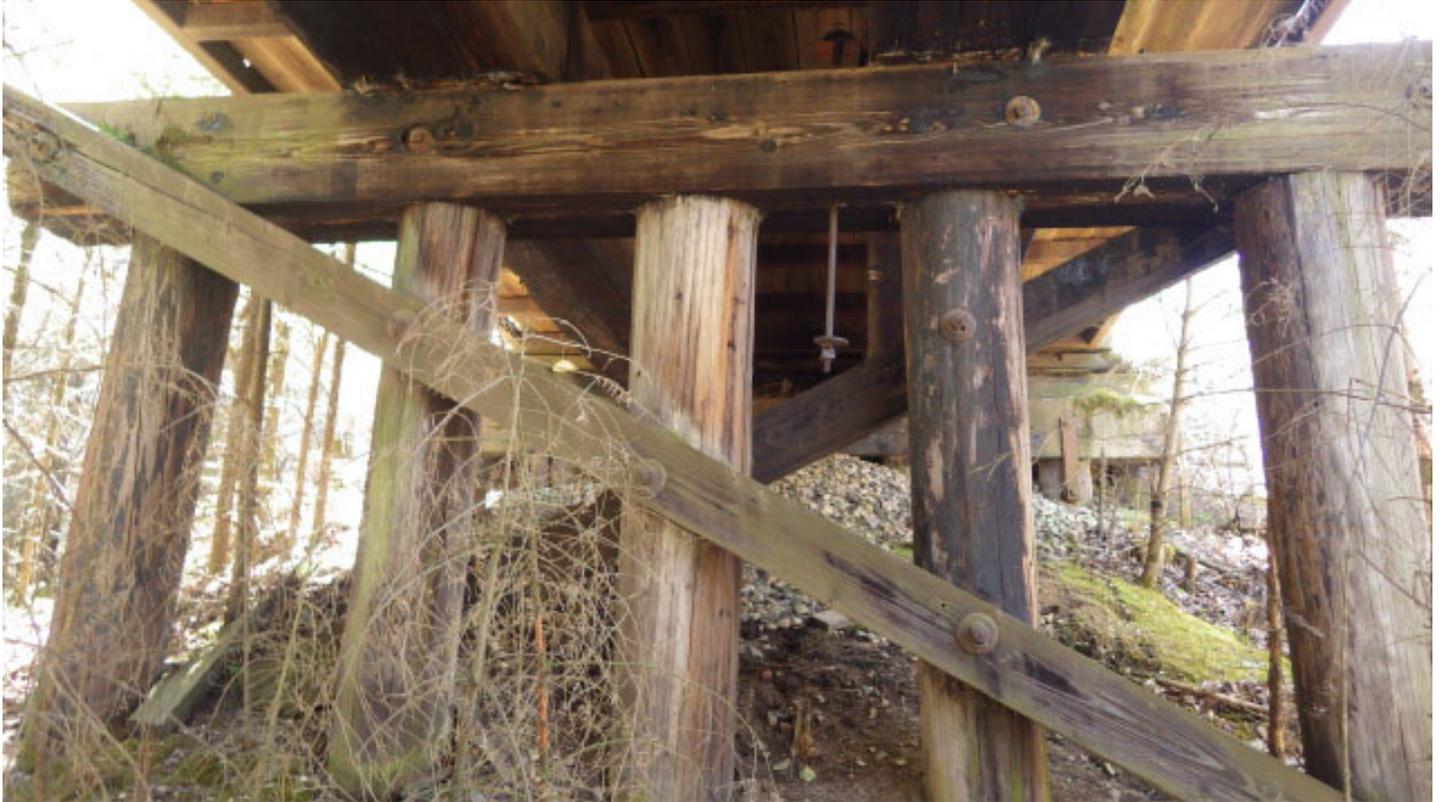
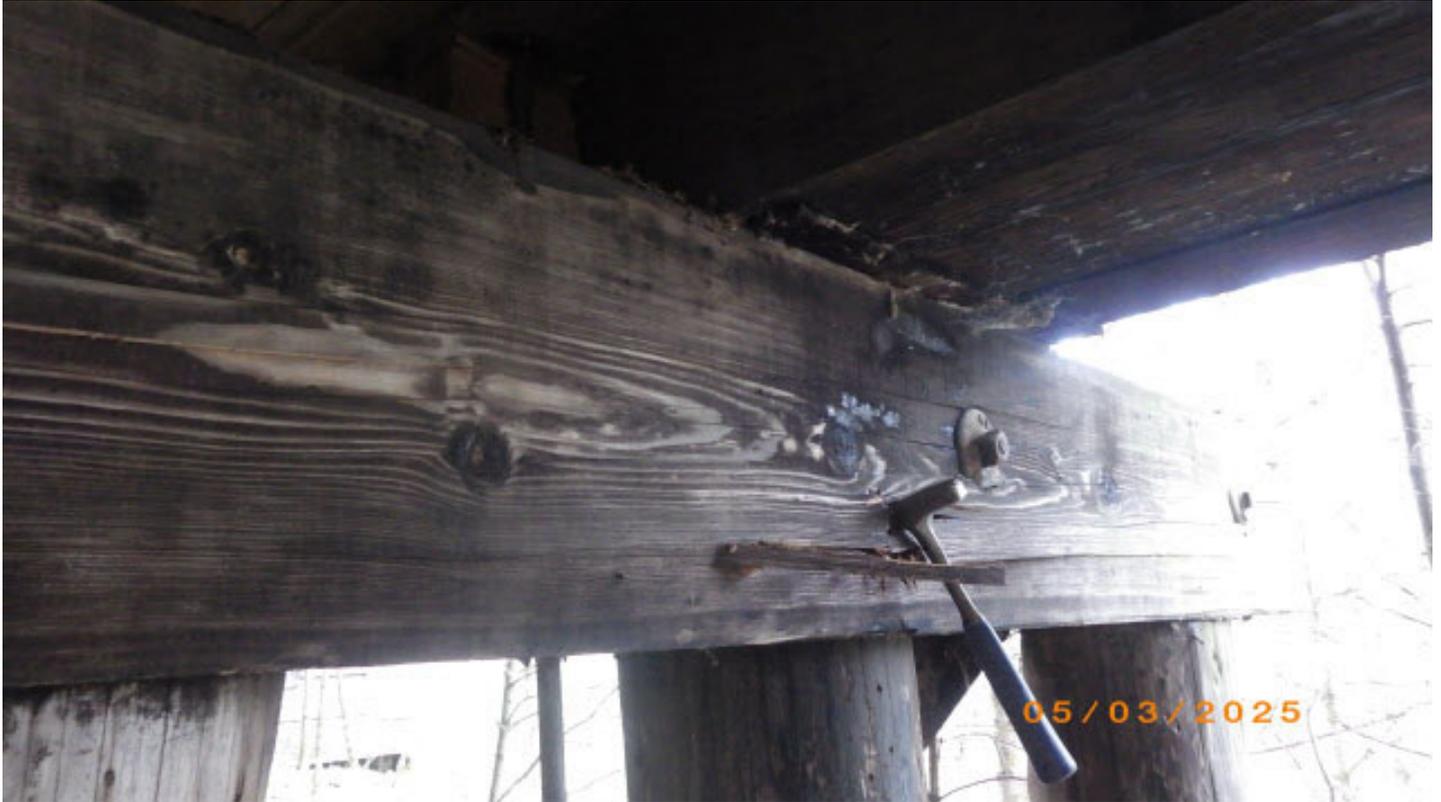
Bent #1, cap rotten / crushing

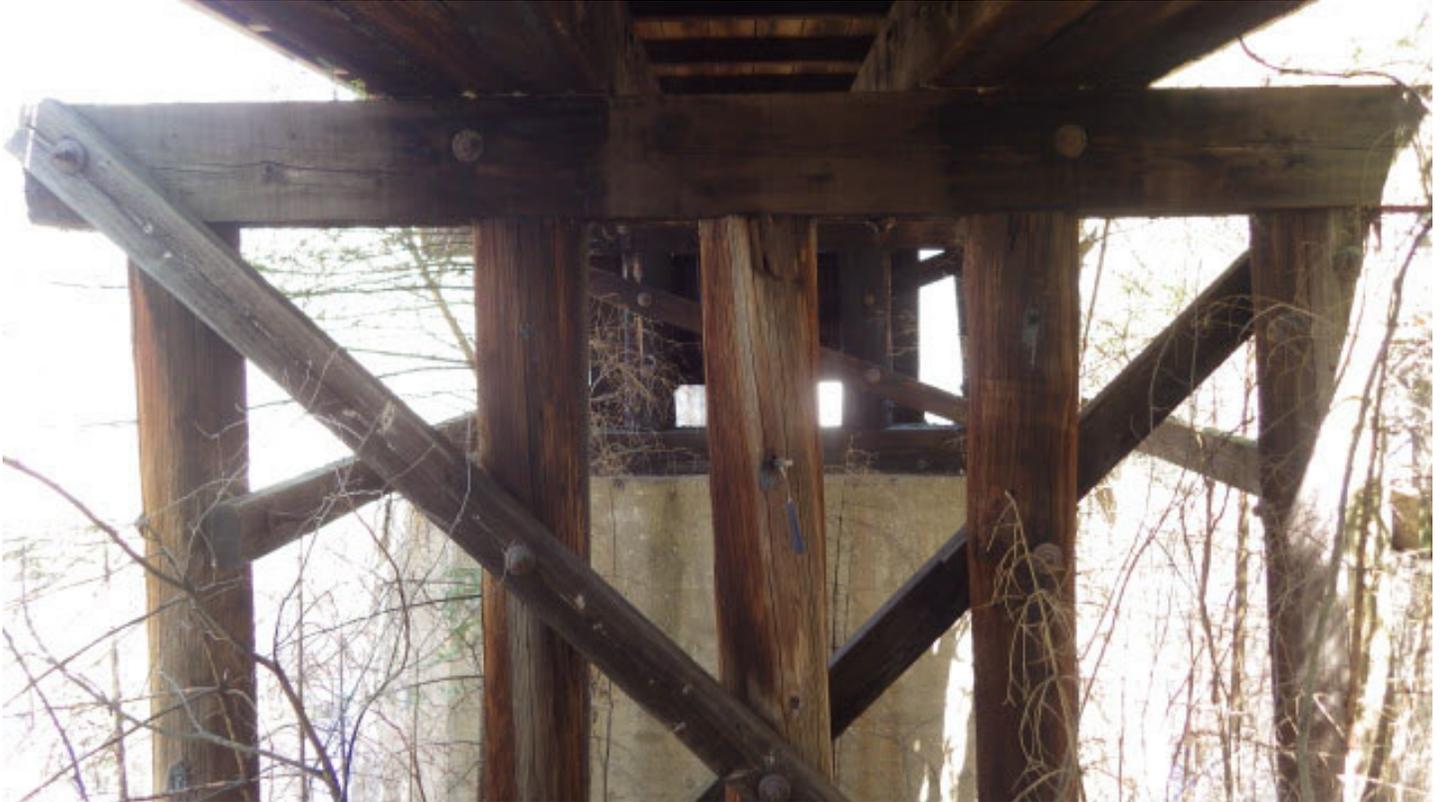
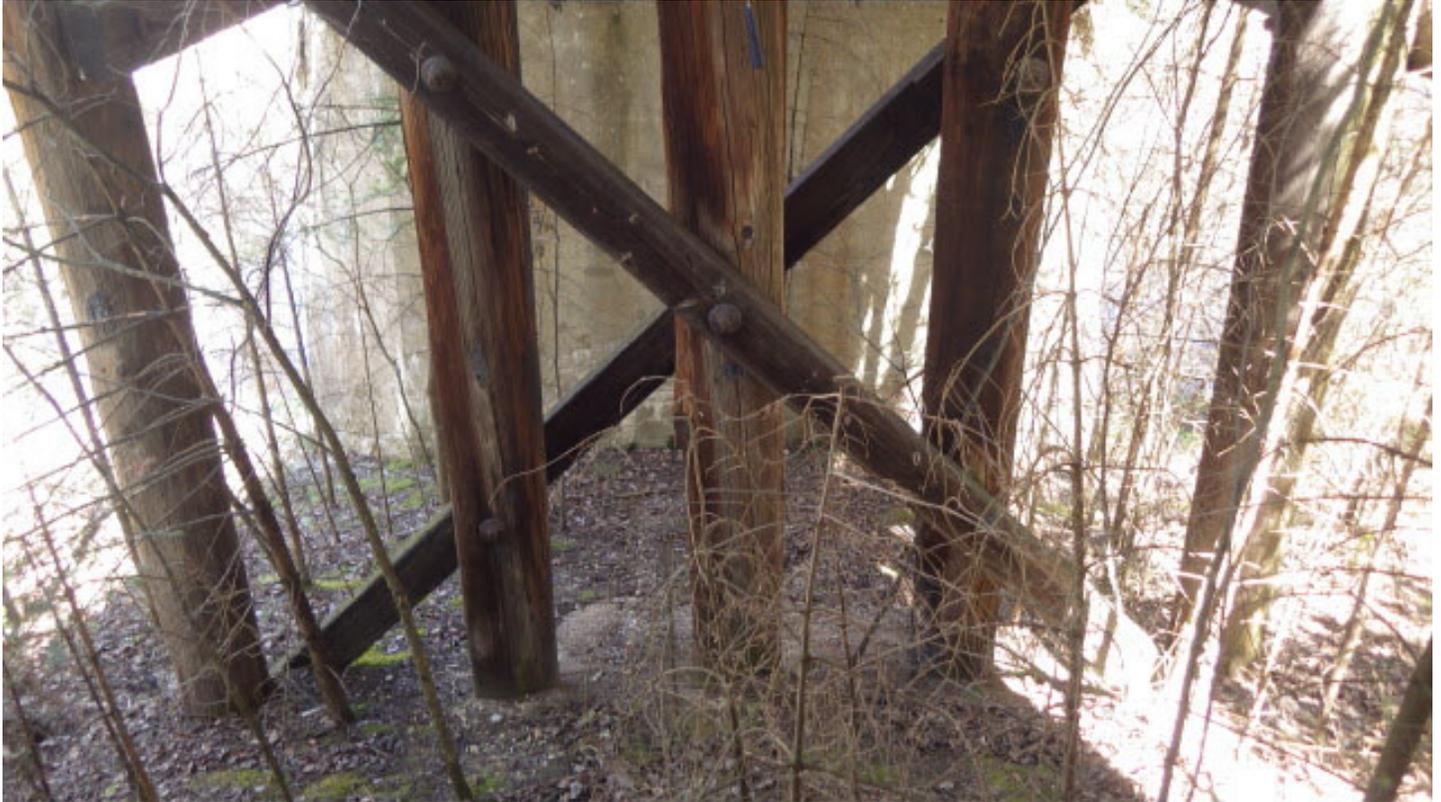
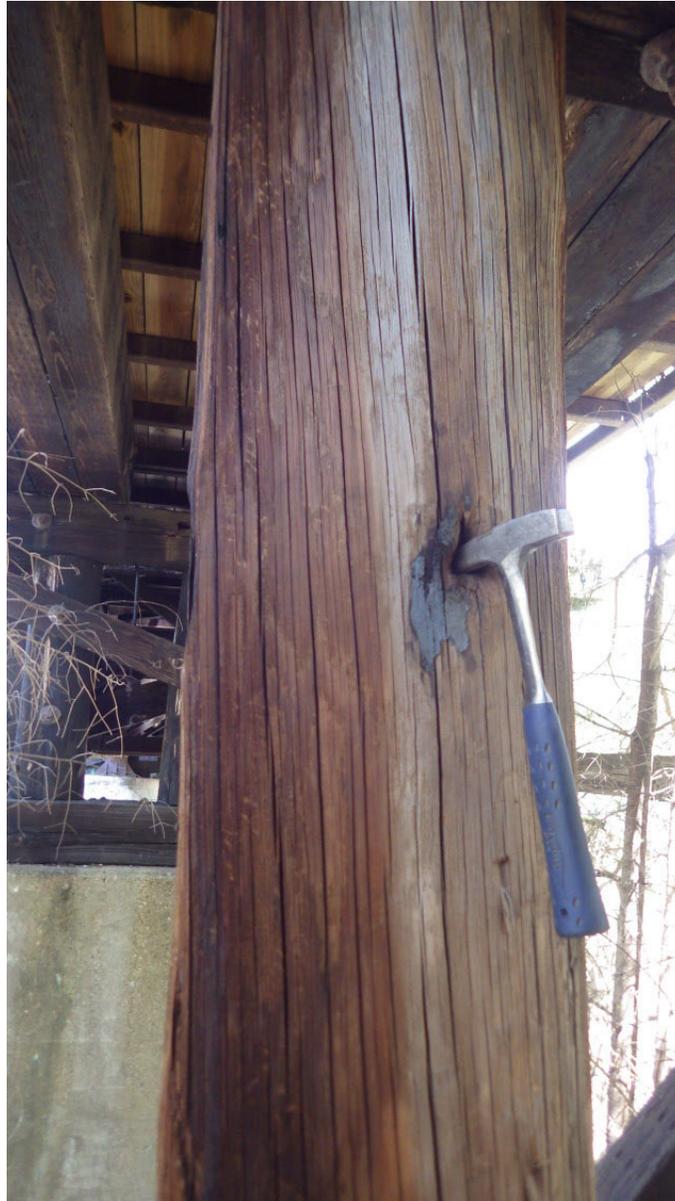
Bent #2 (top), center pile hollow

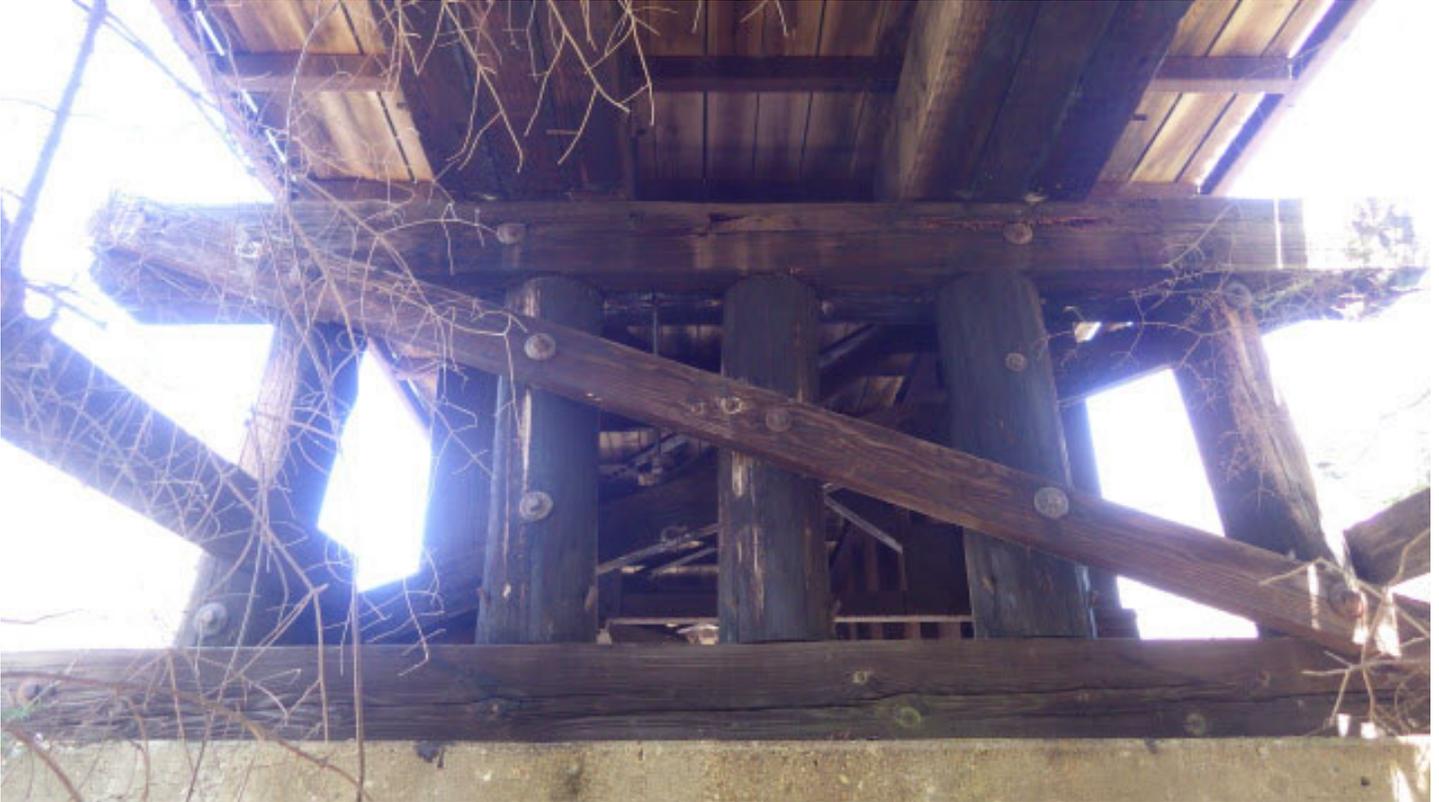
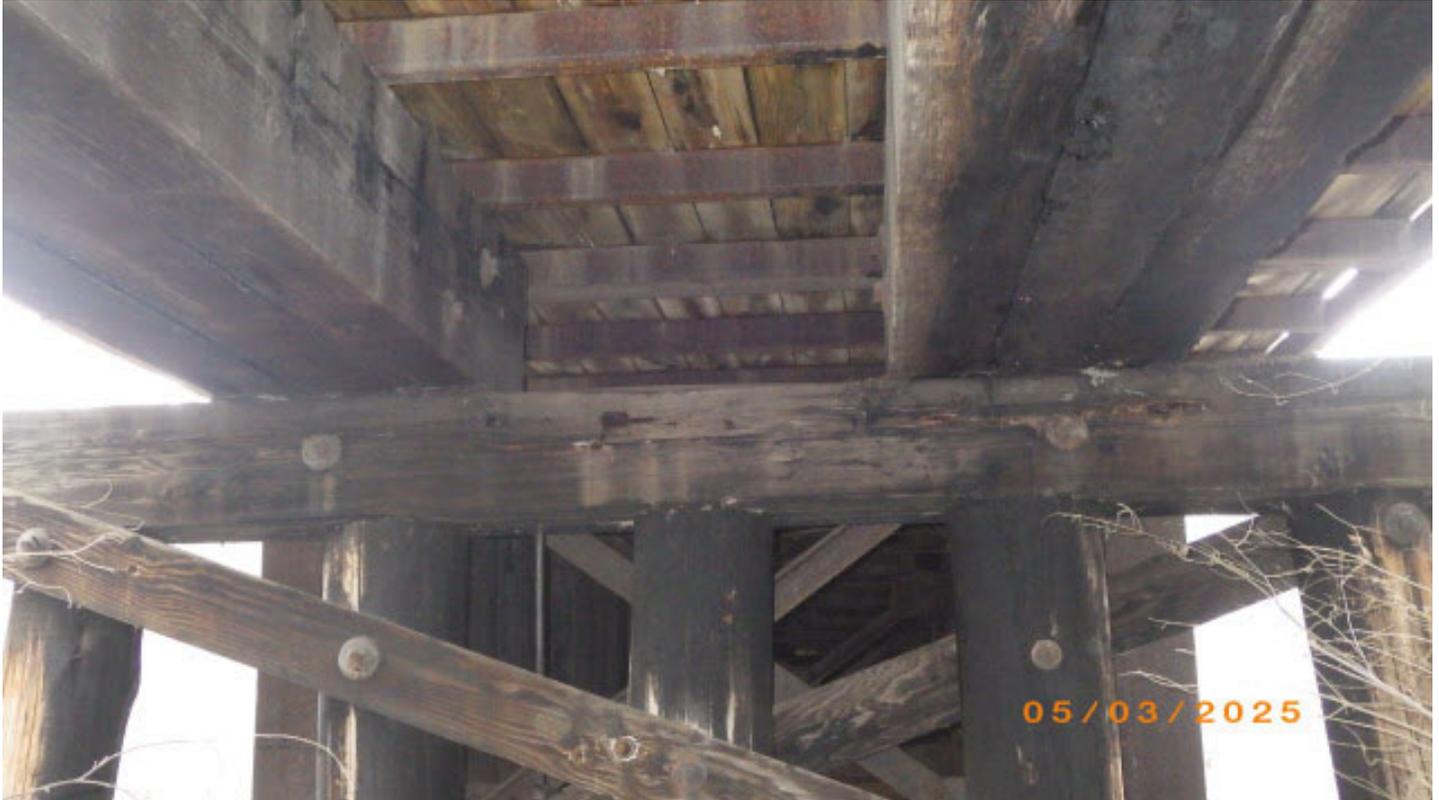
efflorescence. Top section of pier is timber and the cap is rotten / crushing. Concrete pier #4 has very large 4'x4'x1' CS3 spalls at both the upstream and downstream top edge. CS3 cracking with efflorescence throughout. Bents #5-8 in fair condition. Bent #9 cap is rotten / crushing. Bent #10 cap is rotten. Bent #11 cap ends are rotten. North abutment cap ends are rotten.

Pier #3, timber cap rotten / crushing
