A-13 Forest Co NST Peshtigo Bridge Replacement

Trail Bridge Inspection

Peshtigo River

Bridge Inspection Report

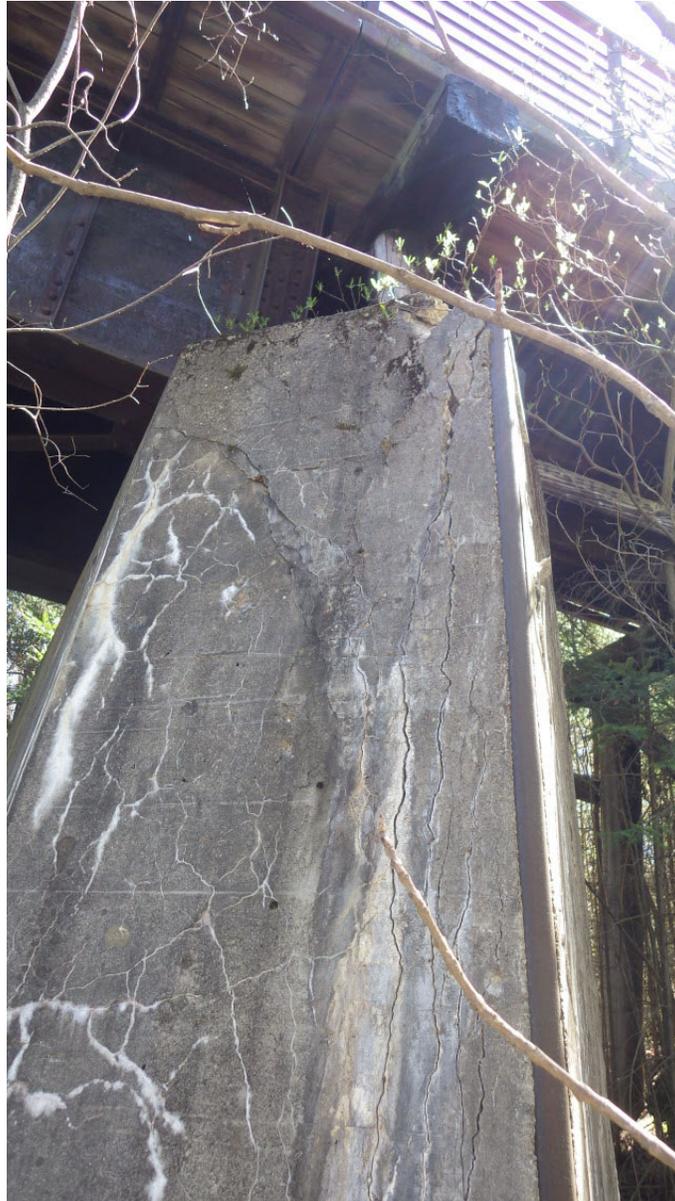
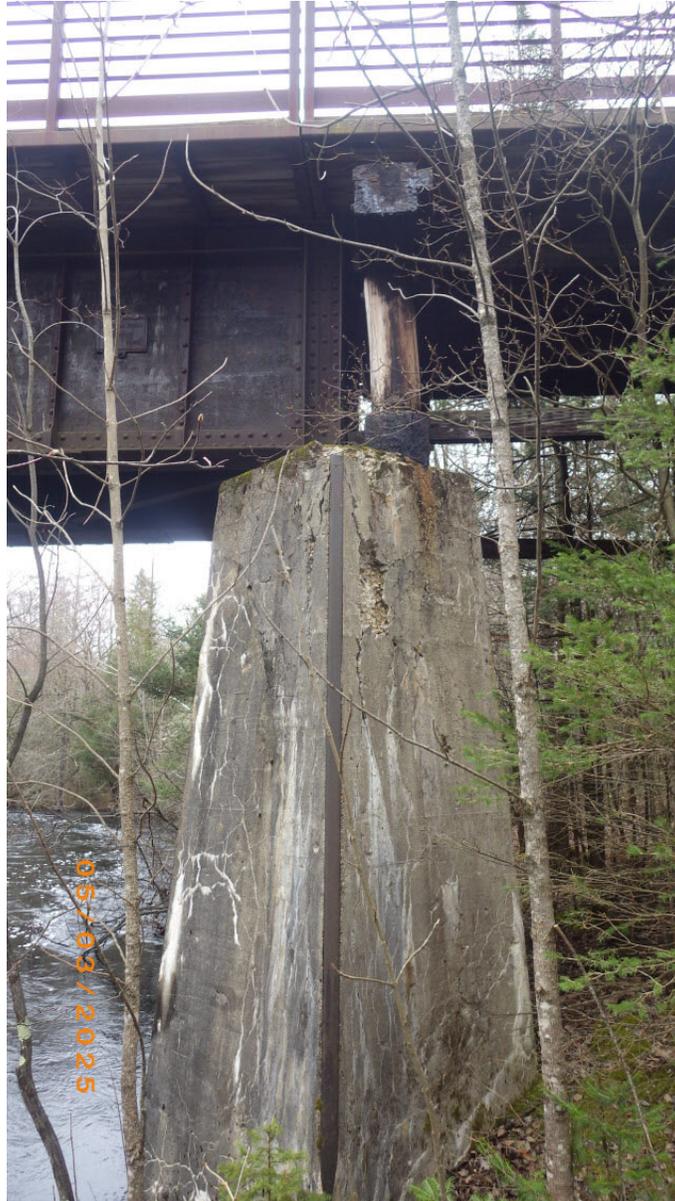
South abutment has rotten piling. Bent #1 pile cap is rotten / crushing. Bent #2 center pile is hollow. Concrete pier #3 has a very large CS3 spall on the upstream and top edge, widespread CS3 cracking with rust stained

Pier #3 concrete wall with very large spall on upstream nose and top edge with CS3 cracking with rust stained efflorescence throughout

****Replace bridge in next 1-3 years****

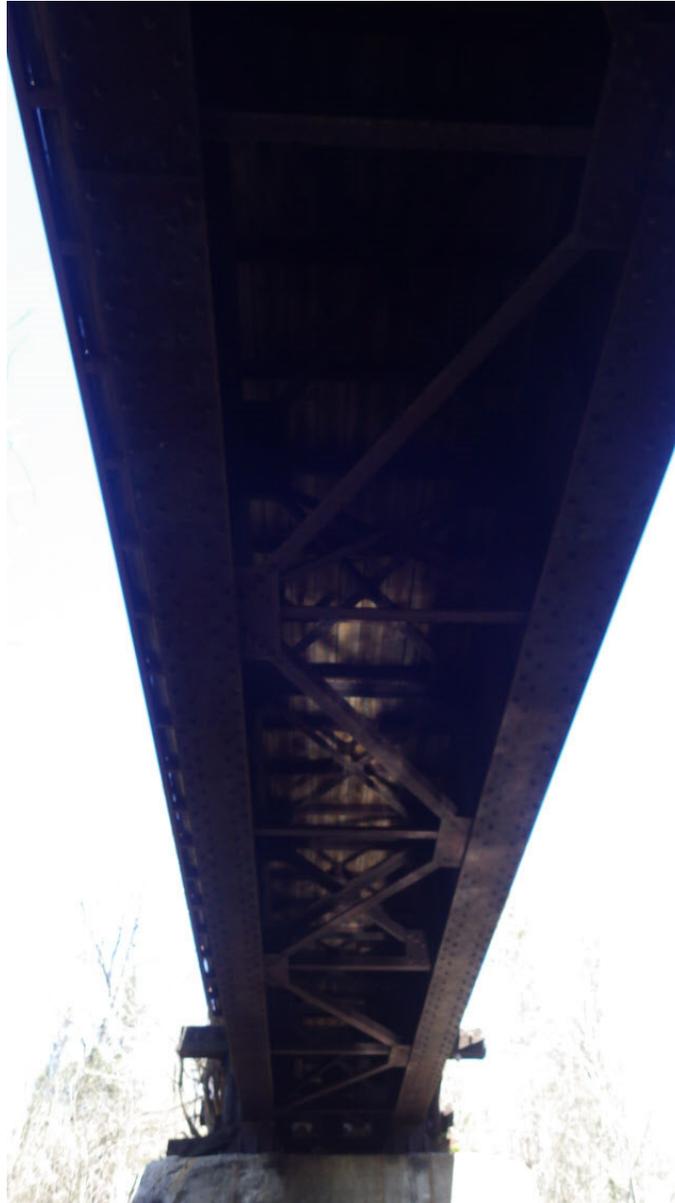
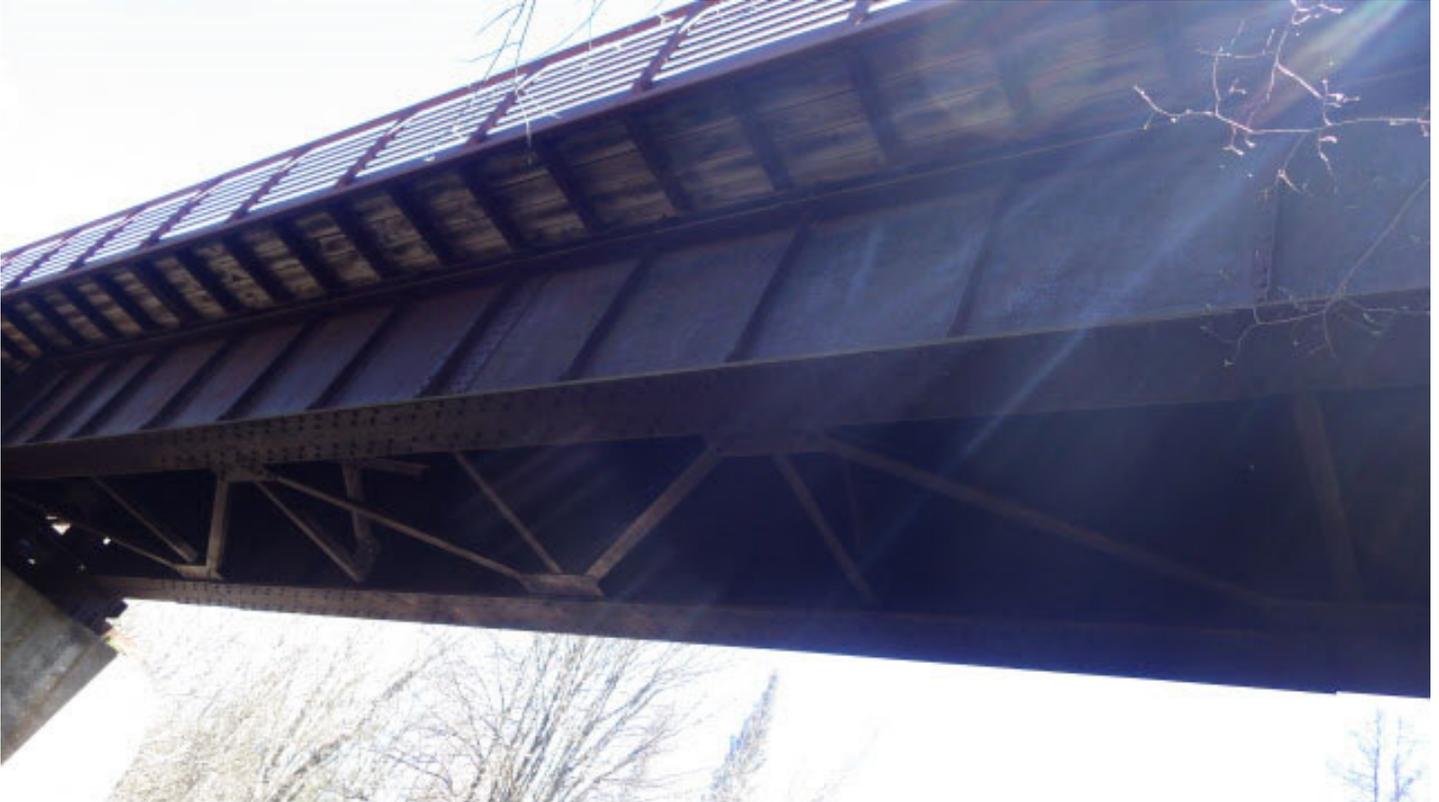
Steel main span is in fair condition (1925 construction plaque). Some exterior timber girders are punky.

Steel main span in fair condition

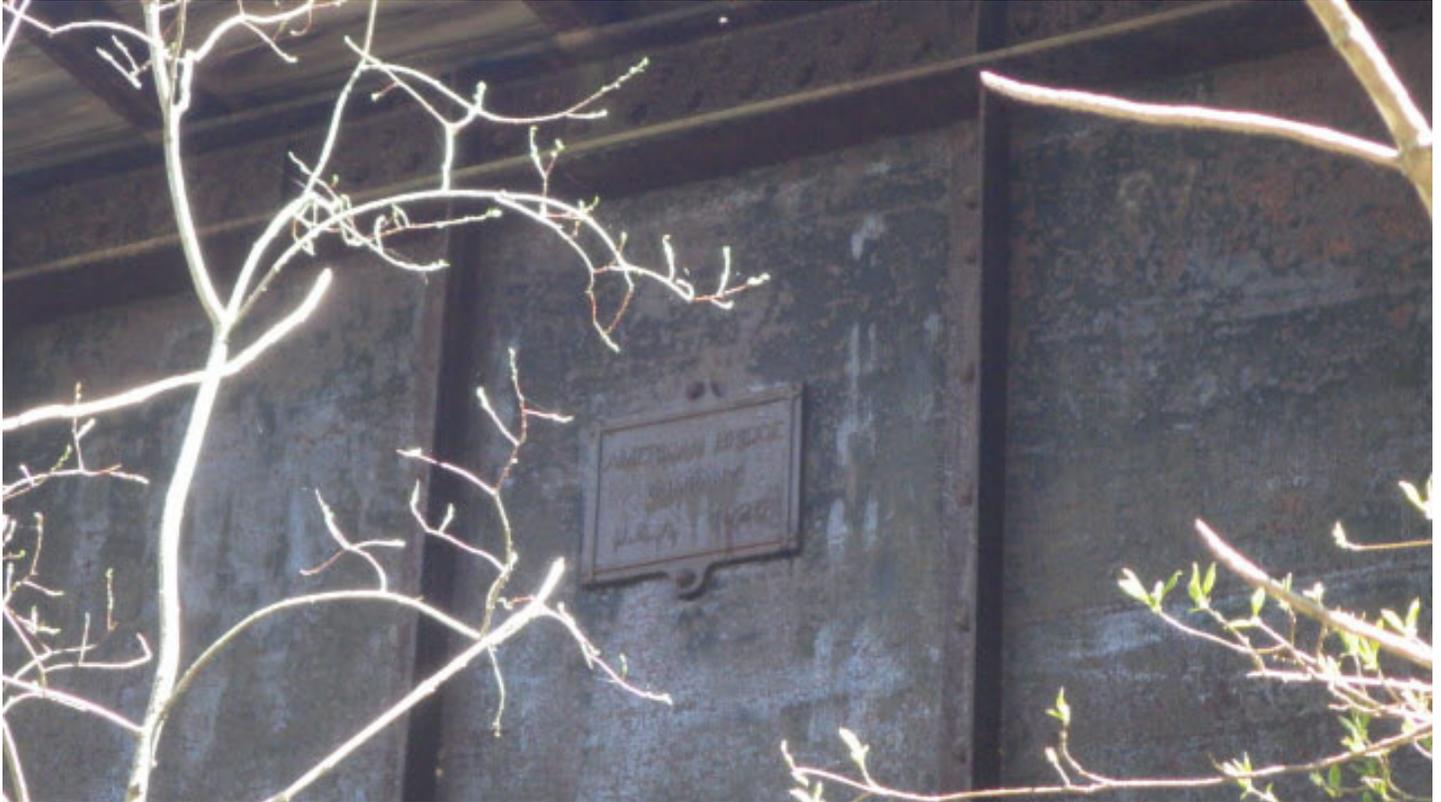
Constructed in 1925 by the American Bridge Company

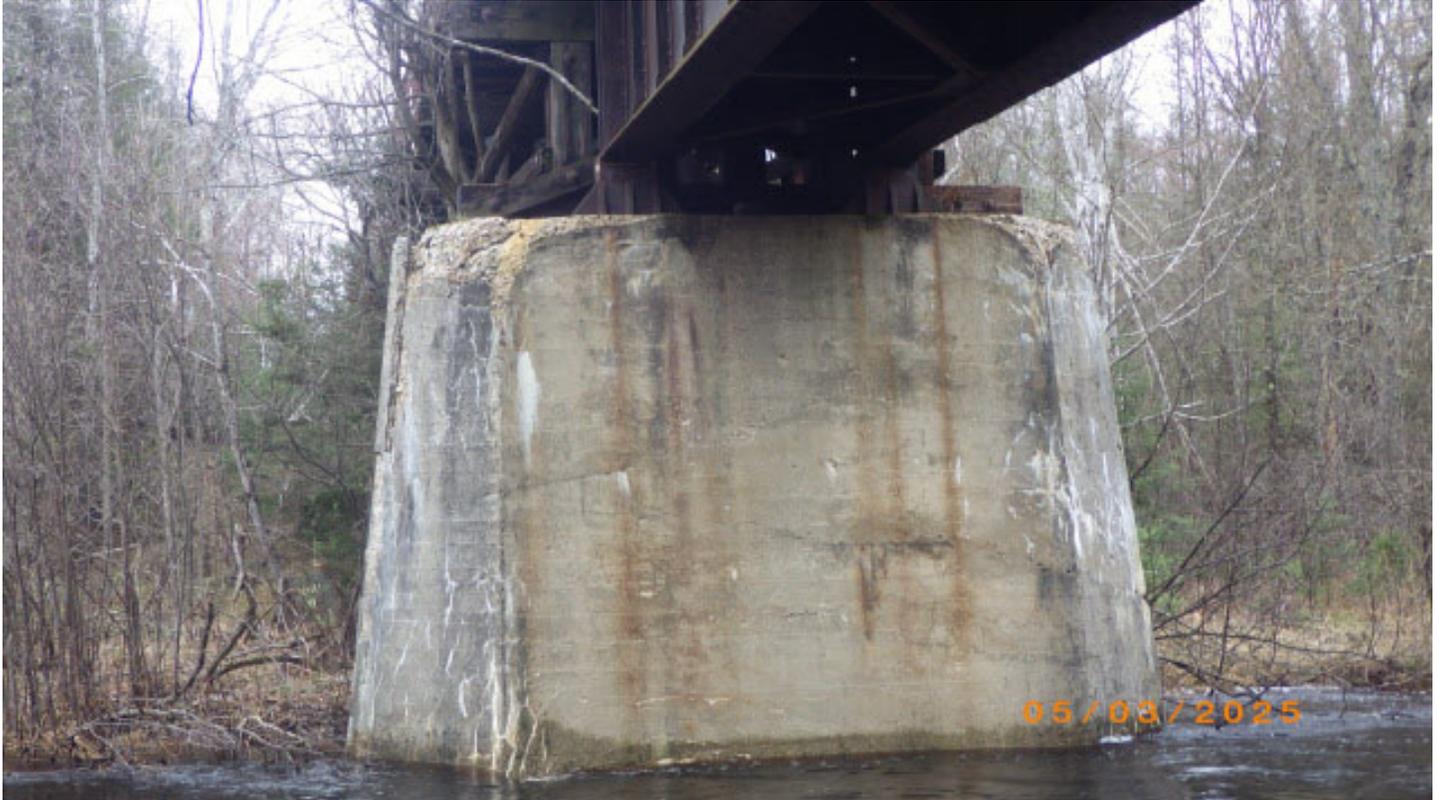
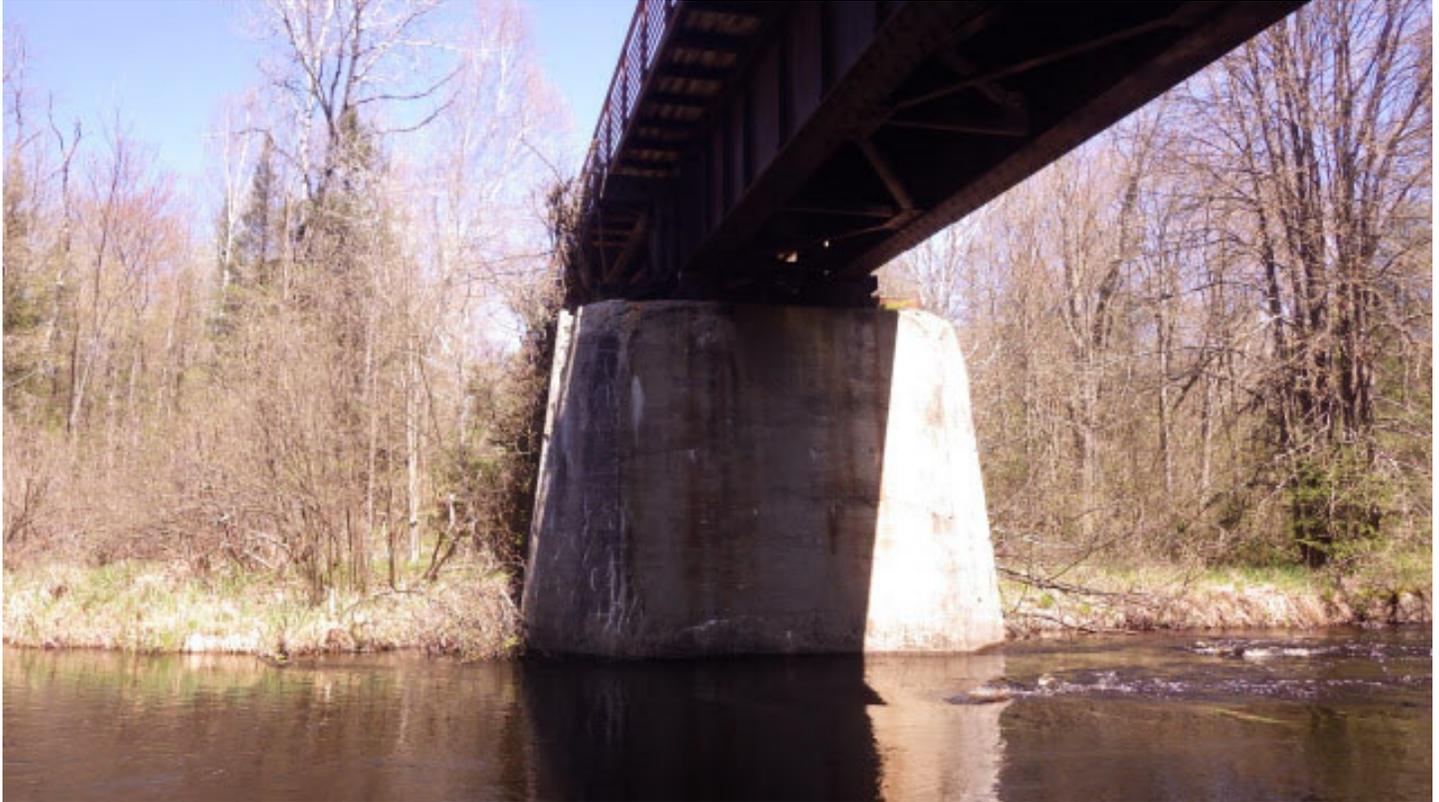
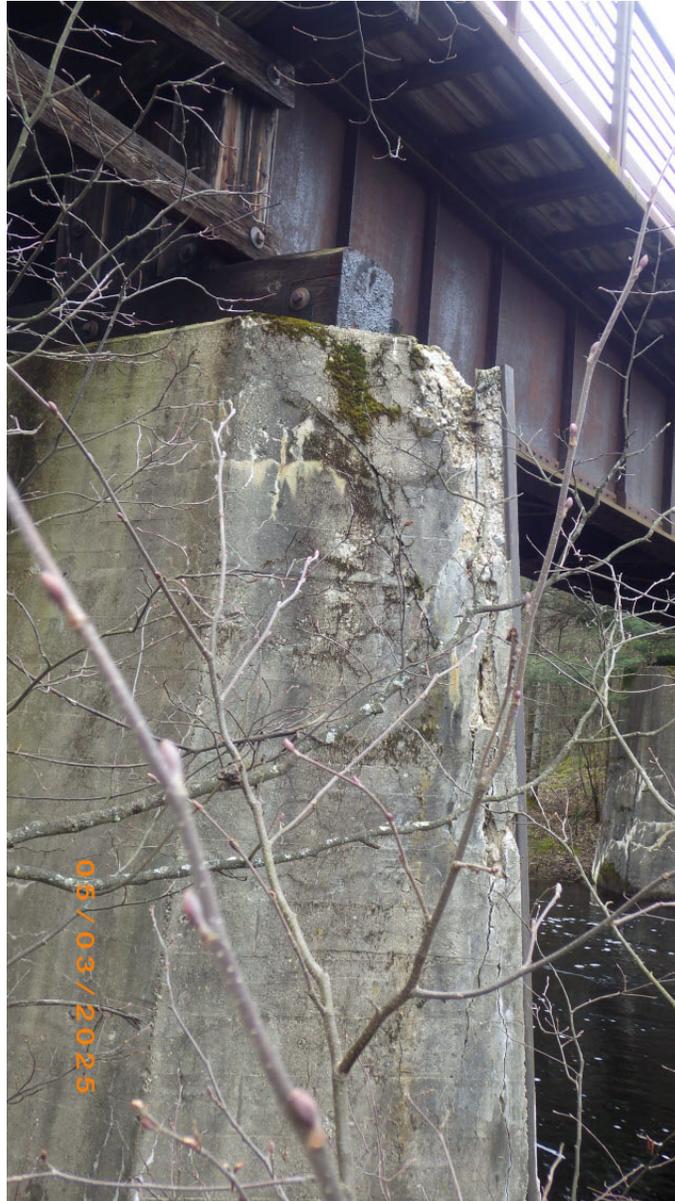
efflorescence. Top section of pier is timber and the cap is rotten / crushing. Concrete pier #4 has very large 4'x4'x1' CS3 spalls at both the upstream and downstream top edge. CS3 cracking with efflorescence throughout. Bents #5-8 in fair condition. Bent #9 cap is rotten / crushing. Bent #10 cap is rotten. Bent #11 cap ends are rotten. North abutment cap ends are rotten.

Pier #4 with very large spalls on top corners and CS3 cracking with efflorescence throughout

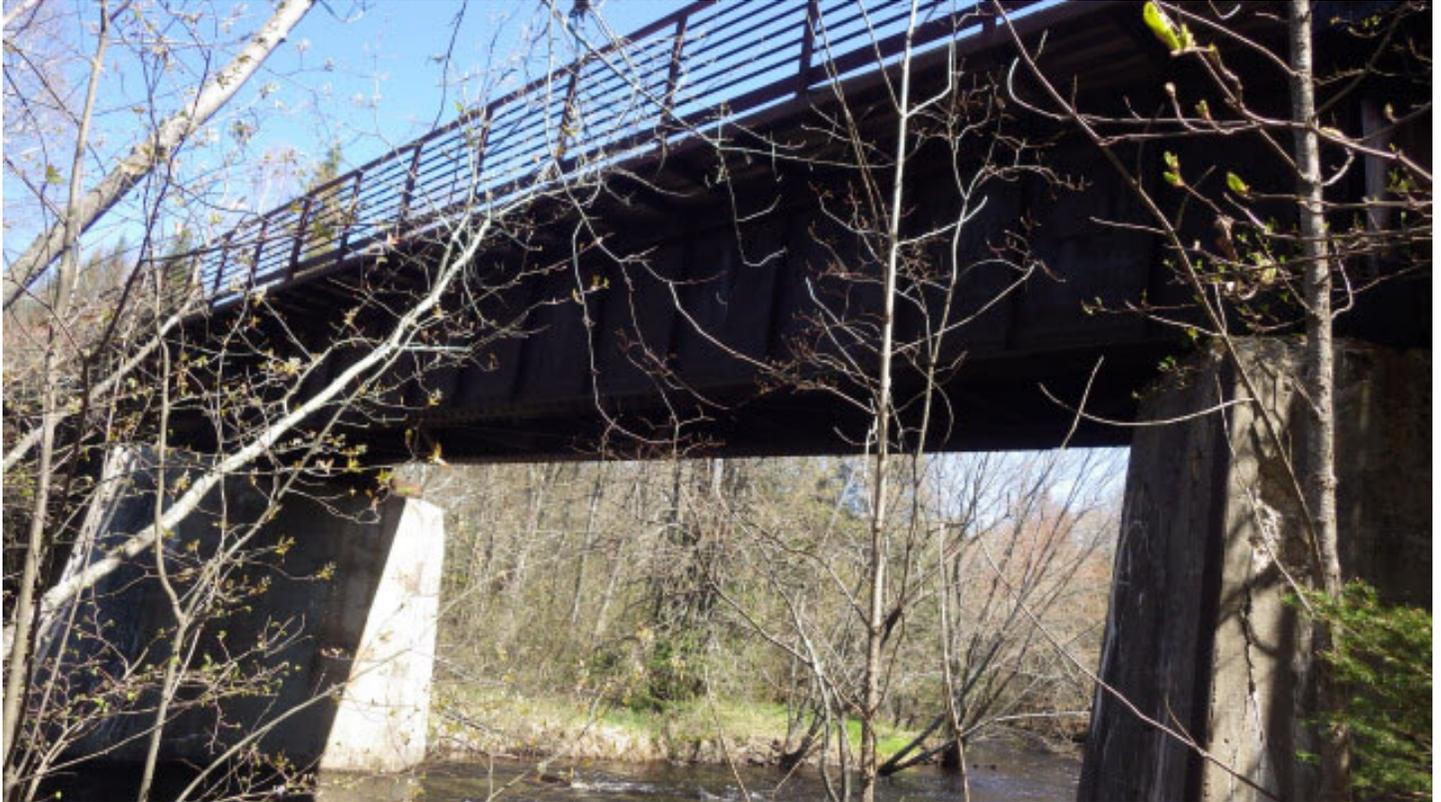
Upstream elevation view

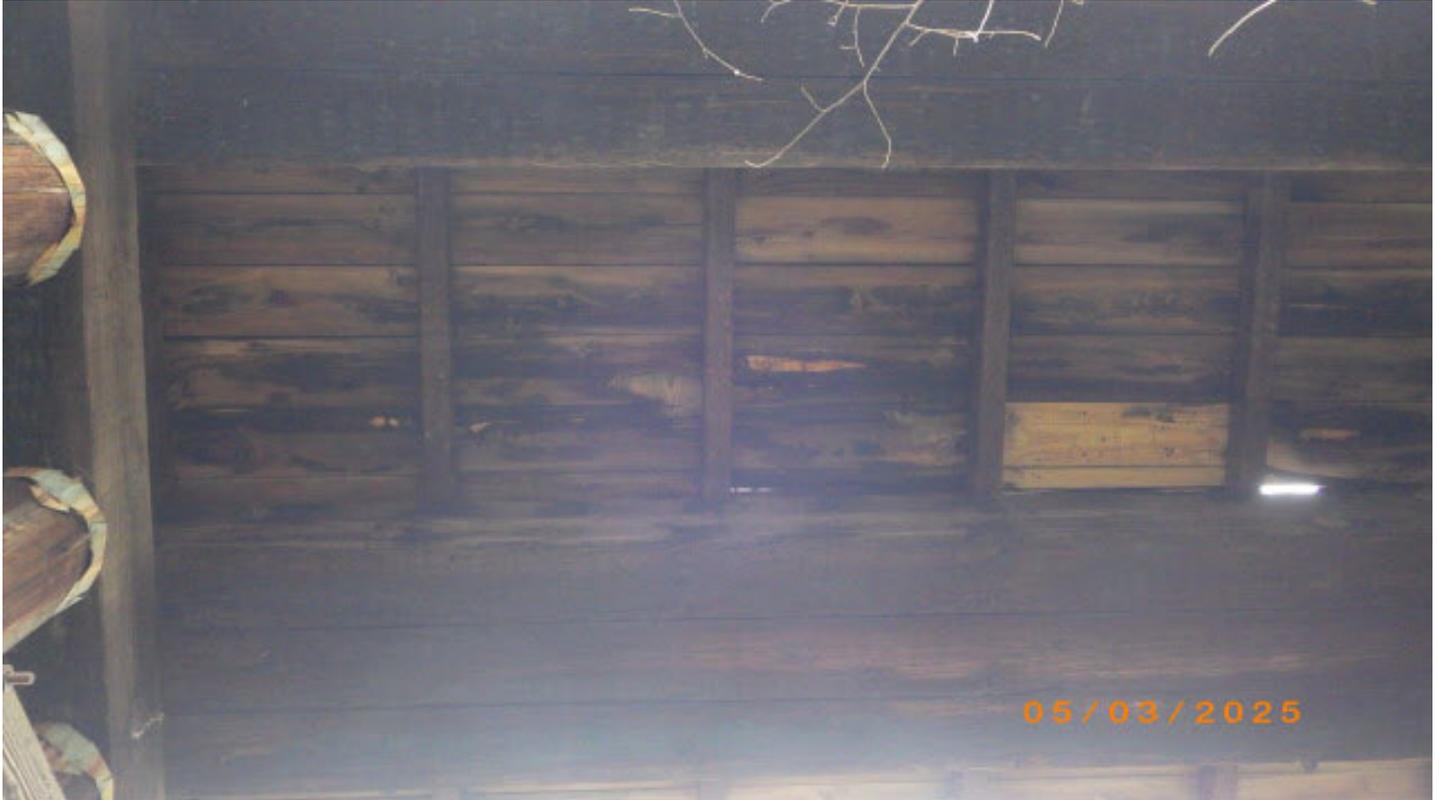
Minor gravel on deck. Scattered wear plank ends sticking up 1"+. 10-20 rotten wear planks. Both wear plank and structural deck underneath rotten through in two locations. First is a 1 SF hole at the center of the bridge and the second is a 1' x 3' hole along the east edge in span 7. The surrounding areas in these regions are rotten on the underside.

Underside of deck at hole in center of bridge. Note other rotten areas.

Replace entire deck with copper naphthenate treated timber planks

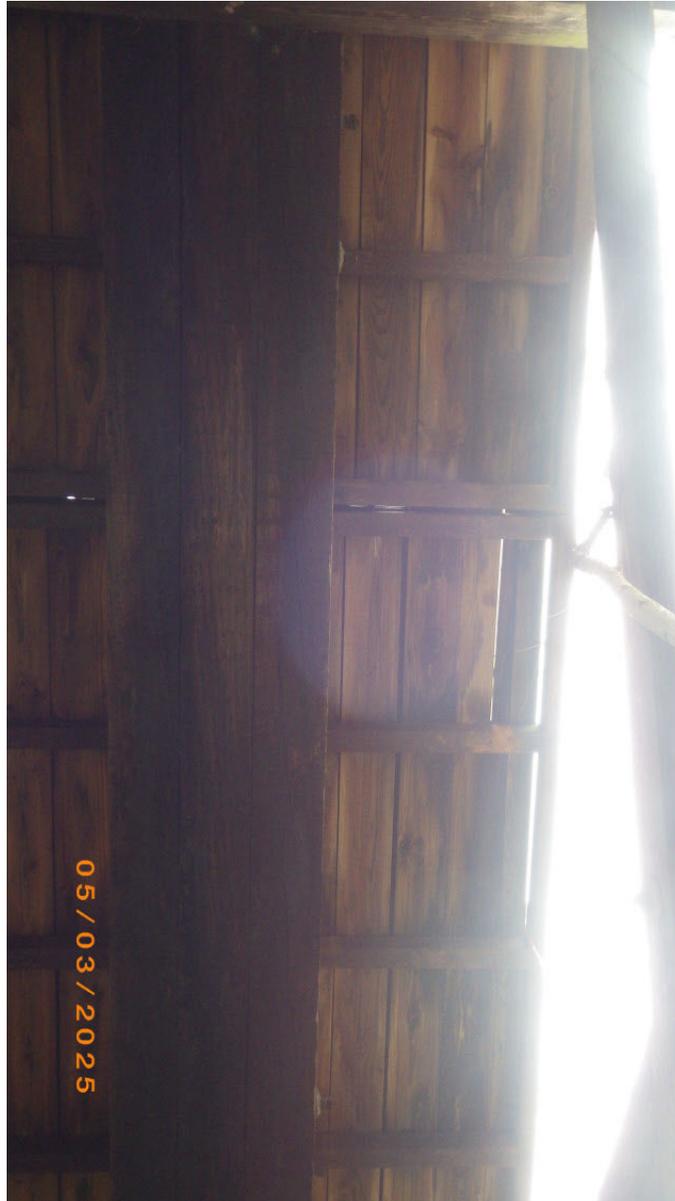
Underside of deck at hole in east edge of span 7. Note other rotten areas.

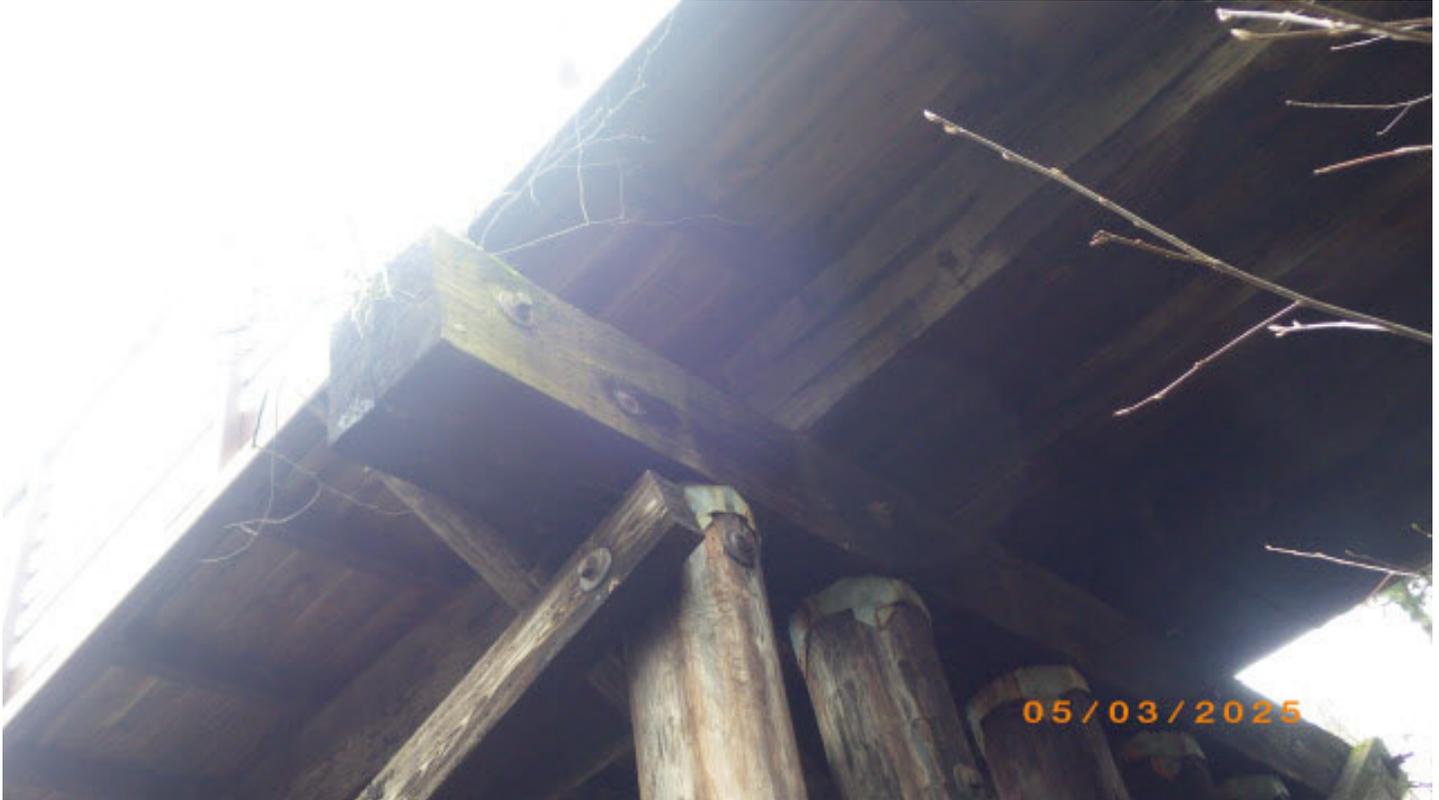
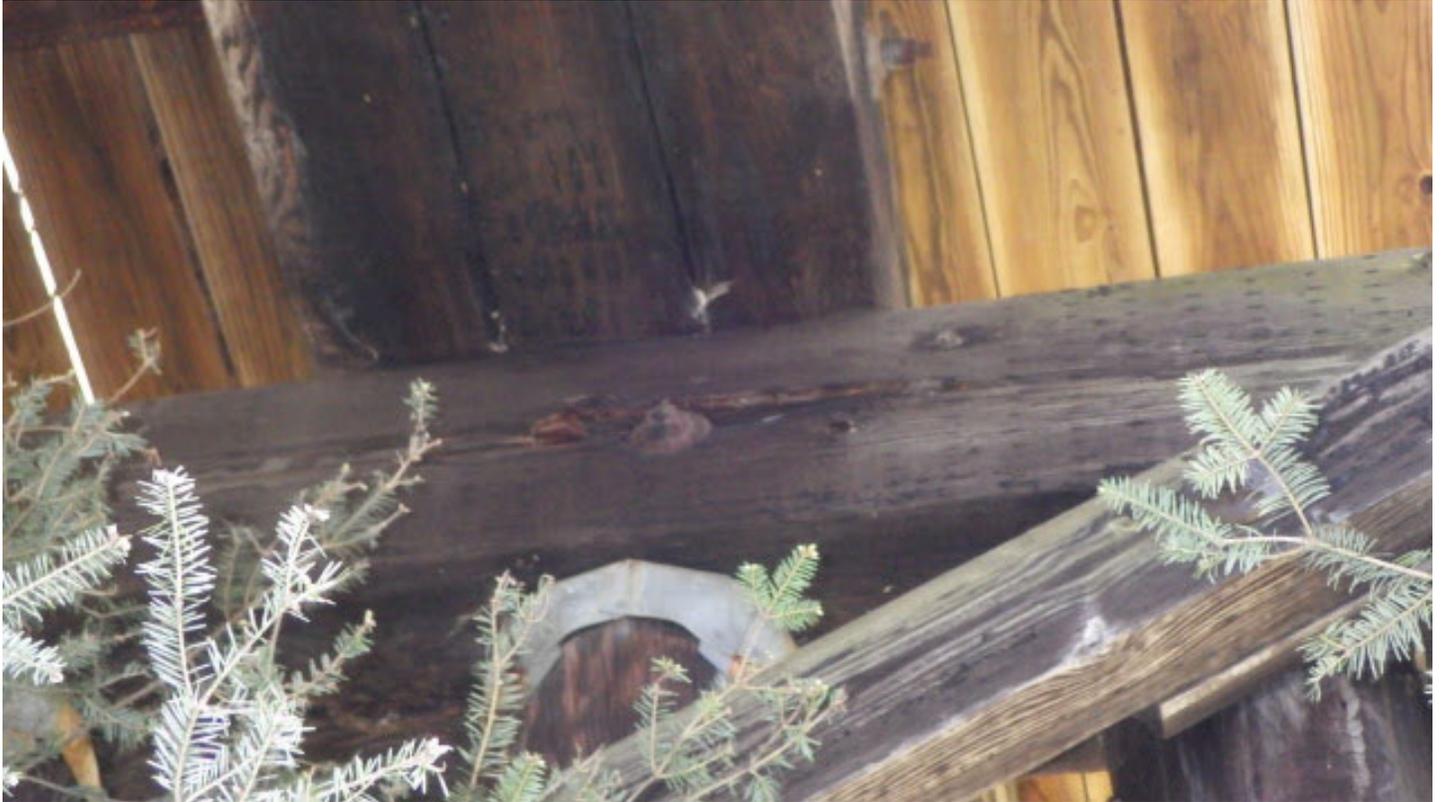
Bent #9 cap is rotten / crushing

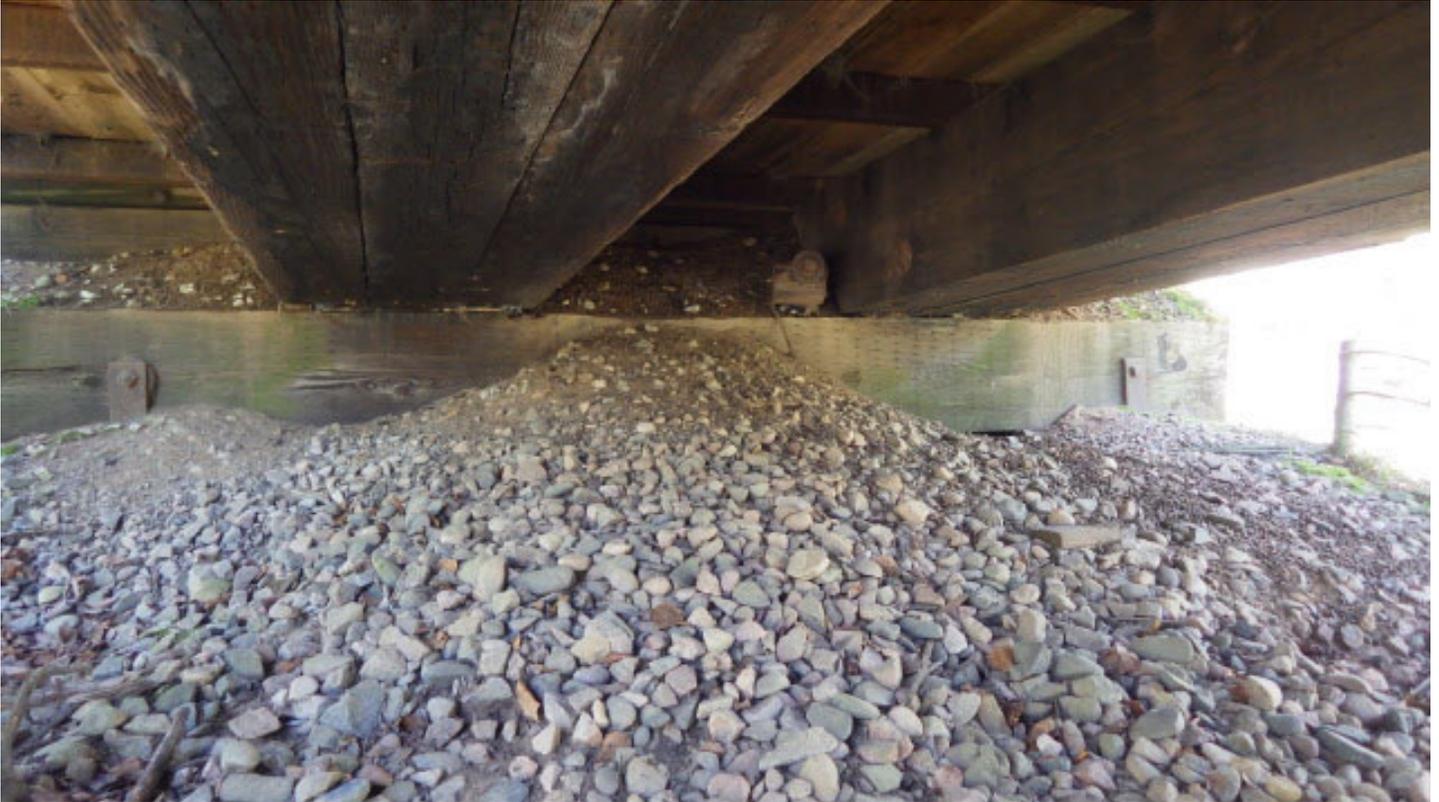
North abutment cap ends rotten
