A-13 Forest Co NST Peshtigo Bridge Replacement

Trail Bridge Inspection

Peshtigo River

Bridge Inspection Report

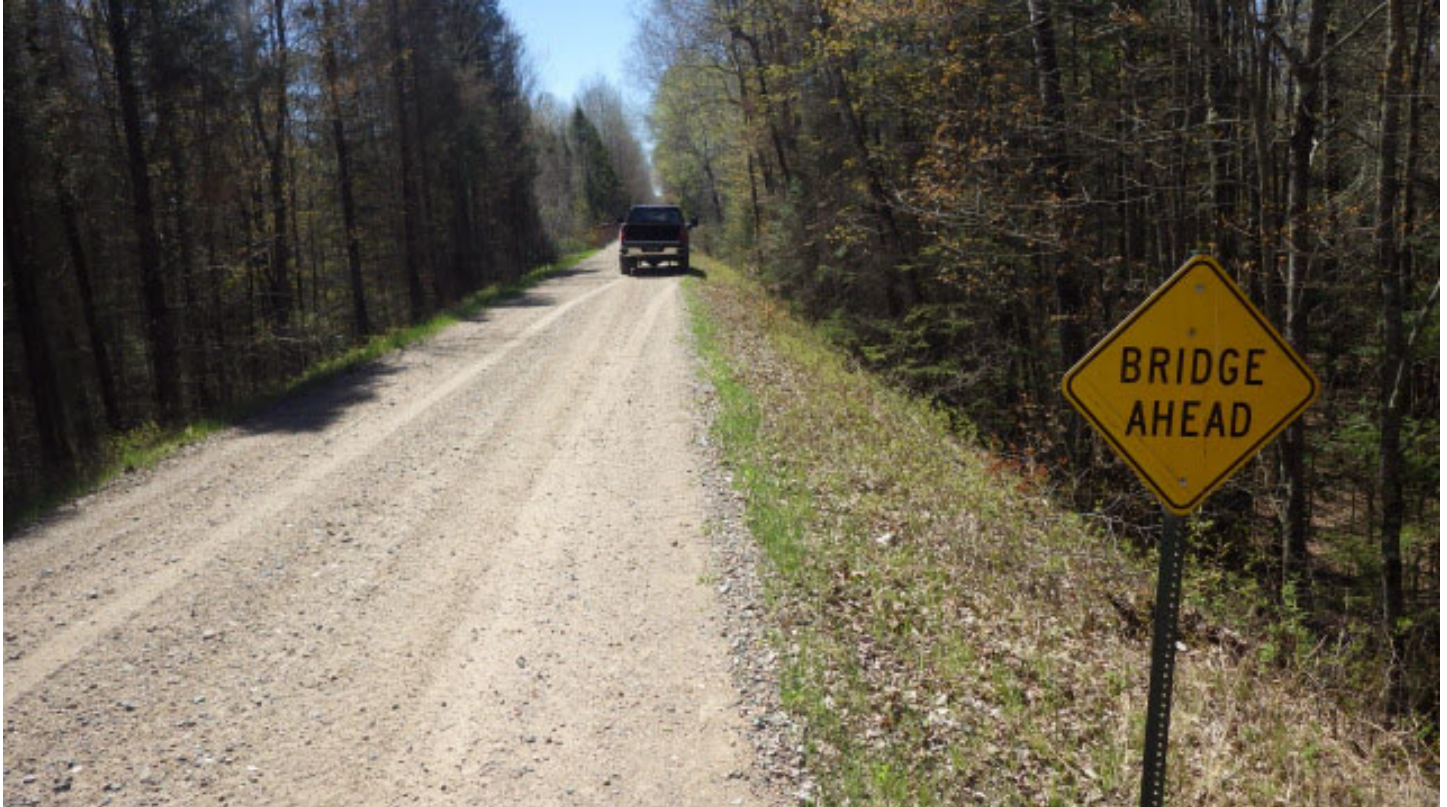
North bridge ahead sign

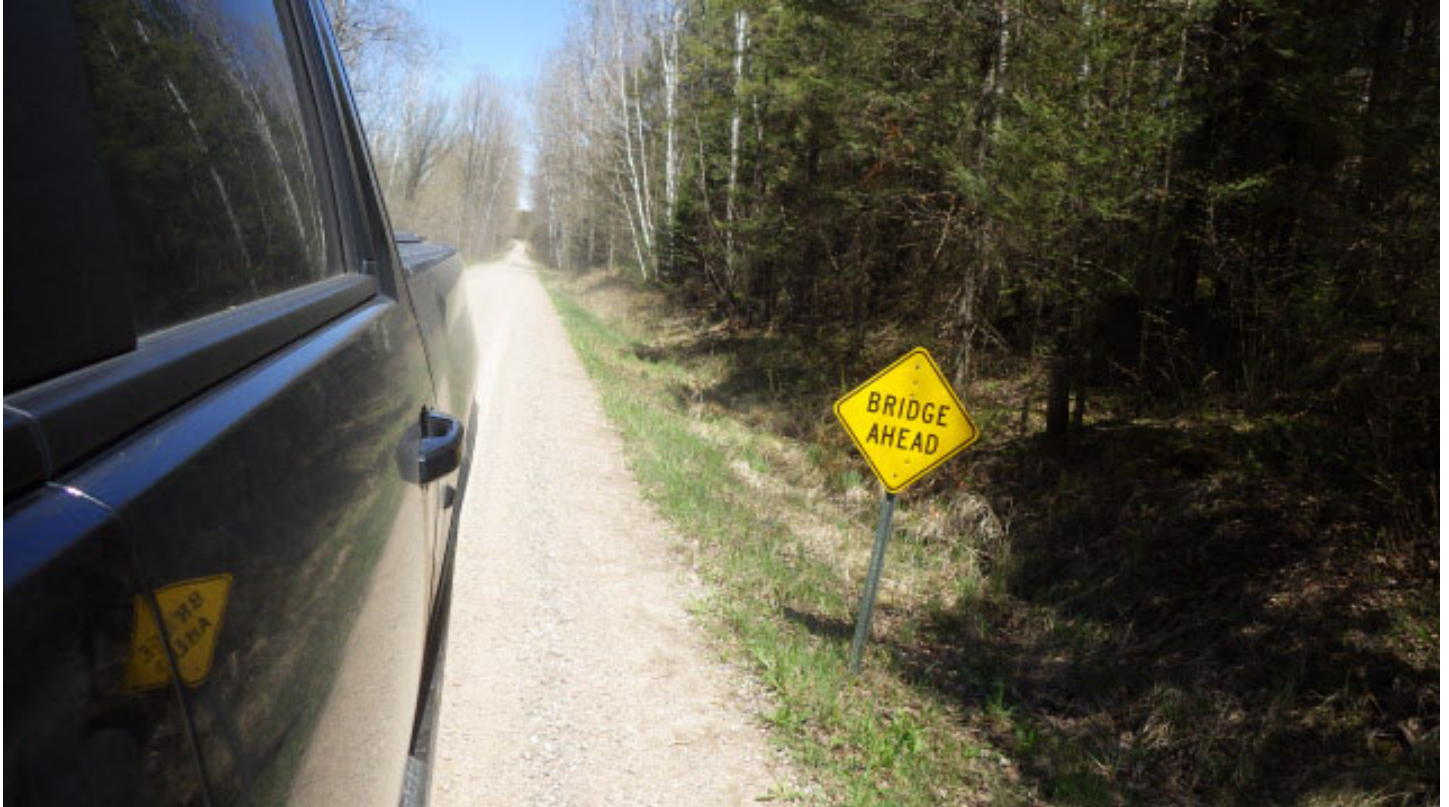
South bridge ahead sign

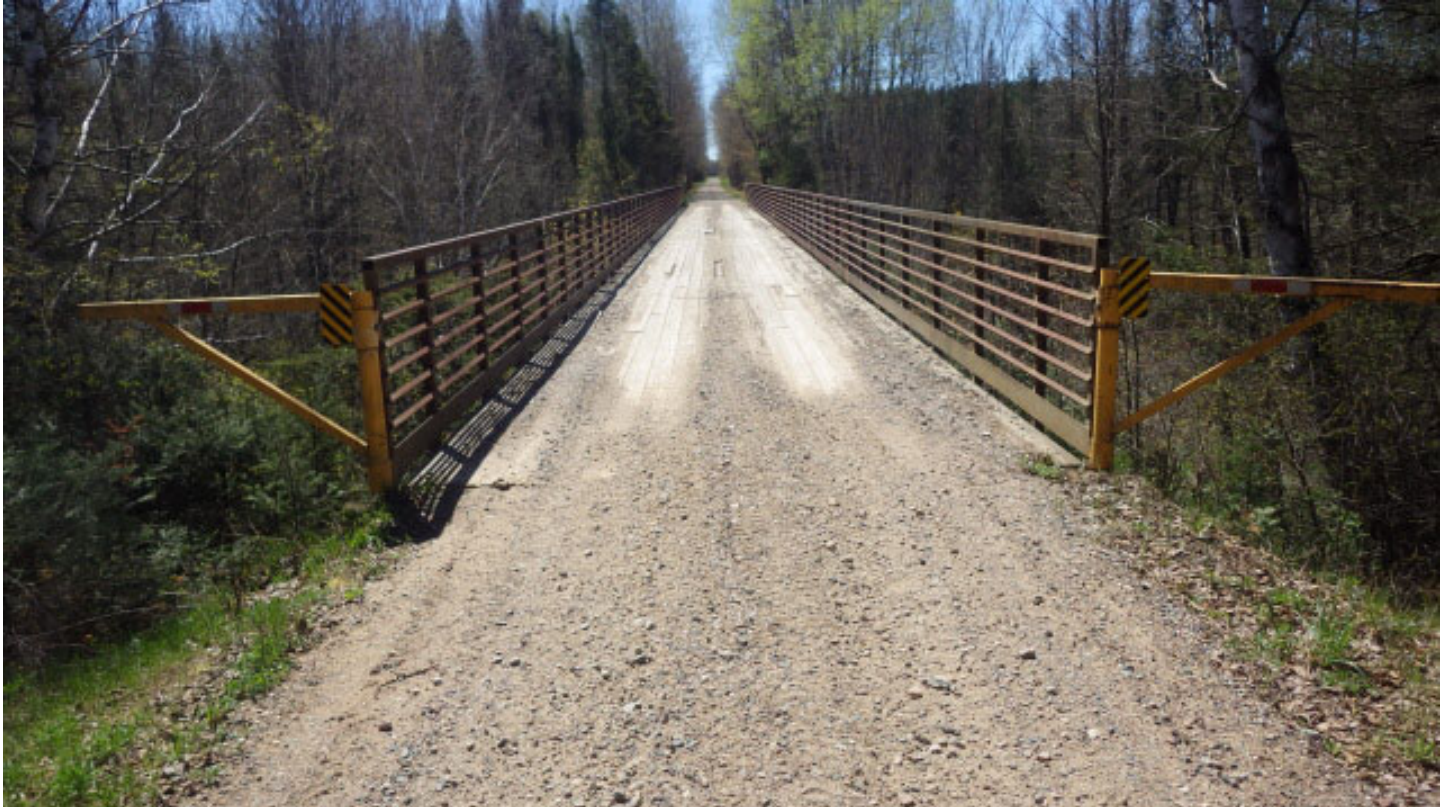
North approach

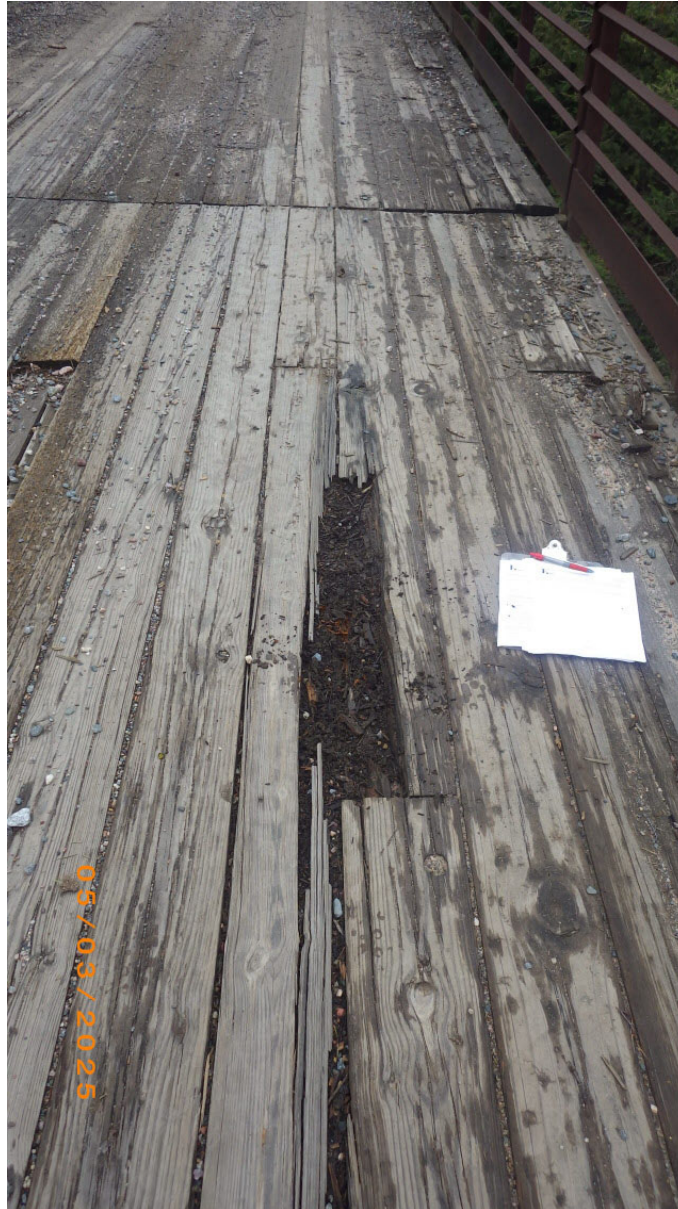
Minor gravel on deck. Scattered wear plank ends sticking up 1"+. 10-20 rotten wear planks. Both wear plank and structural deck underneath rotten through in two locations. First is a 1 SF hole at the center of the bridge and the second is a 1' x 3' hole along the east edge in span 7. The surrounding areas in these regions are rotten on the underside.

Missing / rotten wear planks

Replace entire deck with copper naphthenate treated timber planks

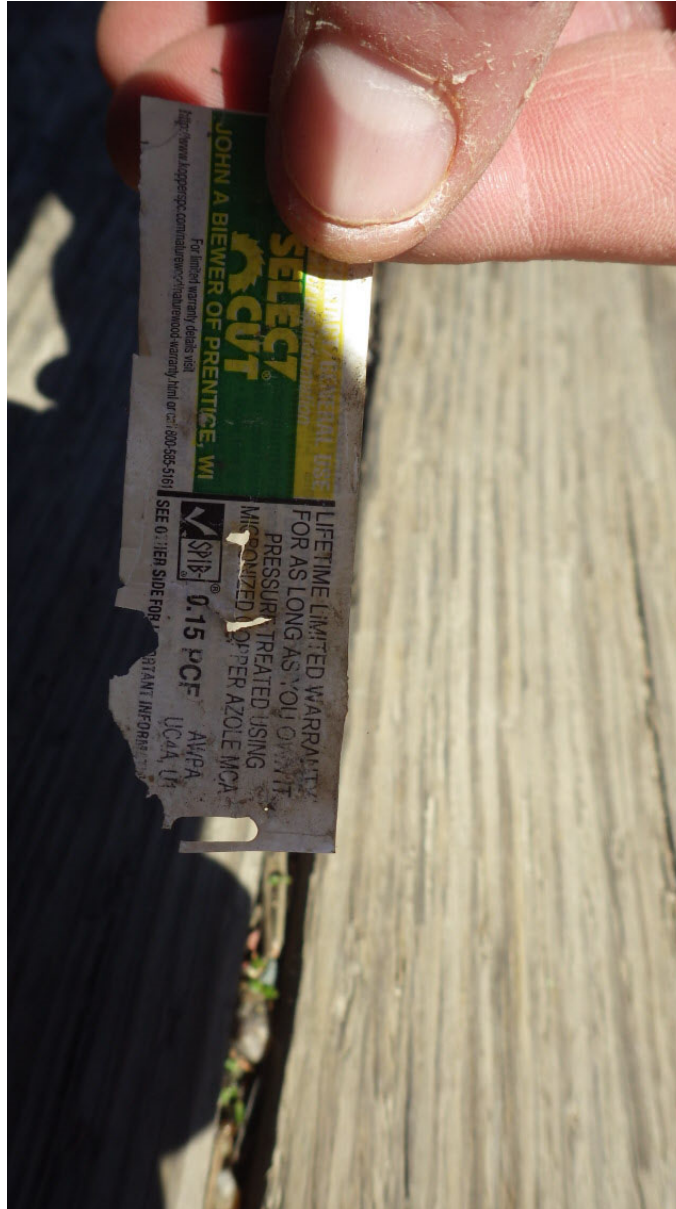
Decking is MCA treated to UC4A which is insufficient for structural applications

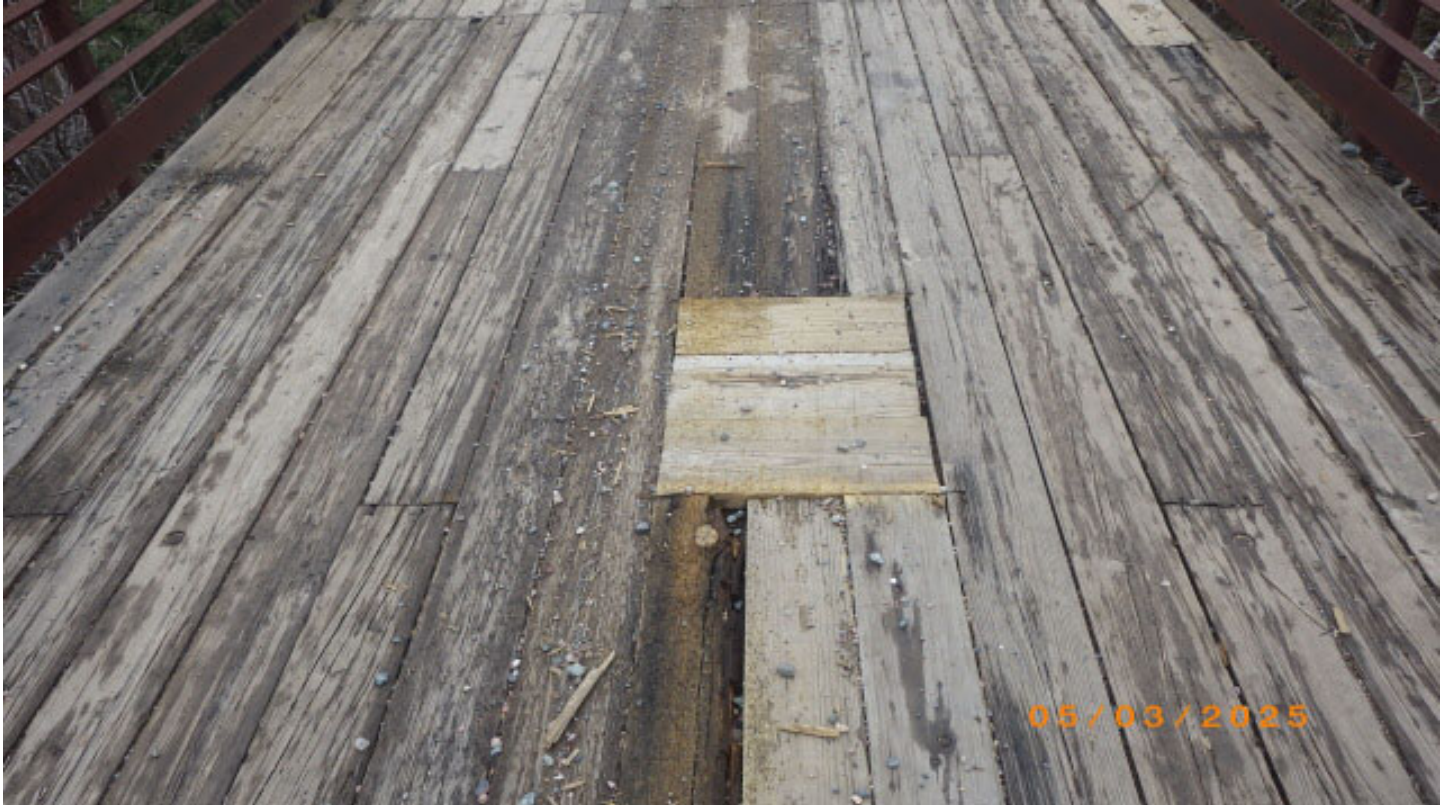
Patched hole near center of bridge

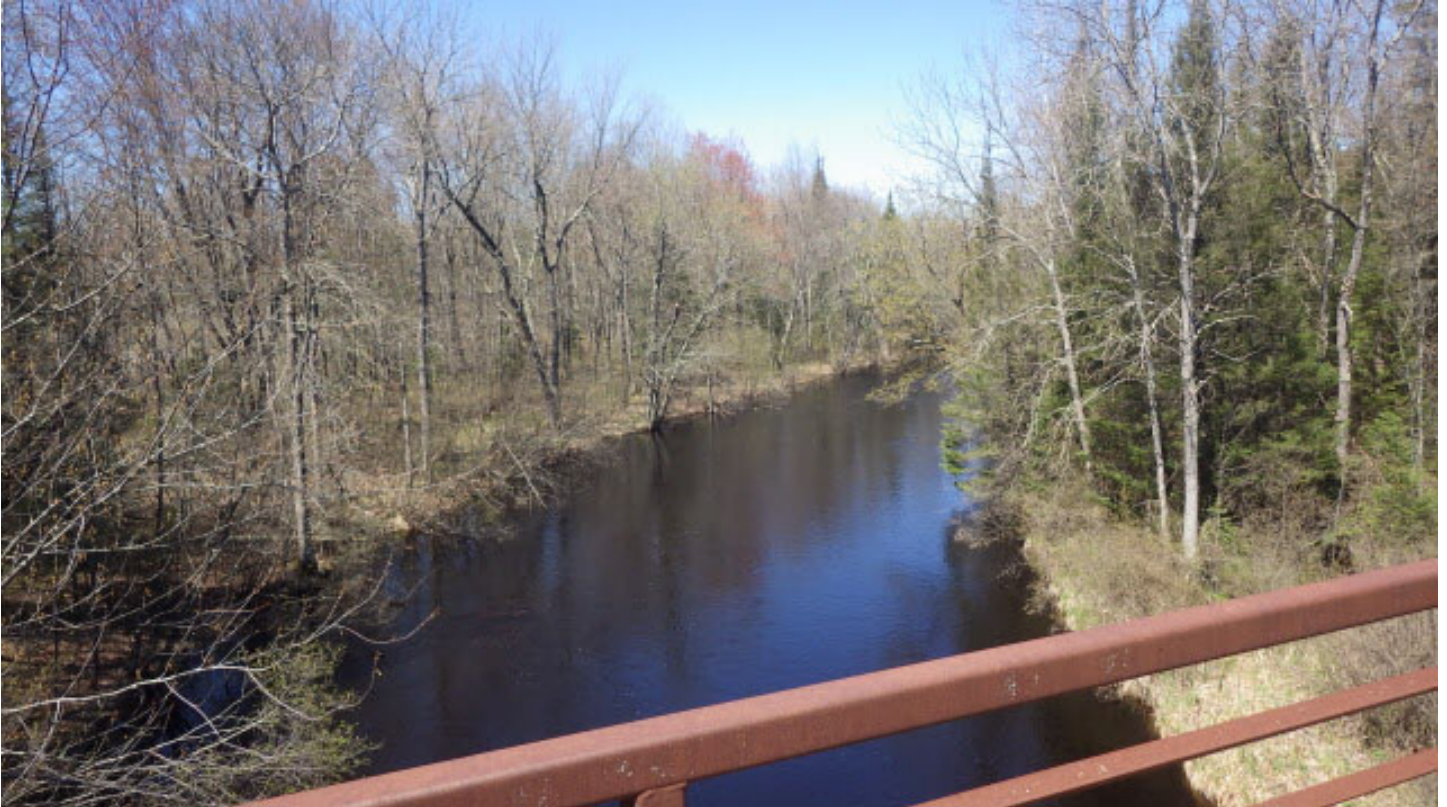
Channel is in good condition with lots of trees and brush in floodplain under bridge.

Channel looking upstream

Cut brush around / under bridge

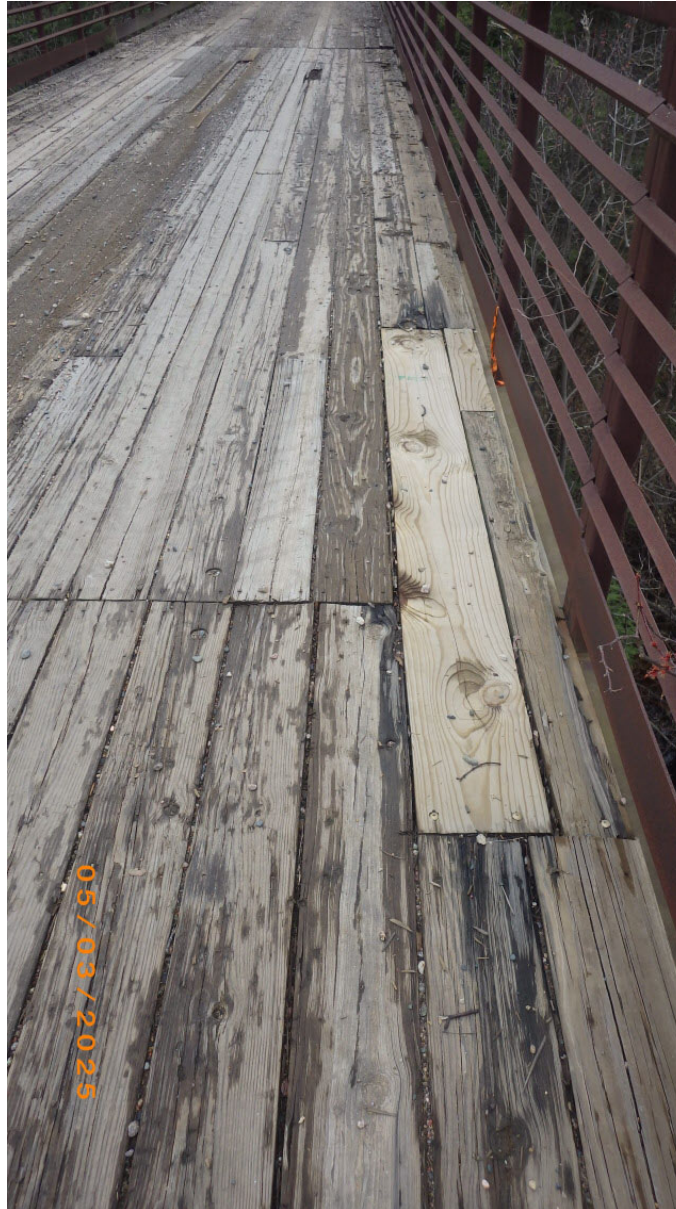
Patched hole at east edge of span 7

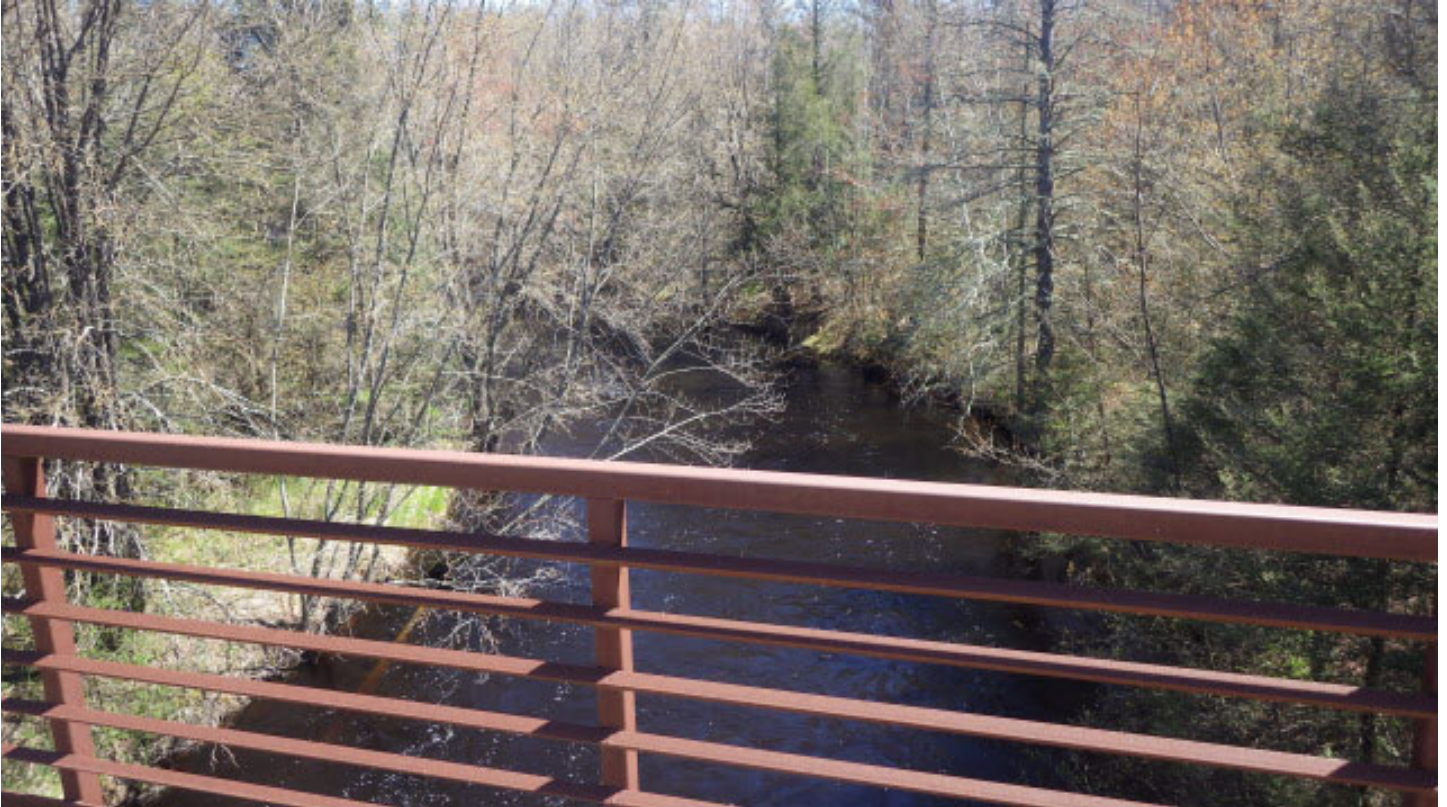
Channel looking downstream

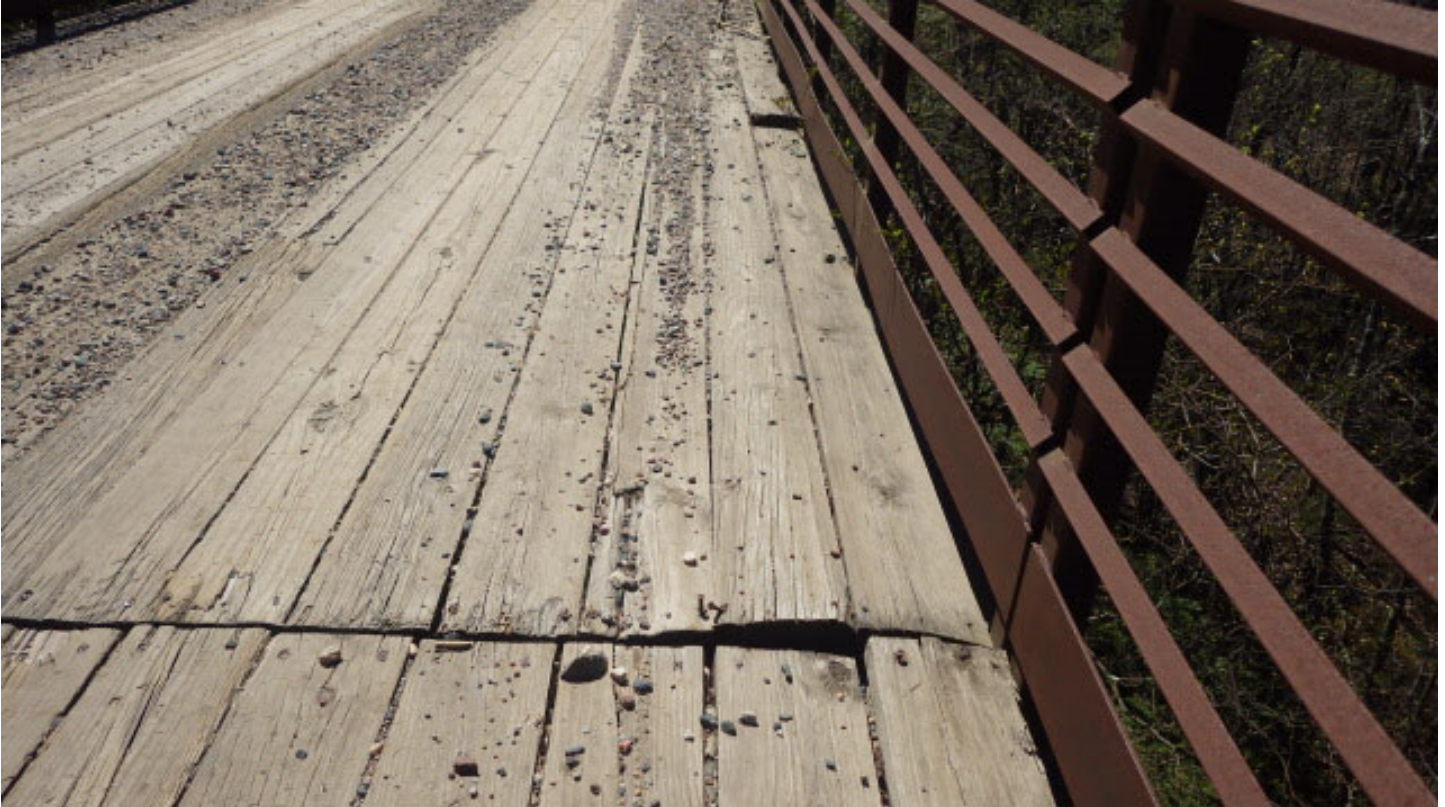
Running planks with ends sticking up 1"+

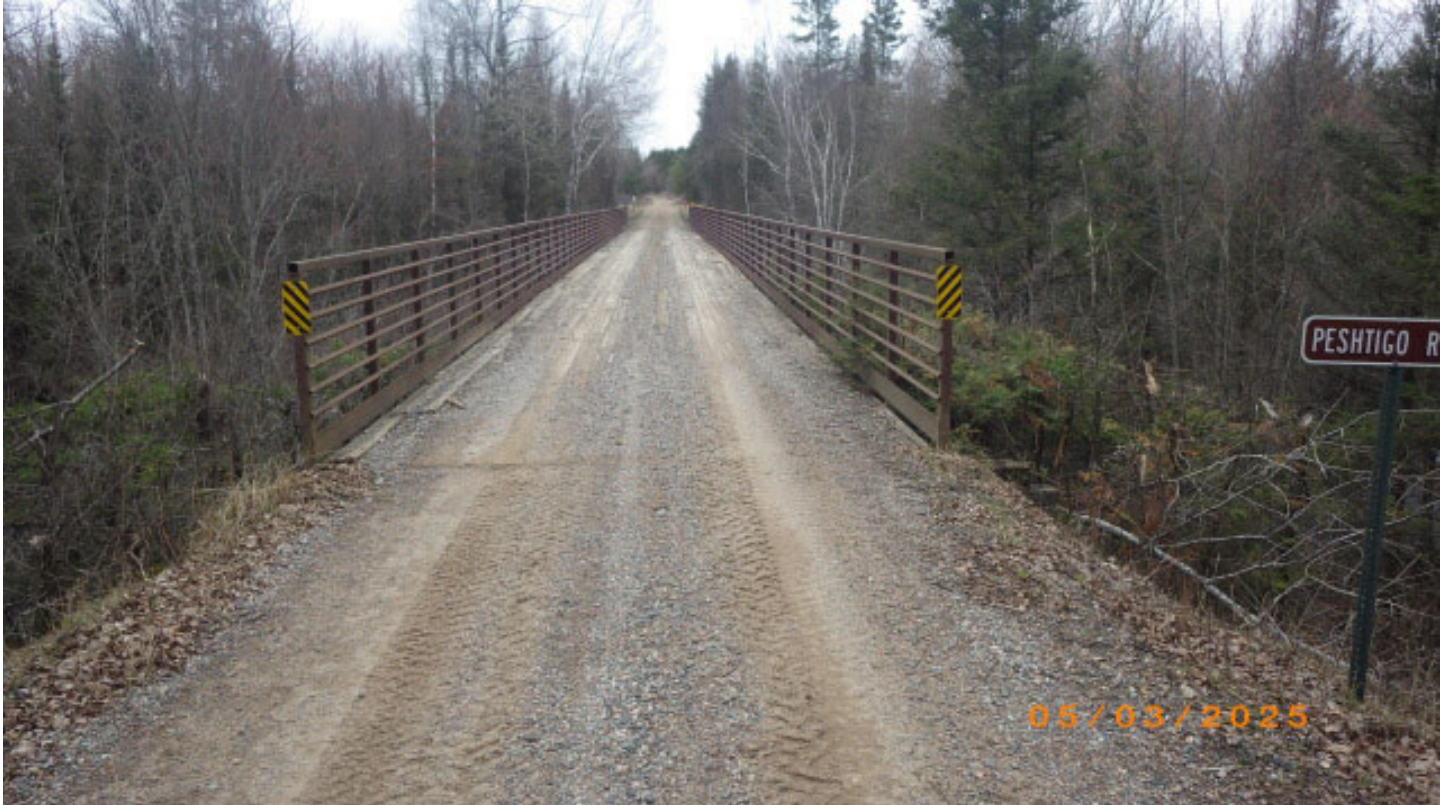
South approach

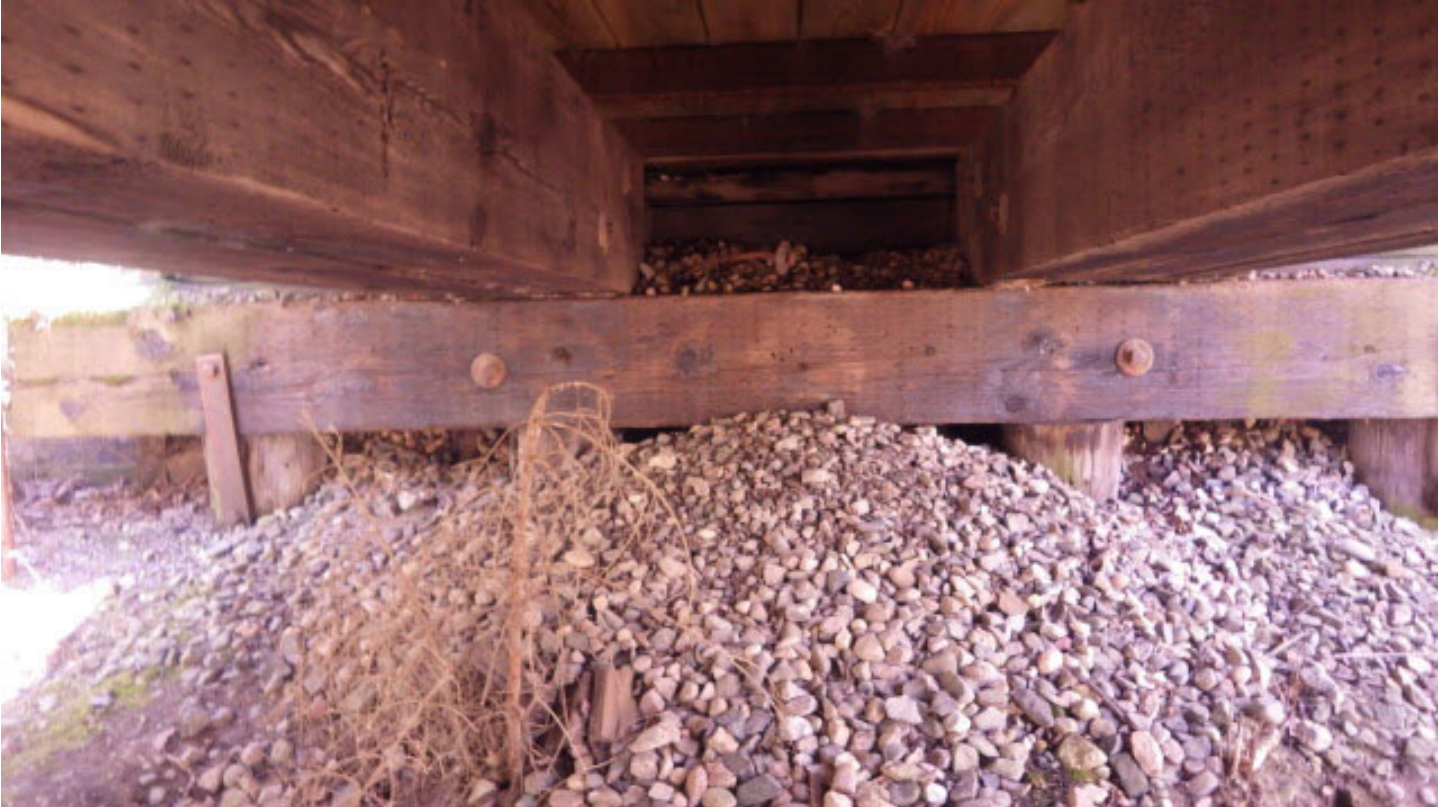
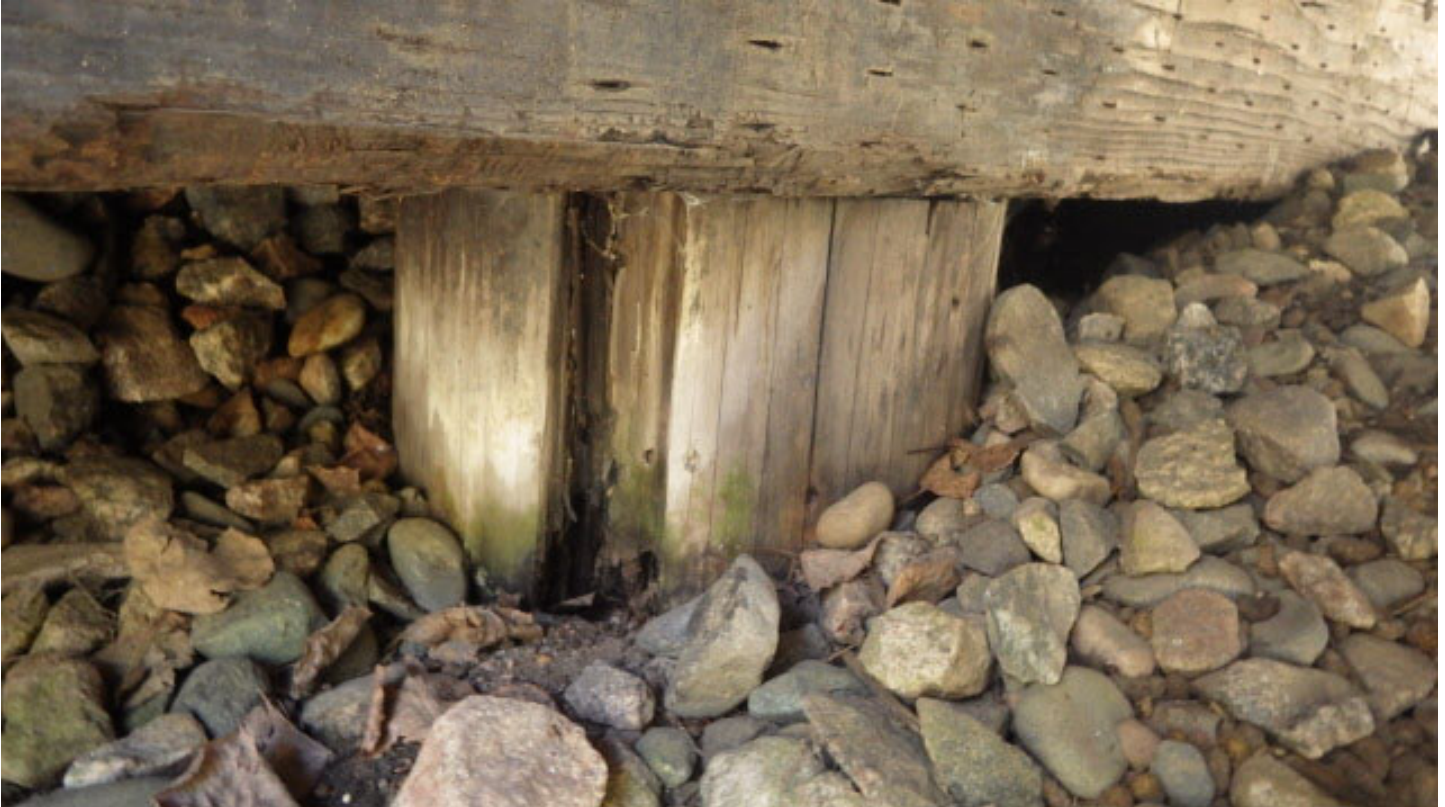
South abutment has rotten piling. Bent #1 pile cap is rotten / crushing. Bent #2 center pile is hollow. Concrete pier #3 has a very large CS3 spall on the upstream and top edge, widespread CS3 cracking with rust stained

South abutment rotten piling

****Replace bridge in next 1-3 years****

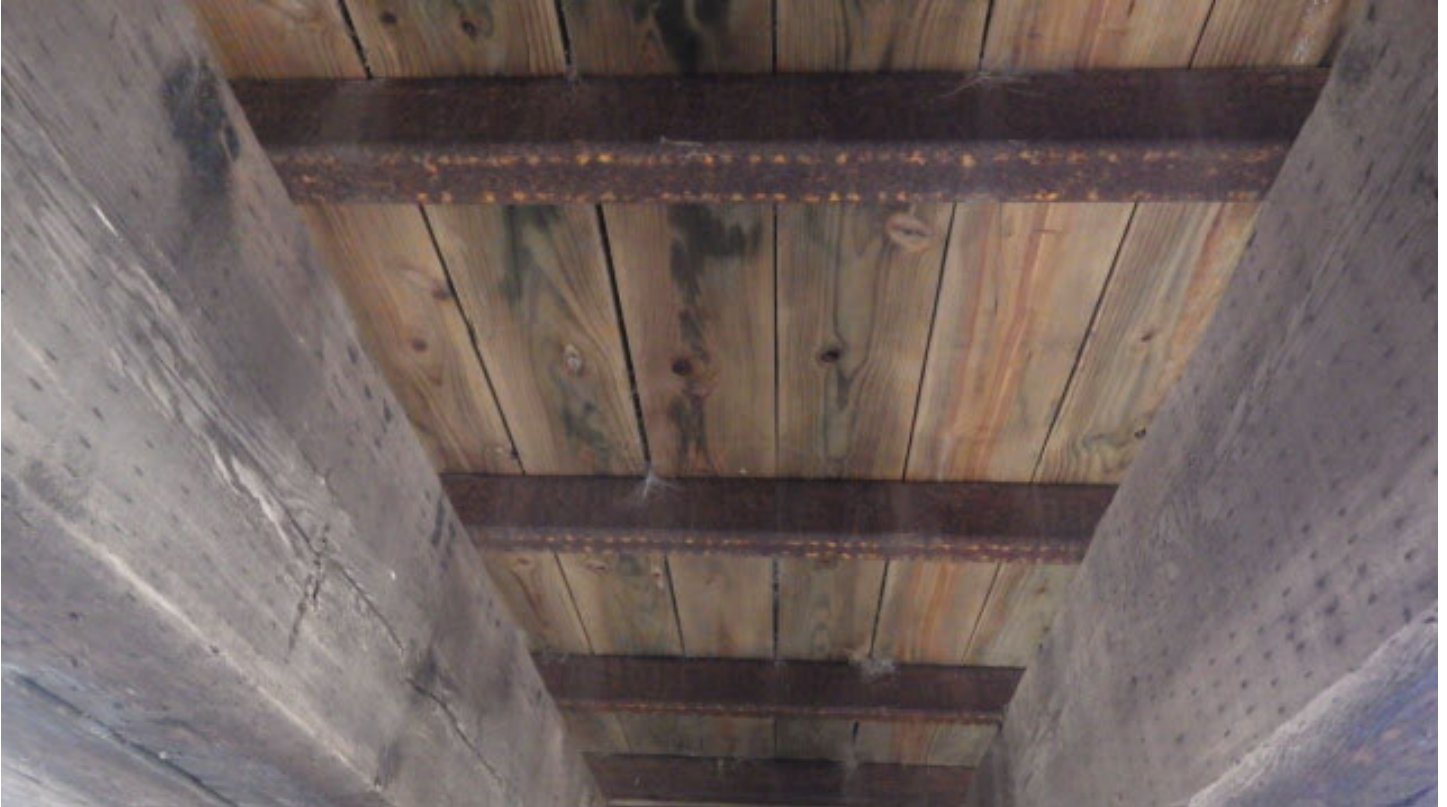
typical underside of deck, scattered black mold.

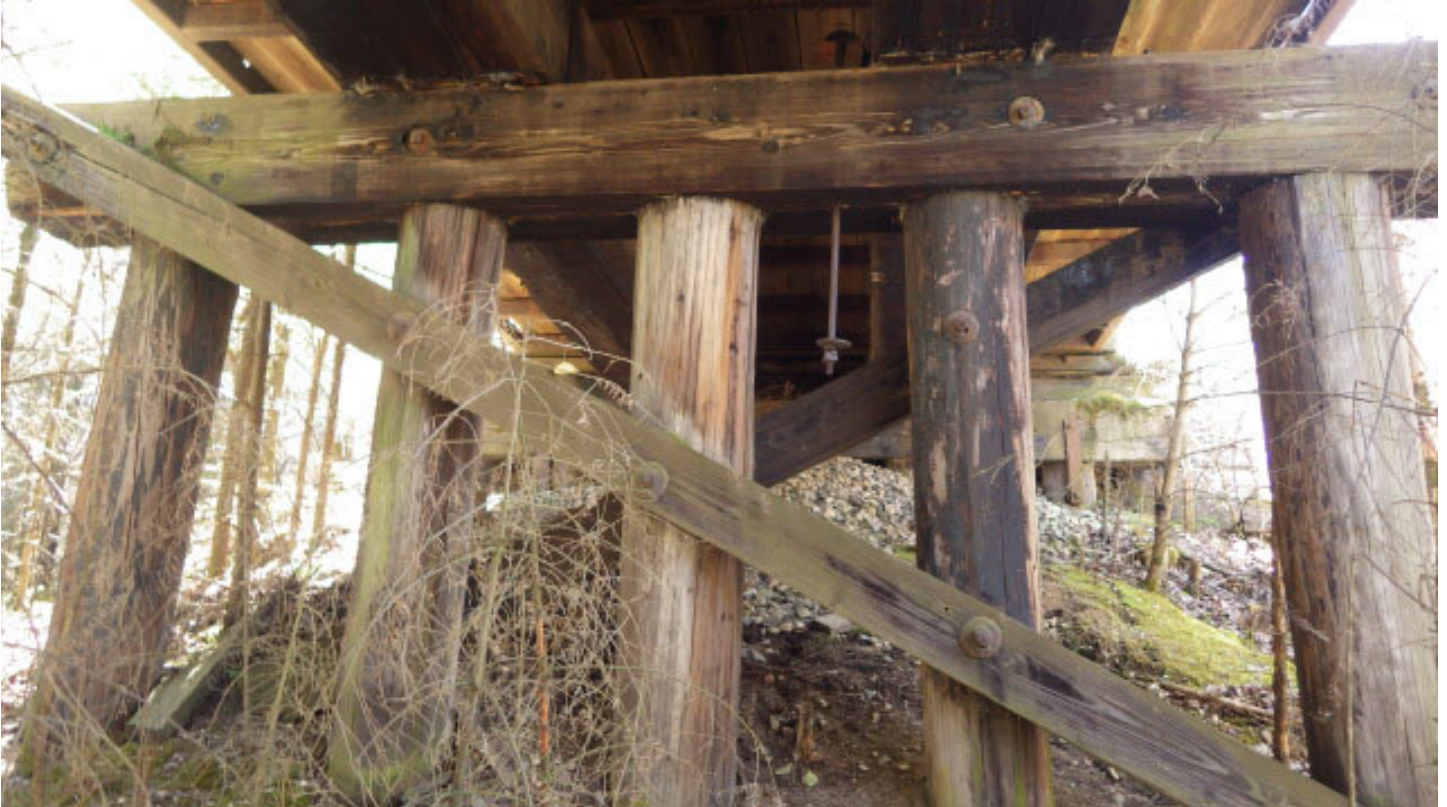
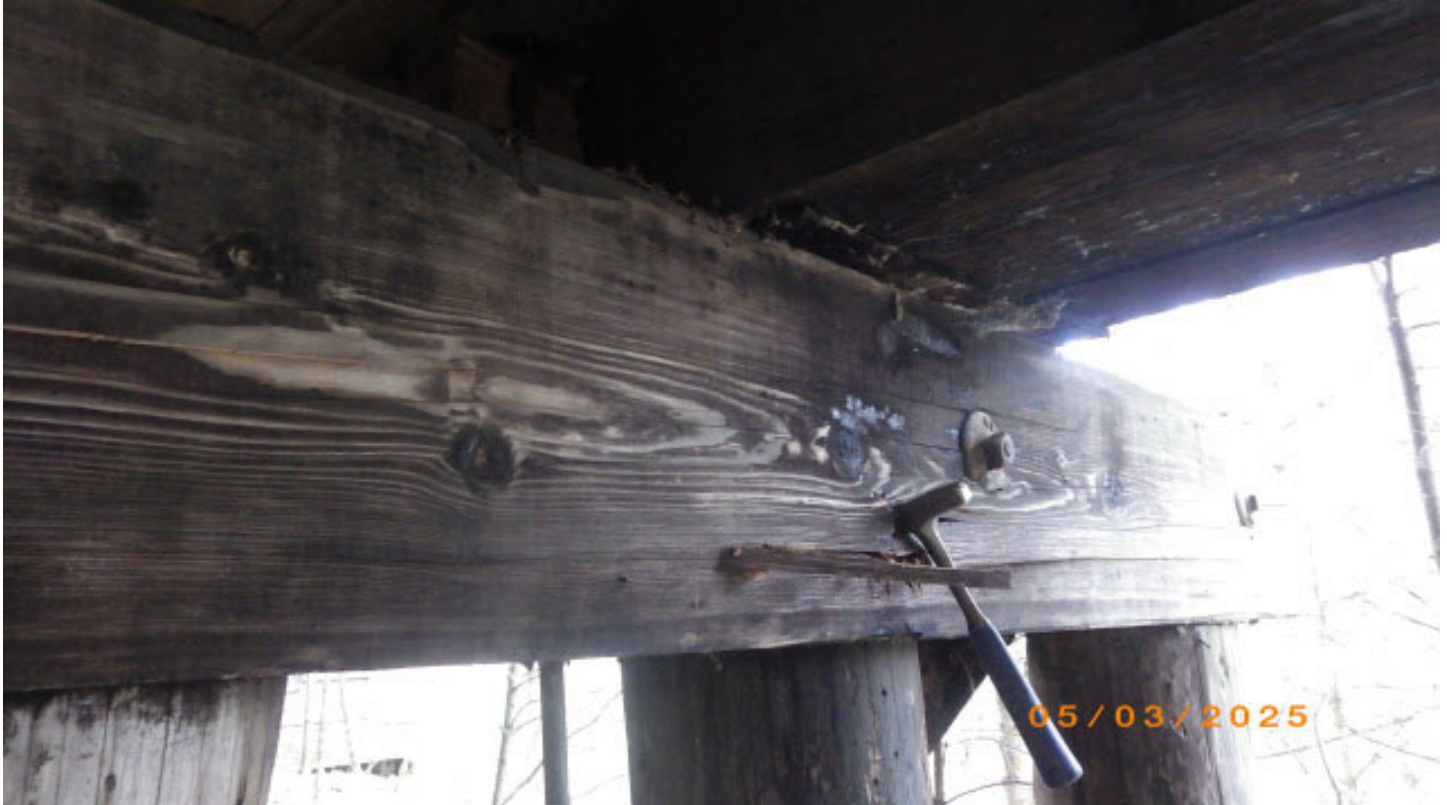
Bent #1, cap rotten / crushing

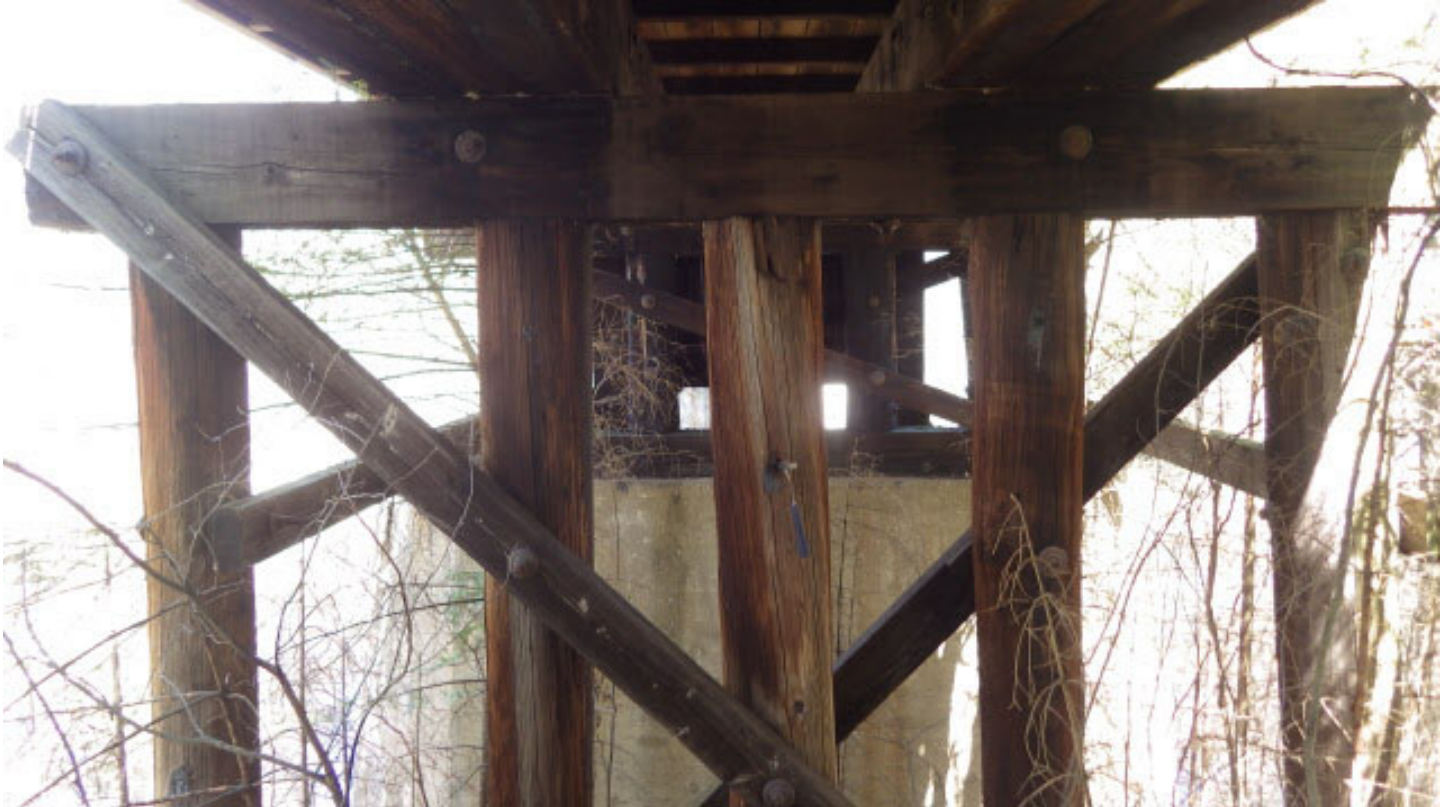
Bent #2 (top), center pile hollow

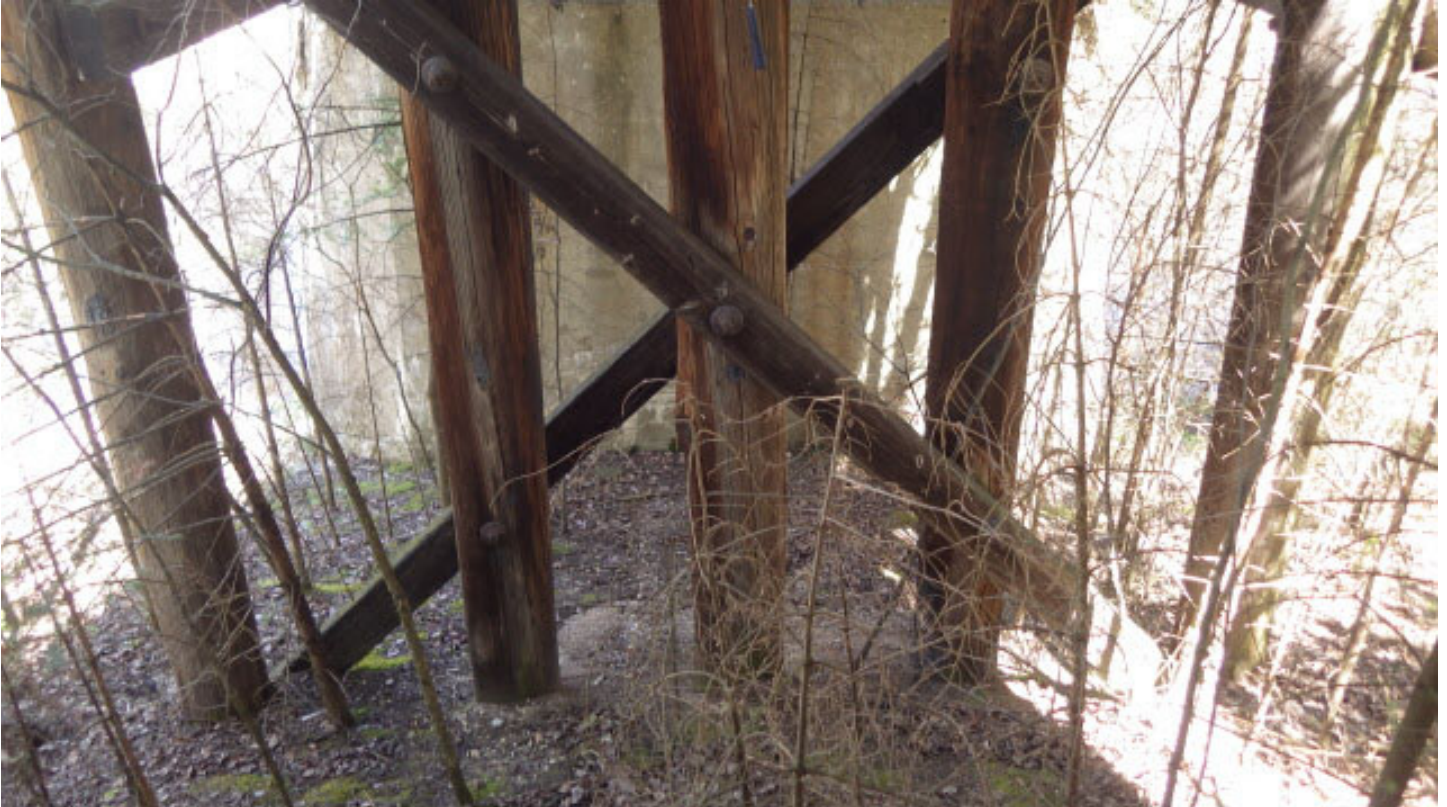
Bent #2 (bottom), center pile hollow

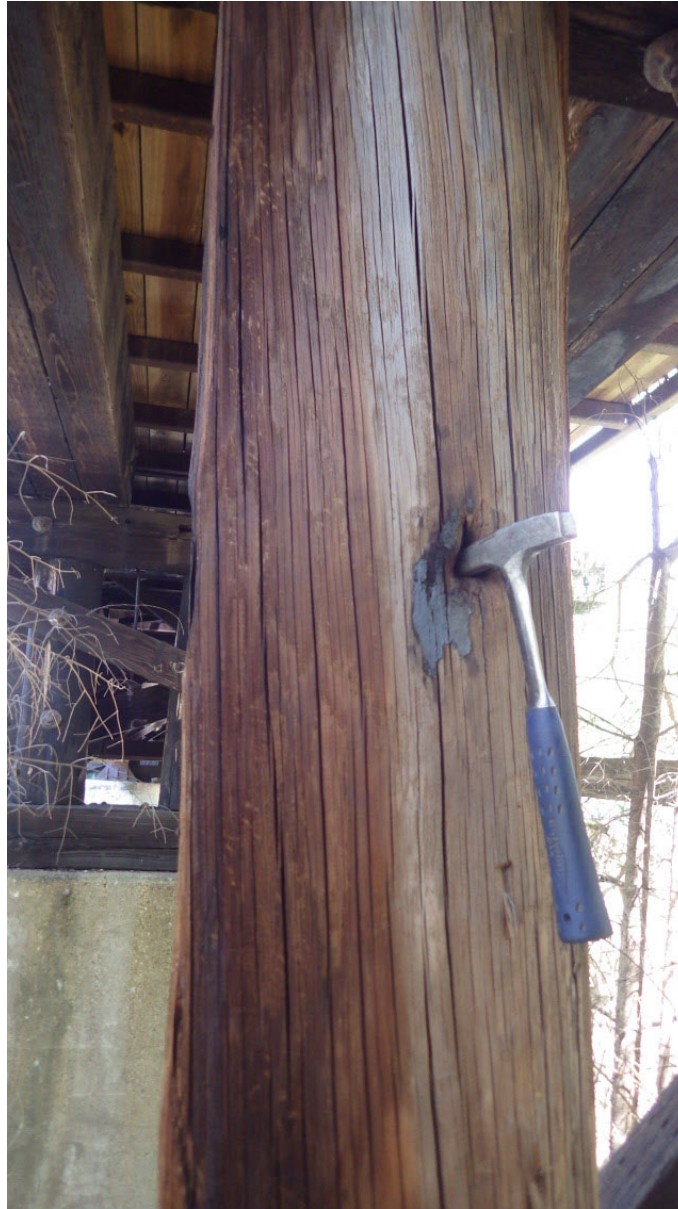
Bent #2, center pile hollow

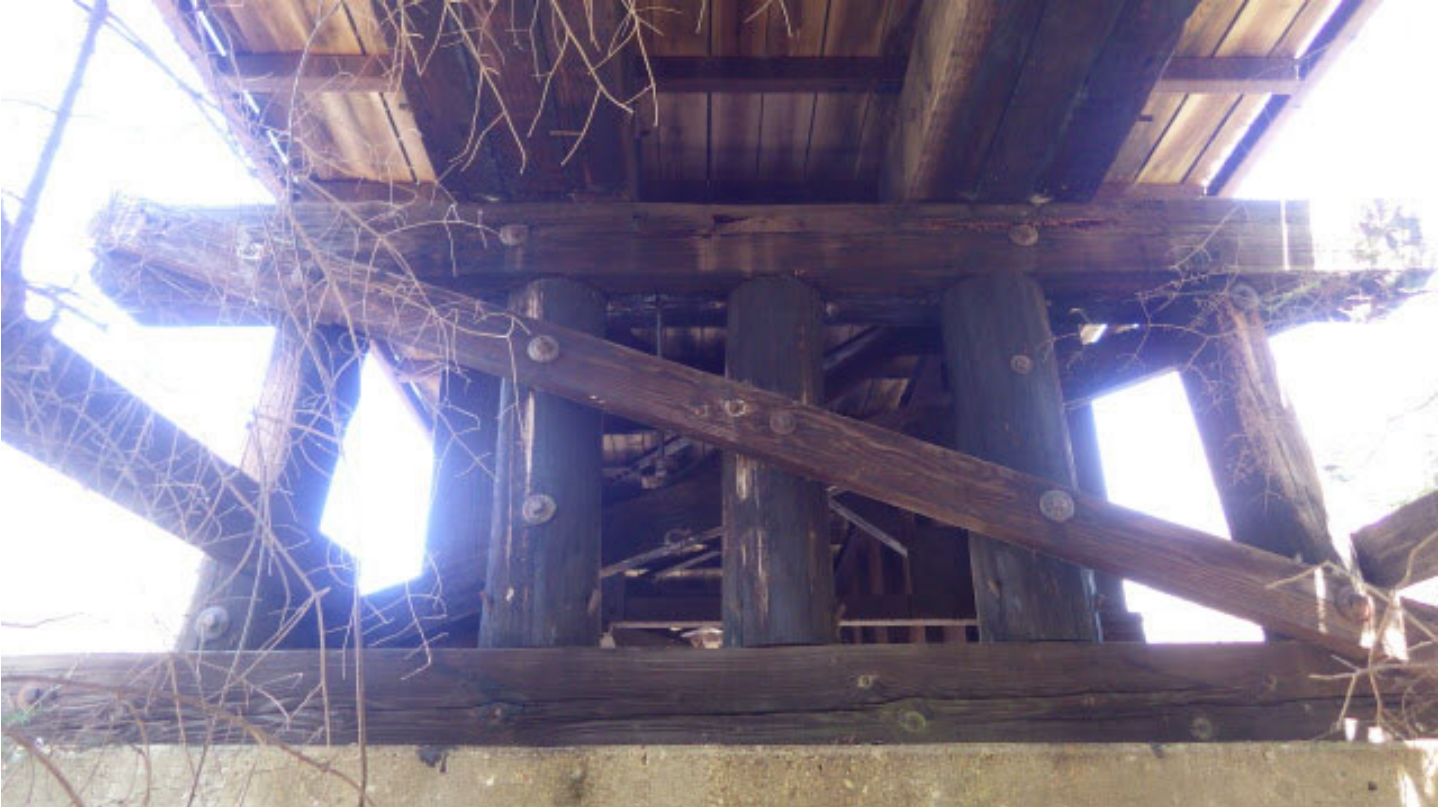
efflorescence. Top section of pier is timber and the cap is rotten / crushing. Concrete pier #4 has very large 4'x4'x1' CS3 spalls at both the upstream and downstream top edge. CS3 cracking with efflorescence throughout. Bents #5-8 in fair condition. Bent #9 cap is rotten / crushing. Bent #10 cap is rotten. Bent #11 cap ends are rotten. North abutment cap ends are rotten.

Pier #3, timber cap rotten / crushing
