A-13 Forest Co NST Peshtigo Bridge Replacement

Trail Bridge Inspection

Peshtigo River

Bridge Inspection Report

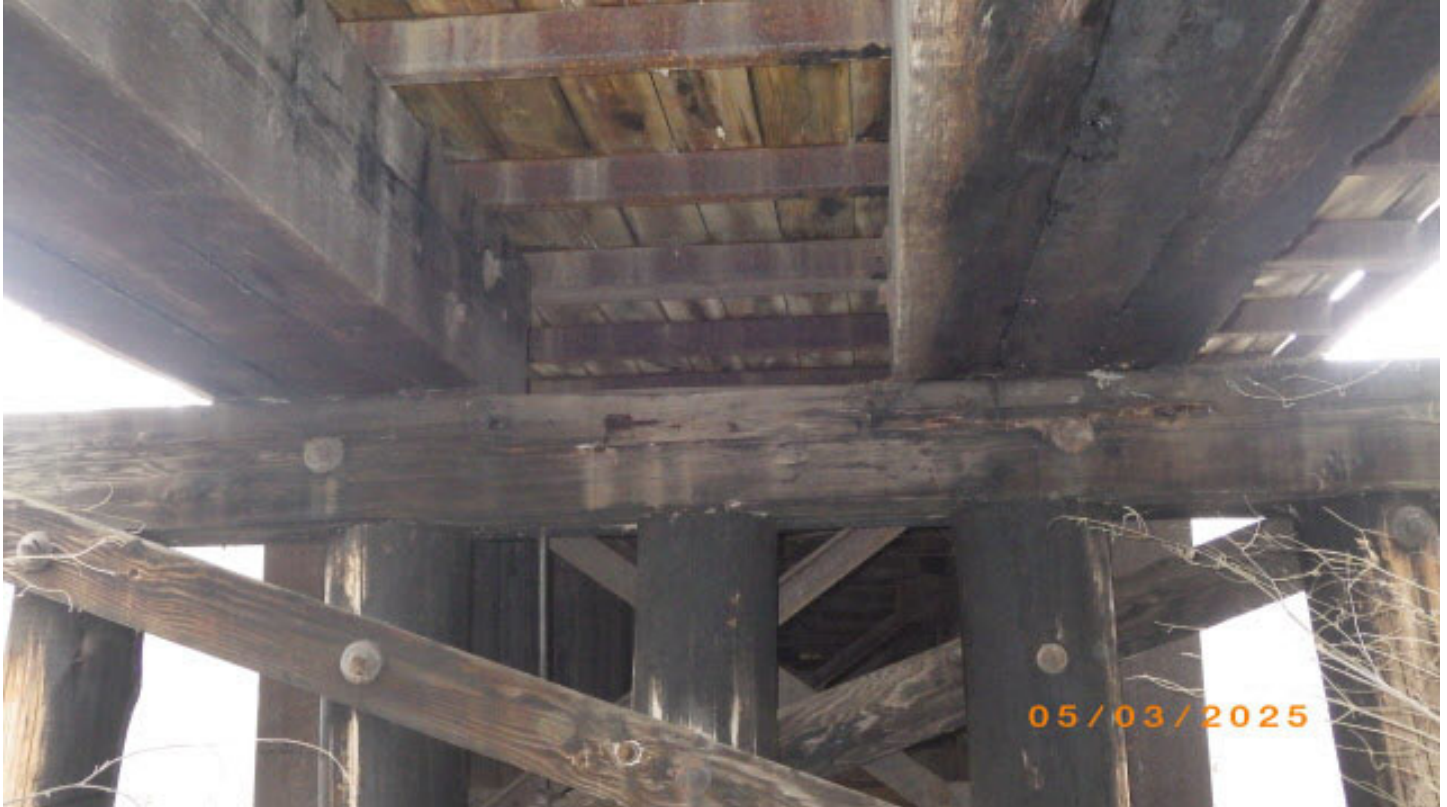
Pier #3, timber cap rotten / crushing (close-up)

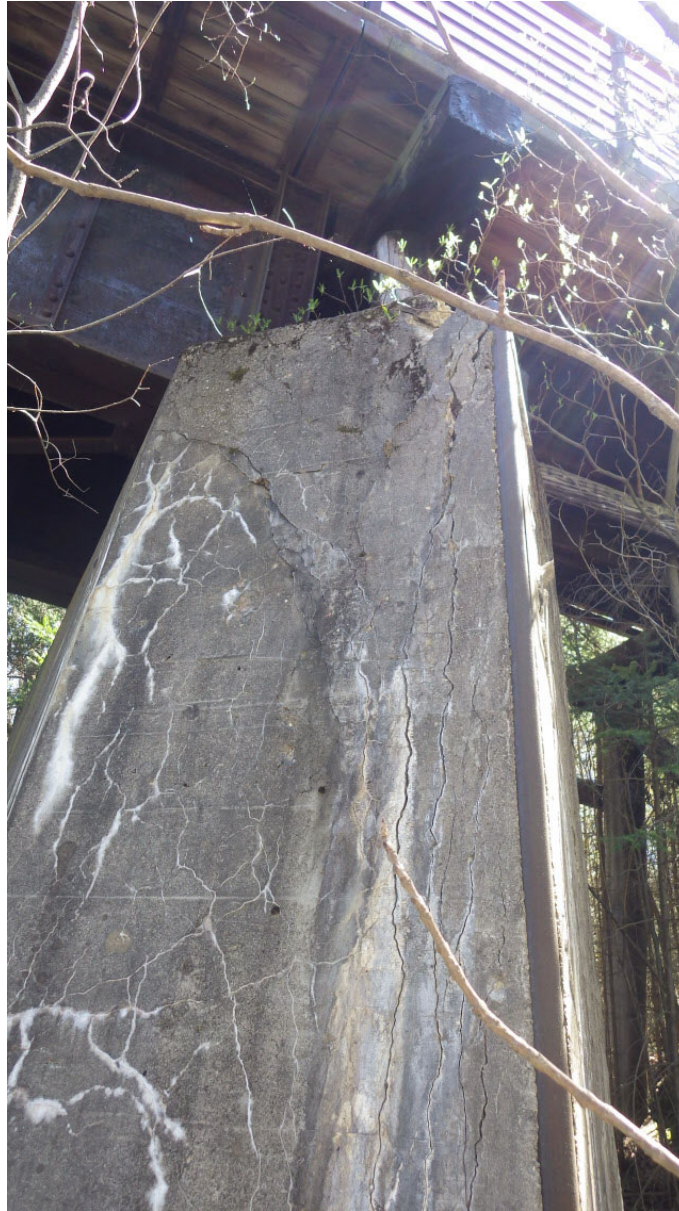
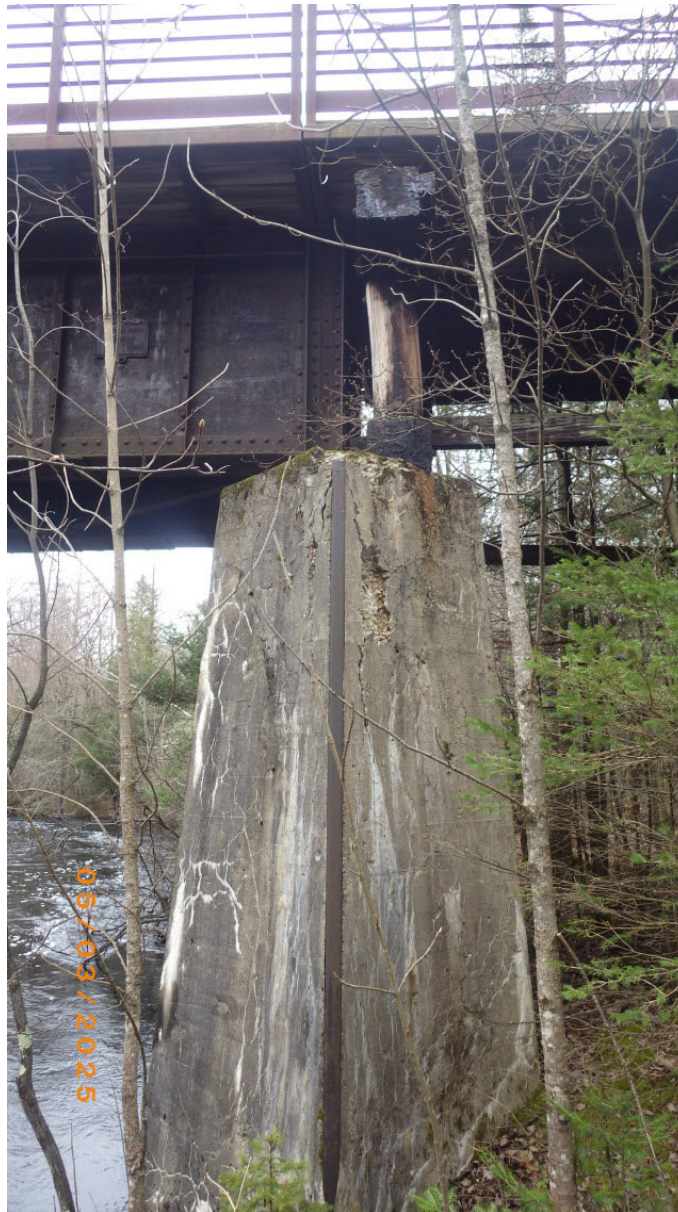
South abutment has rotten piling. Bent #1 pile cap is rotten / crushing. Bent #2 center pile is hollow. Concrete pier #3 has a very large CS3 spall on the upstream and top edge, widespread CS3 cracking with rust stained

Pier #3 concrete wall with very large spall on upstream nose and top edge with CS3 cracking with rust stained efflorescence throughout

****Replace bridge in next 1-3 years****

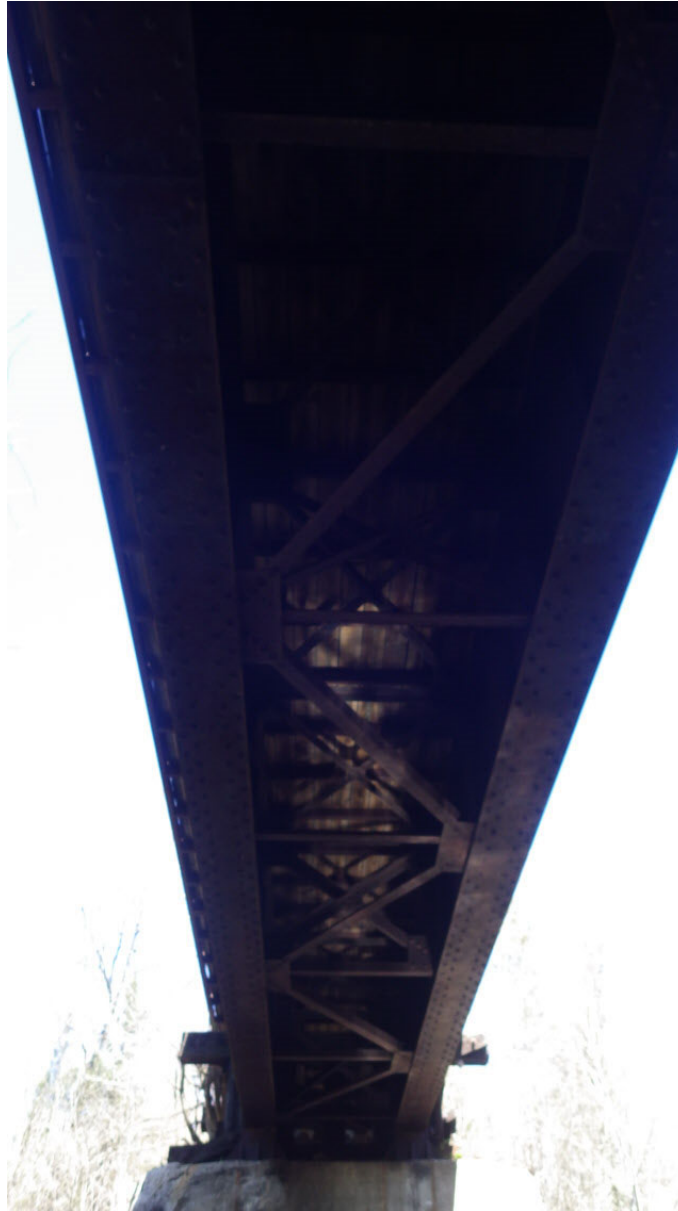
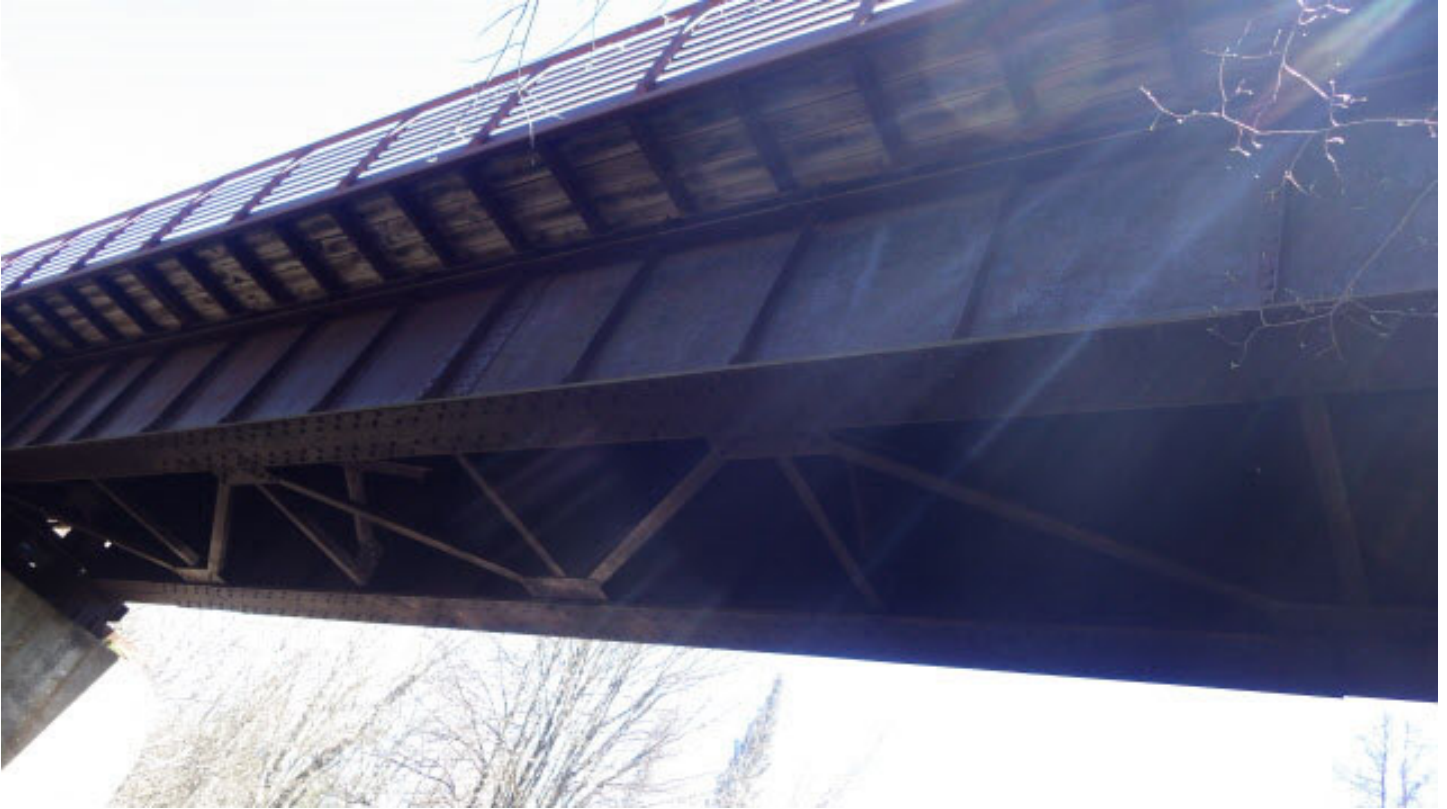
Steel main span is in fair condition (1925 construction plaque). Some exterior timber girders are punky.

Steel main span in fair condition

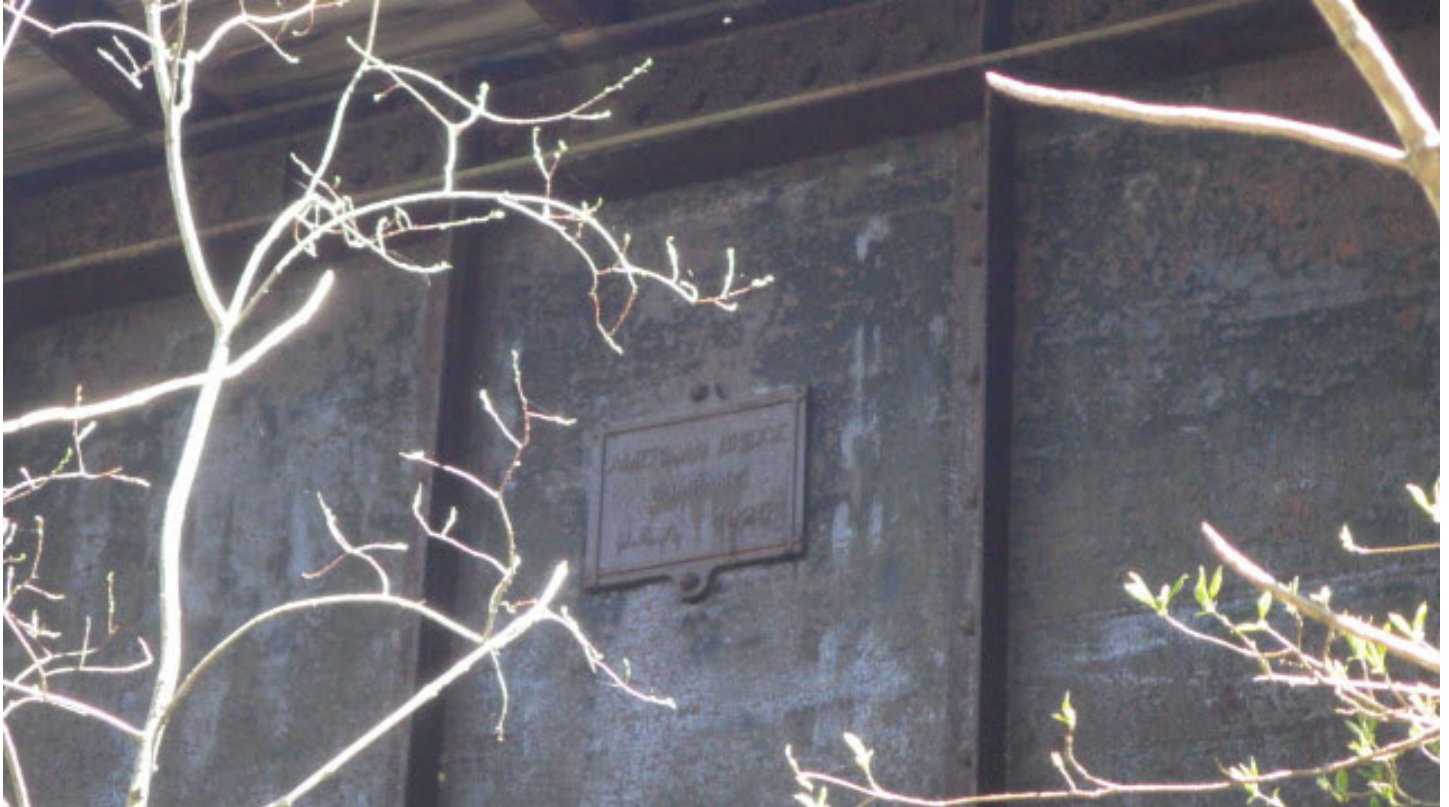
Constructed in 1925 by the American Bridge Company

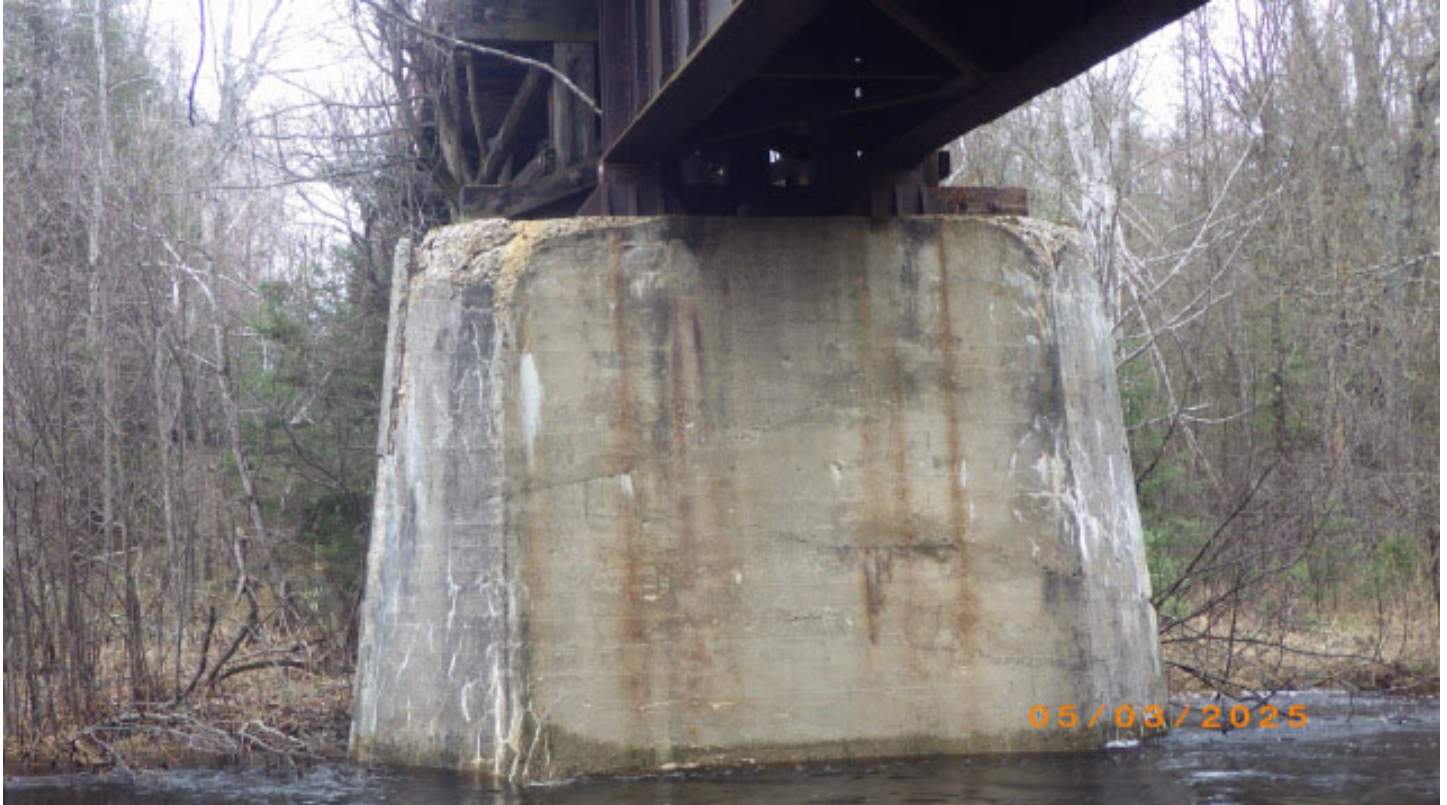
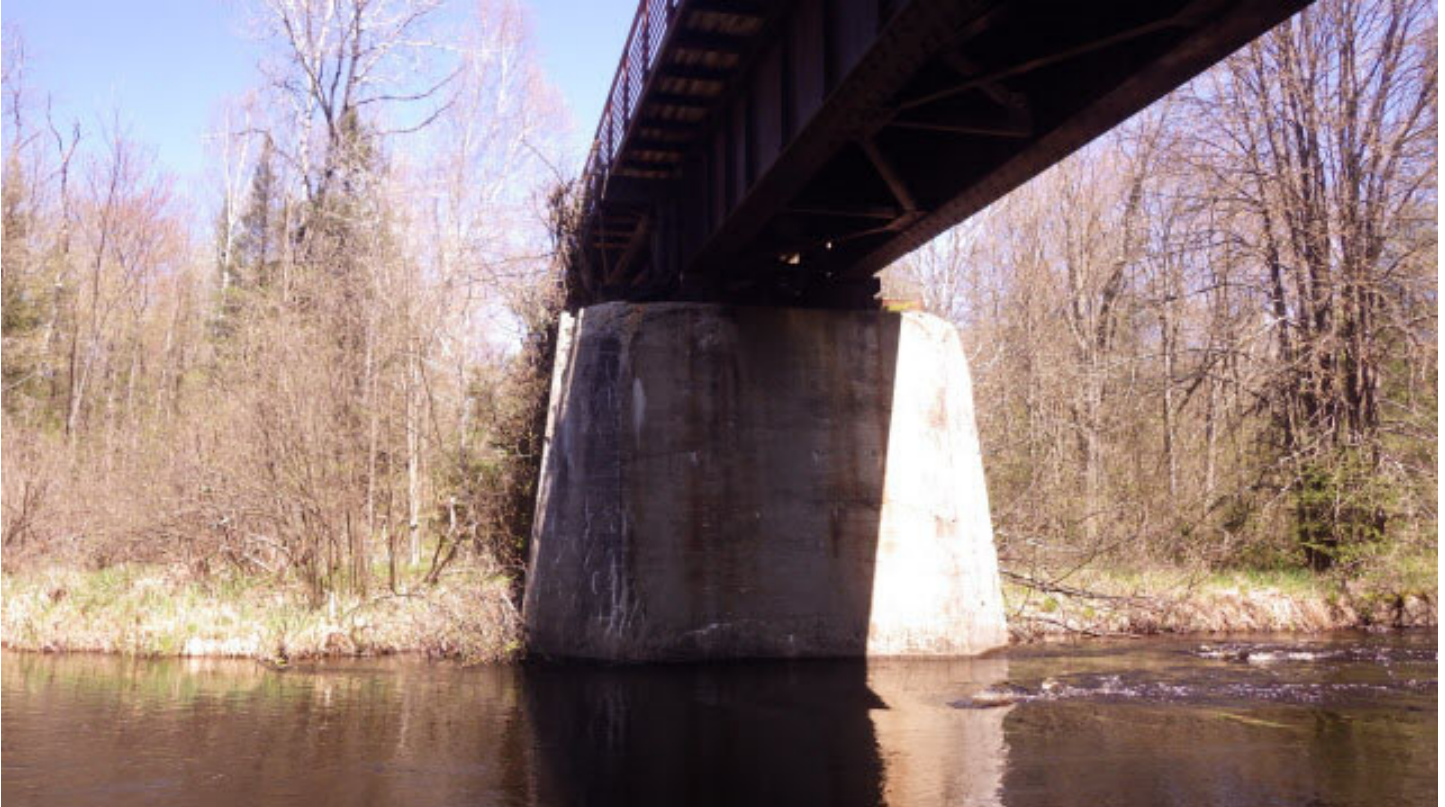
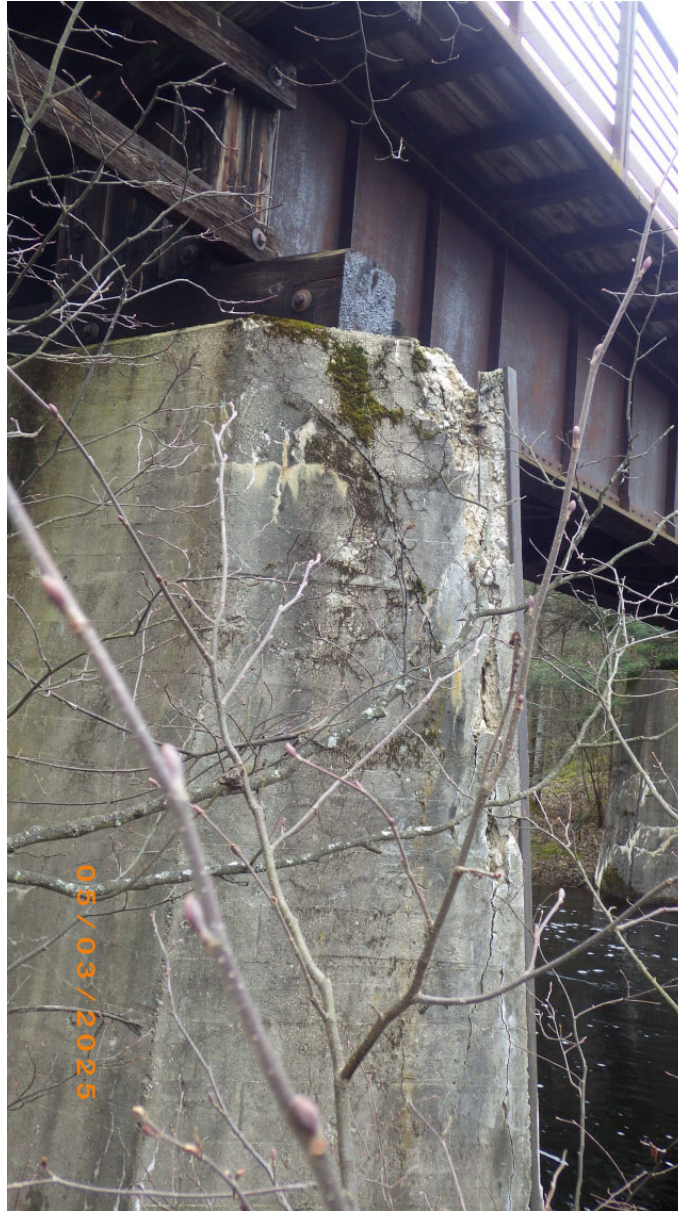
efflorescence. Top section of pier is timber and the cap is rotten / crushing. Concrete pier #4 has very large 4'x4'x1' CS3 spalls at both the upstream and downstream top edge. CS3 cracking with efflorescence throughout. Bents #5-8 in fair condition. Bent #9 cap is rotten / crushing. Bent #10 cap is rotten. Bent #11 cap ends are rotten. North abutment cap ends are rotten.

Pier #4 with very large spalls on top corners and CS3 cracking with efflorescence throughout

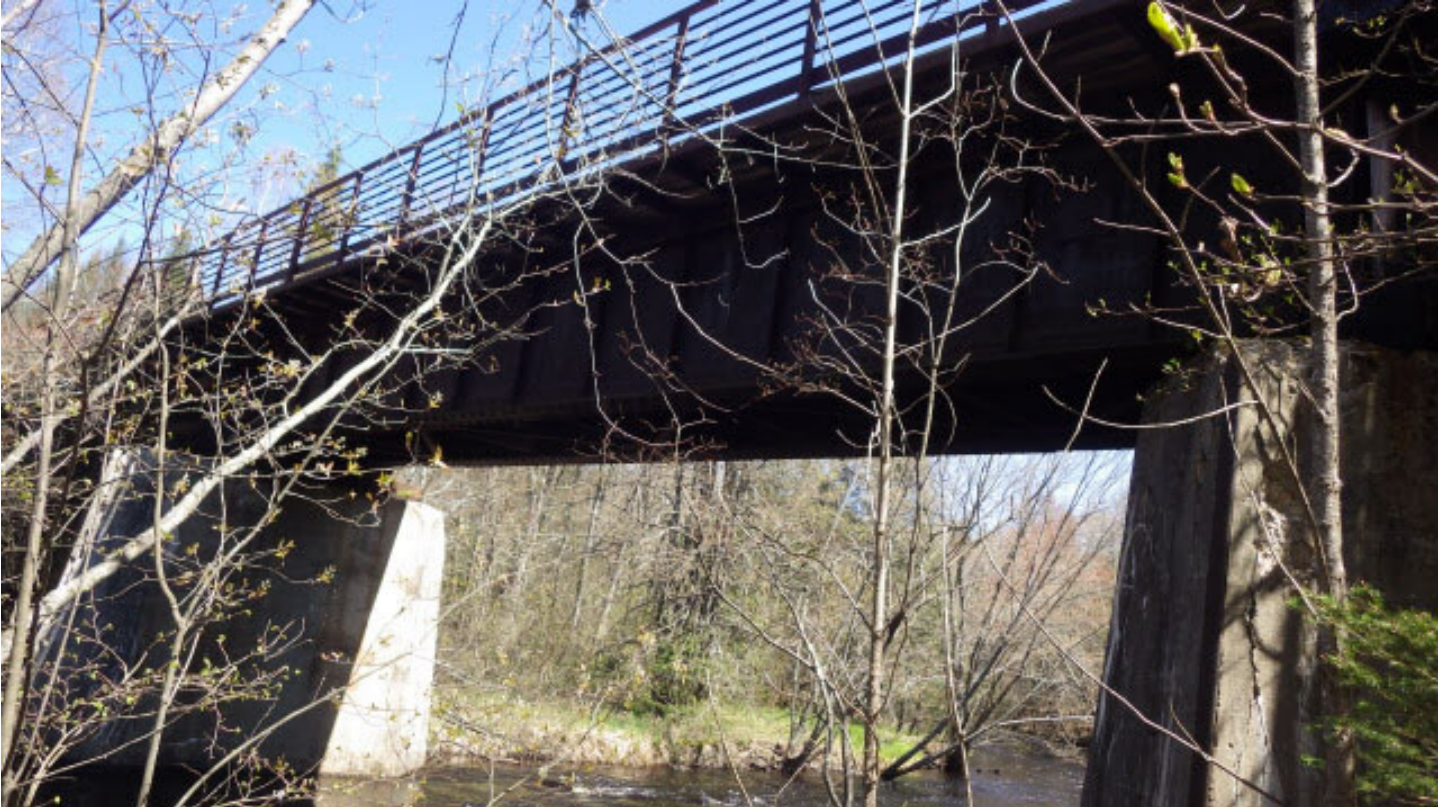
Upstream elevation view

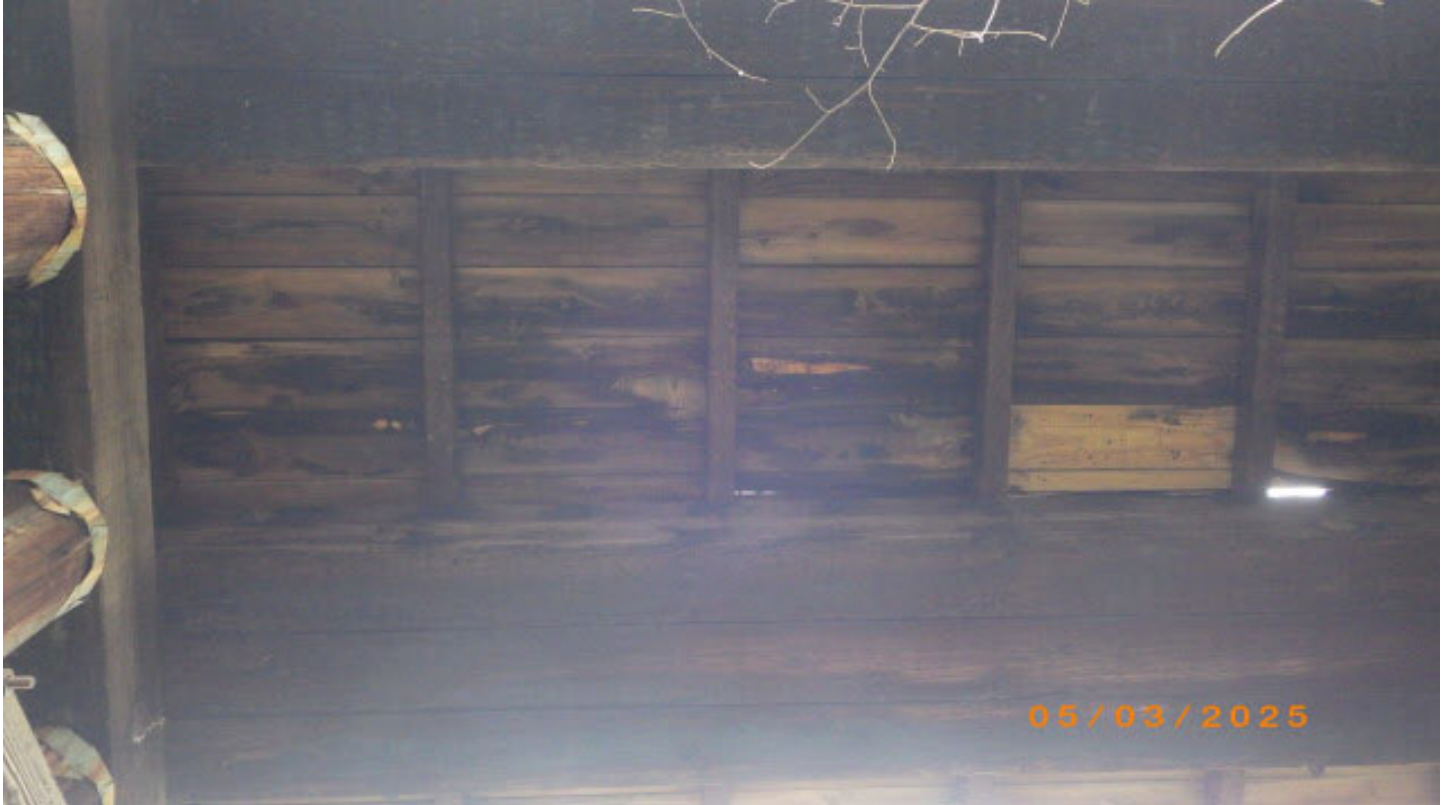
Underside of deck at hole in center of bridge. Note other rotten areas.

Replace entire deck with copper naphthenate treated timber planks

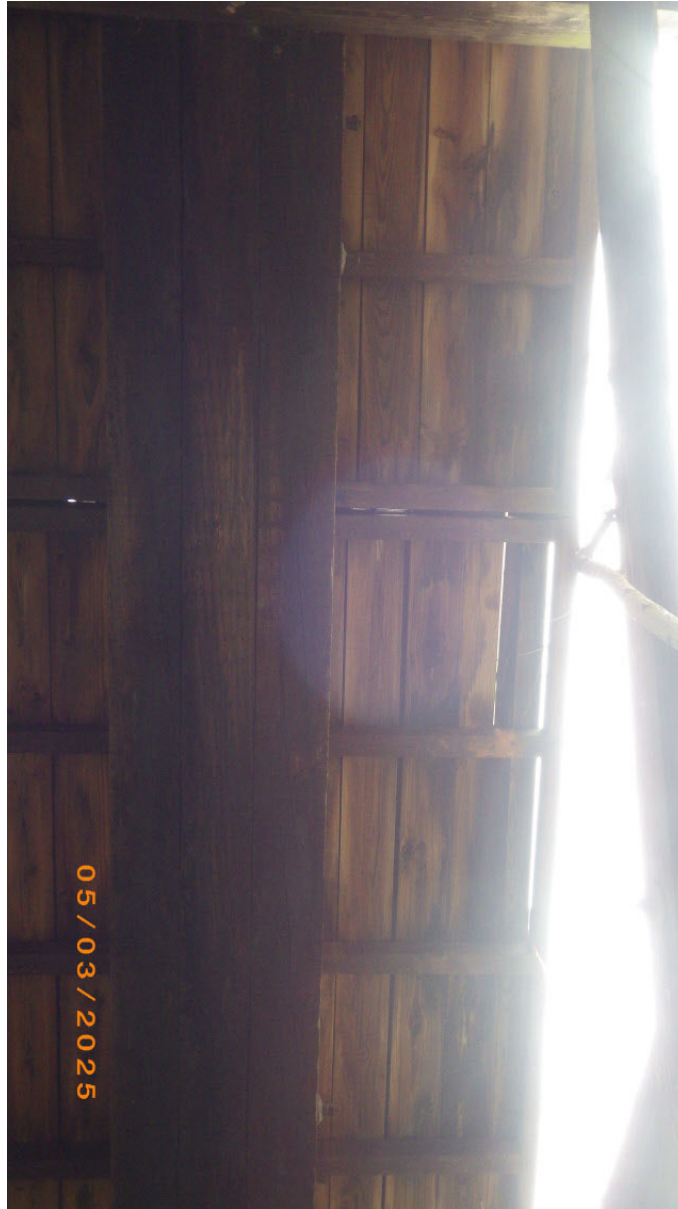
Underside of deck at hole in east edge of span 7. Note other rotten areas.

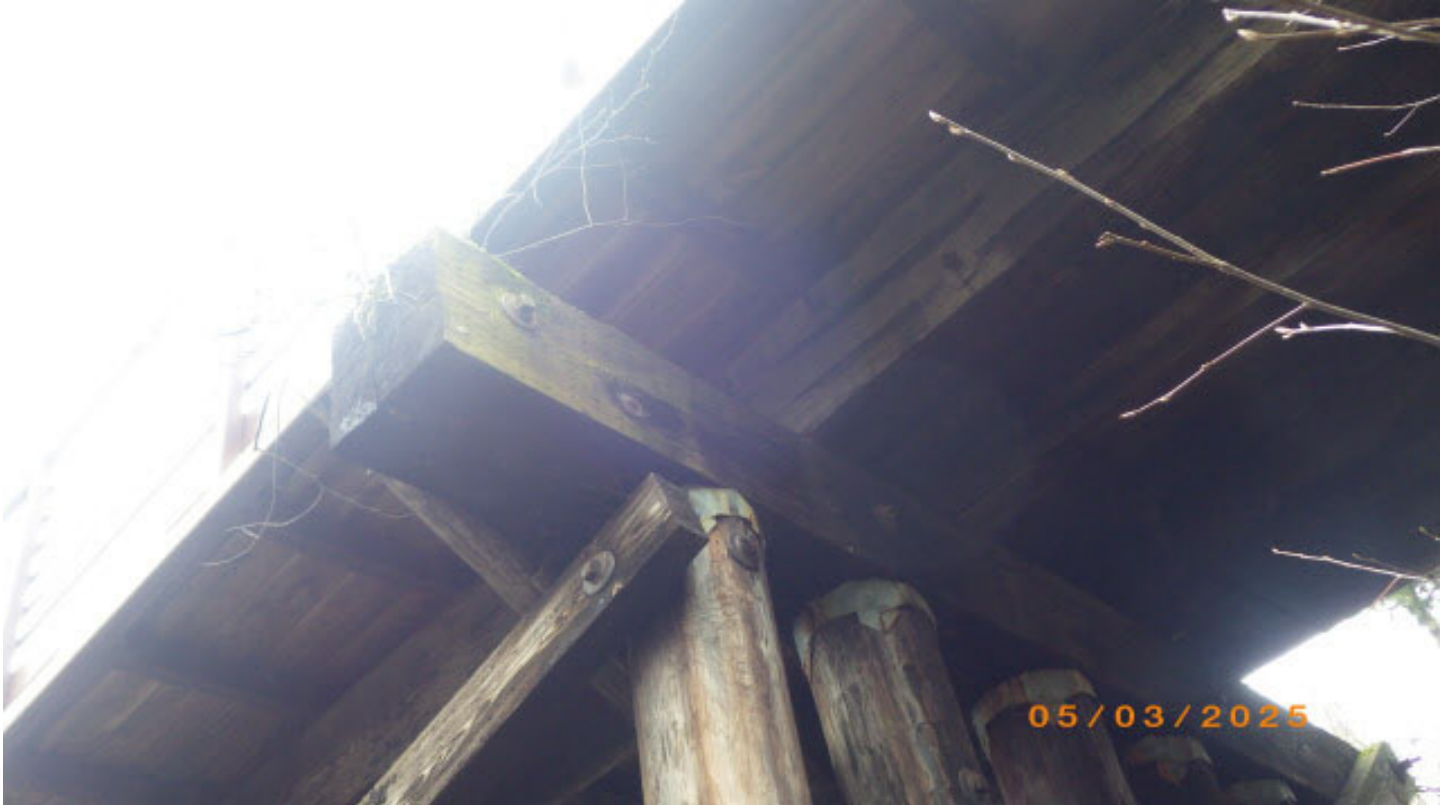
Bent #9 cap is rotten / crushing

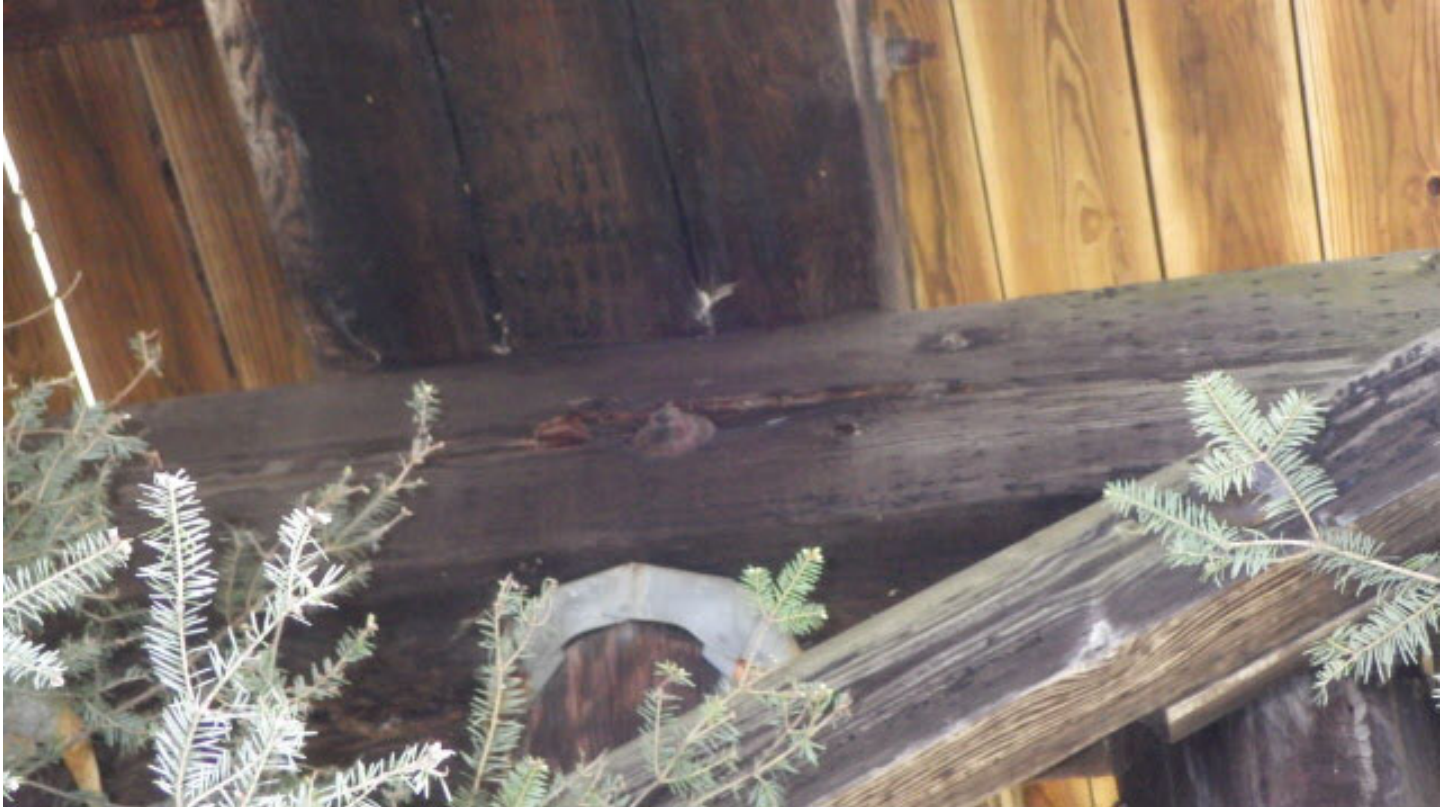
Bent #9 cap is rotten / crushing (close-up)

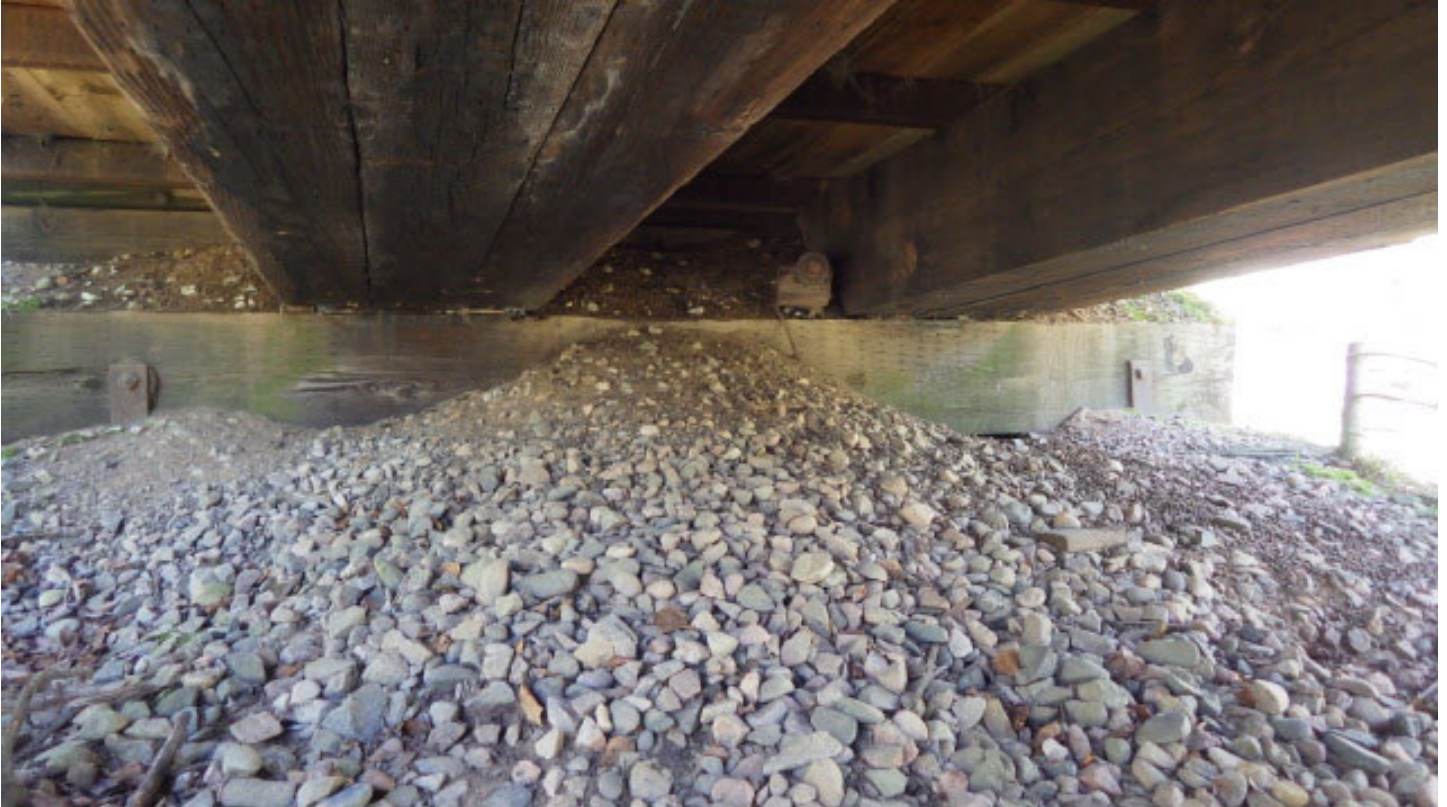
North abutment cap ends rotten
