A-13 Tri Co/Cheese Country Bridge #36

Project Title Cheese Country Trail Bridge #36 Replacement					Current Funded Miles	New Miles (if applicable)
County Lafayette	Township 01 N	Range 5	Section 12	¼ ¼ UN	¼ UN	GPS Coordinates: Lat. 42.572812 Long. -89.856157

## Inspection Report for

## Cheese Country Trail over Unnamed Stream

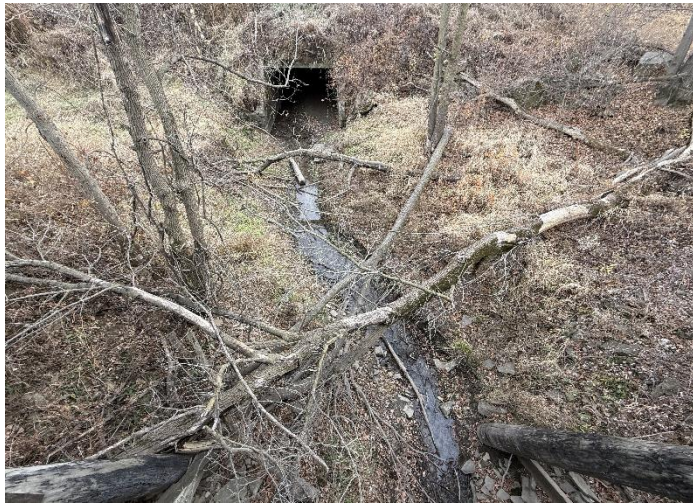
Photo 3 – Upstream Looking South.

- Flood debris in upstream channel. Embankments are generally stable.

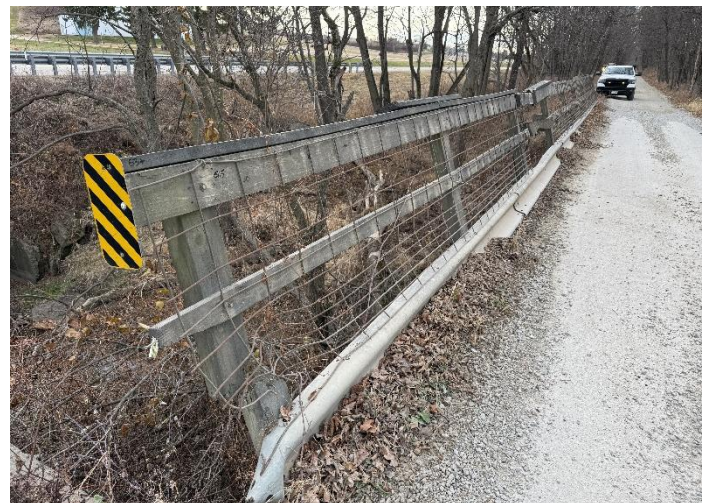
1. Hog panel fencing supported by dimensional timber rails with angled timber posts. W-beam bridge rail curbs.
2. Initial signs of incipient decay of timber components. Timber preservative treatment appears marginally effective.
3. Widespread areas of severe damage to hog fencing, timber rails, and timber posts.
4. Multiple cracked/broken rail posts.

Photo 6 – South Rail Looking West.

Repair damaged rail components.

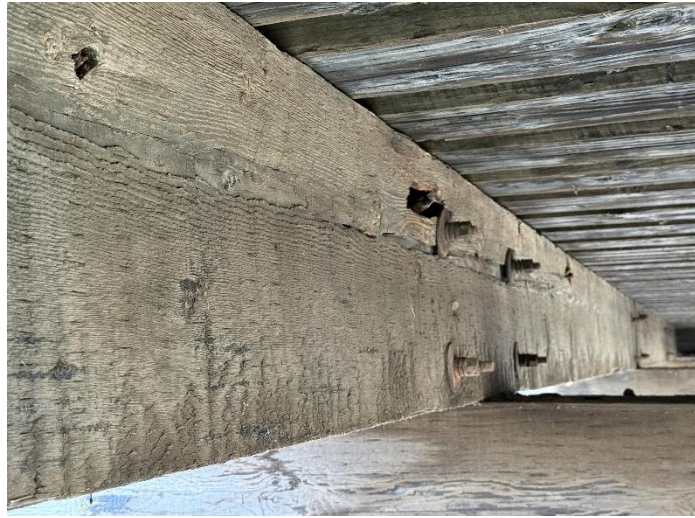
1. (2) lines of timber beams each comprised of (3) through-bolt connected laminations.
2. Beams are decayed +/- 75% throughout with widespread prominent checking and generally appear hollow when sounded. Multiple areas of more advanced decay and signs of horizontal shear cracking.
3. **Overload distress (crushing) observed in multiple beams over the east abutment and east pier.** Condition is indicative that the strength/performance of the bridge has been compromised, and the structure is unable to support the existing loads.
4. Beams are highly susceptible to overload damage; additional crushing will likely require immediate closure.

Photo 7 – South Beam/North Face Over East Pier.

No feasible rehabilitation options to strengthen or extend longevity of component.

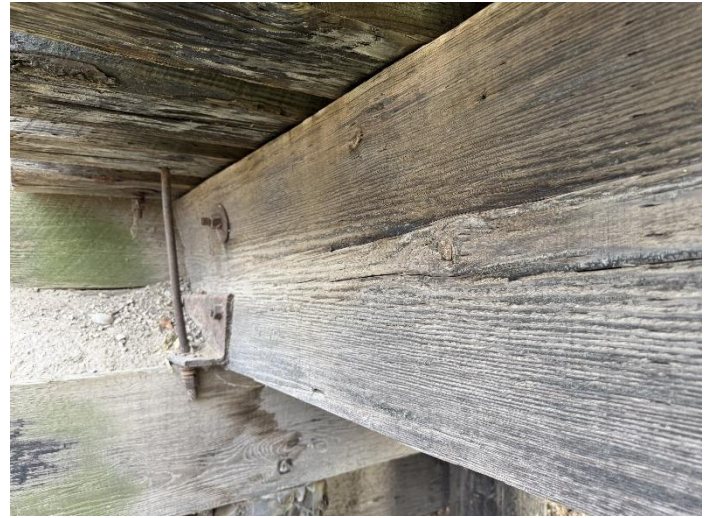
Photo 8 – North Beam/North Face Over E. Abutment.

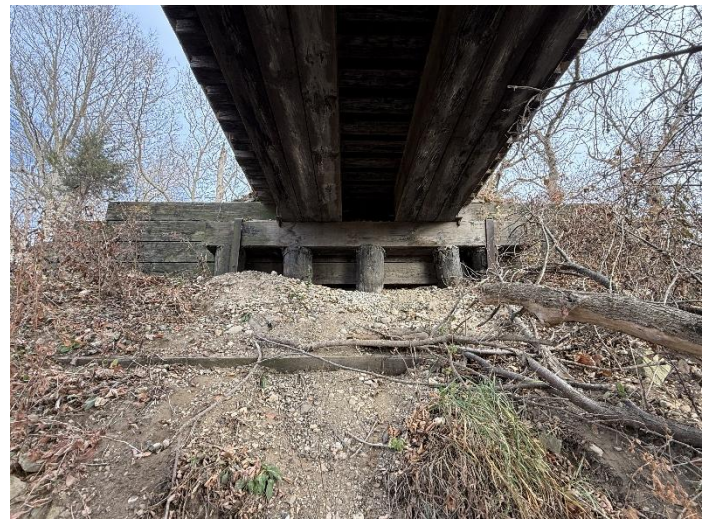
Photo 10 – East Abutment.

1. Driven timber piles, timber pile caps, and timber backwall plank.
2. Decayed timber components throughout with no signs of readily evident crushing.
3. Caps are decayed 50%-75% throughout with widespread minor checking and generally appear hollow when sounded. Isolated areas of more advanced decay and splitting at ends. East cap split with minimal separation.
4. Piles: Exposed bearing piles are starting sound hollow with an estimated 25%-75% loss of section.

1. Embankment Erosion: Erosion of natural earth embankment has undermined the backwall plank in the east abutment. Top of 1:1 embankment at east backwall and west pier. 2’-3’ vertically cut embankments throughout.
2. Drift: No significant deposits in channel. Flood debris in upstream channel.
3. Channel Change: Waterway flows through span W3. All substructure units are beyond channel flow. Upstream channel position stabilized by roadway culvert. Main channel within 200’ downstream of trail bridge.
4. Adequacy of Opening: No readily visible signs of overtopping.

Installation of channel protection would reduce likelihood of future erosion/scour issues. Channel armoring may not be feasible, and/or recommended, given the expected longevity of the structure and current observed conditions.

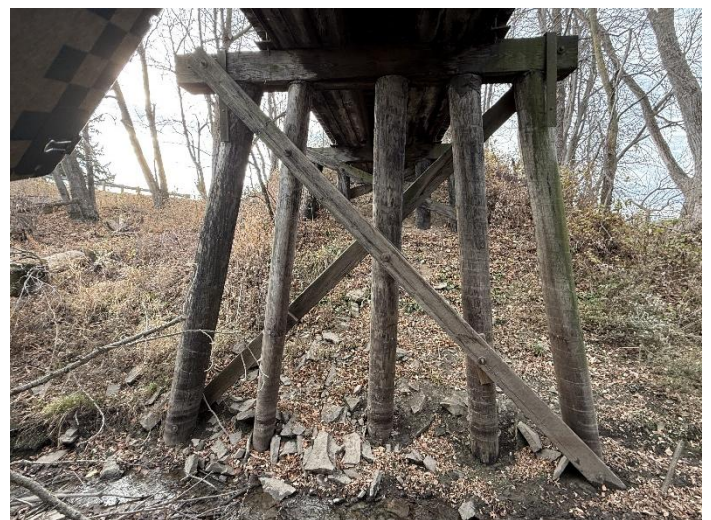
Photo 12 – Pier W2 Looking West.

1. Driven timber piles and timber pile caps.
2. Decayed timber components throughout with no readily evident signs of crushing– pile caps are highly susceptible to overload damage.
3. Caps are decayed +/- 75% throughout with widespread minor checking and generally appear hollow when sounded. Isolated areas of more advanced decay and splitting at ends. All caps appear to be split vertically along the full length of the caps with minimal separation observed.
4. Piles: Bearing piles sound hollow with an estimated 50%-75% loss of section. Multiple piles are split vertically.

No feasible rehabilitation options to strengthen or extend longevity of component.
