A-14 Tri Co/Cheese Country Bridge #7

Project Title Cheese Country Trail Bridge #7 Replacement					Current Funded Miles	New Miles (if applicable)
County Lafayette	Township 04 N	Range 3	Section 31	¼ ¼ NW	¼ SW	GPS Coordinates: Lat. 42.778328 Long. -90.188072

Inspection Report for

Cheese Country Trail over Unnamed Stream

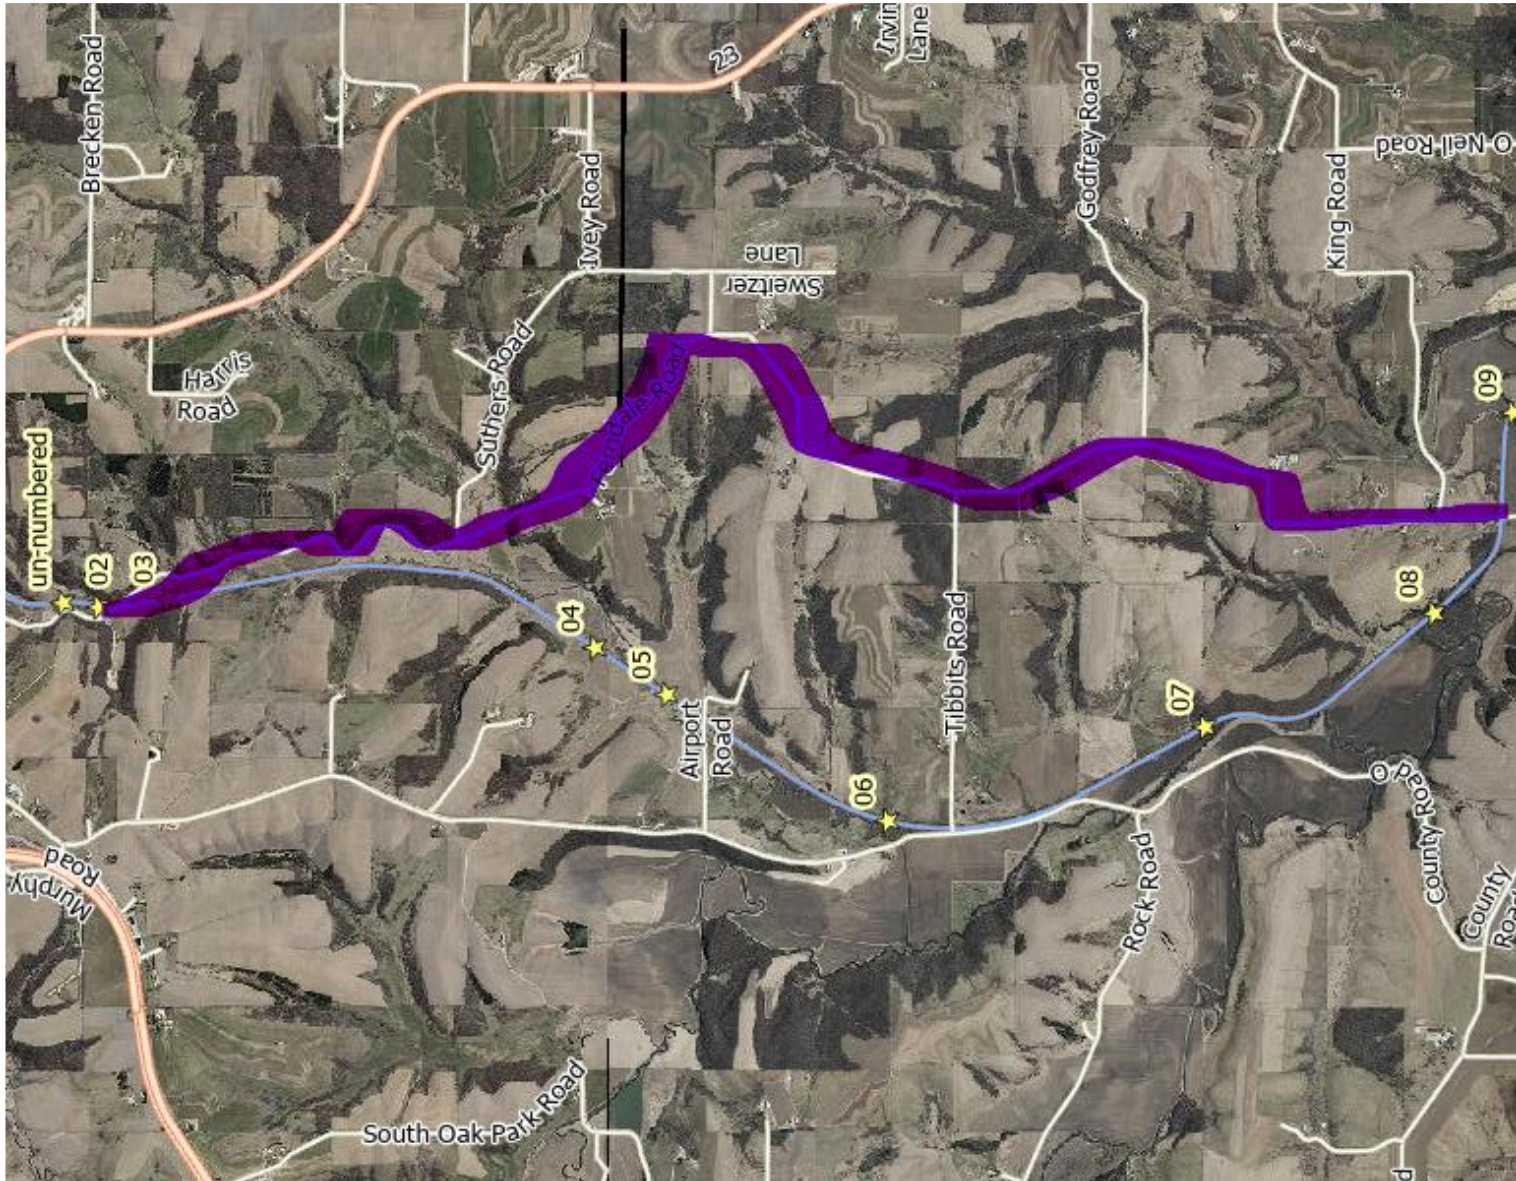
Trail re-route if bridge 7 would have to close.

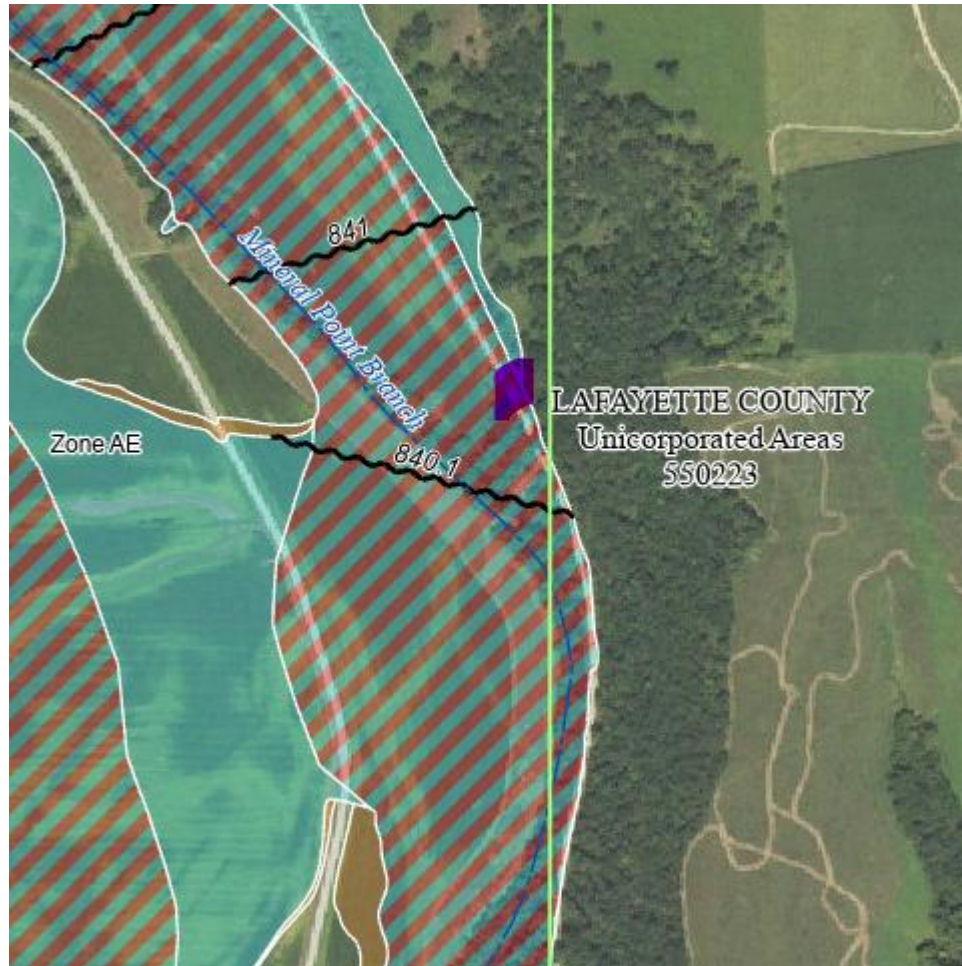
Bridge is located in the purple highlighted area. This area is within FEMA regulated floodplain.

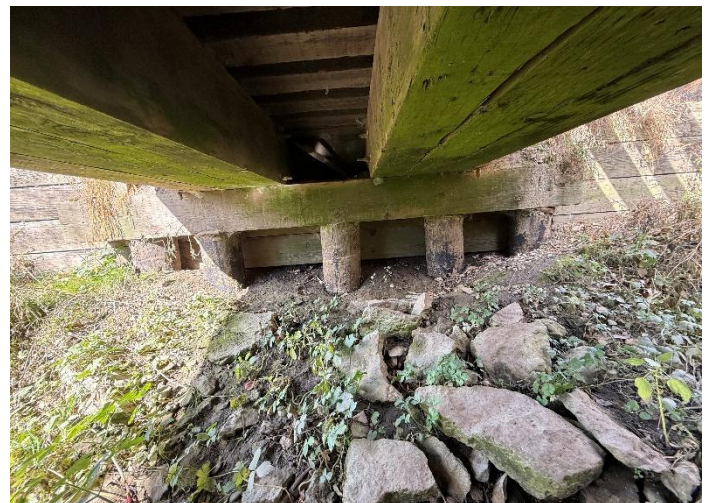
Photo 6 – North Abutment

1. Driven timber piles, timber pile caps, and timber backwall plank.
2. South backwall/wingwall plank undermined and separating. Portion of north backwall plank undermined.
3. Decayed timber components throughout. Backwall piles checking w/ signs of decay and section loss. All bearing piles sound hollow with +/- 50% loss section. No signs of lateral/overload distress observed.

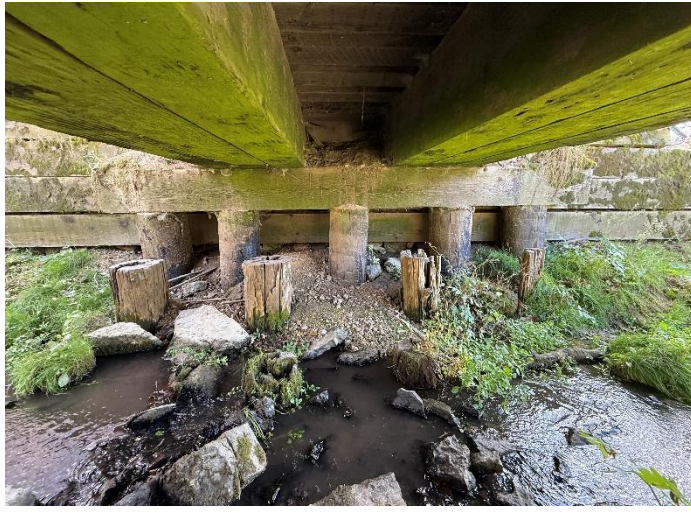
Photo 7 – South Abutment.

- Erosion at the south abutment has undermined the wingwall plank.

1. Embankment Erosion: Erosion has undermined the full-length south abutment backwall plank and approximately 8ft of the north abutment backwall plank.
2. Drift: No significant deposits in channel.
3. Channel Change: Channel flows through the center of the opening.
4. Adequacy of Opening: No readily visible signs of overtopping. Low clearance opening is susceptible to overtopping during high flow events.

Repair erosion/undermining of south abutment backwall plank.

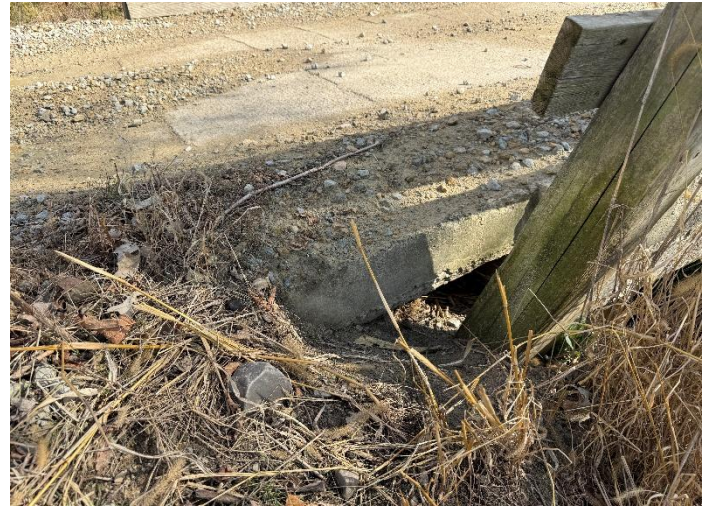
Photo 8 – West Corner of North Approach. Typical.

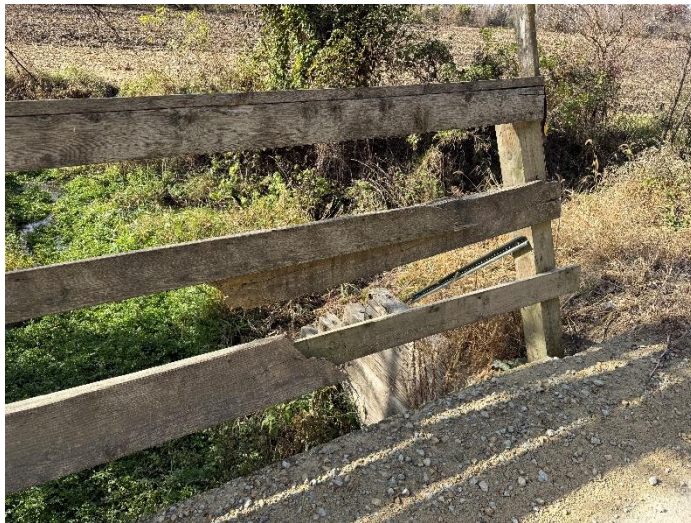
1. (3) rows of dimensional timber bridge rail supported by angled timber posts.
2. Patched collision damage to rails. Posts and rail decayed/loosely connected. Timber preservative treatment appears marginally effective.

Photo 9 – North End of West Rail.

Repair damaged railing components.

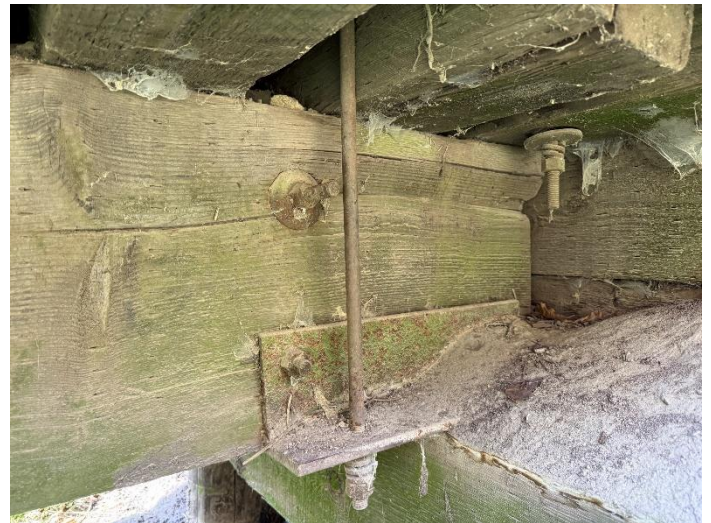
1. (2) lines of timber beams each comprised of (3) through-bolt connected laminations.
2. Beams are decayed throughout with prominent checking and portions appear hollow when sounded.
3. **Beams are showing signs of overload distress** (crushing) over the north abutment. Condition is indicative that the strength/performance of the bridge has been compromised, and the structure is unable to support the existing loads.

Photo 10 – East Beam Over North Abutment.

No feasible rehabilitation options to strengthen or extend longevity of component.
