A-15 Tri Co/Cheese Country Bridge #5

Project Title Cheese Country Trail Bridge #5 Replacement					Current Funded Miles	New Miles (if applicable)
County Lafayette	Township 04 N	Range 3	Section 19	¼ ¼ SE	¼ NW	GPS Coordinates: Lat. 42.809769 Long. -90.185664

Bridge #5

Cheese Country Trail over Furnace Creek

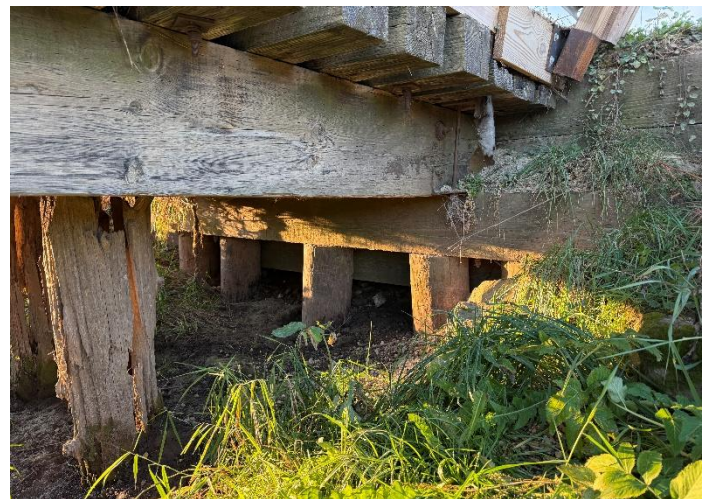
1. Driven timber piles, timber pile caps, and timber backwall plank.
2. South backwall plank undermined.
3. Decayed timber components throughout. Backwall piles checking w/ signs of decay and section loss. All bearing piles sound hollow with an estimated 25%-50% loss section. No signs of lateral/overload distress observed.

1. Embankment Erosion: Erosion at the south embankment has undermined the south abutment backwall plank. Vertical cut embankments throughout channel.
2. Drift: Flood debris built-up on south pier.
3. Channel Change: Channel favors south side of opening. Waterway flows through center span, north ¼ of south span. Both piers within channel flow during inspection with less than 2ft max water depth.
4. Adequacy of Opening: Debris on south pier cap may be evident of low member submergence.

Photo 6 – South Abutment.

- Remove flood debris.
- Repair erosion/undermining of south abutment backwall plank.

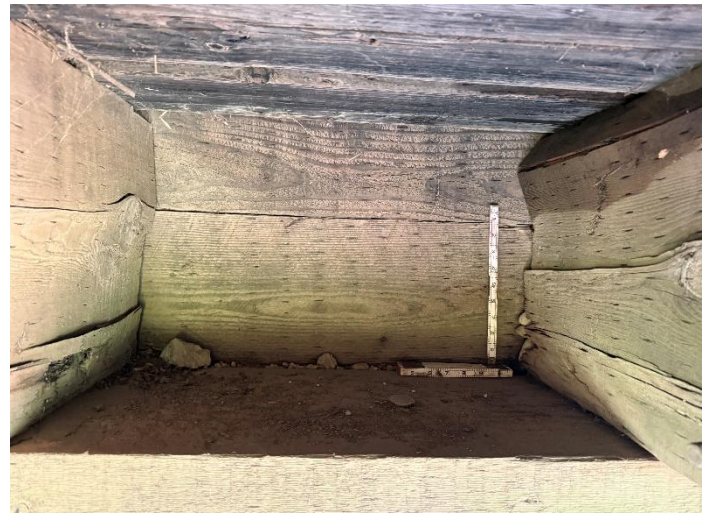
1. (2) lines of timber beams each comprised of (3) through-bolt connected laminations.
2. Beams are decayed throughout with prominent checking and portions appear hollow when sounded.
3. **Beams are showing signs of overload distress** (crushing) over the south abutment. Condition is indicative that the strength/performance of the bridge has been compromised, and the structure is unable to support the existing loads.

Photo 8 – Beams Crushing Over South Abutment.

- **Bridge should be evaluated for structural capacity posted for load at the most restrictive allowable limit.**
- Schedule for complete replacement.

No feasible rehabilitation options to strengthen or extend longevity of component.
