Motorized Recreation Grant Application

Project Title Dam 16 Crossing					Current Funded Miles 63.4 ATV, 376.2 SNO	New Miles (if applicable)
County Clark	Township 25 N	Range 4	Section 11	Section ¼ ¼	GPS Coordinates: Lat. 44.667912 Long. -90.831092

Structure Inspection Clark Country Trail Bridge

Inspection Date: March 25, 2026
Inspector: Colin Olson, P.E. Bridge Inspector No. 9770

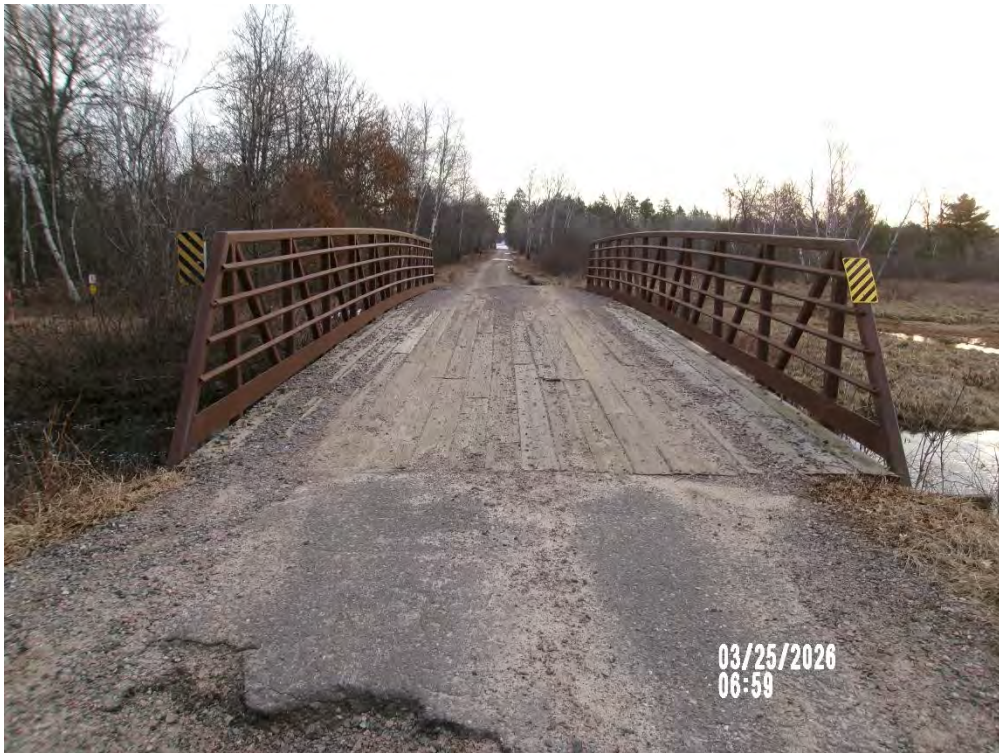
Figure 2: West Approach looking East

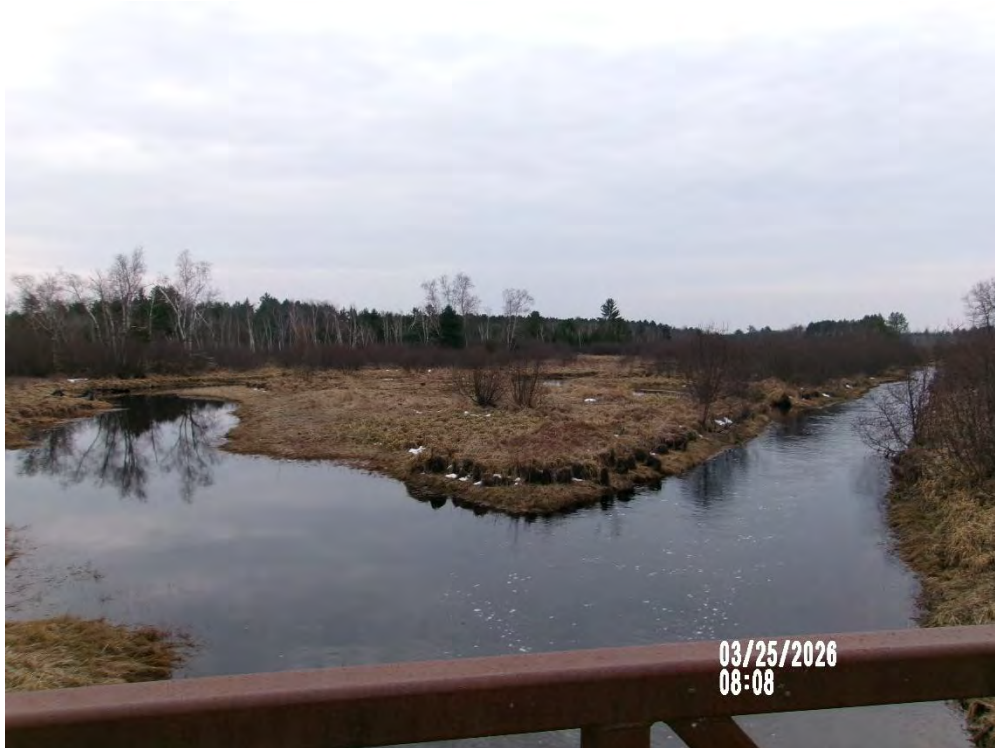
Figure 3: Looking Upstream from Top of Deck

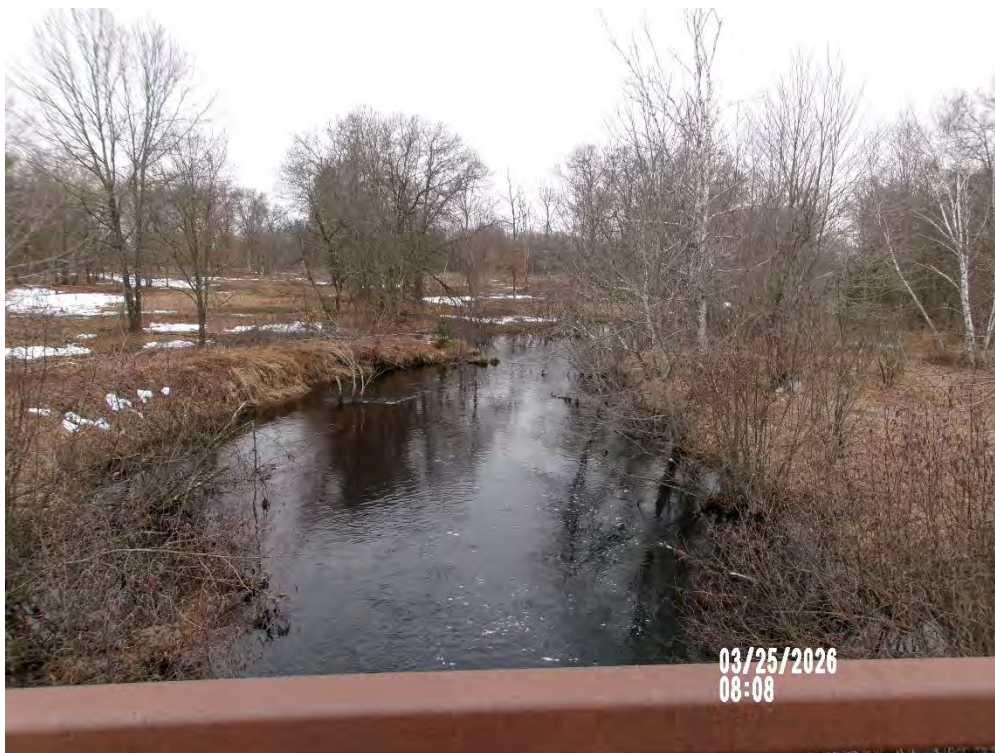
Figure 4: Looking Downstream from Top of Deck

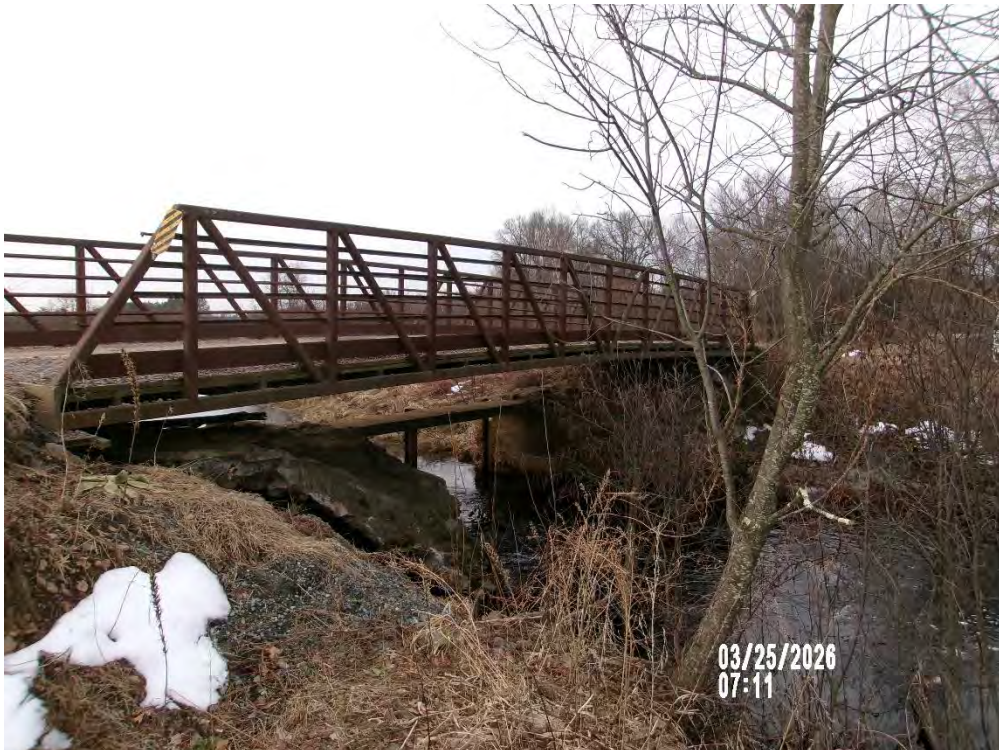
Figure 6: Profile Looking Upstream

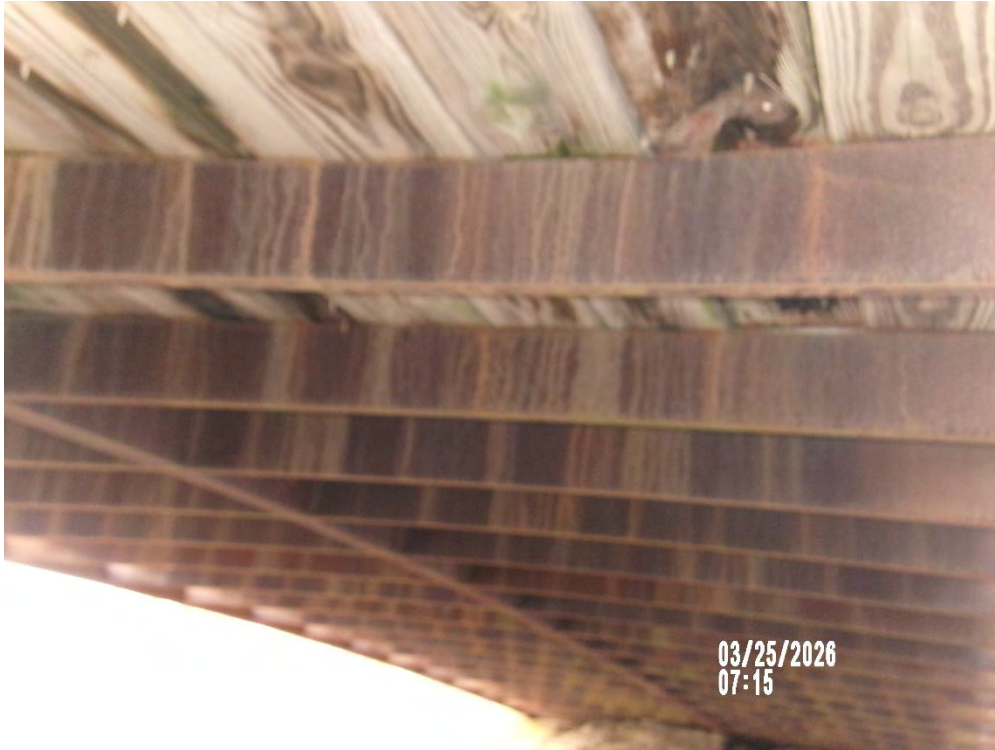
Good Condition. All surfaces have minor surface rust consistent with weathering steel this age.

Figure 11: Typical floor beam condition

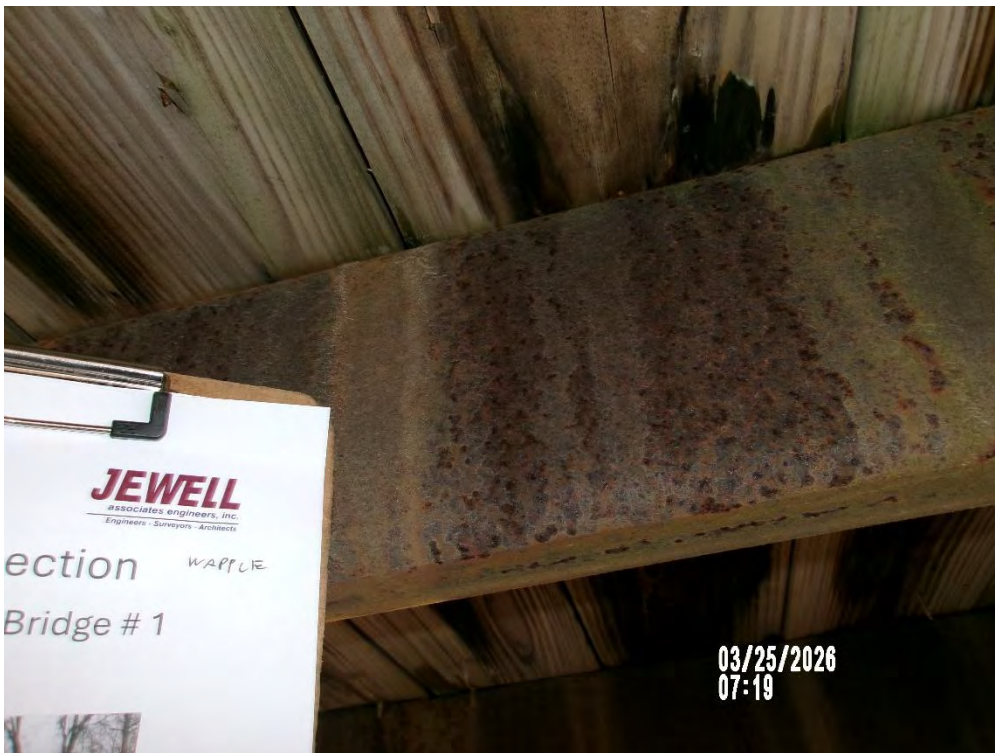
Figure 12: Worst case floor beam condition
