A-17 Lincoln Co Hilt Lake Bridge Rehab

Project Title Hilt Lake Summer ATV UTV Bridge Rehab					Current Funded Miles 47.4	New Miles (if applicable)
County Lincoln	Township 35 N	Range 8	Section 14	¼ ¼ NW	¼ SE	GPS Coordinates: Lat. 45.515 Long. -89.457

Trail Bridge Inspection

Bailey Trail Bridge

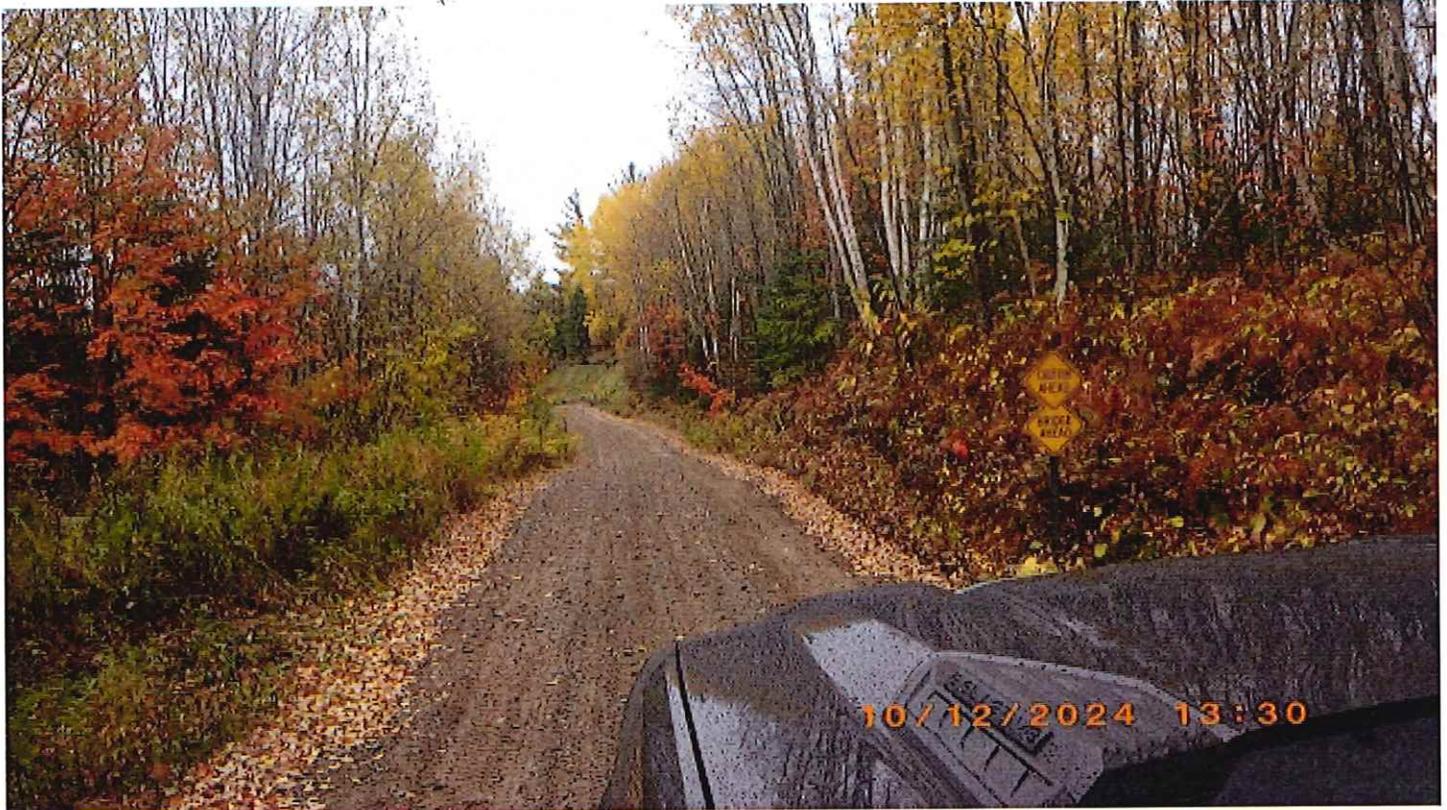
Approaches are in good condition. Bridge ahead signs are CS1. Object markers are CS1.

West bridge ahead sign

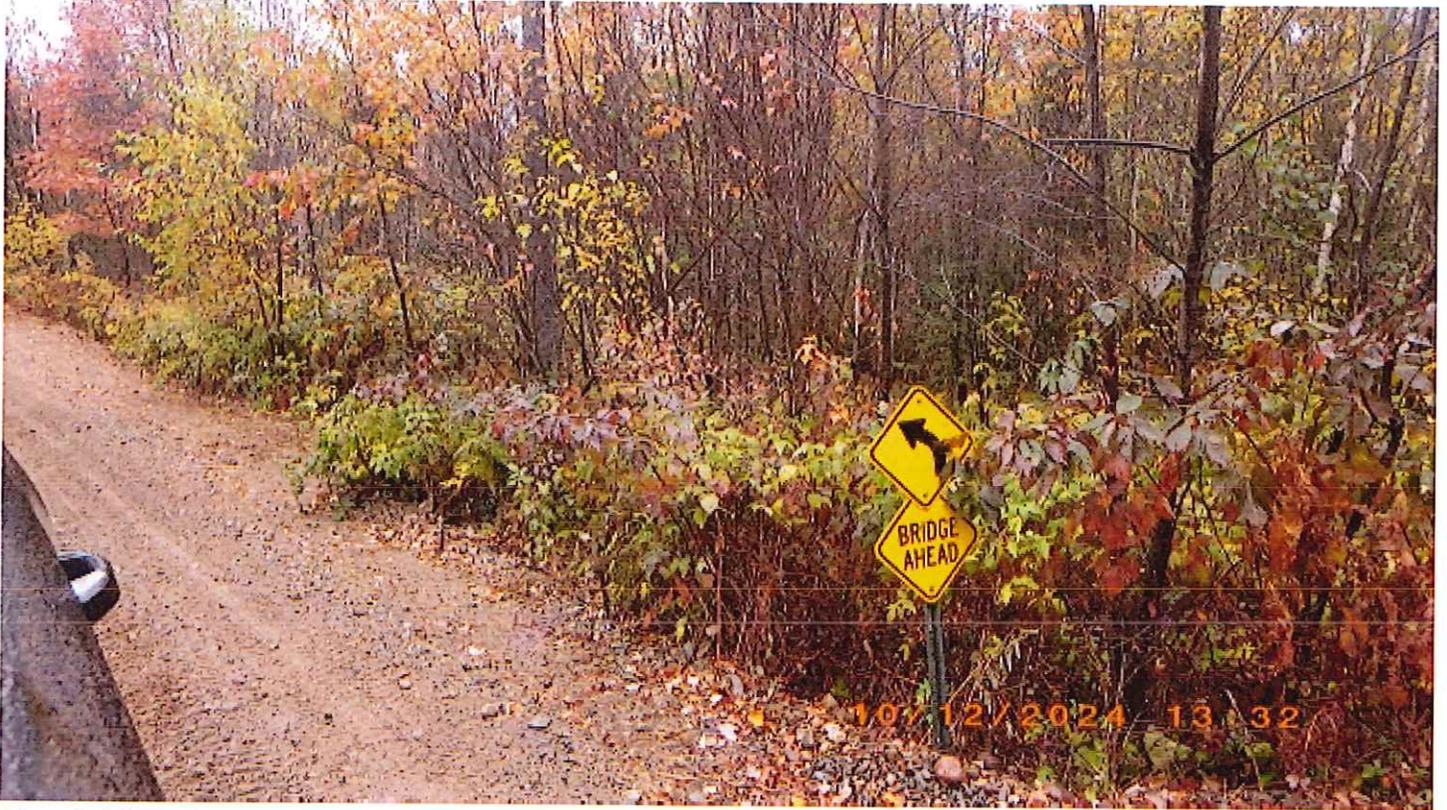
East bridge ahead sign

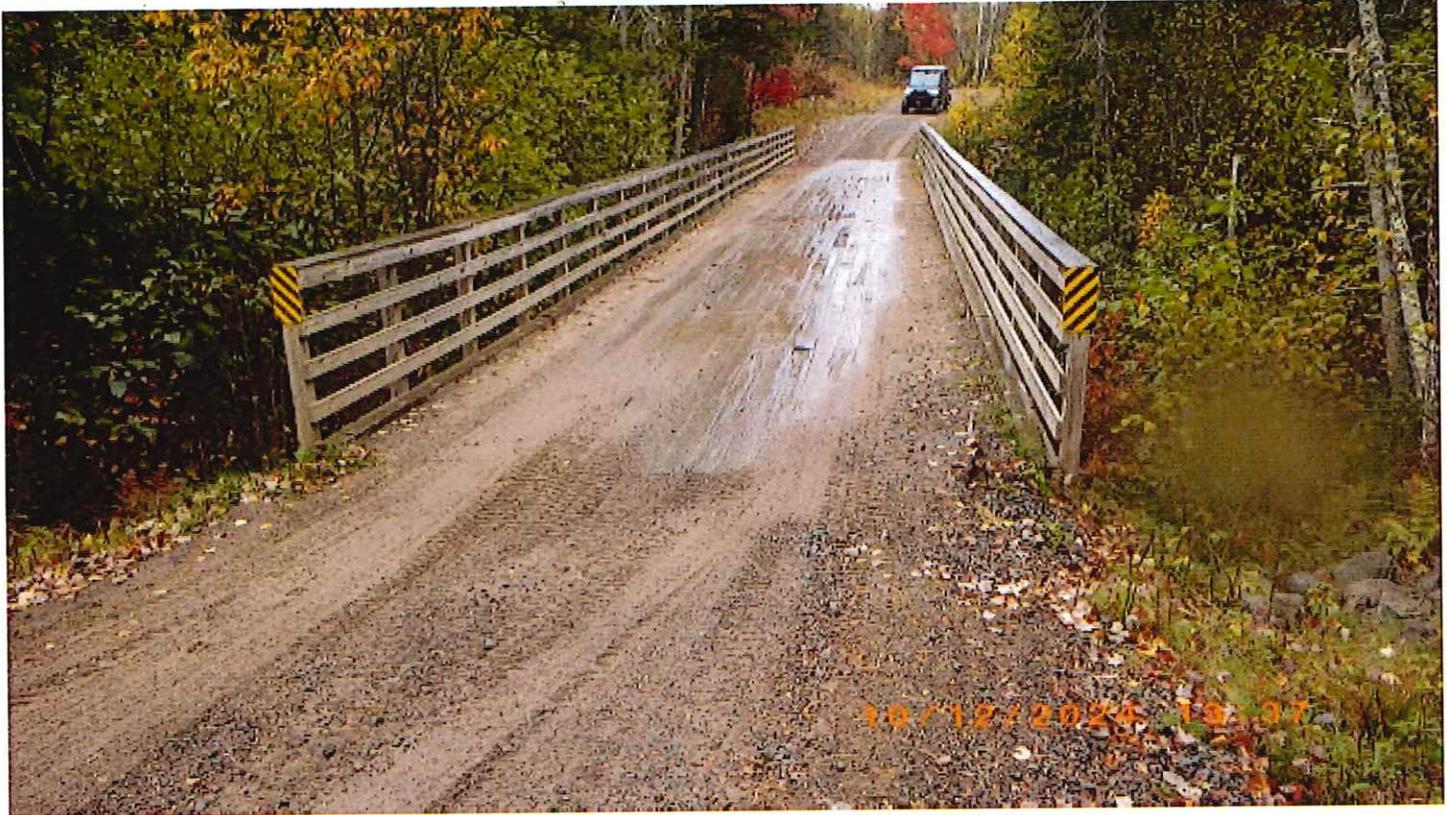
West approach

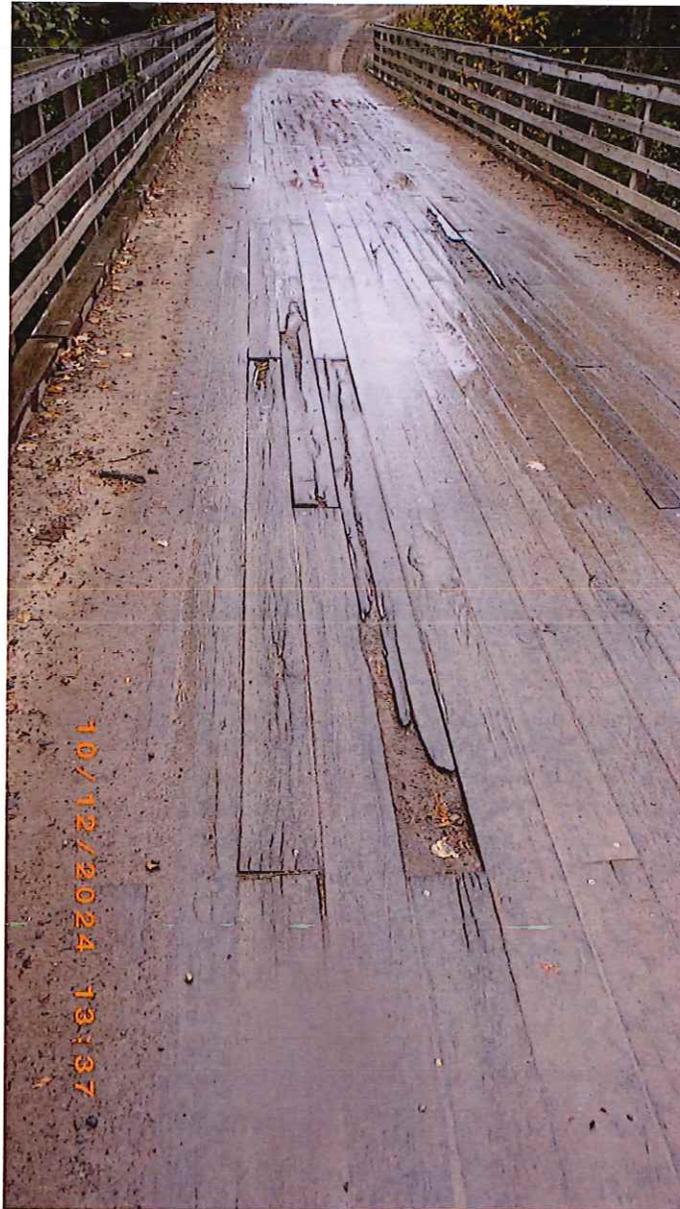
Wearing surface has CS3 wear at center and scattered sections that are CS4, completely rotten or gone. Edges are gravel covered.

Top of deck

- Replace entire deck / wearing surface
- Highly recommend load rating superstructure before redecking. (questionable capacity for groomers by inspection)
- Clean deck
- Add scupper blocks under curbs for drainage

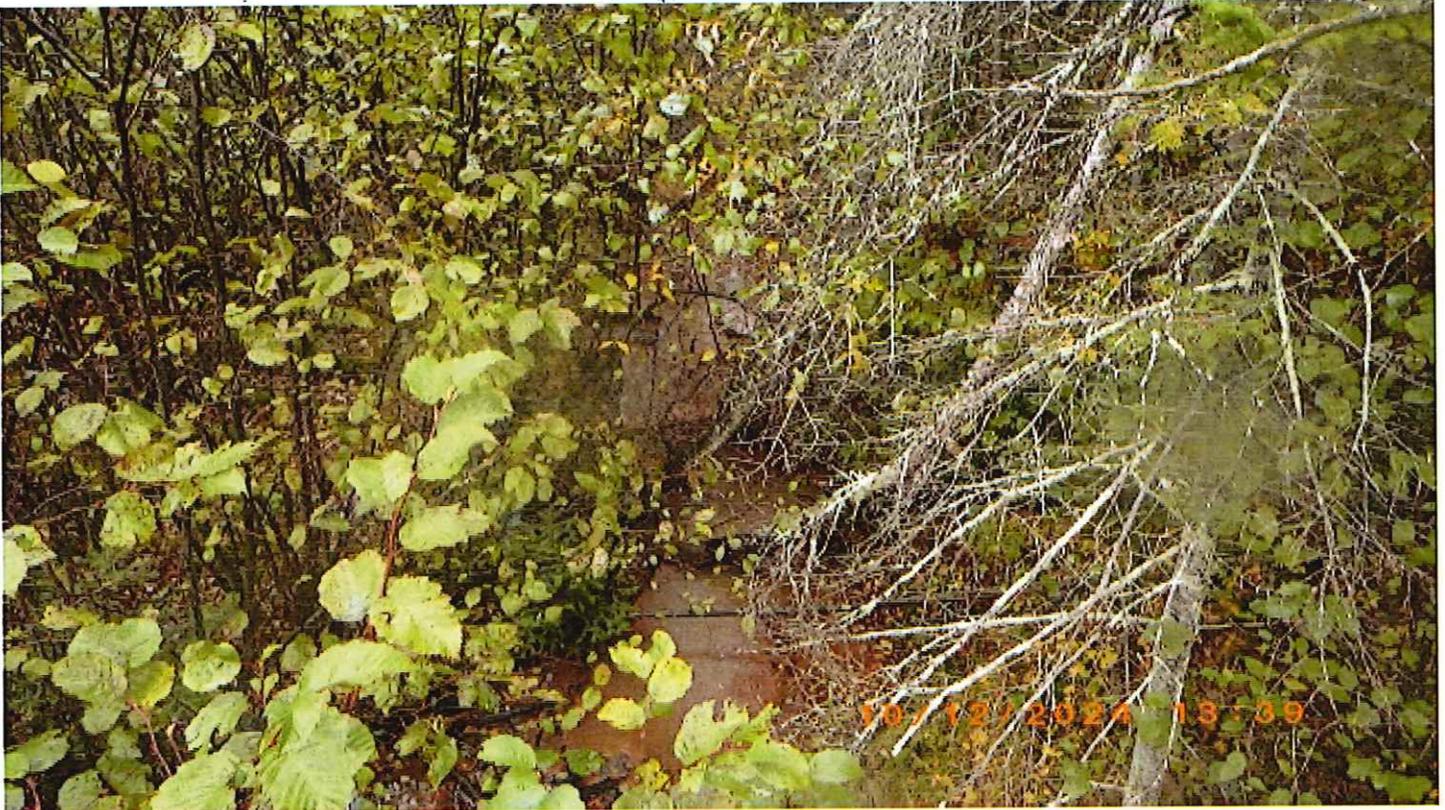
Channel is in good condition. There is a tree over the stream downstream.

Channel looking upstream

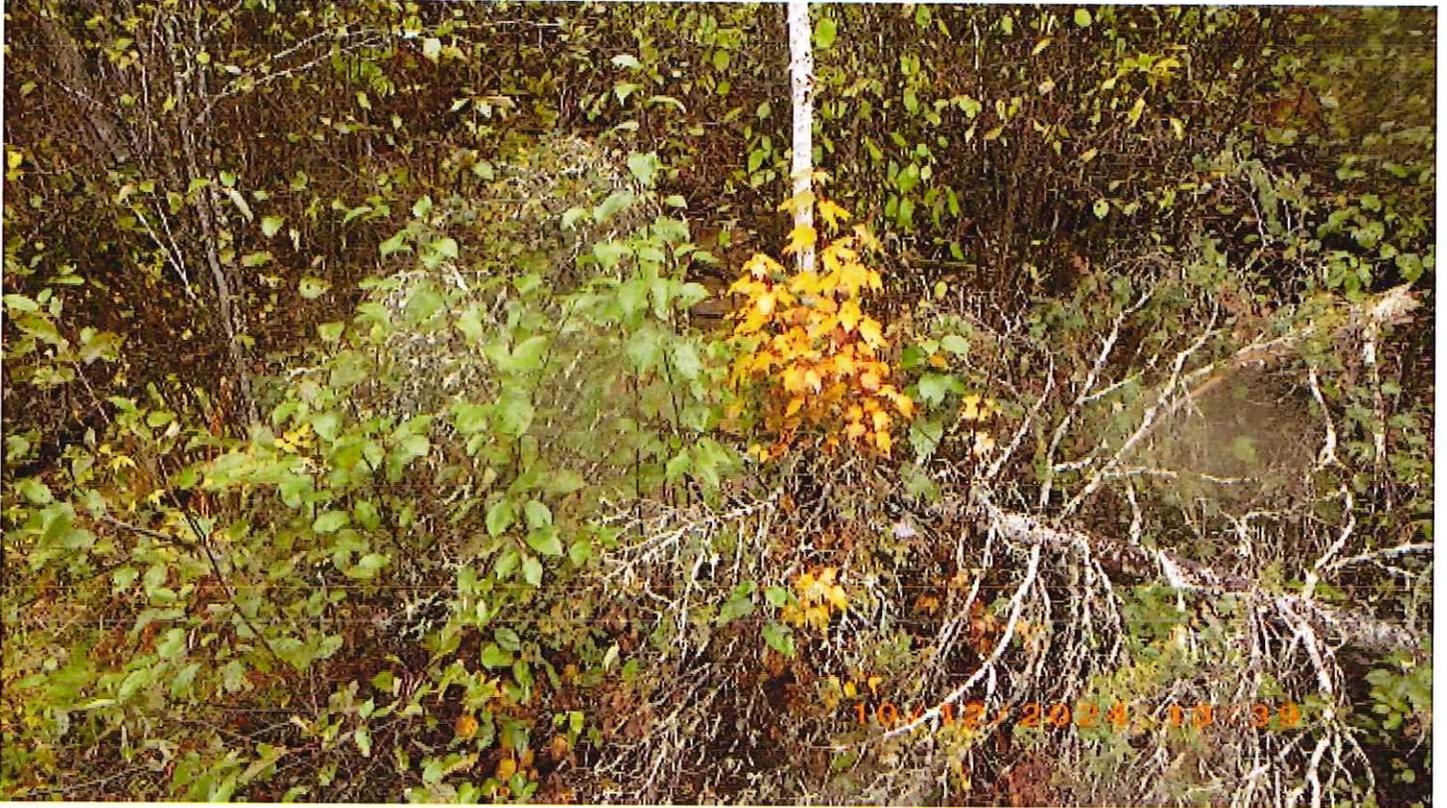
Channel looking downstream

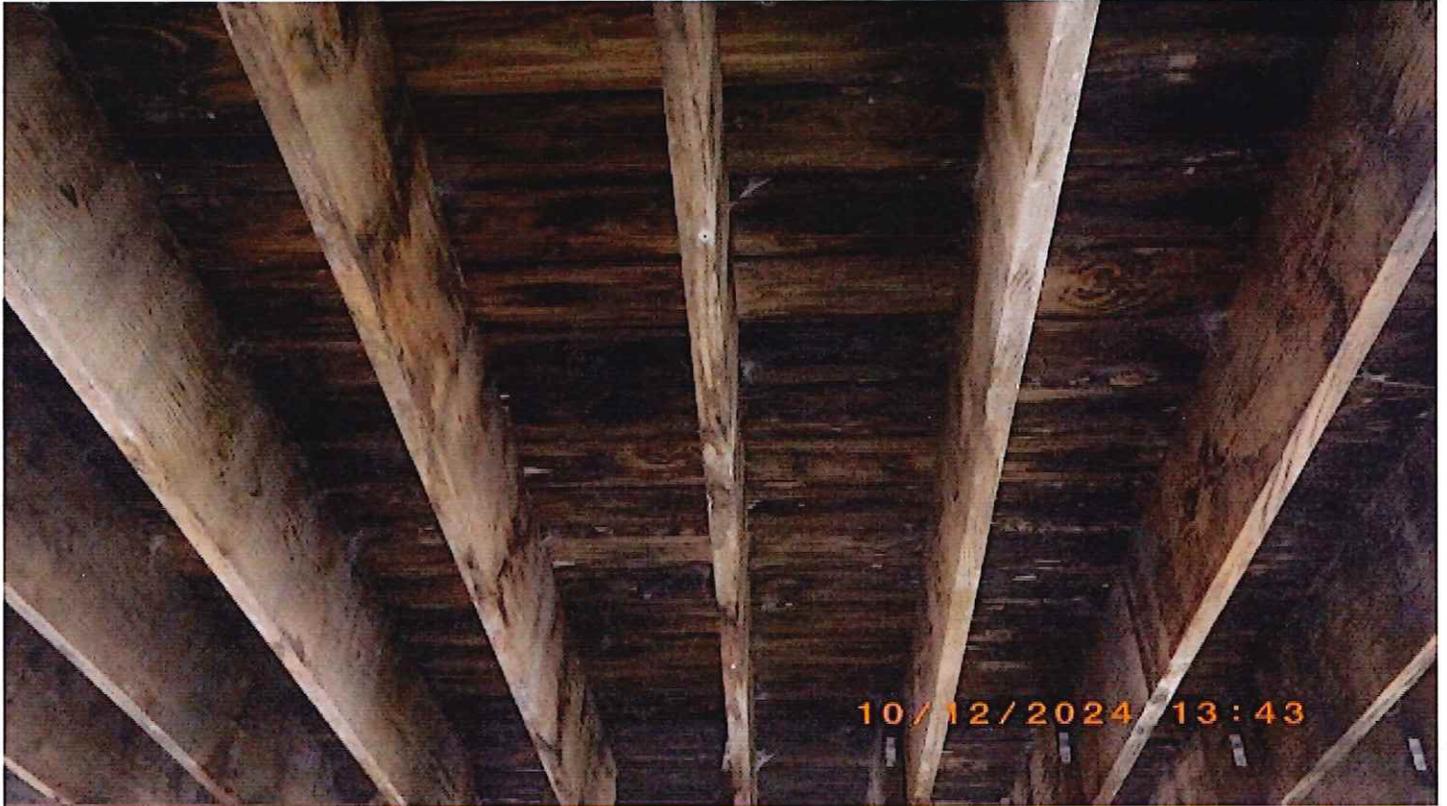
Decking has widespread CS3 black / white rot. No drainage under curbs.

Typical deck underside

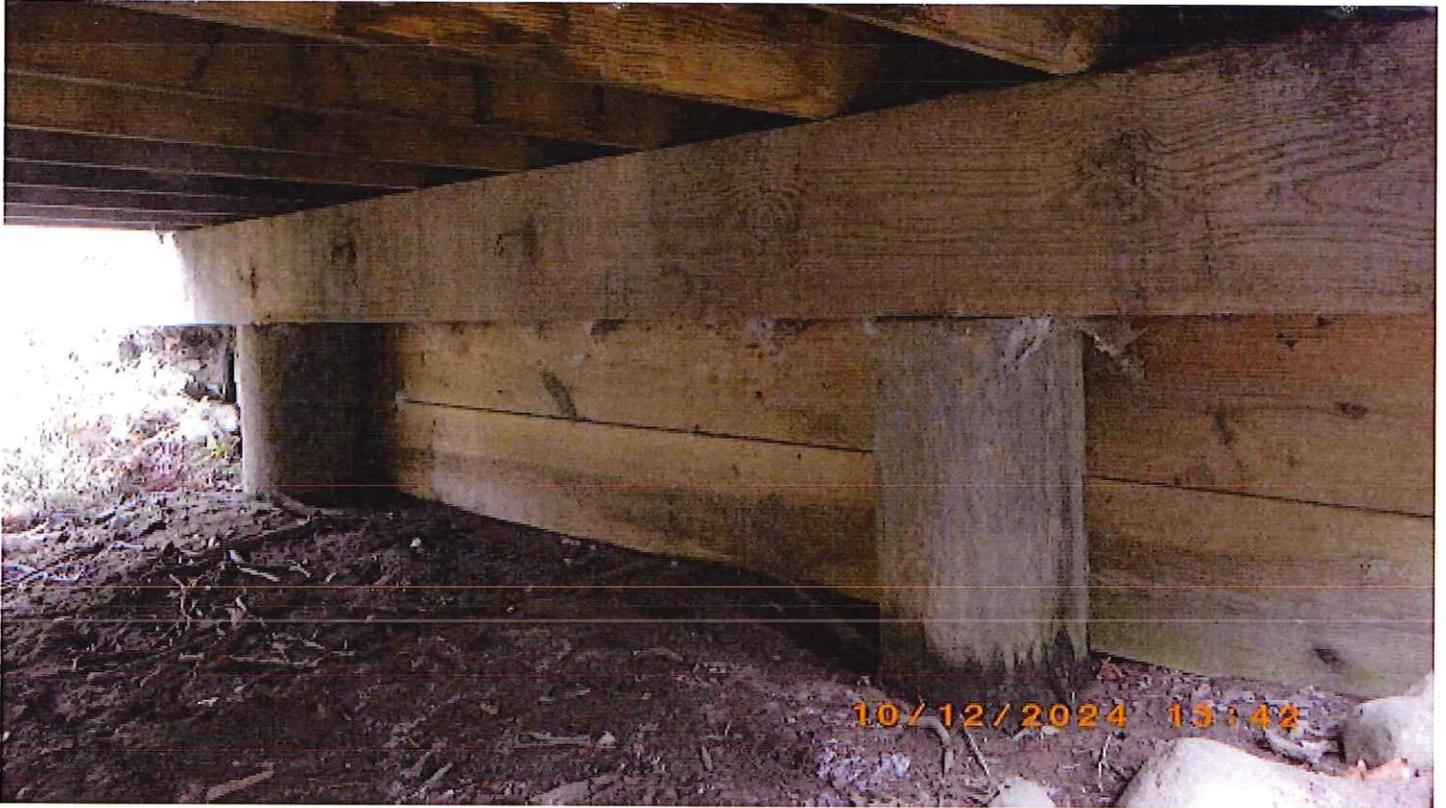
Abutments have slight undermining of backwalls, CS2. Piles and pile caps have some minor checking.

West abutment

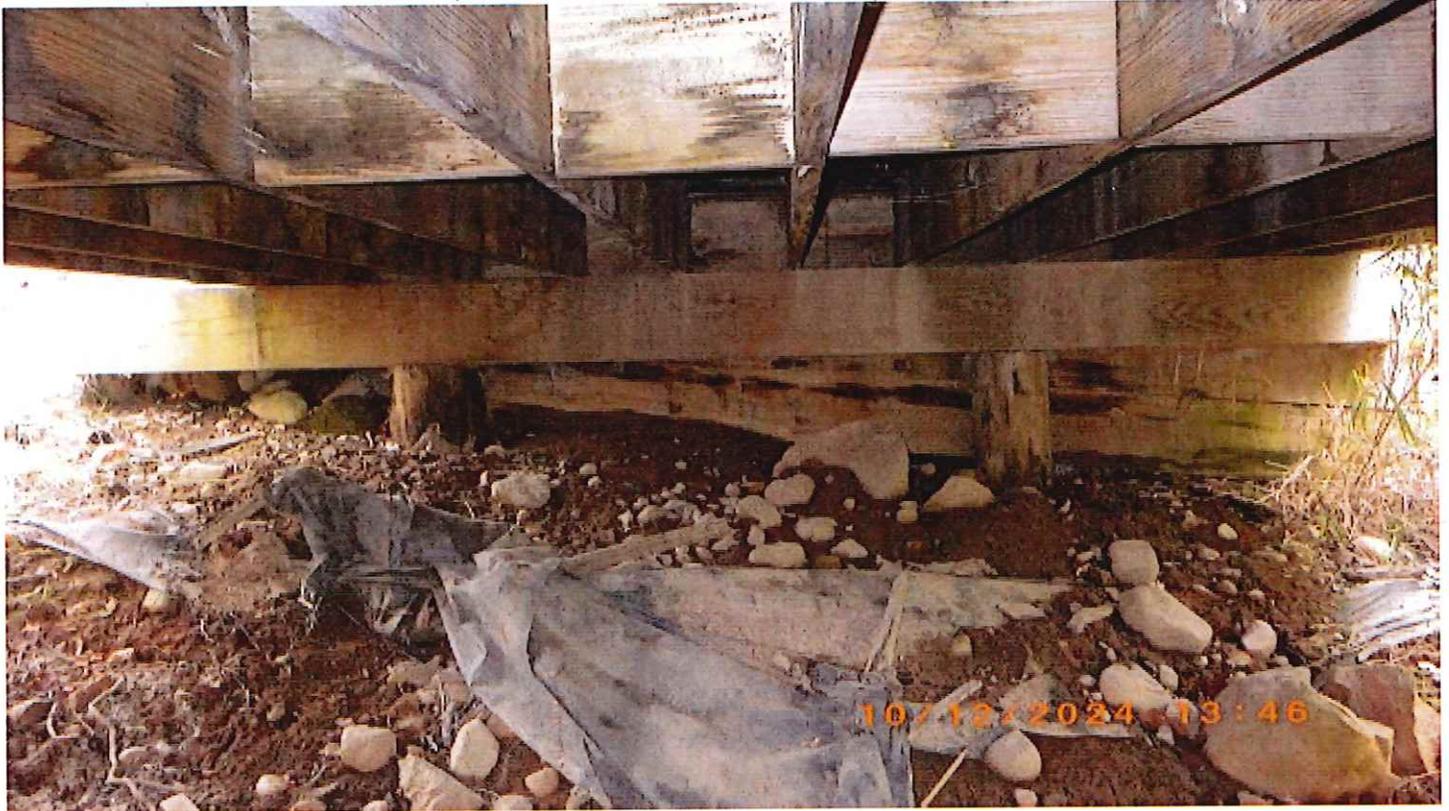
East abutment

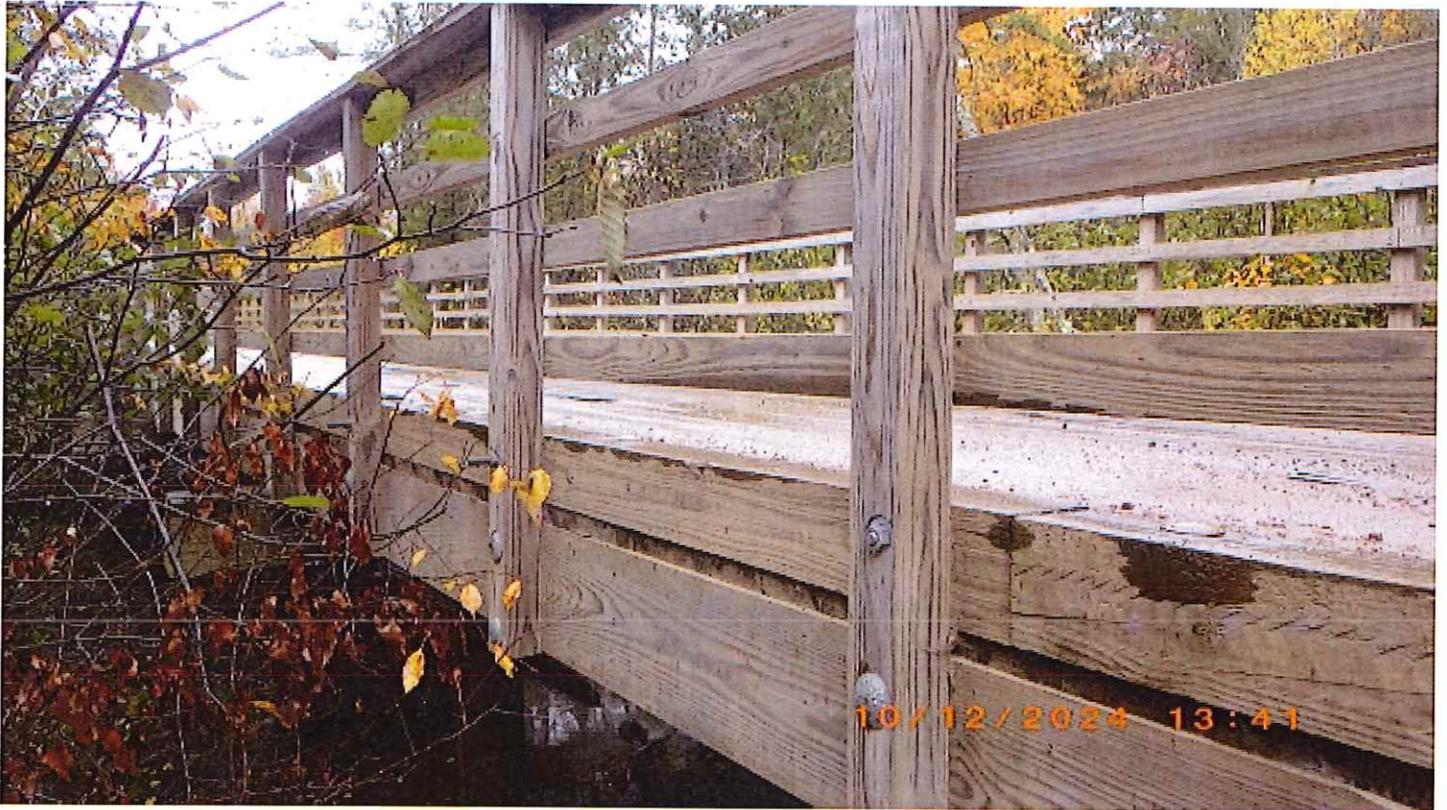
Stringers have widespread black mold staining, sounded solid, but will begin to rot soon, CS2.

Upstream elevation view

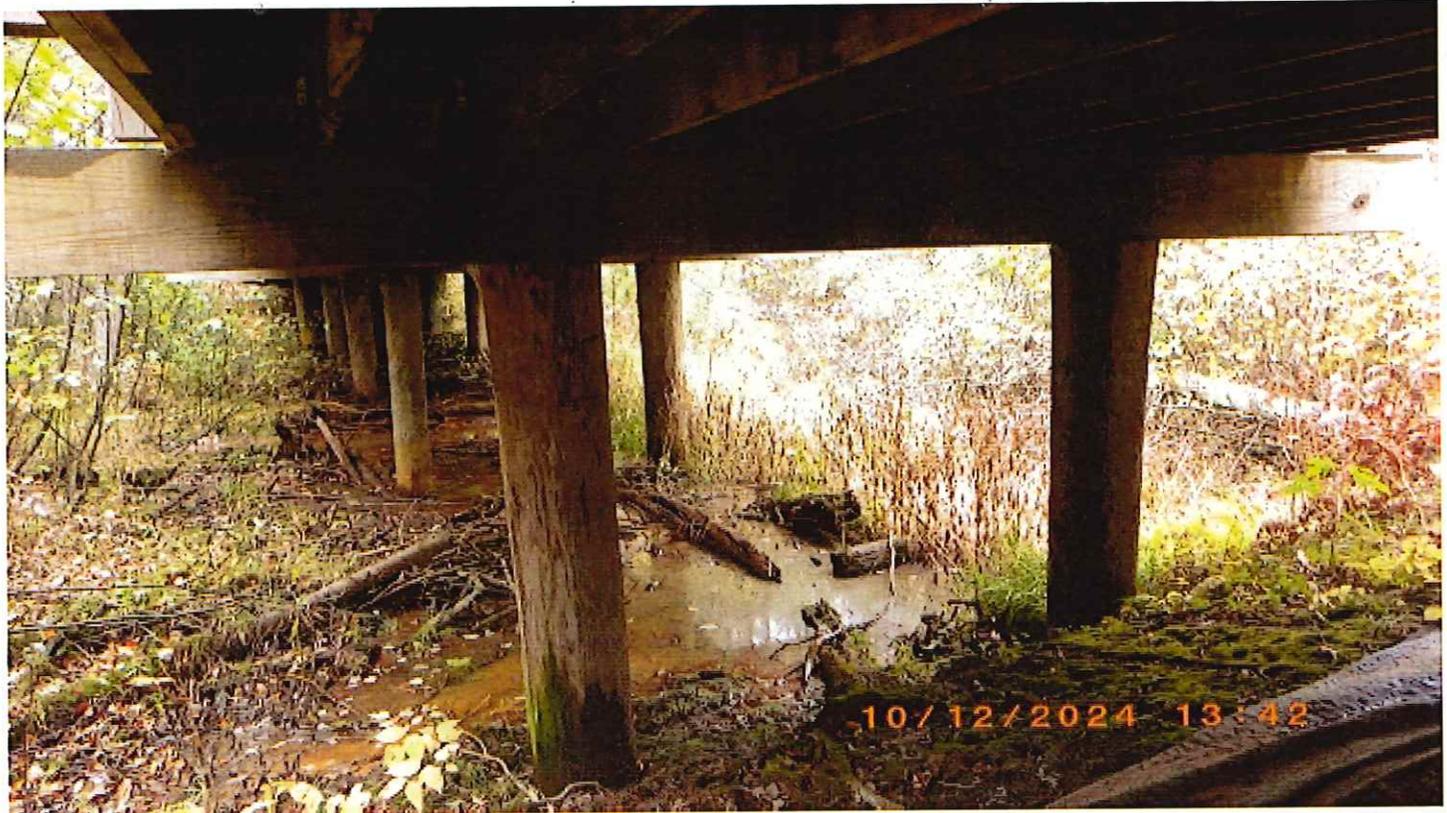
Typical pier elevation view

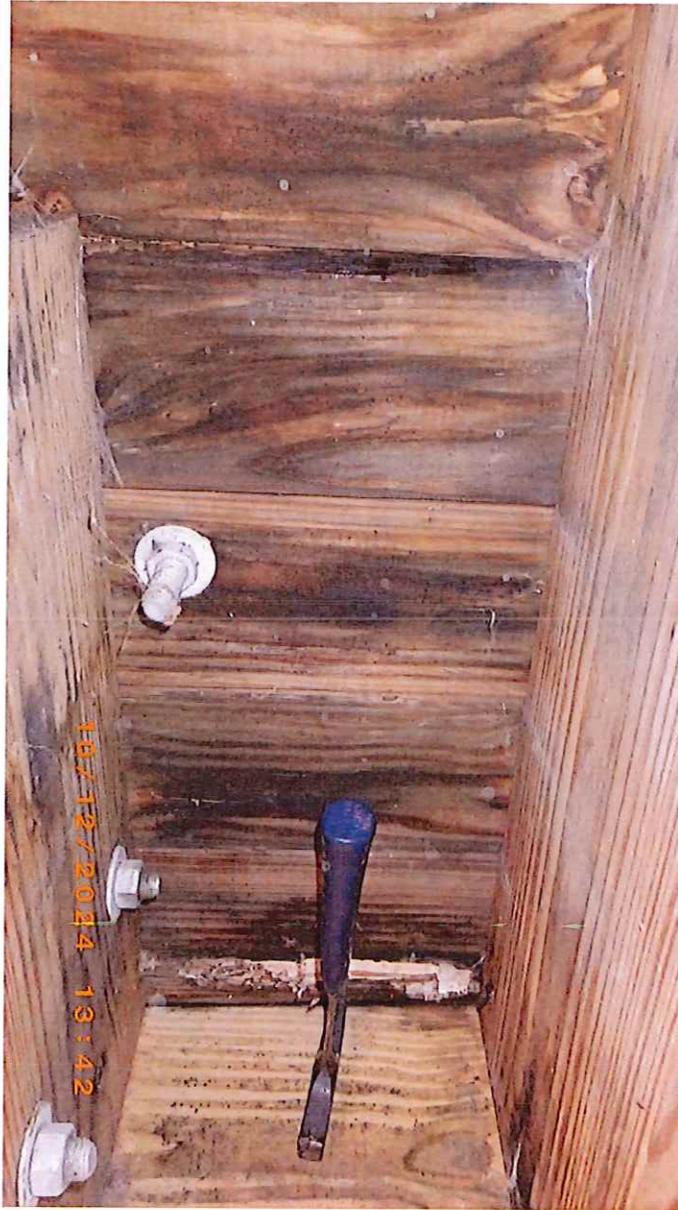
Rotten deck planks

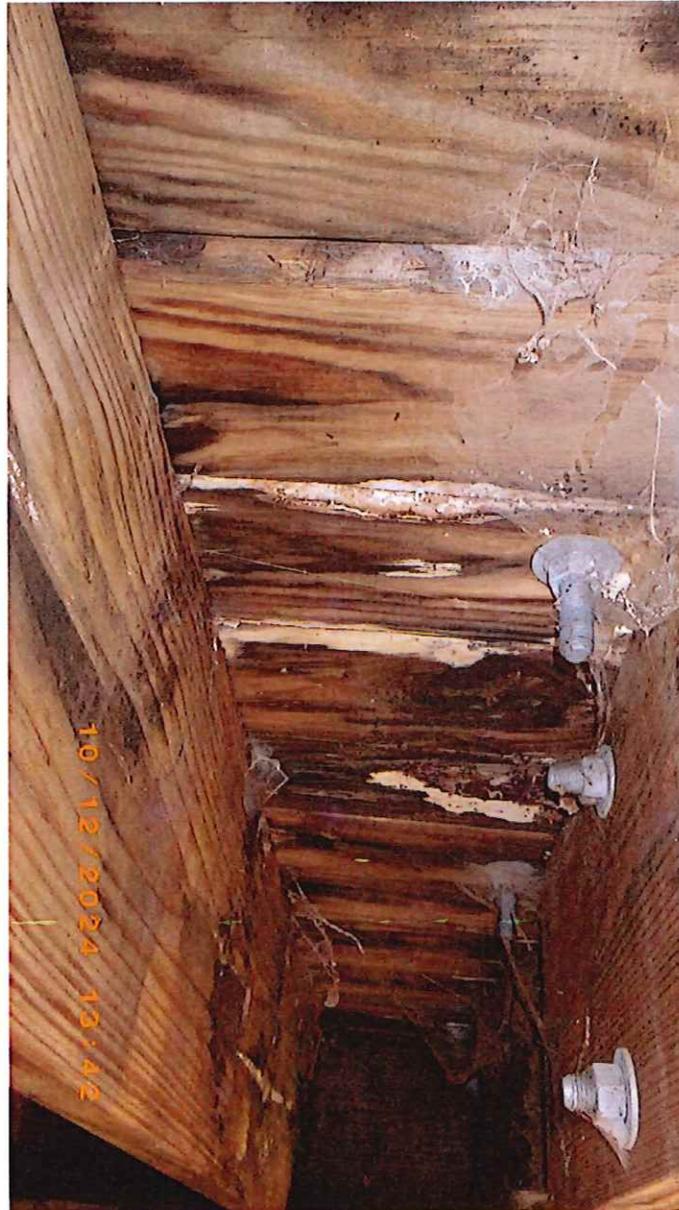
Rotten deck planks

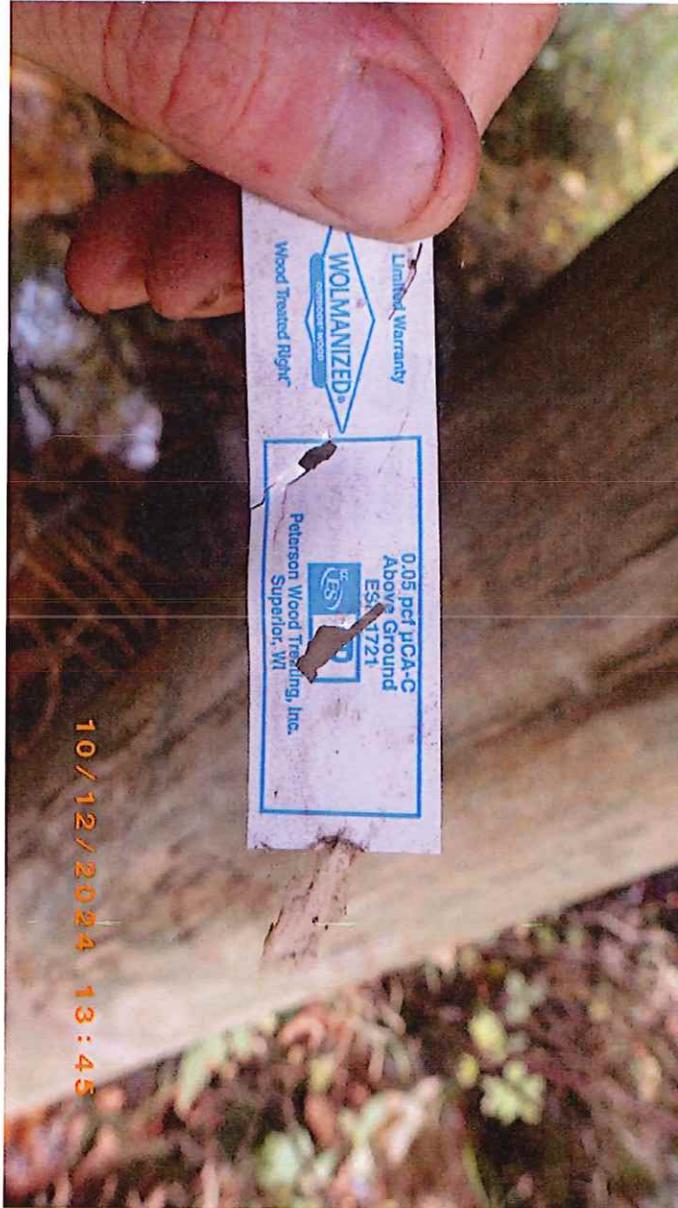
Preservative tag Copper Azole, 0.05 pcf above ground (insufficient treatment for high humidity bridge use)

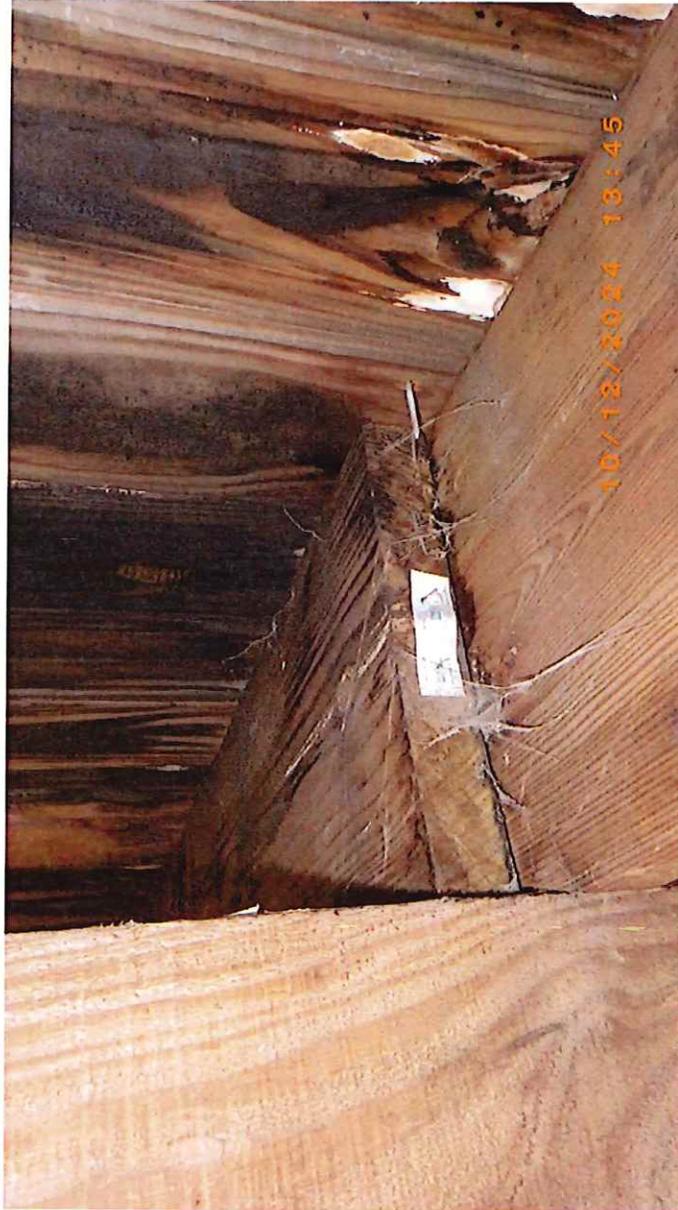
tag location on stringer
