A-17 Lincoln Co Hilts Lake Bridge Rehab

Motorized Recreation Grant Application

# Trail Bridge Inspection Lincoln County

### **Bridge Inspection Report**

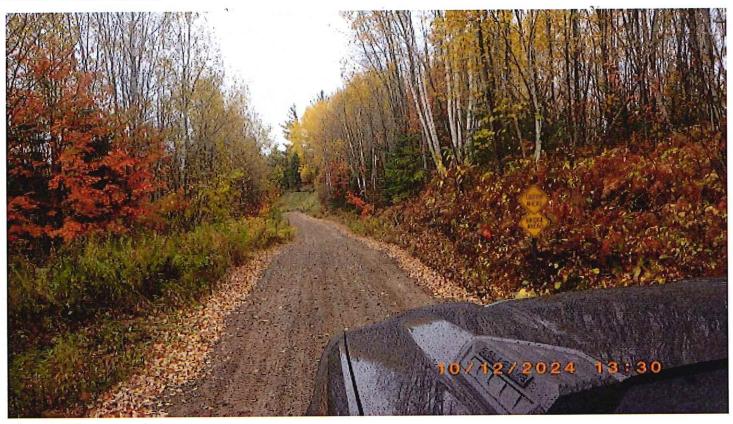
West bridge ahead sign

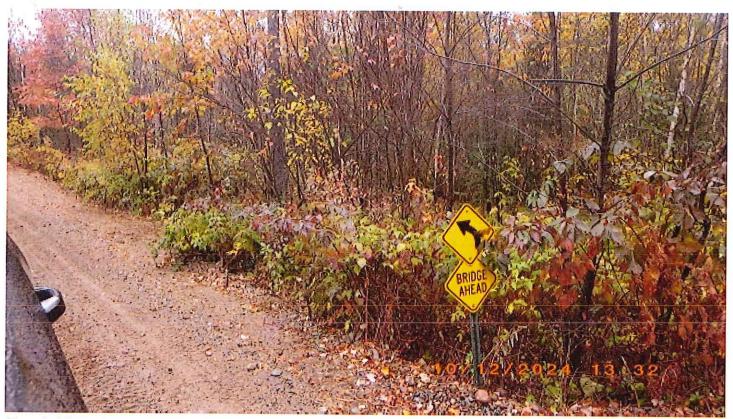
East bridge ahead sign

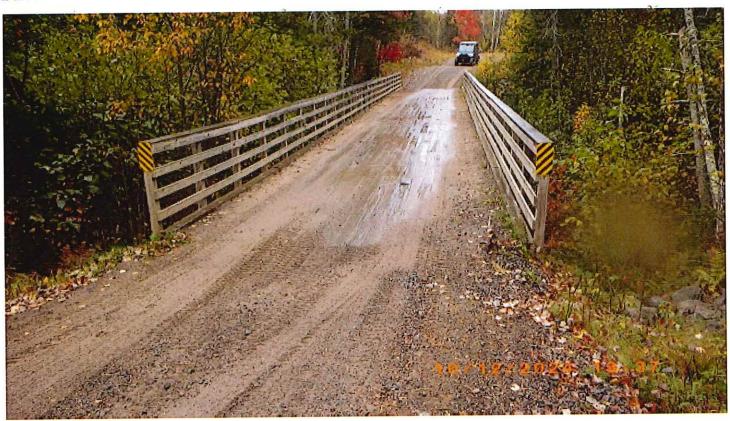
West approach

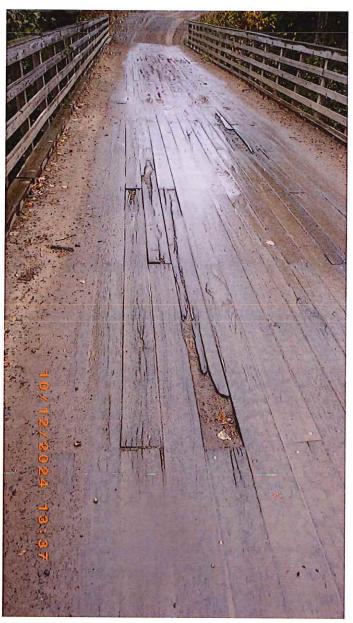
Wearing surface has CS3 wear at center and scattered sections that are CS4, completely rotten or gone. Edges are gravel covered.

Top of deck

Replace entire deck / wearing surface

Clean deck

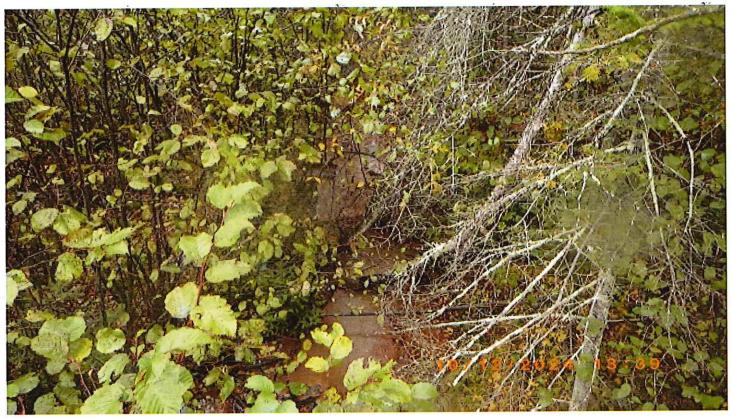
Channel looking upstream

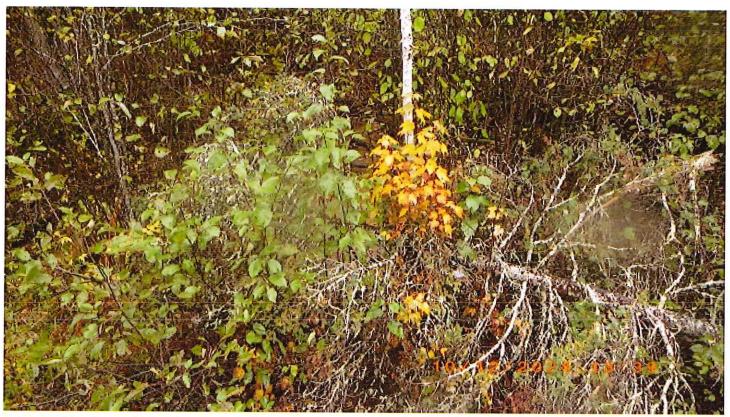
Channel is in good condition. There is a tree over the stream downstream.

Channel looking downstream

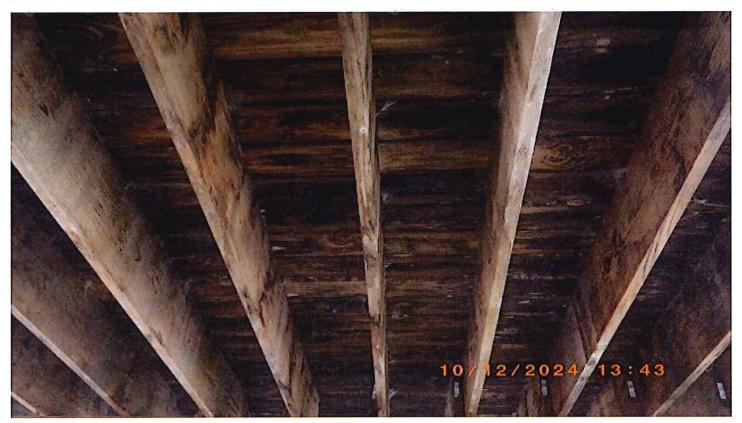
Decking has widespread CS3 black / white rot. No drainage under curbs.

Typical deck underside

Add scupper blocks under curbs for drainage

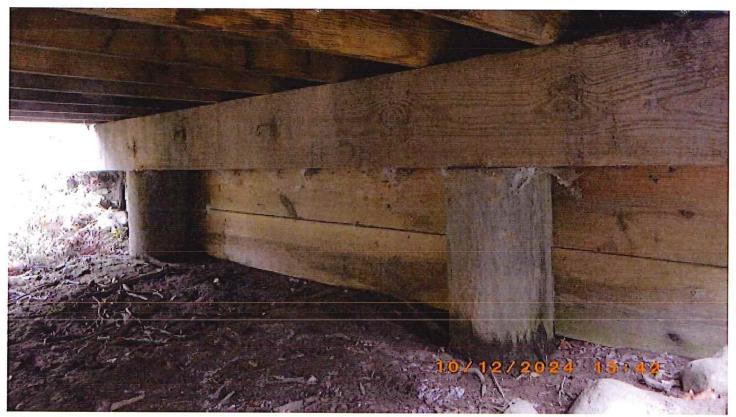
Abutments have slight undermining of backwalls, CS2. Piles and pile caps have some minor checking.

West abutment

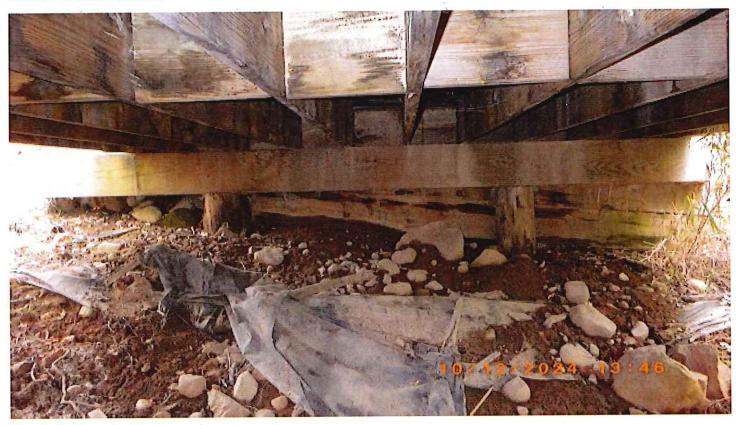
East abutment

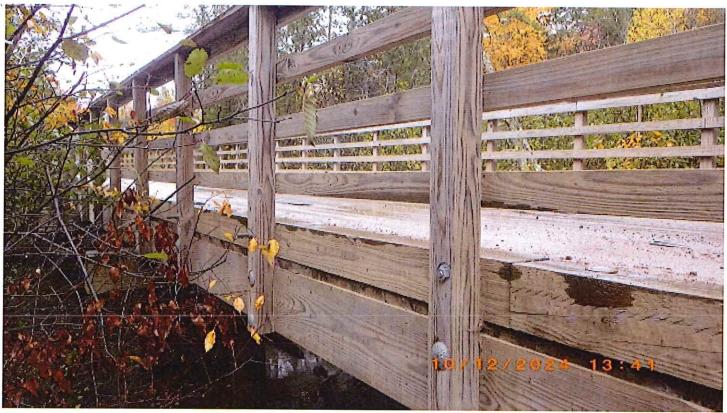
Upstream elevation view

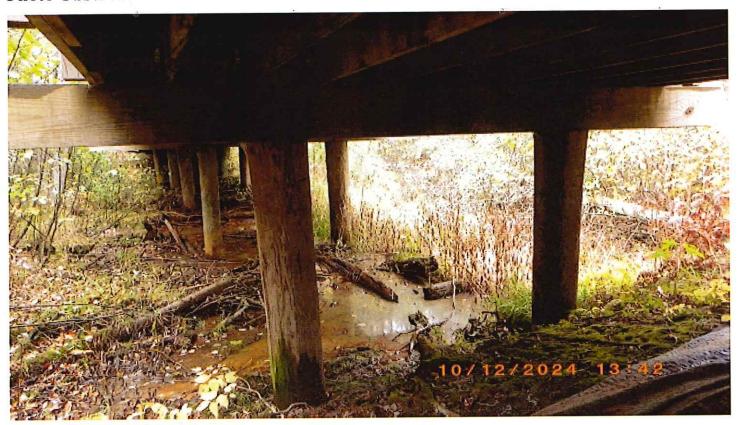
Typical pier elevation view

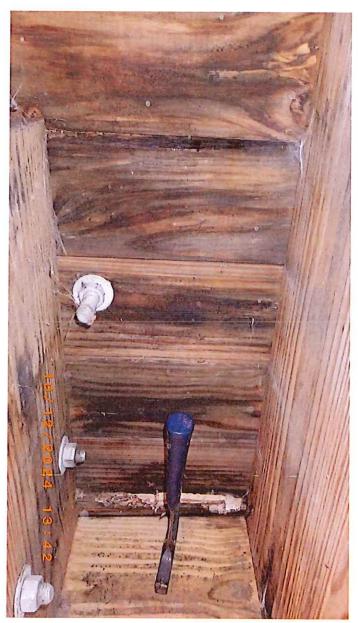
Rotten deck planks

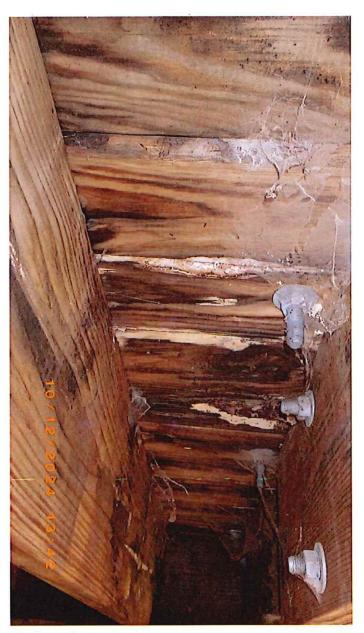
Rotten deck planks

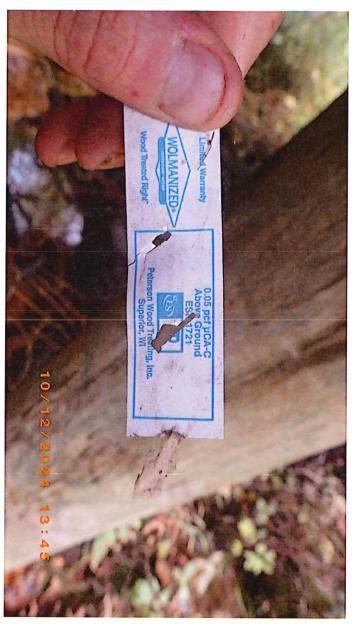
Preservative tag Copper Azole, 0.05 pcf above ground (insufficient treatment for high humidity bridge use)

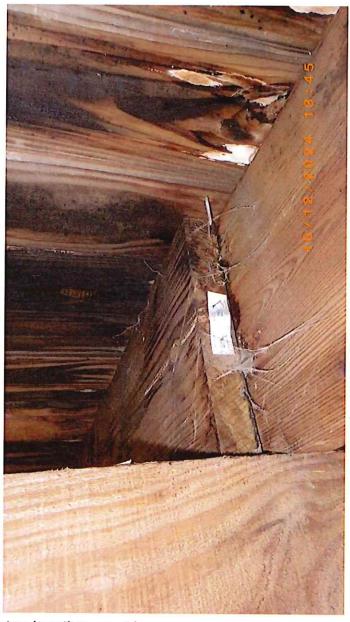
Stringers have widespread black mold staining, sounded solid, but will begin to rot soon, CS2.

tag location on stringer
