Motorized Recreation Grant Application

Project Title Langlade County Bridge 6 Rehab					Current Funded Miles	New Miles (if applicable)
County Langlade	Township 34 N	Range 10	Section 20	¼ ¼ <input checked="" type="radio"/> E <input type="radio"/> W	¼	GPS Coordinates: Lat. 45.4241 Long. -89.26847

Trail Bridge Inspection

Bridge #
6

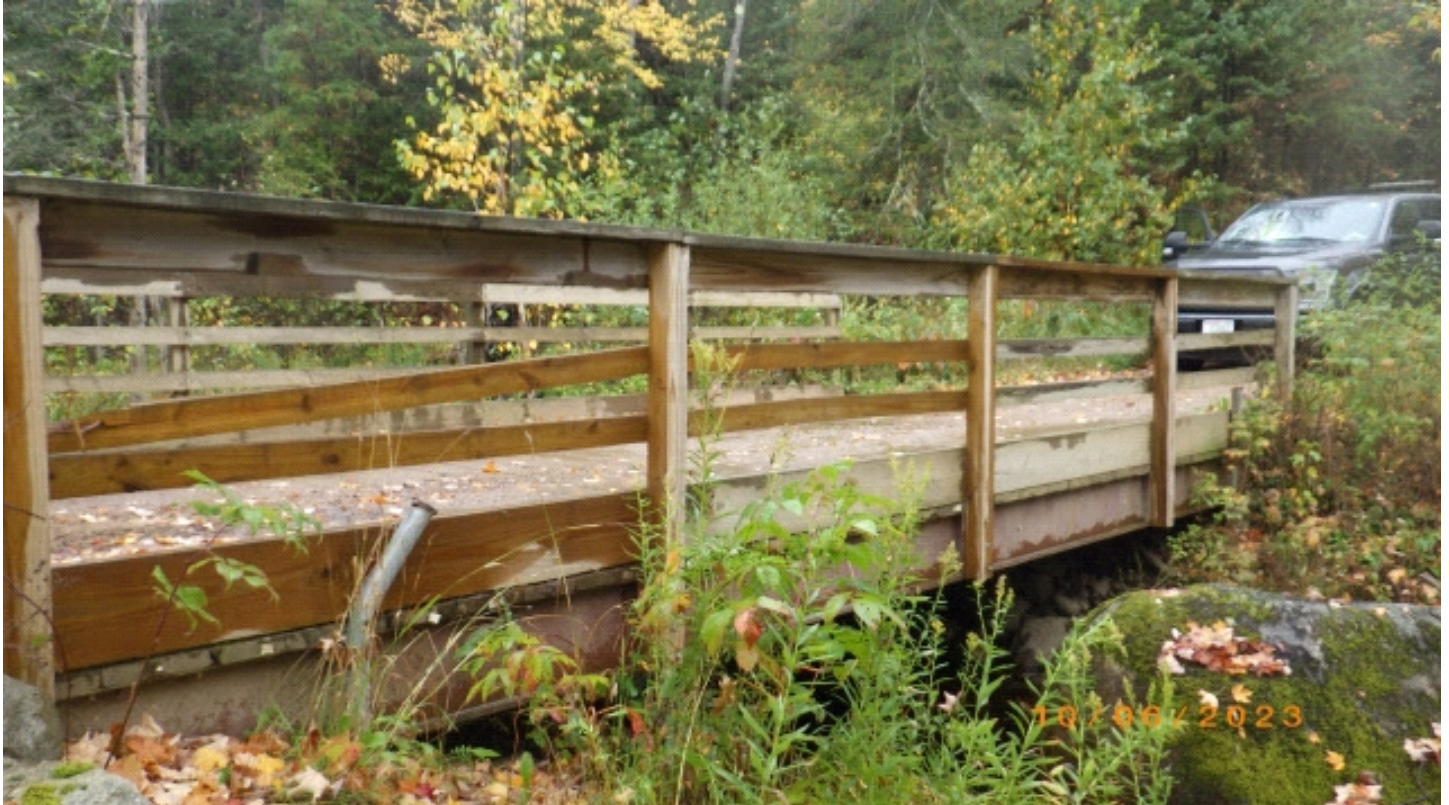
Railing has 8 LF of damage, SE and SW corner.

Looking West, damaged railing.

Repair railing boards on SE and SW corners.

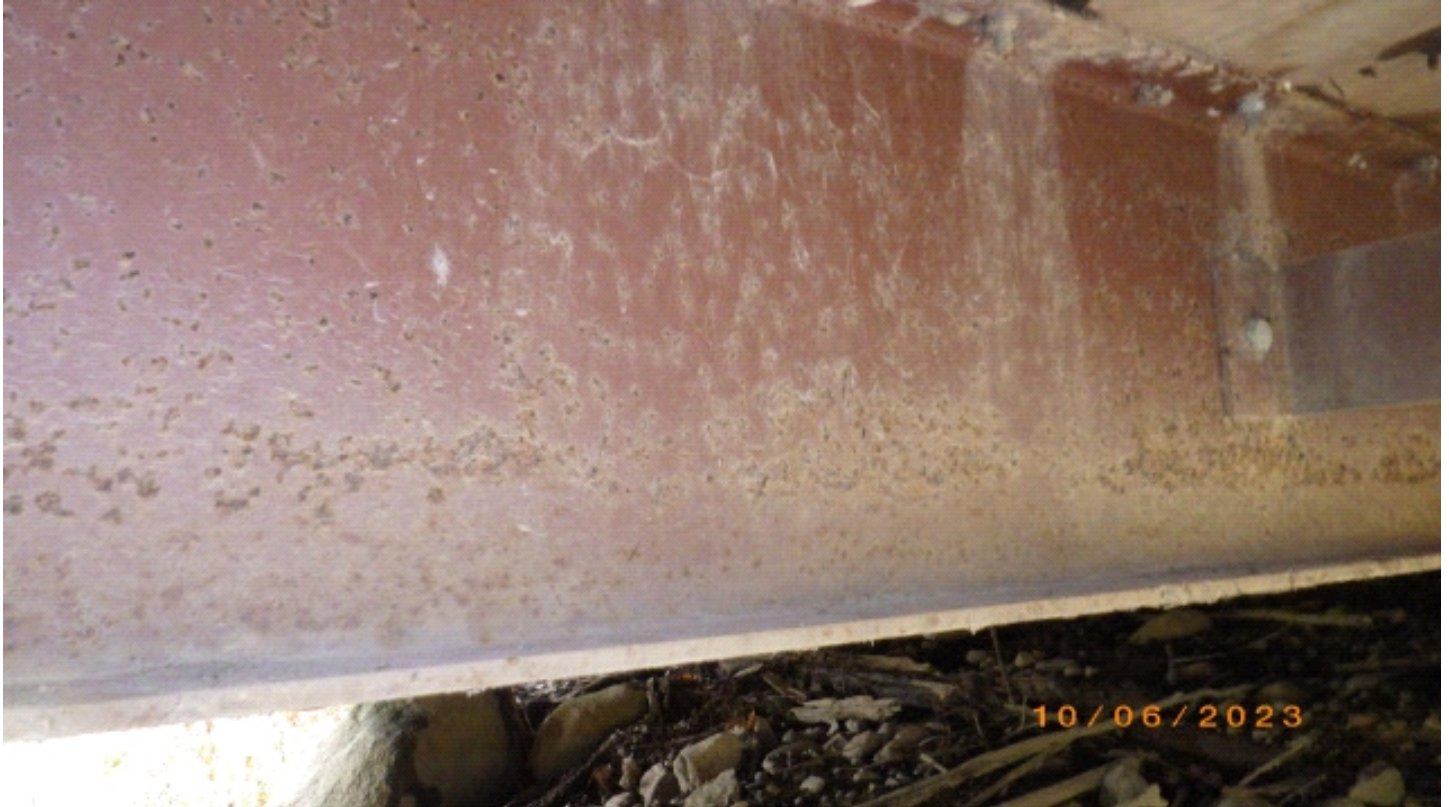
Girders have CS2 corrosion, minor rust.

CS2 corrosion, typ.

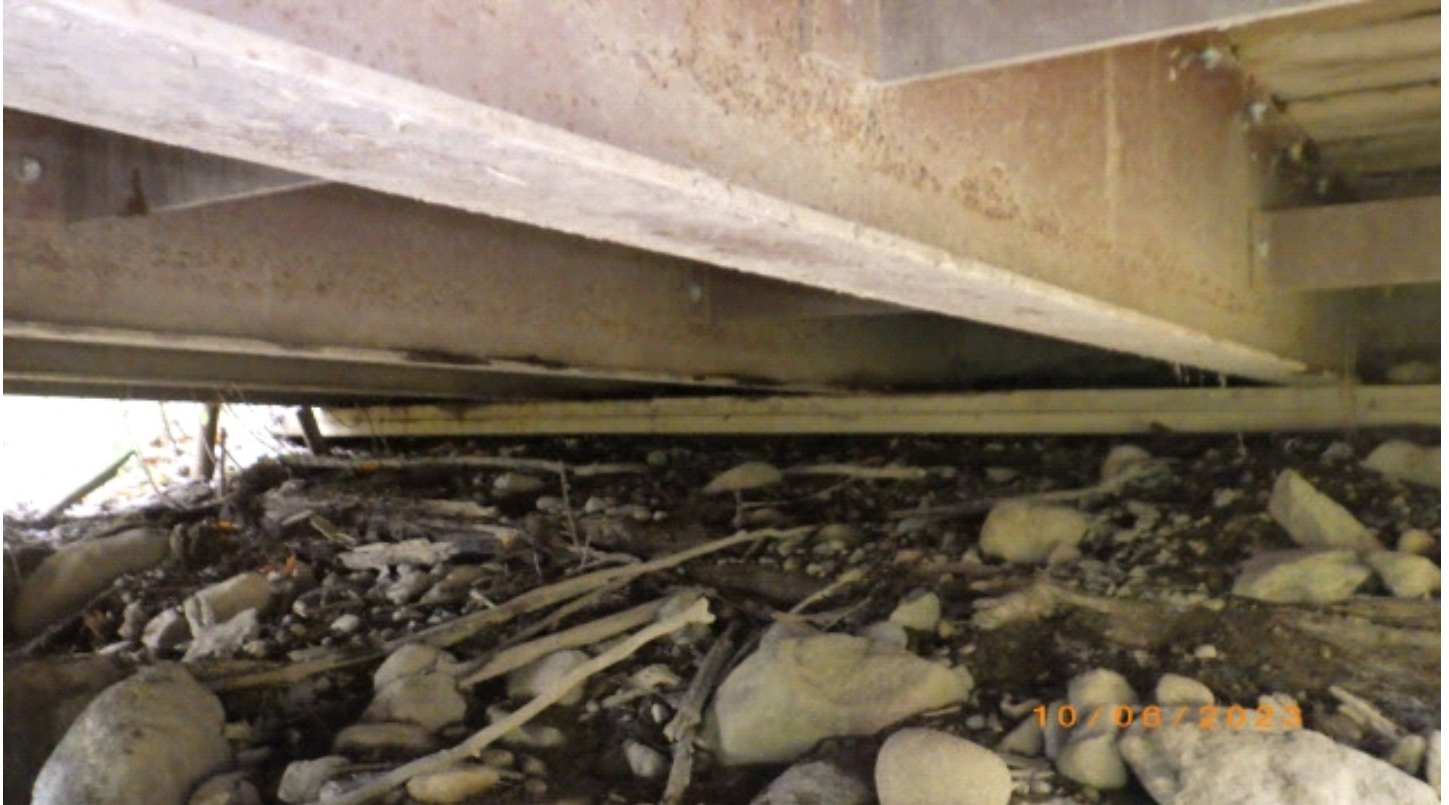
Abutments are twin timber planks forming a sill, good condition.

Stacked timber sill

Grout in the bottom of the sill plates on both abutments.

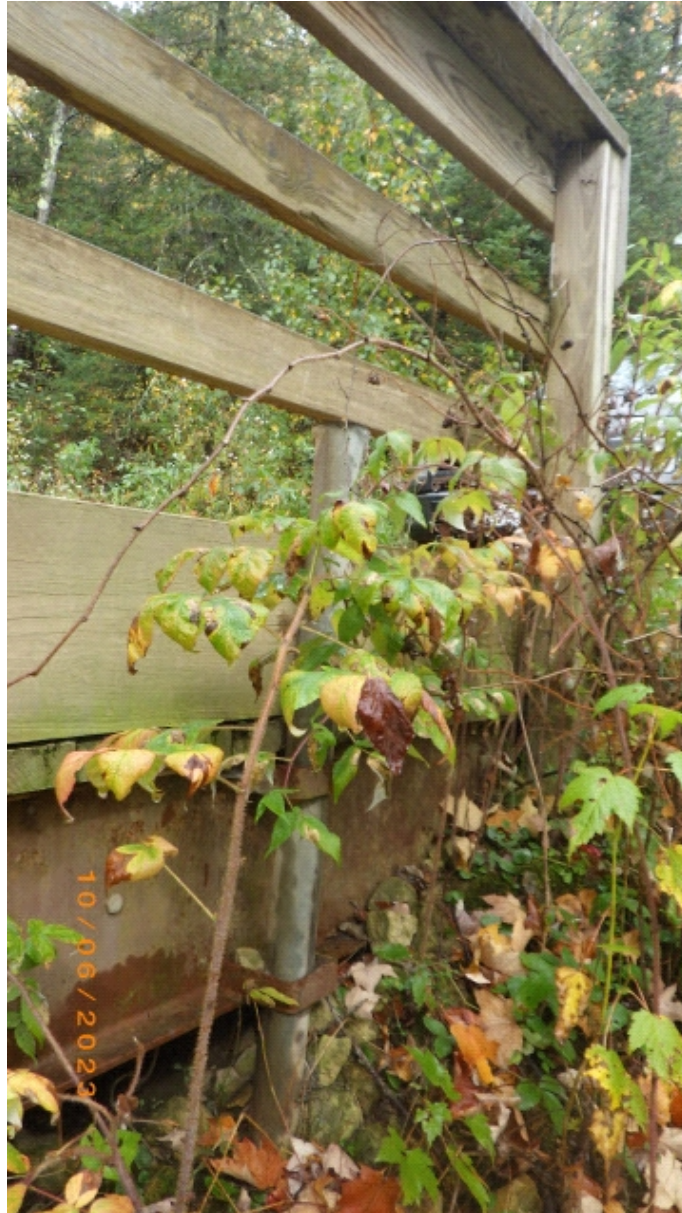
Steel post staking bridge in place, all 4 corners.

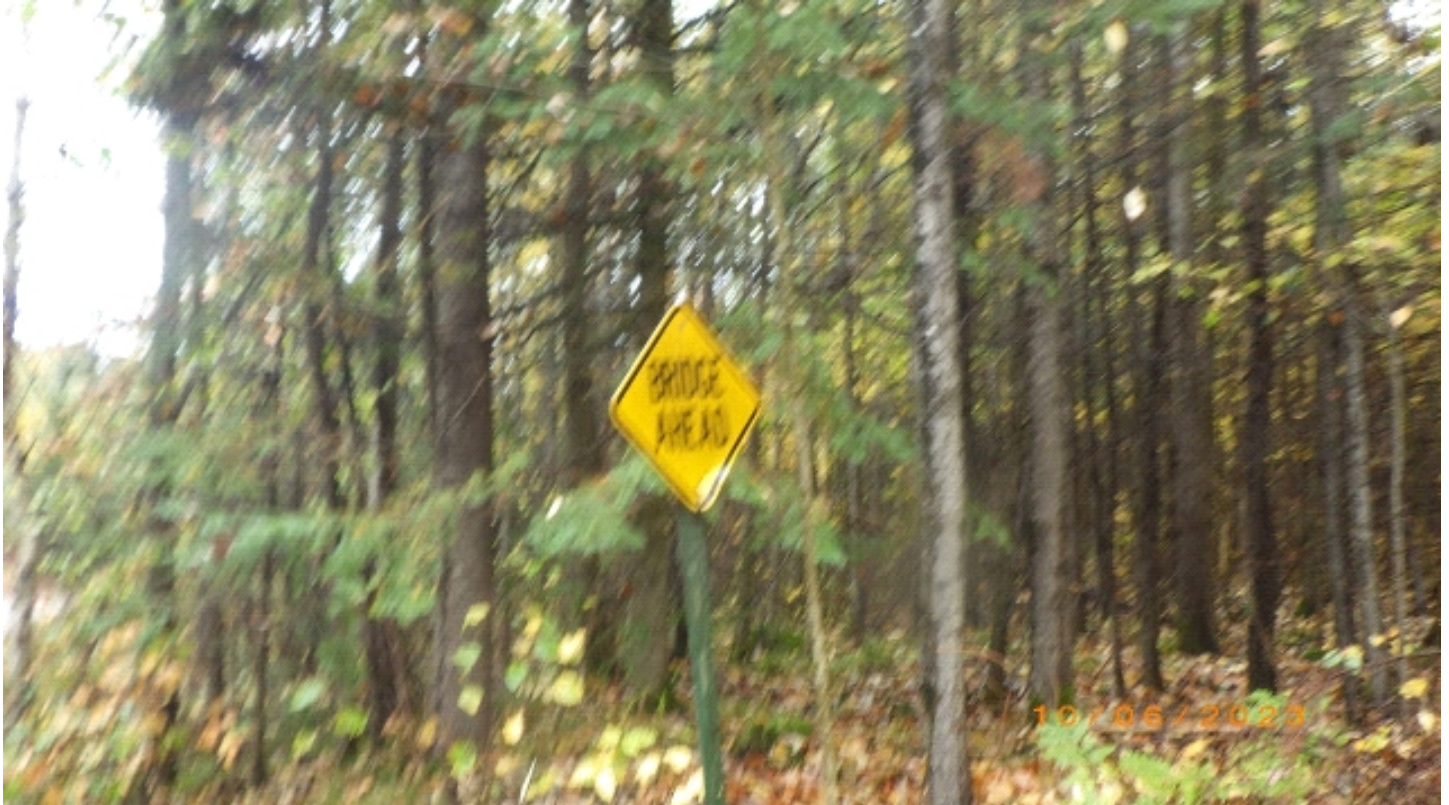
Both Bridge Ahead signs have minor damage.

North Bridge Ahead sign

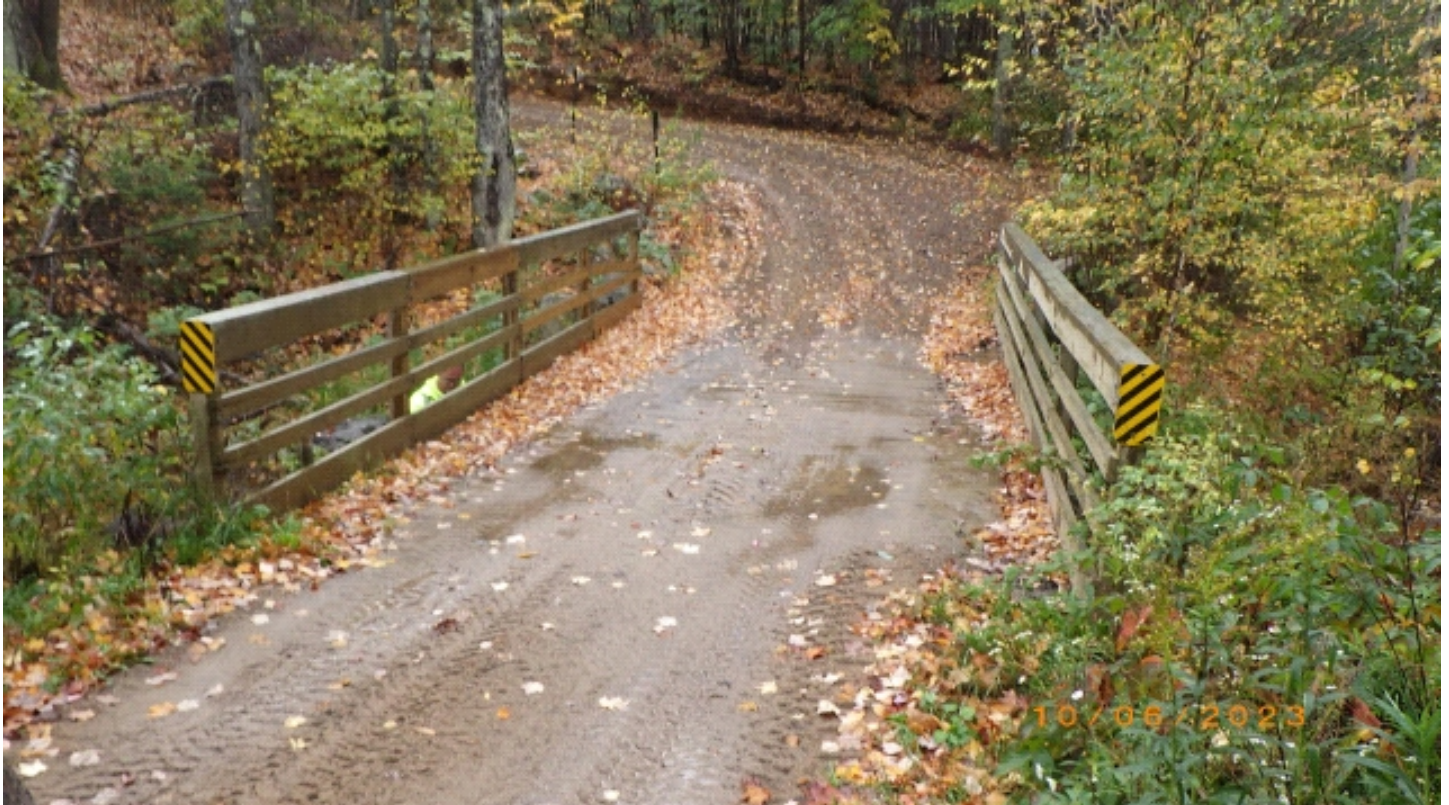
Looking South

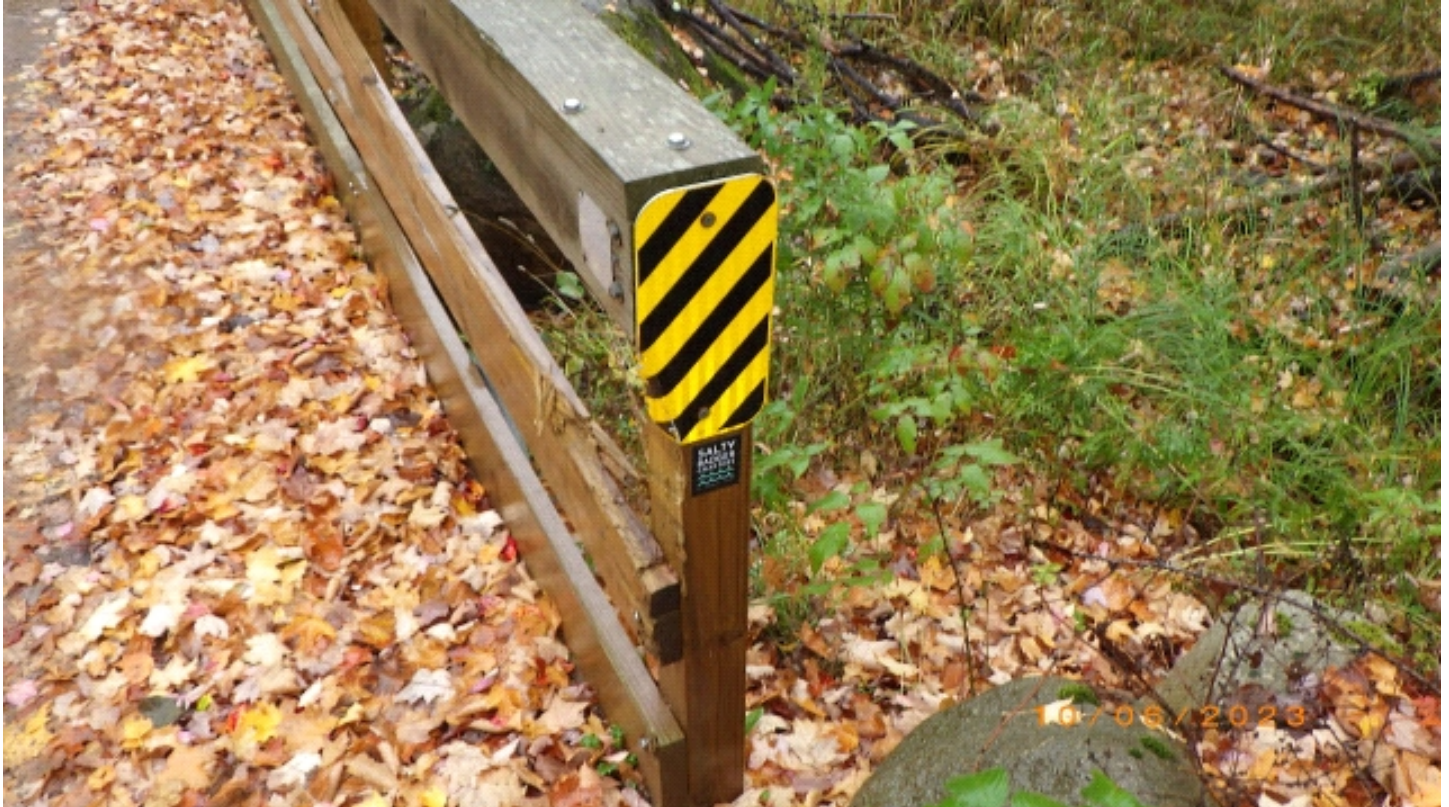
NW and SE object markers have minor damage.

SE C2 Object marker.

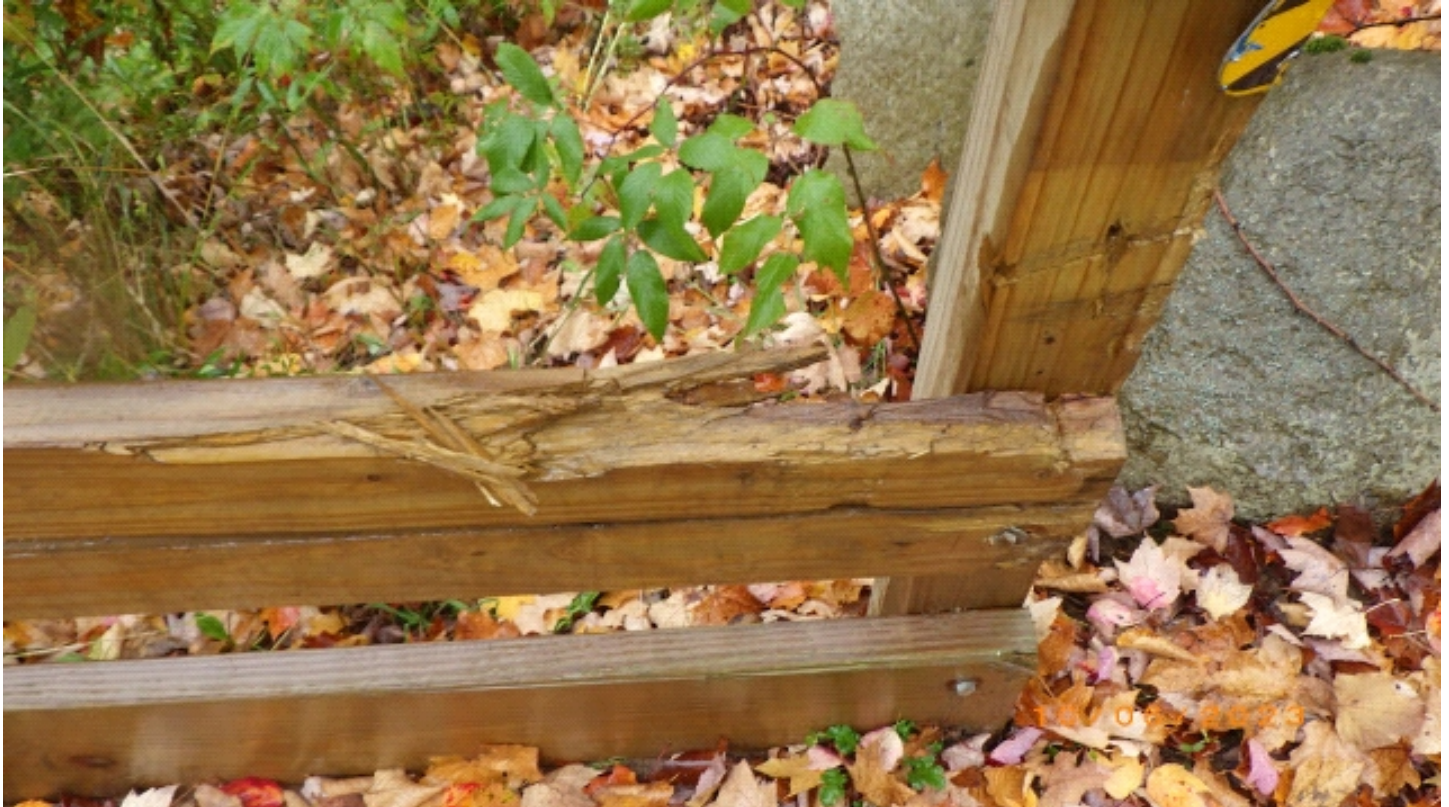
Damage railing.

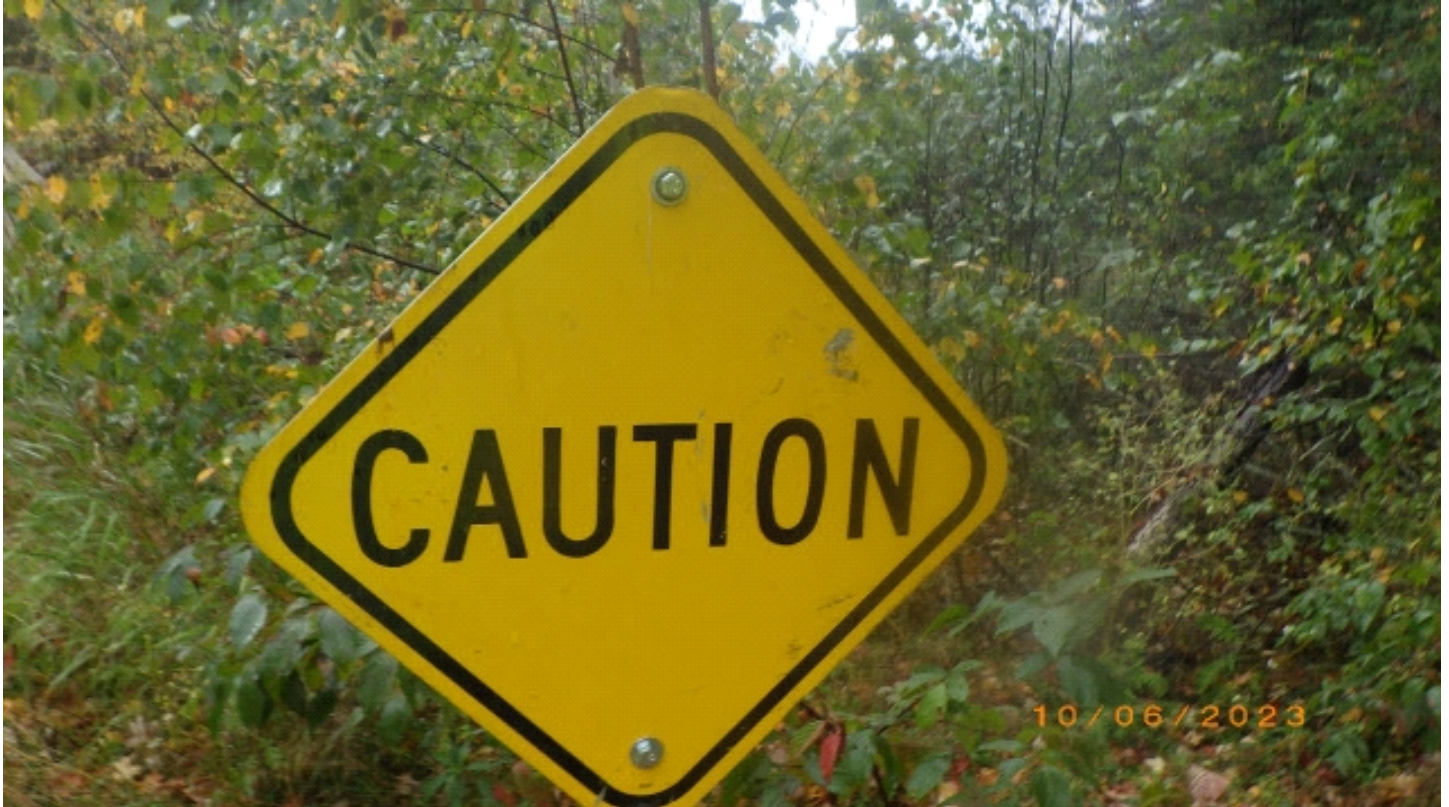
Both Caution signs have minor damage.

North Sign, minor damage.
