Motorized Recreation Grant Application

Project Title Dam 16 Crossing					Current Funded Miles 63.4 ATV, 376.2 SNO	New Miles (if applicable)
County Clark	Township 25 N	Range 4	Section 11	Section ¼ ¼	GPS Coordinates: Lat. 44.667912 Long. -90.831092

Structure Inspection Clark Country Trail Bridge

Inspection Date: March 25, 2026
Inspector: Colin Olson, P.E. Bridge Inspector No. 9770

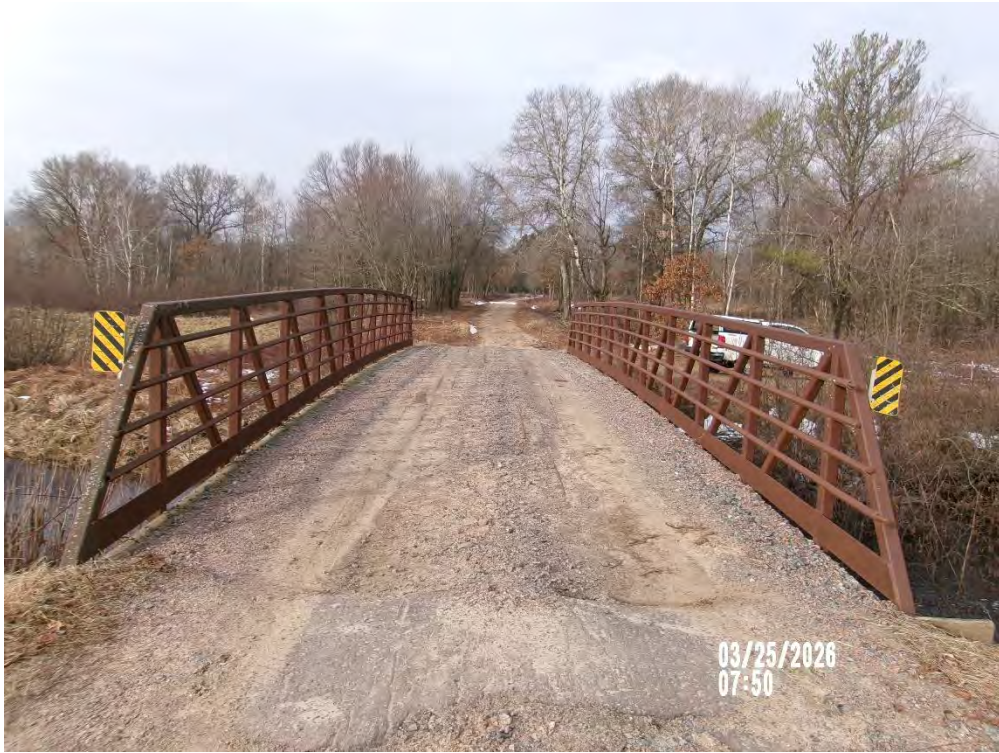
Figure 1 East Approach Looking West

Both approaches rough. East approach is 1 ¼” inches higher than the deck due to abutment settling. 1.5” drop off at the north wheel path.

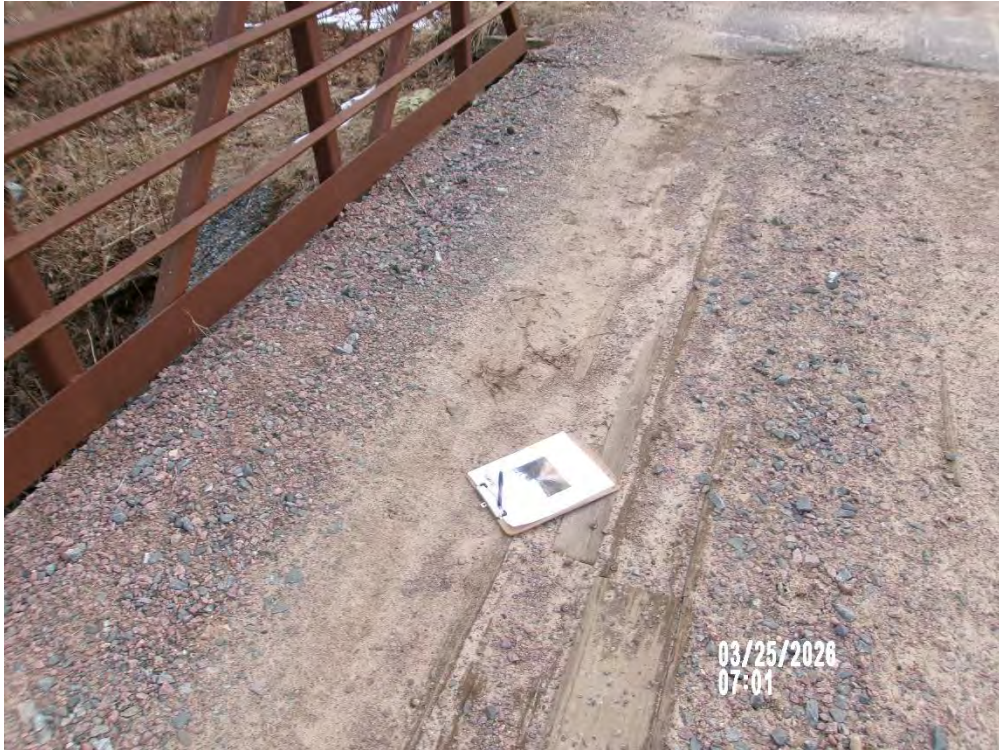
Satisfactory condition. Boards lightly worn. 14 SF of boards are warped and uneven. Gravel covering 30% of deck – mostly on the east side.

Figure 5: Wearing surface with gravel

- Replace uneven/warped deck boards

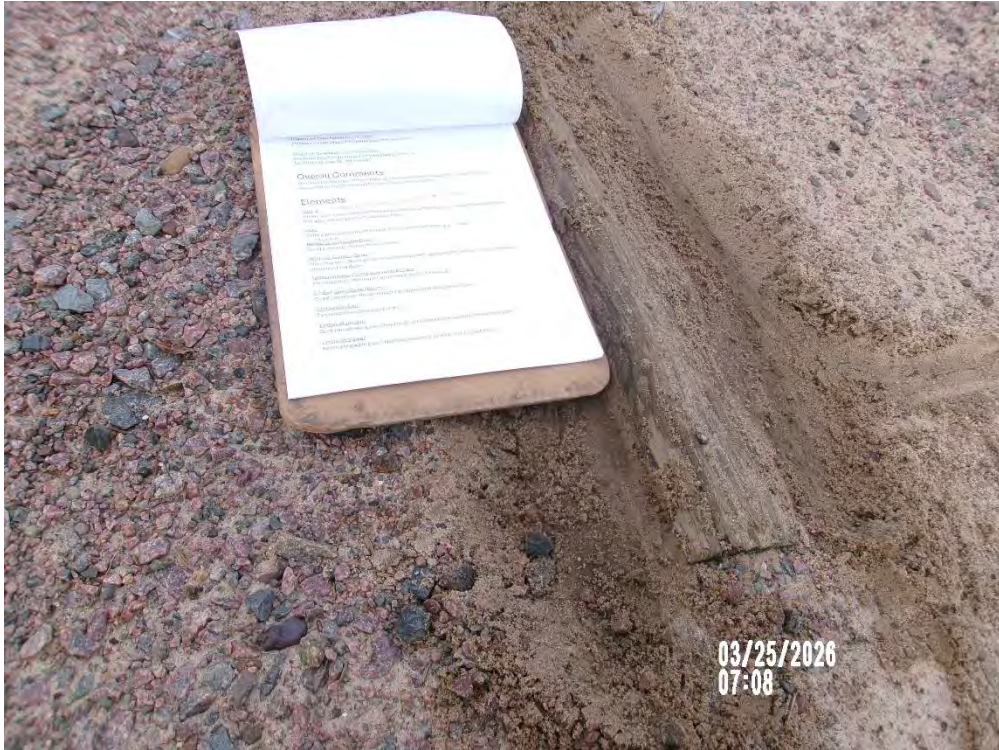
East abutment Poor condition – two timber blocks supporting truss. Timber in good condition. Plank under blocks has failed and is allowing the east end to settle. East

abutment has settled 1 ¼” measured from top of abutment backing to top of timber wearing surface in the north wheel path. North bearing of the east abutment undermined up to 2” deep, 12” wide, and 4” under.

Figure 7: Settlement at East Abutment

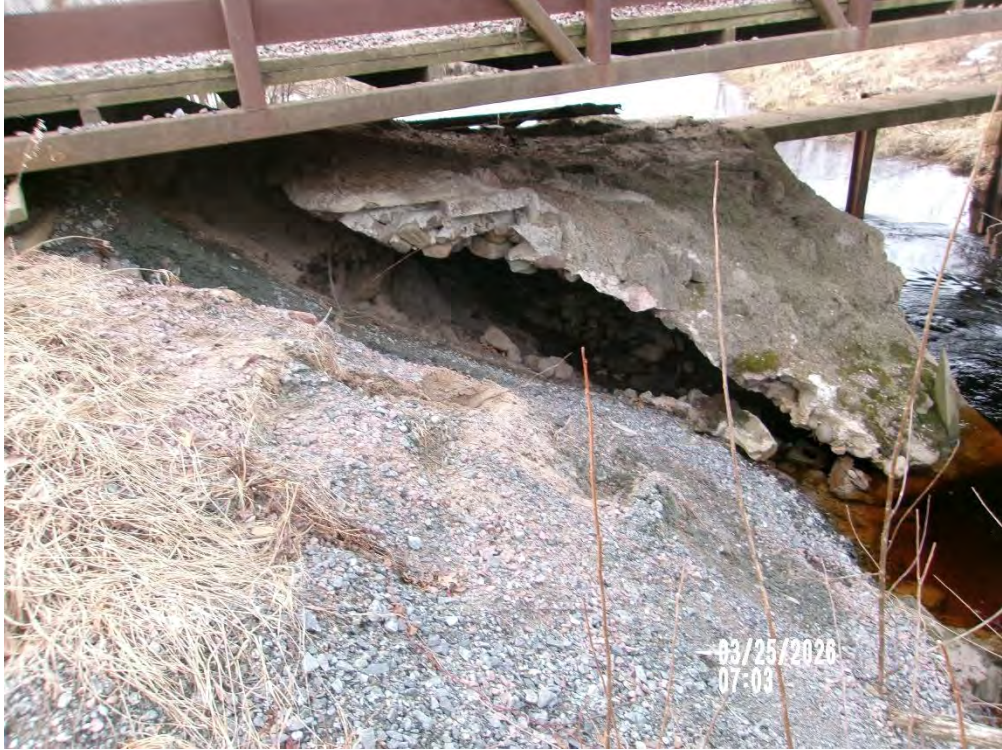
Grouted riprap at east is undermined completely. Only in contact with top of slope near abutment, the upstream side concrete, and the streamside concrete – void is 11’ under the grouted riprap, 2’ deep, 10’ wide (along slope). Grouted riprap at west has undermined 3’ under, 2’ deep, and 10’ (along slope)

Figure 9: East slope protection undermining

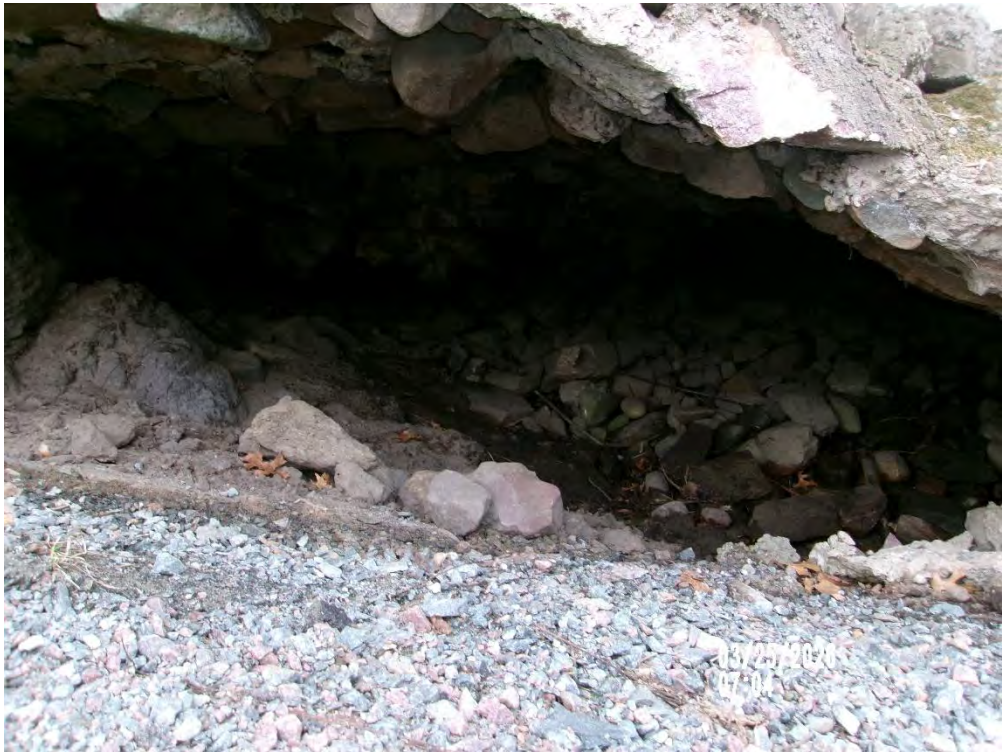
Figure 10: East slope protection undermining

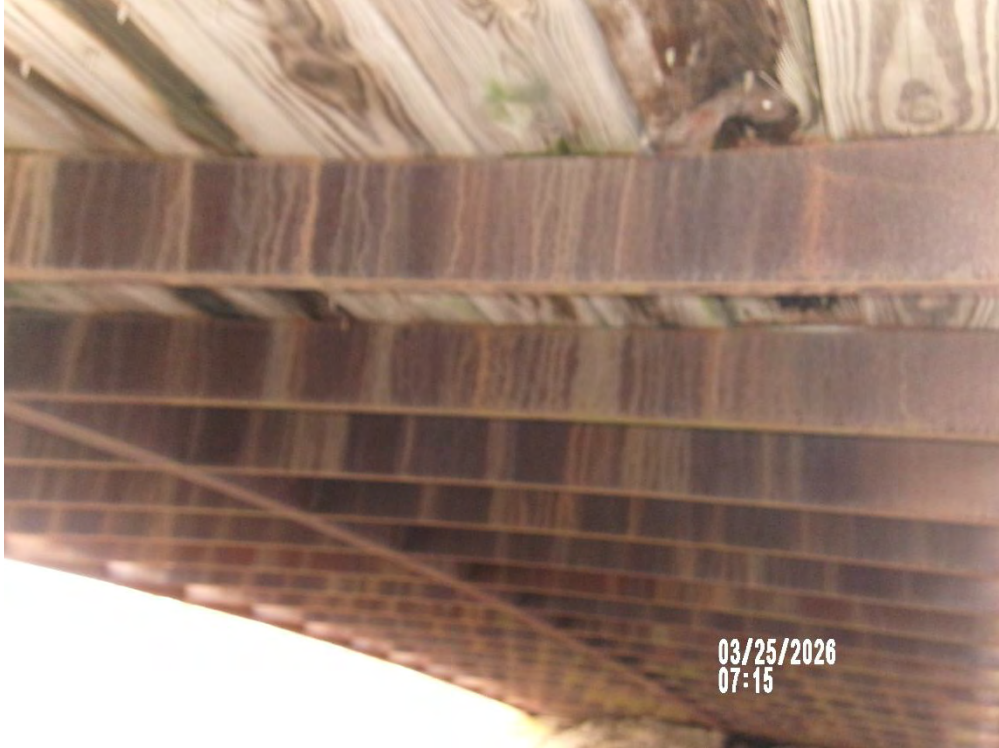
Good Condition. All surfaces have minor surface rust consistent with weathering steel this age.

Figure 11: Typical floor beam condition

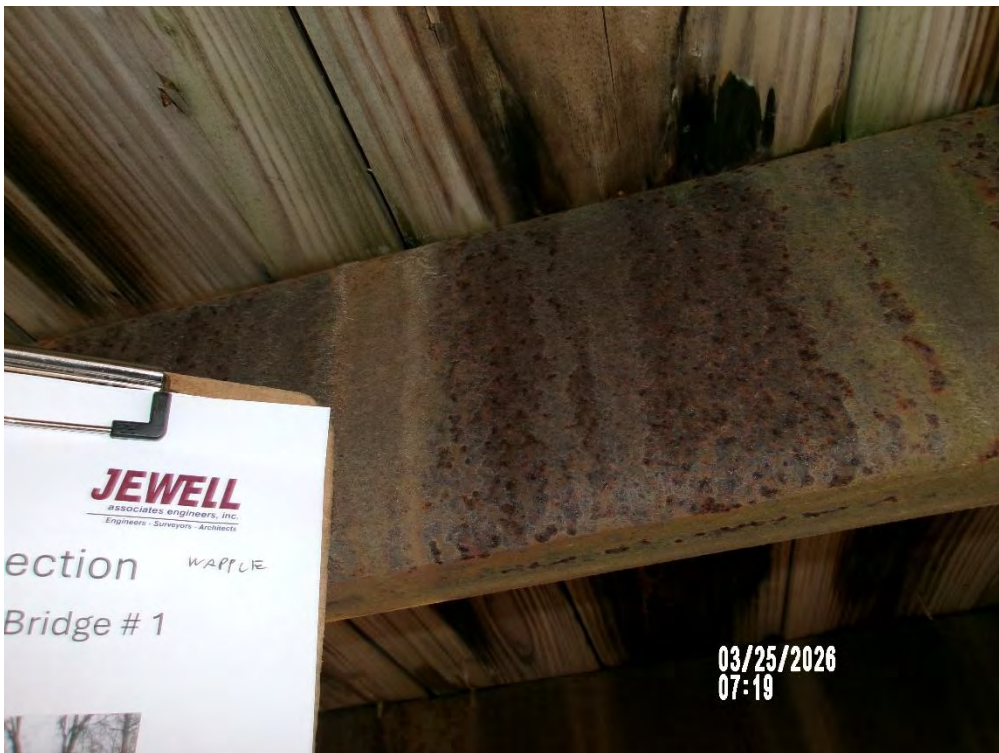
Figure 12: Worst case floor beam condition

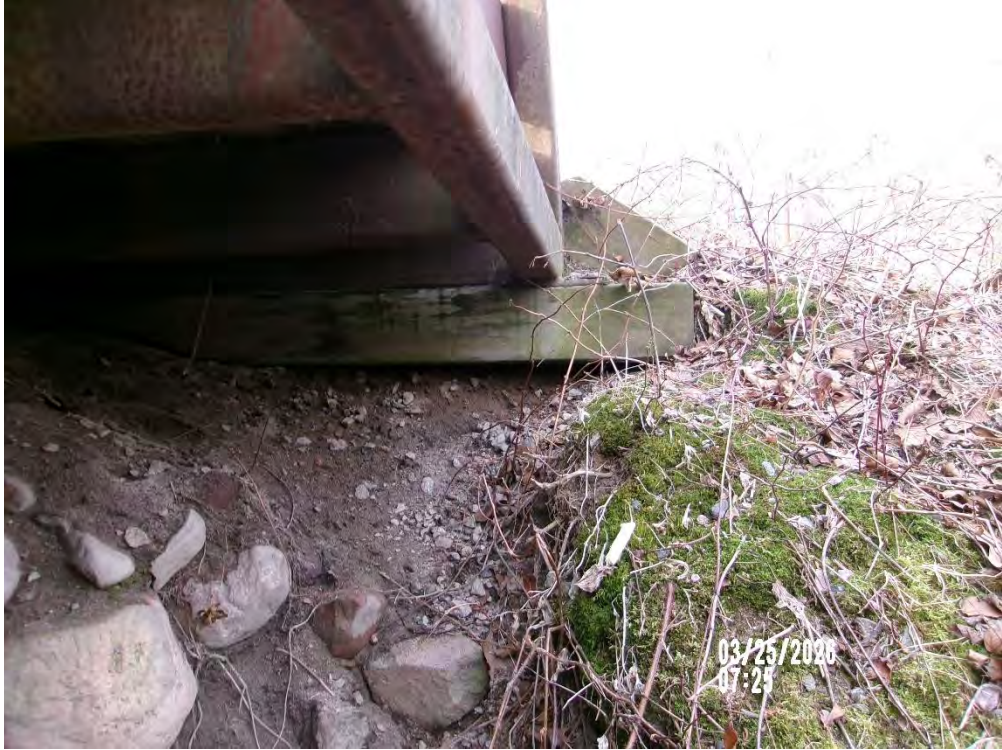
West abutment Fair condition – timber pier cap supporting truss. Undermining at NW 3' along the length of abutment, 4" deep, entire cap width (6") under.

Figure 13: NW pier cap undermining

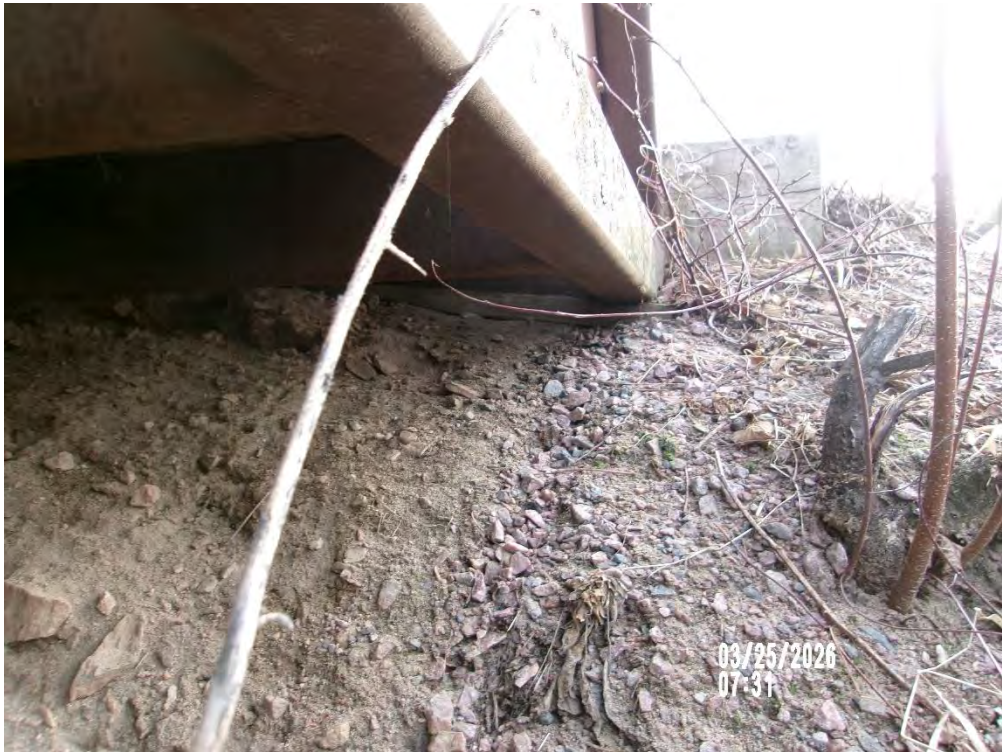
Figure 14: SE bearing board broken allowing sinking
