S-2 Fond du Lac Wild Goose Park Bridge Redeck

**Wild Goose State Trail Bridge over
East Branch Fond du Lac River
Feasibility Study**

Fond du Lac County

November 21, 2023

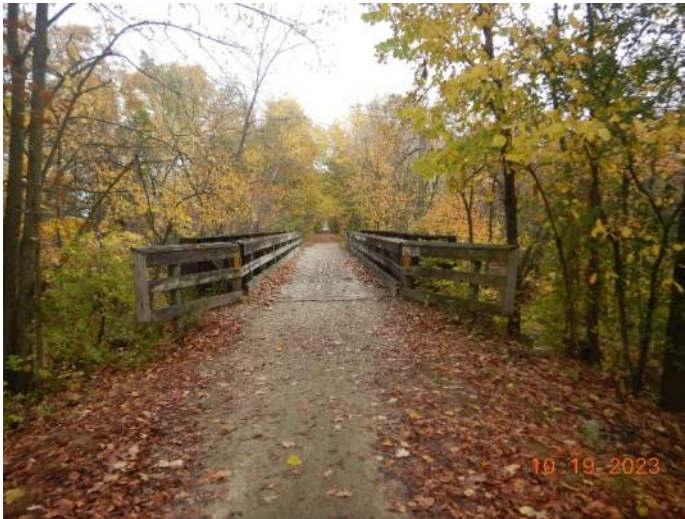
South approach looking north.

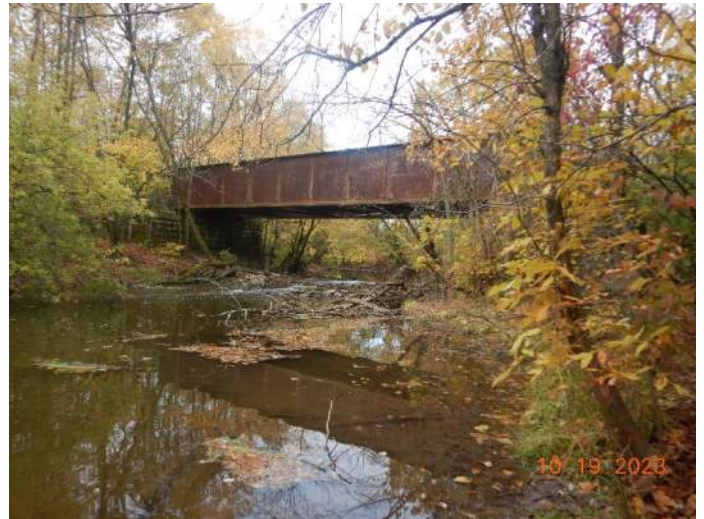
East profile (downstream).

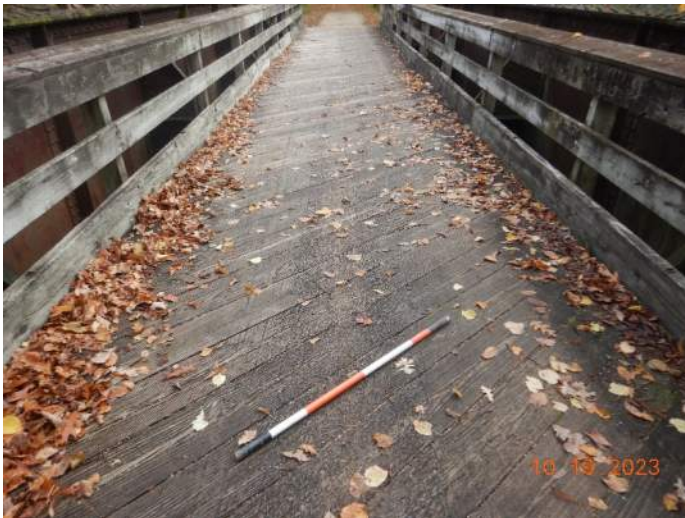
Typical wearing surface.

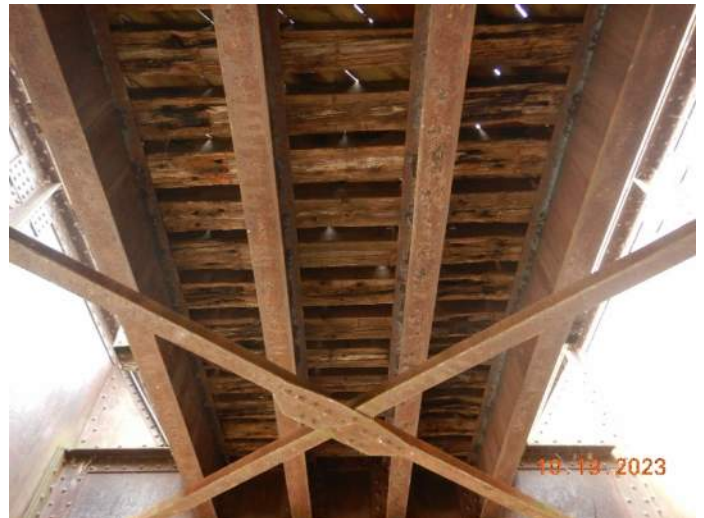
Typical deck underside.

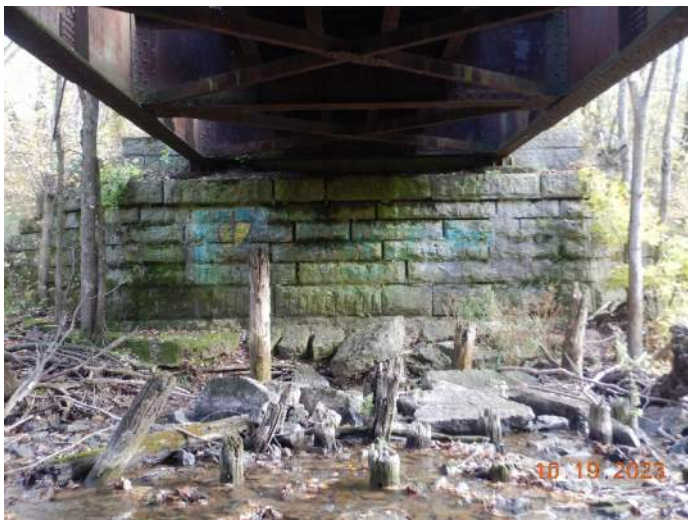
Typical abutment.

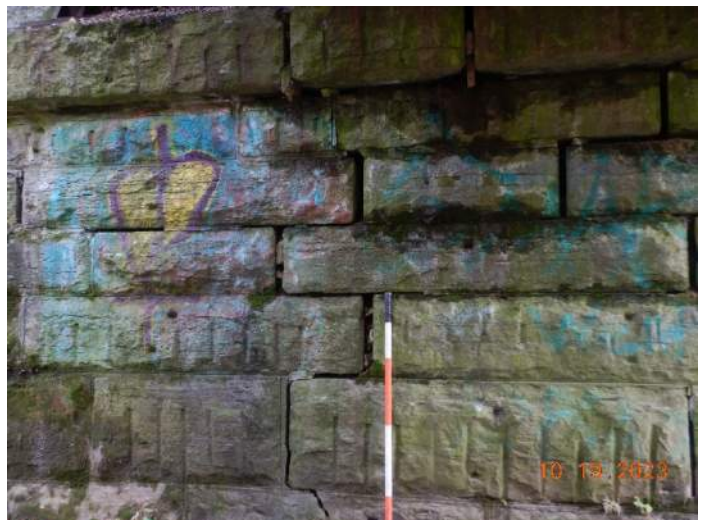
The abutments are in poor condition. There is loss and deterioration of the mortar of the masonry. The deterioration of the mortar is worse at the north abutment. Also at the north abutment, there is wide crack in a masonry block just below the northeast bearing. The masonry on the wingwalls is in similar condition to the abutment masonry.

Typical missing mortar in joints at north abutment
(south abutment similar).

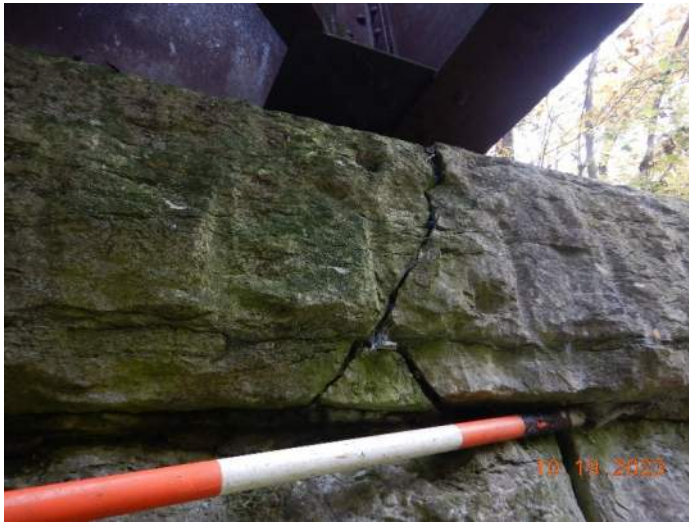
Wide crack in abutment stone cap at north abutment east end.

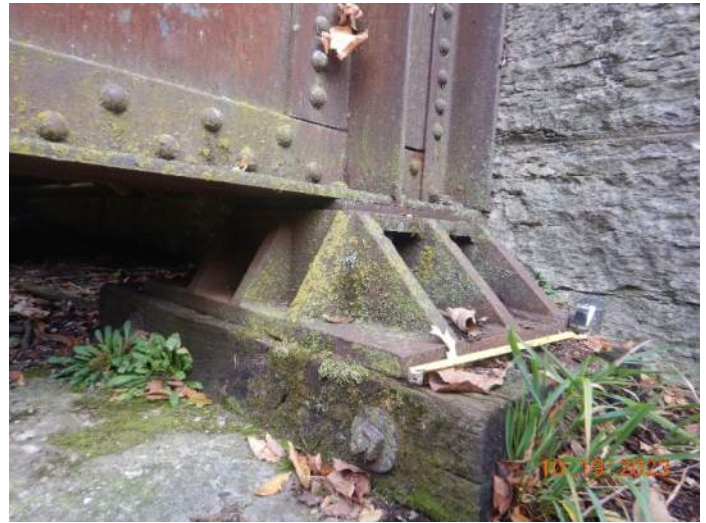
Overview of bearing (NE shown).

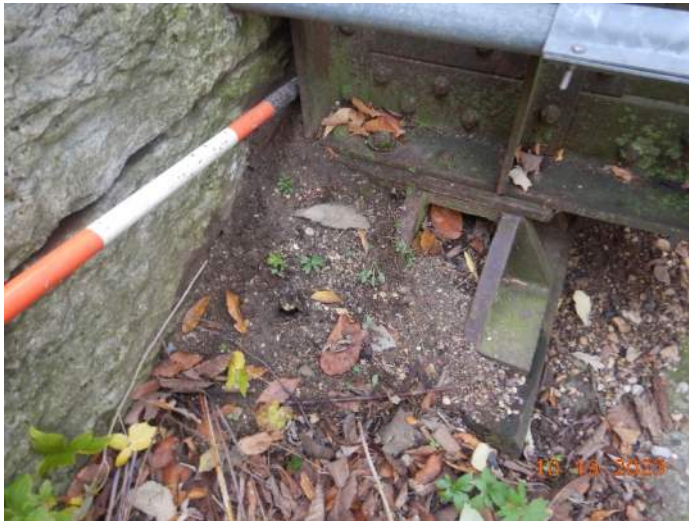
Typical debris and sediment buildup around bearing (NW shown).

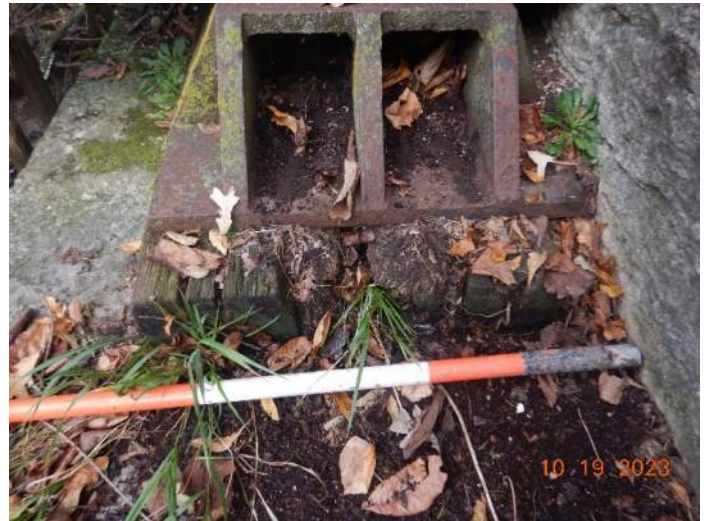
Rotten timber bearing pad under the NE bearing.

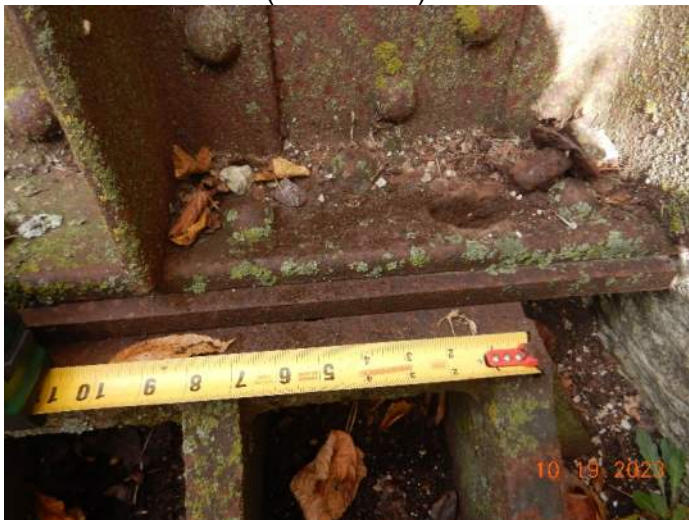
Broken keeper rod at the NE bearing.

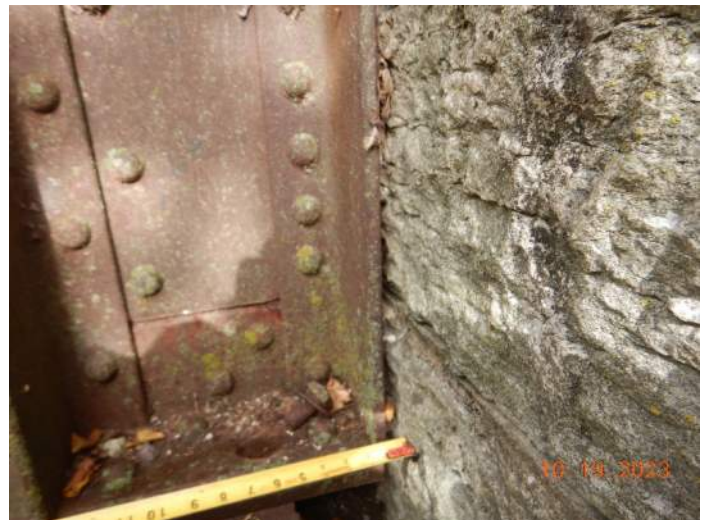
Through girder tight against backwall in NE quadrant.

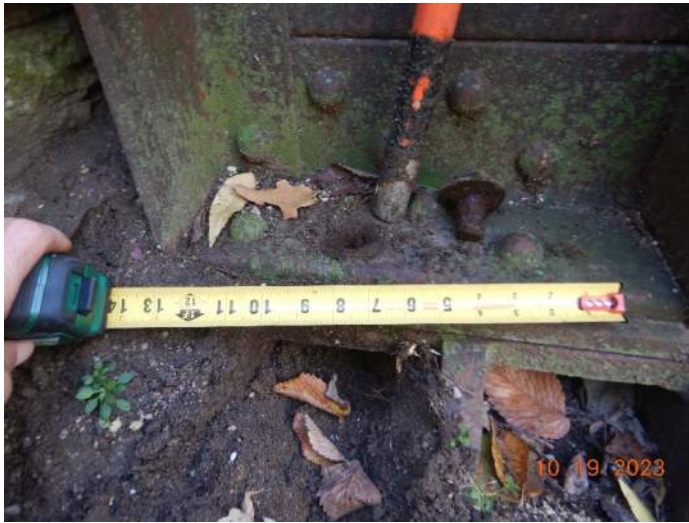
Broken keeper rod at the NW bearing

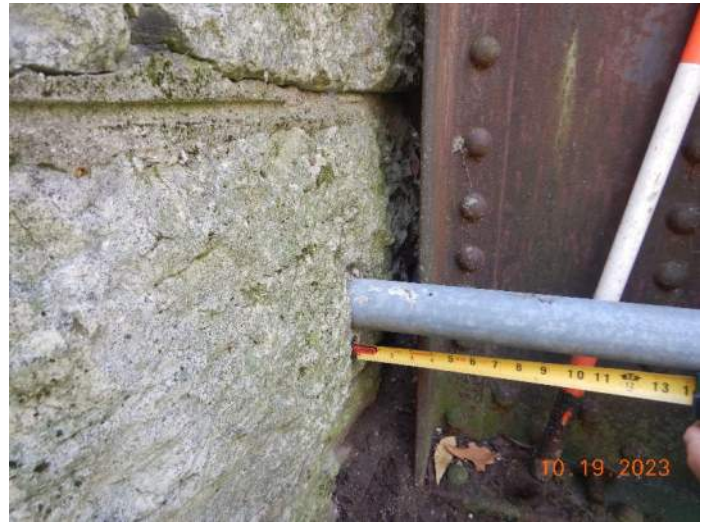
Through girder with minimal gap at backwall in NW quadrant

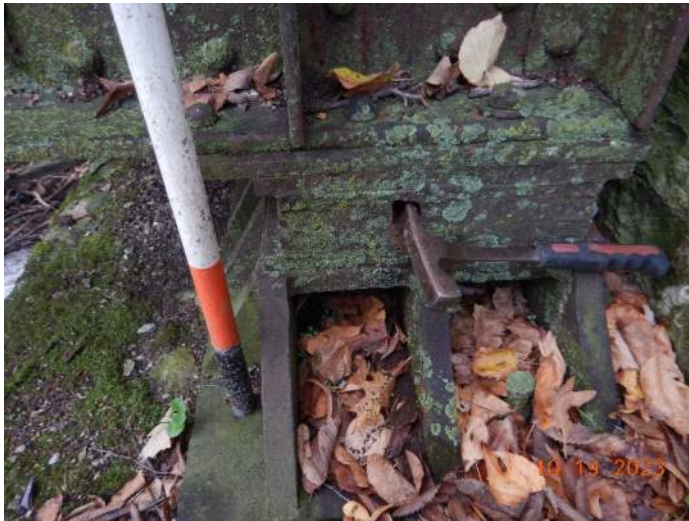
Hole in filler plates at SW bearing.

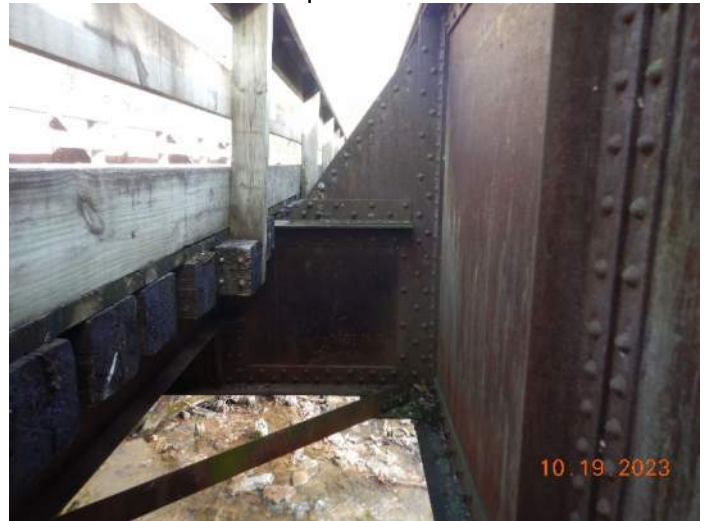
Typical minor surface corrosion of all steel members.
Overview of floor beam through truss connection.

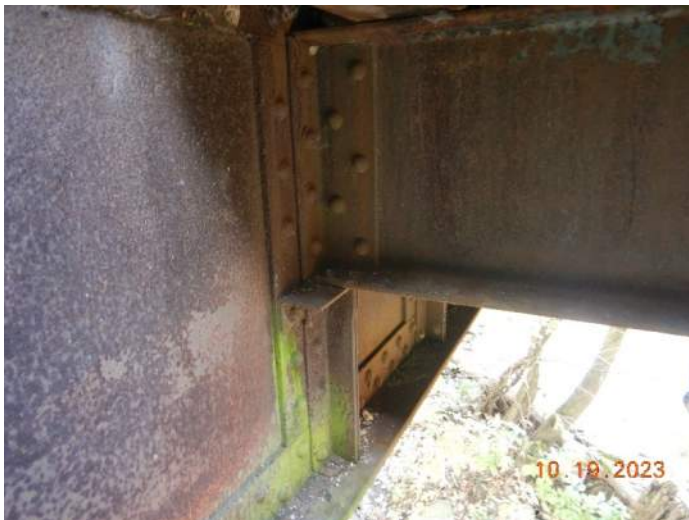
Typical floor beam to stringer connection.

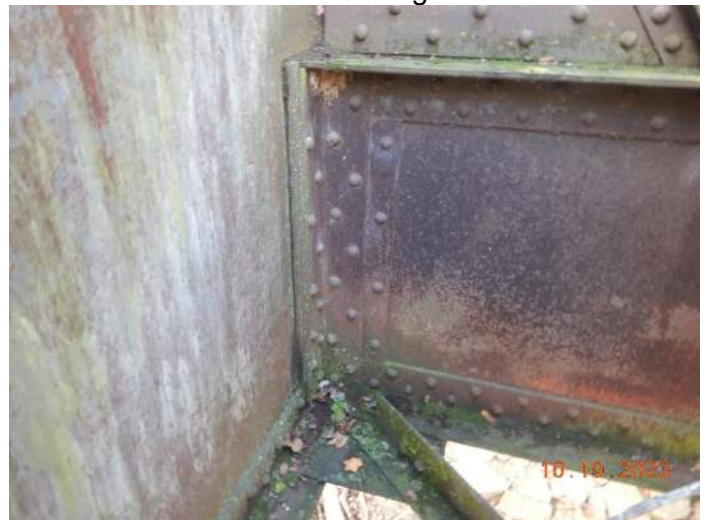
Typical through girder, floor beam, lateral bracing connection.

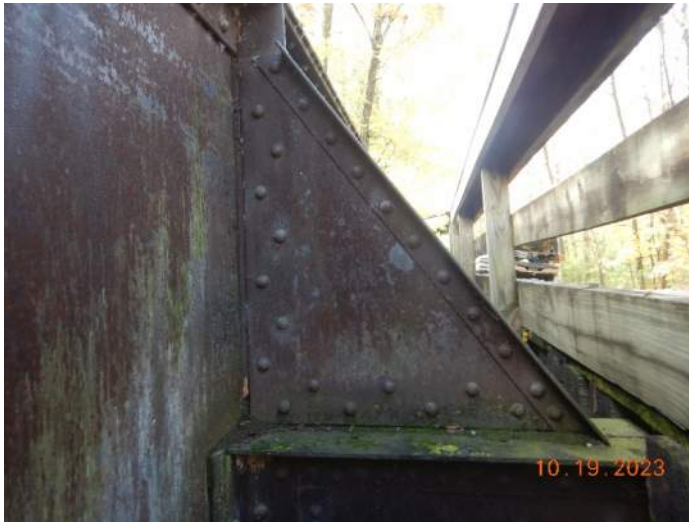
Typical triangular connection to through girder and floor beam.

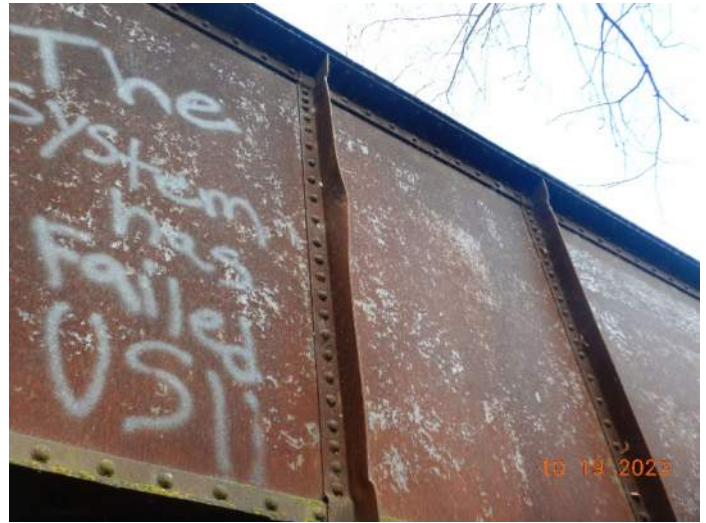
Bent outside stiffener east through girder south end.

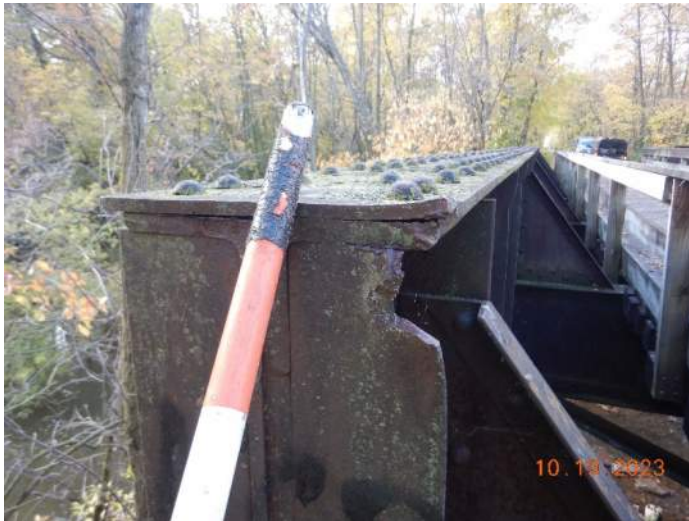
Minor damage to through girder NE quadrant.

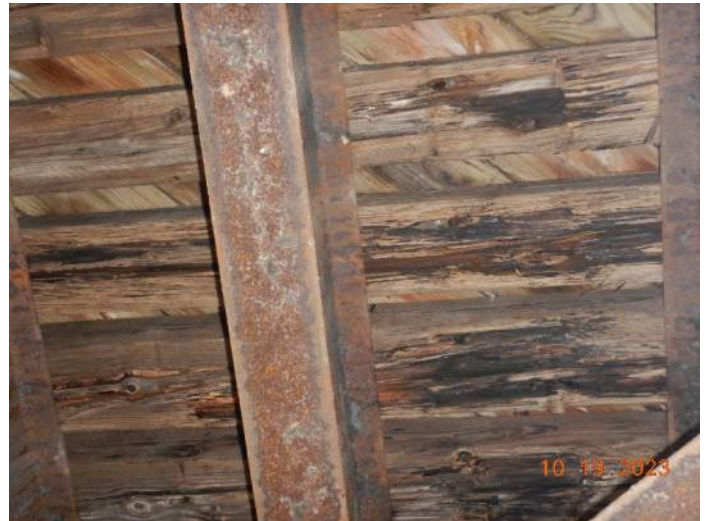
Typical deterioration of timber railroad ties.

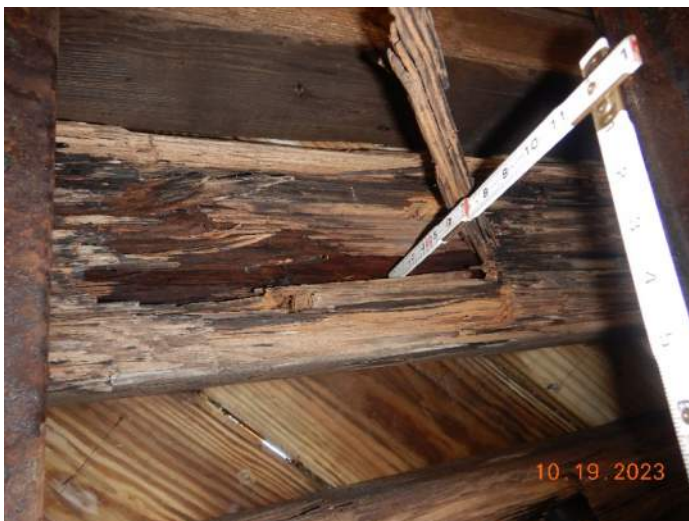
Typical deterioration, severe rot, and section loss of timber railroad ties.

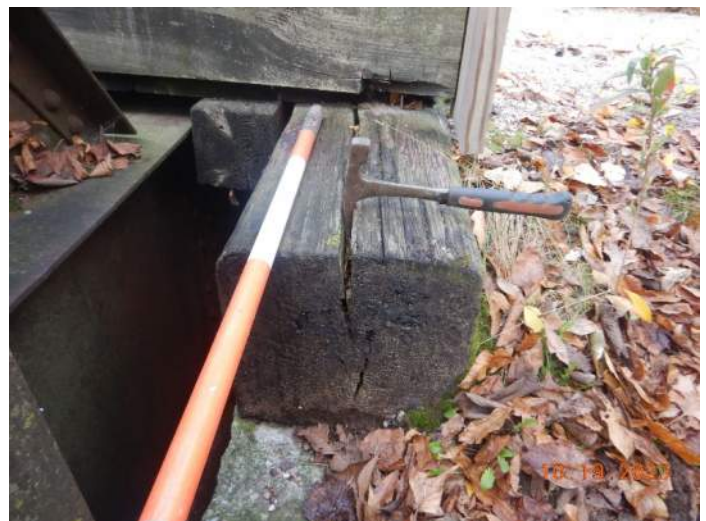
Typical timber cap split and rotten (NE quadrant shown).

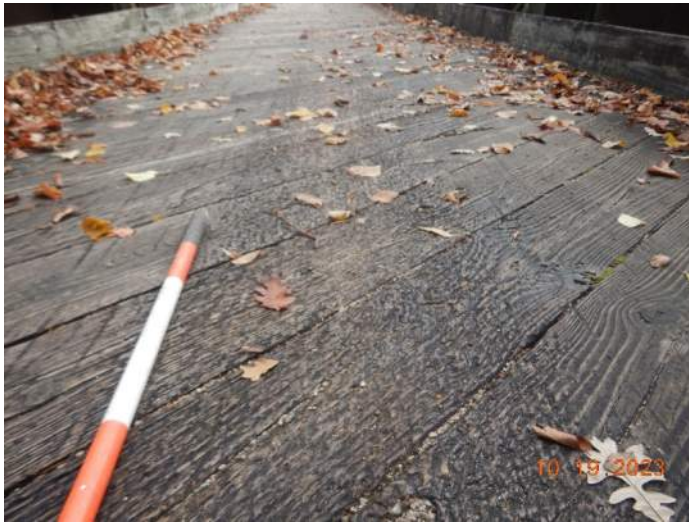
Moderate to heavy wear of deck boards down centerline.

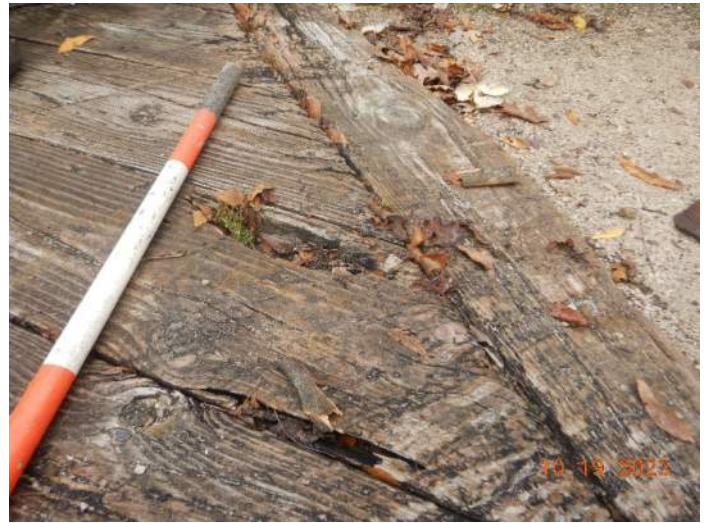
Rotten timber deck boards with minor section loss at north end.

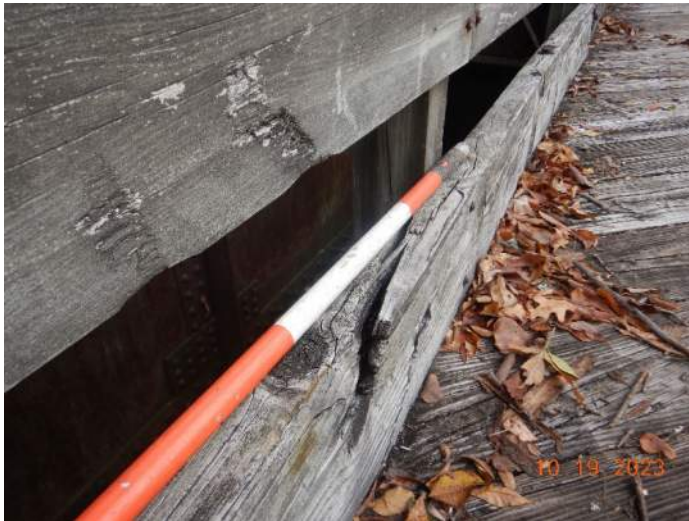
Split toe rail in the NE quadrant.

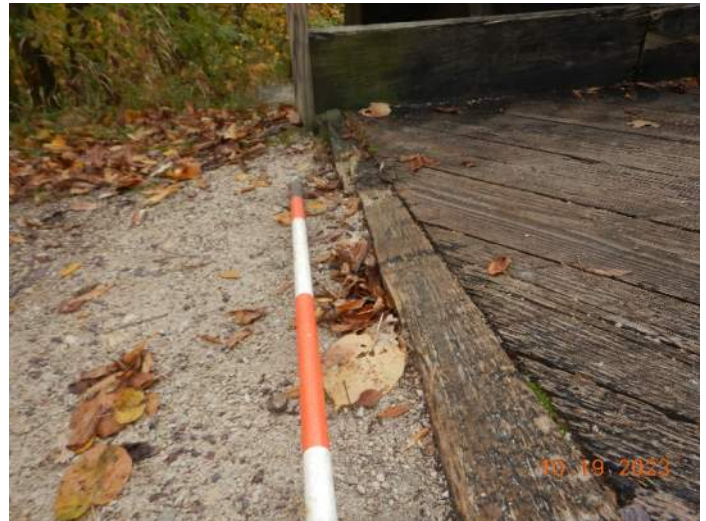
Split and portion missing timber header at north approach.

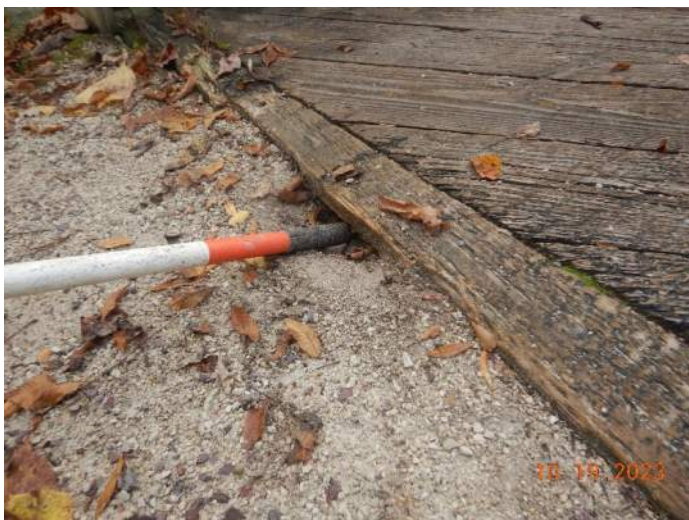
Minor sinkhole at the north approach.

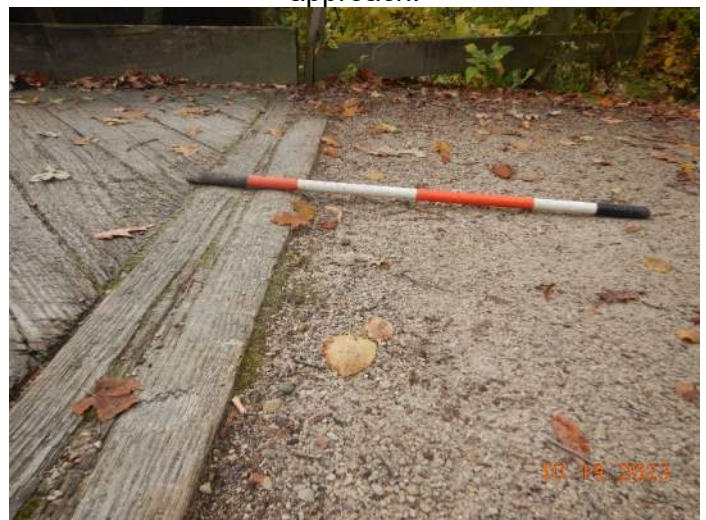
Typical settlement of gravel approaches (south shown).

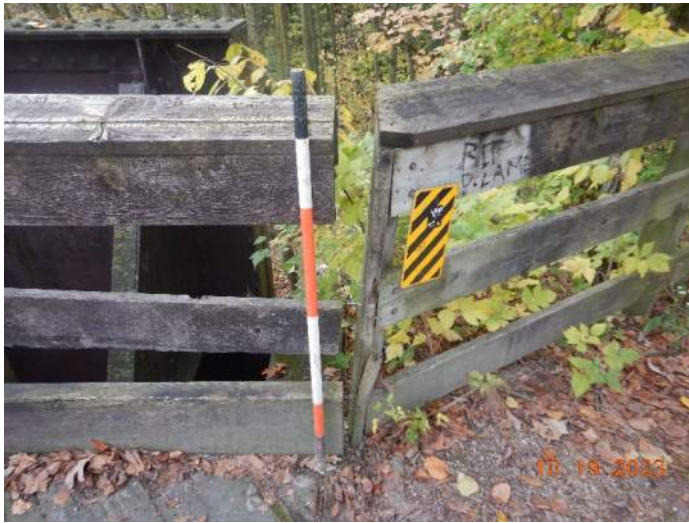
Typical approach rail in south approach not connected to structure.

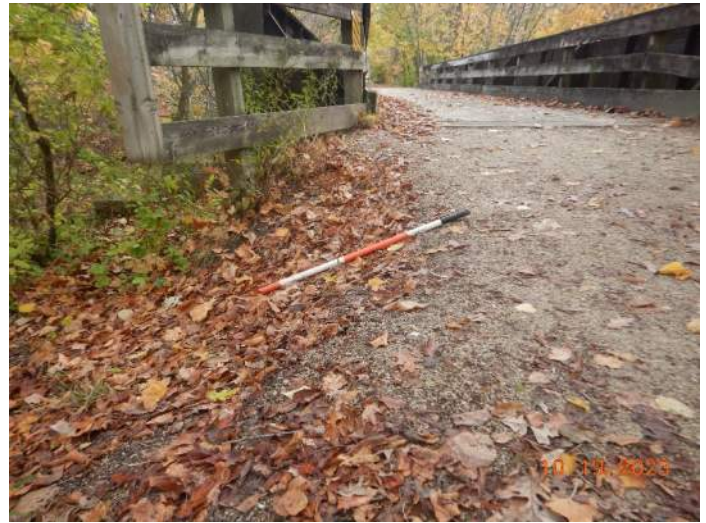
Erosion and settlement of shoulder and approach slope in SW quadrant.

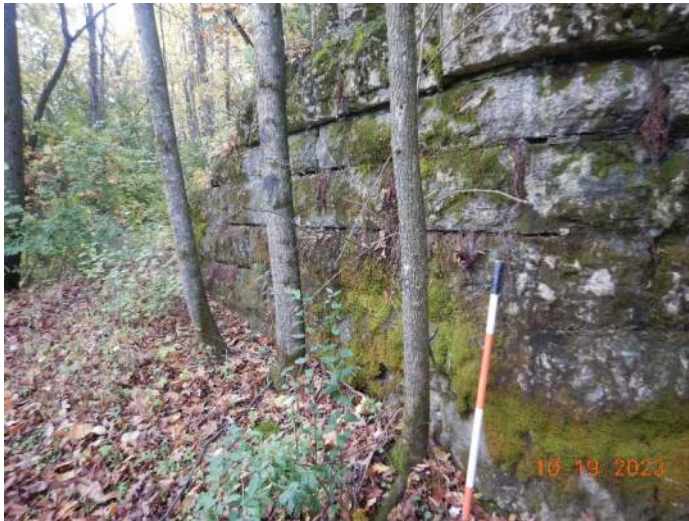
There is moderate to heavy vegetation/brush/trees along wingwalls and fascia.

Typical tree growth along wingwalls (fascia similar).

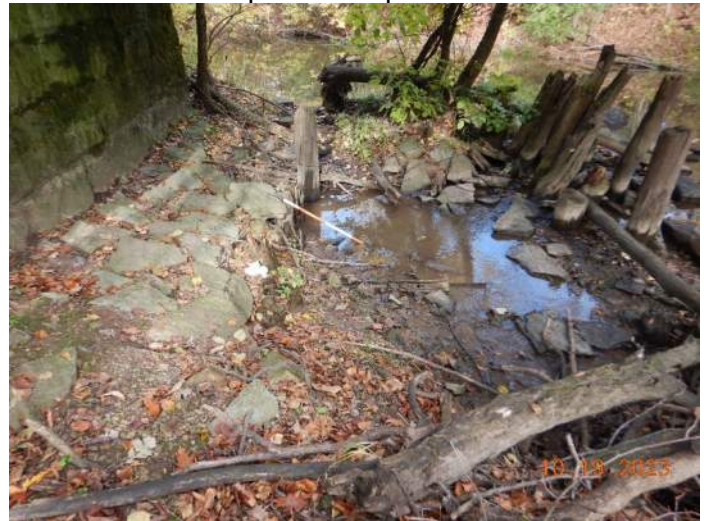
Minor to moderate scour in front of south abutment.
