## #4 Oconto Nicolet ST Oconto River Bridge Redecking

# **Inspection Report for**

# **Structure 23**

# Oconto Co. Rec. Trail over Oconto River November 20, 2020

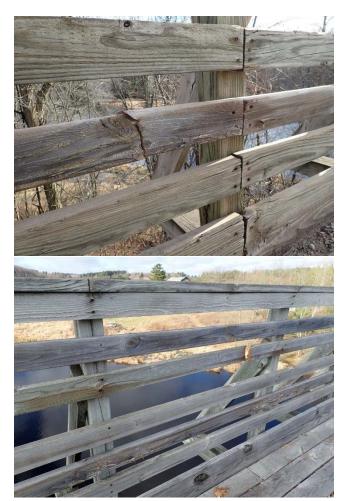
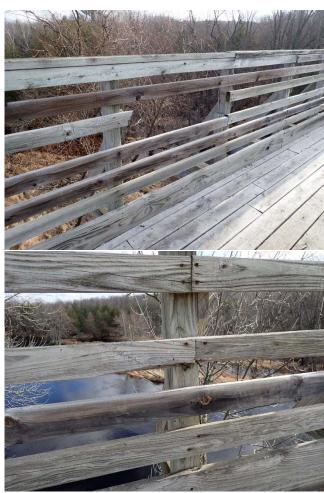
Railing shows signs of age but also has several damaged or decaying locations.

Item						Priority	Recomme	ended by	1	St	atus	Status Change	
Misc	– Cut Br	rush	1		l	high	Eple	ev. Bria	n (9712)	ider	ntified		
							-r-						
Plant	s and tree	es gr	owing	on pier	rs need	to be removed.	. Consider	patchin	ıg/filling join	ts to preven	t future grov	wth.	
Deck	c – Repai	r Ra	ailing			medium	Eple	ey, Bria	an (9712) ide		ntified		
			::	:1:									
repia	ce broker	ı and	iissim t	ng raiiii	ng 								
Deck – Patching						medium Epley, Bria			n (9712) identified

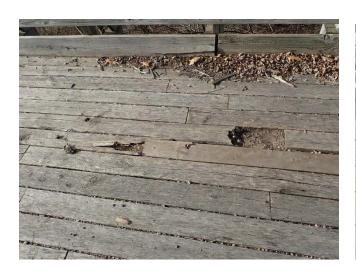
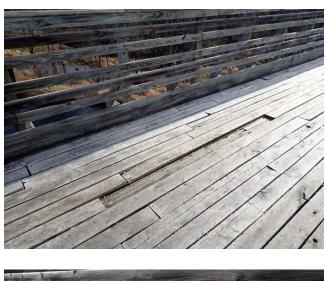
Wearing surface is aging but mostly intact. Several locations need proper replacements or repairs.

replace broken and missing deck boards, replace previous repairs made with plywood

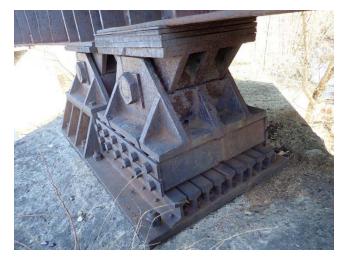
Cracked bearing at pier 3, east side

Removal of all decking materials down to steel girders and replace and widen to 12' width and install new railings. Repair crack in brearing located on pier 3. Repair cracks in concrete on pier tops to prevent further break down from vegative growth.

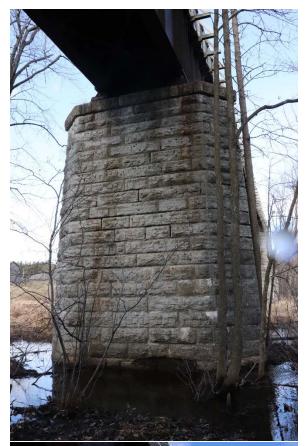
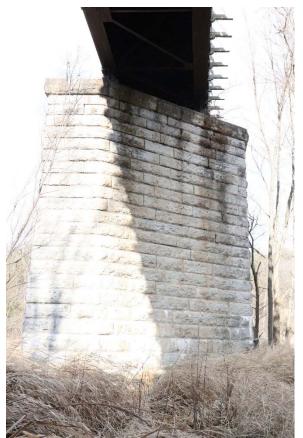
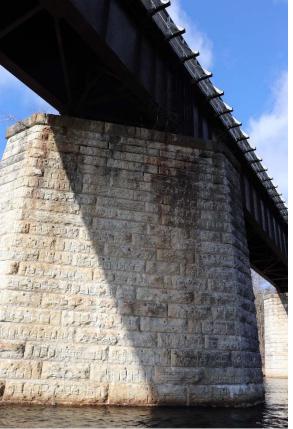
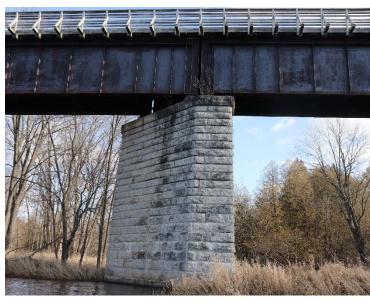
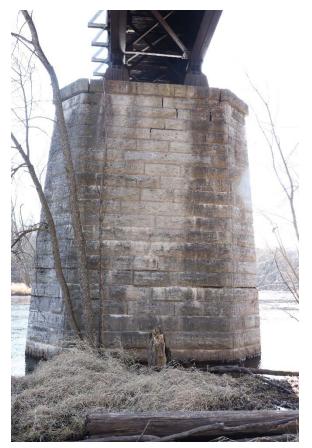
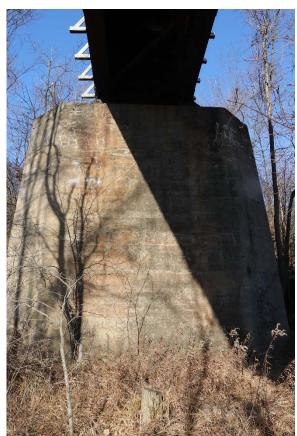
210		Reinforced Concrete Pier Wall	LF	25		25							
Comments:	Pier 5 -	Square											
	1130	Cracking (RC)/ Efflorescence				25							
Comments:	Minor	miscellaneous cracking throughout, some light to	moderate e	efflorescence.				•					
213		Masonry Pier Wall	LF	108		108							
Comments:	Piers 1	& 4 - Square - 25', Piers 2 & 3 - Skewed - 29'				•		1					
		I				108							
	1610	Mortar Breakdown											
Comments:	There a	Mortar Breakdown  are minor issues with joints breaking down and vier filling gaps.	egitation gro	owing our of gap	s, mainly in th	e caps. Vegeta	tion must be i	removed.					
Comments:	There a	re minor issues with joints breaking down and v	egitation gro	owing our of gap	s, mainly in th	e caps. Vegeta	tion must be I	removed.					
	There a	are minor issues with joints breaking down and voer filling gaps.			s, mainly in th	1	tion must be i	removed.					
215	There a	are minor issues with joints breaking down and veer filling gaps.  Reinforced Concrete Abutment			s, mainly in th	1	tion must be	removed.
