#10 Fond du Lac Wild Goose State Park Bridge

**Wild Goose State Trail Bridge over
East Branch Fond du Lac River
Feasibility Study**

Fond du Lac County

November 21, 2023

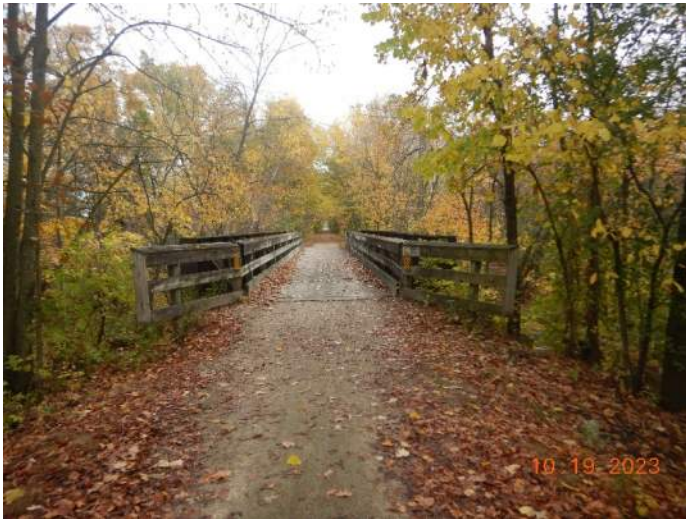
South approach looking north.

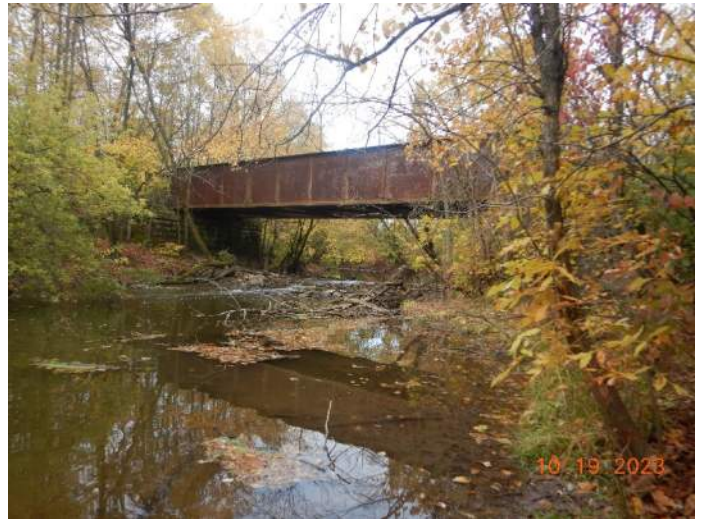
East profile (downstream).

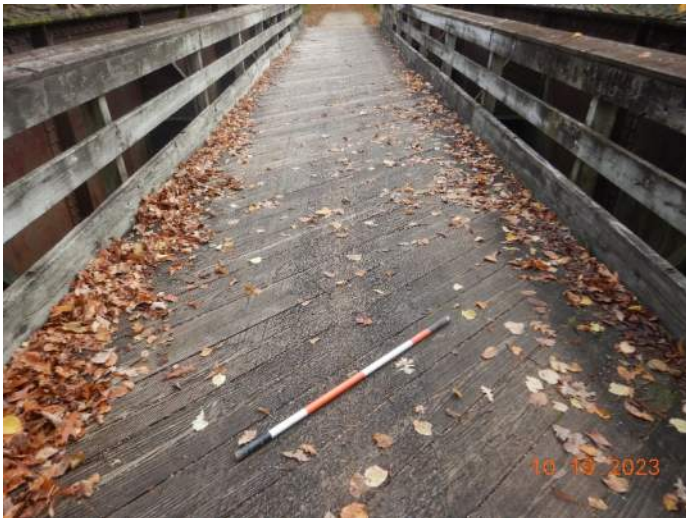
Typical wearing surface.

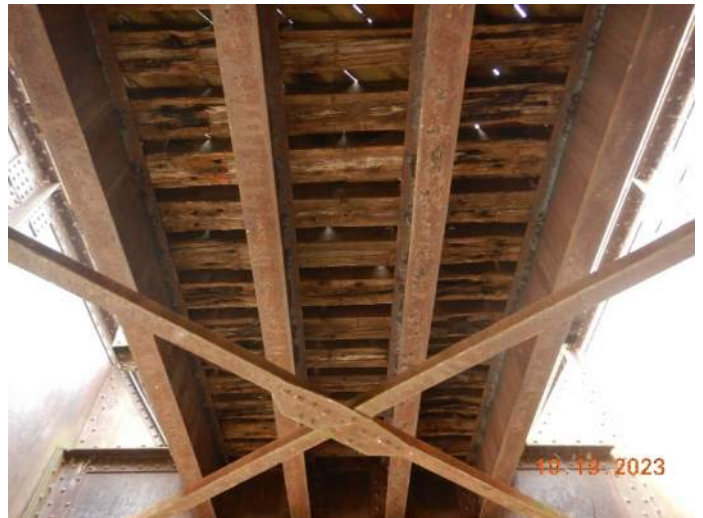
Typical deck underside.

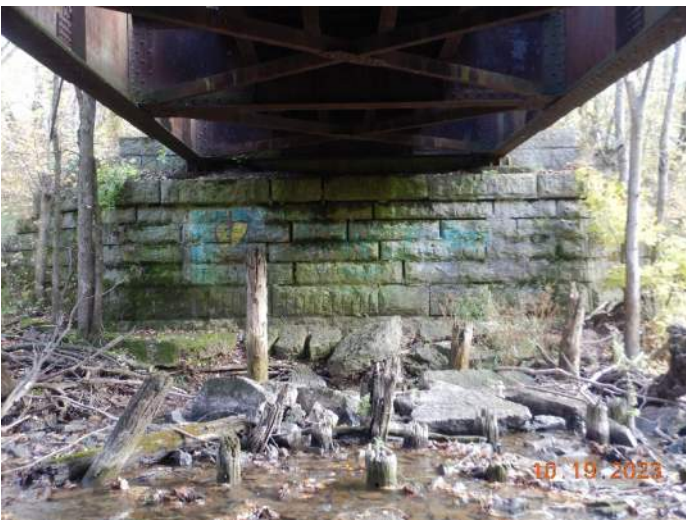
Typical abutment.

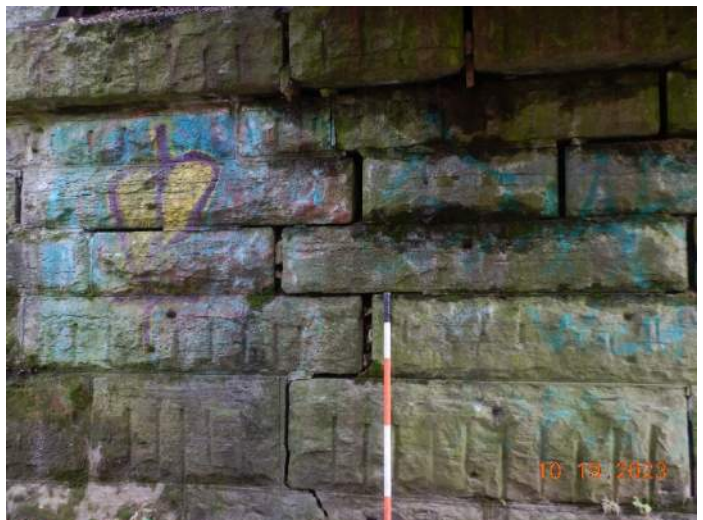
The abutments are in poor condition. There is loss and deterioration of the mortar of the masonry. The deterioration of the mortar is worse at the north abutment. Also at the north abutment, there is wide crack in a masonry block just below the northeast bearing. The masonry on the wingwalls is in similar condition to the abutment masonry.

Typical missing mortar in joints at north abutment (south abutment similar).

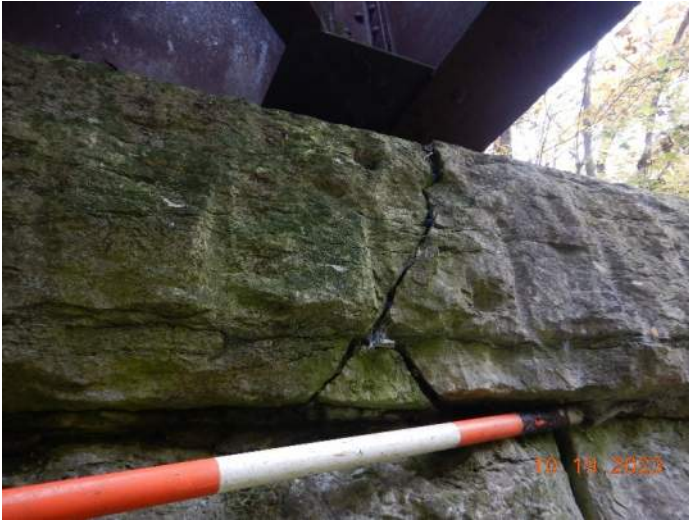
Wide crack in abutment stone cap at north abutment east end.

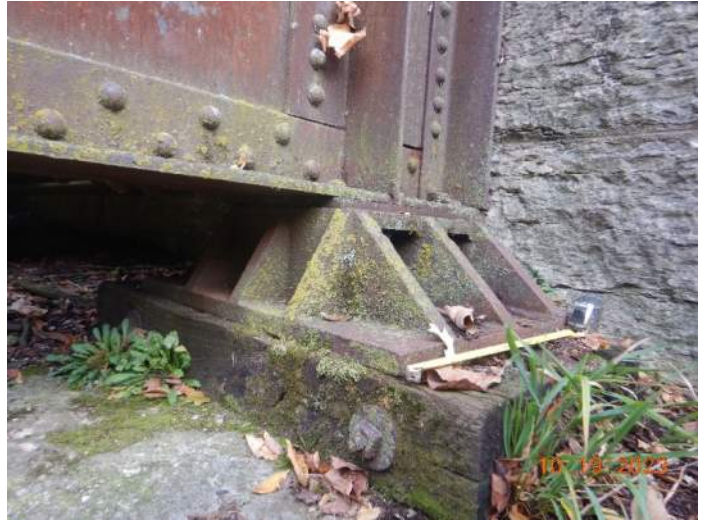
Overview of bearing (NE shown).

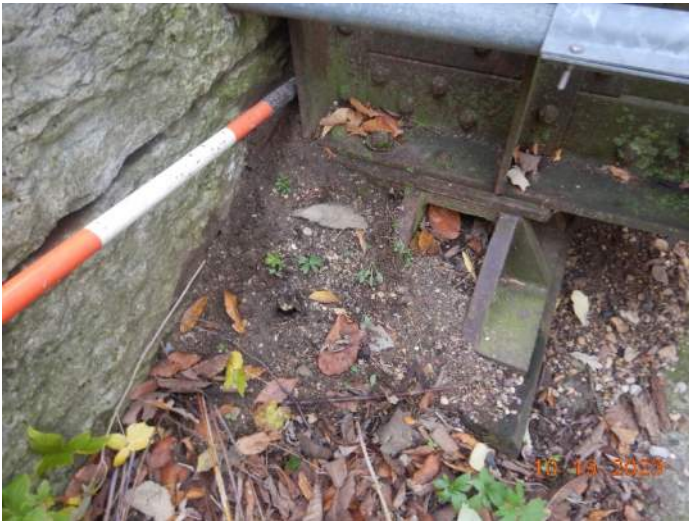
Typical debris and sediment buildup around bearing (NW shown).

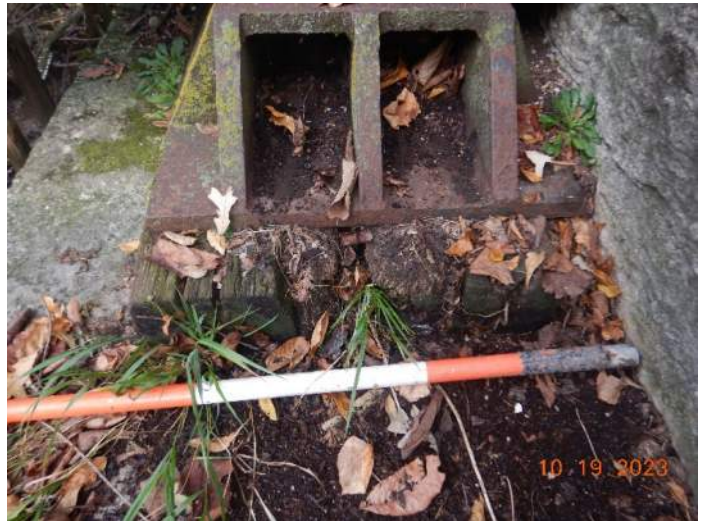
Rotten timber bearing pad under the NE bearing.

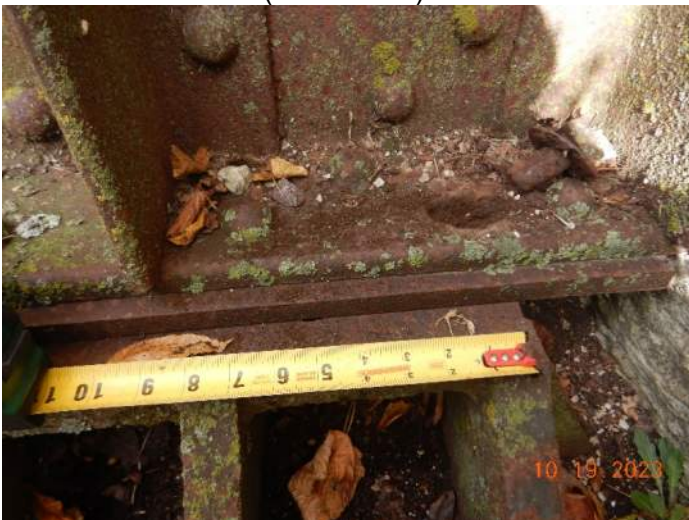
Broken keeper rod at the NE bearing.

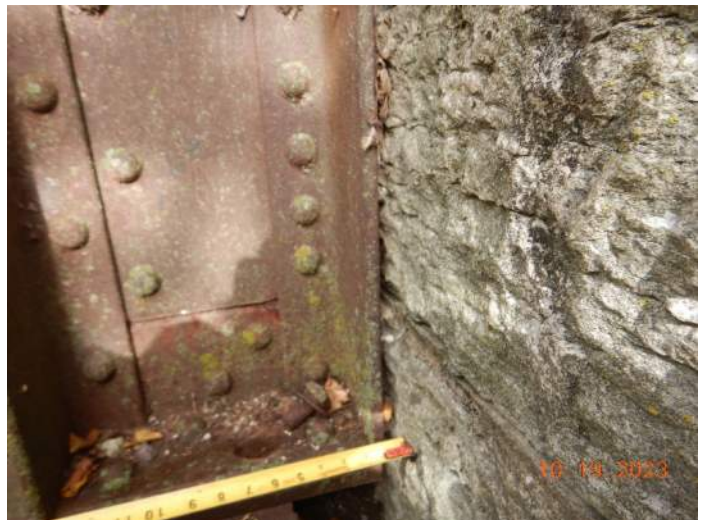
Through girder tight against backwall in NE quadrant.

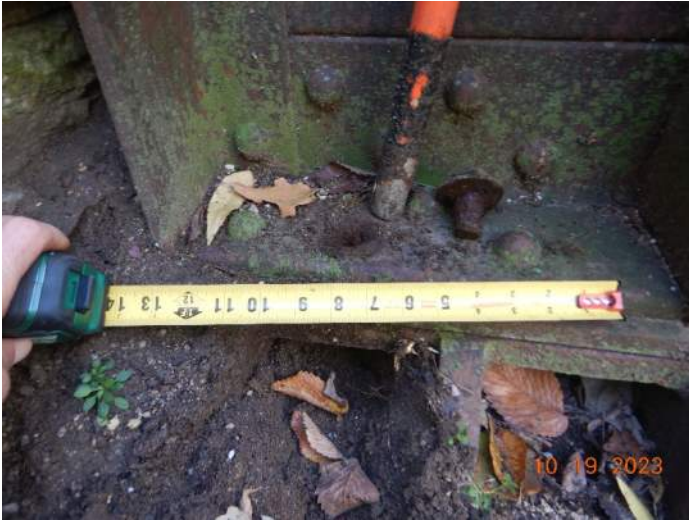
Broken keeper rod at the NW bearing

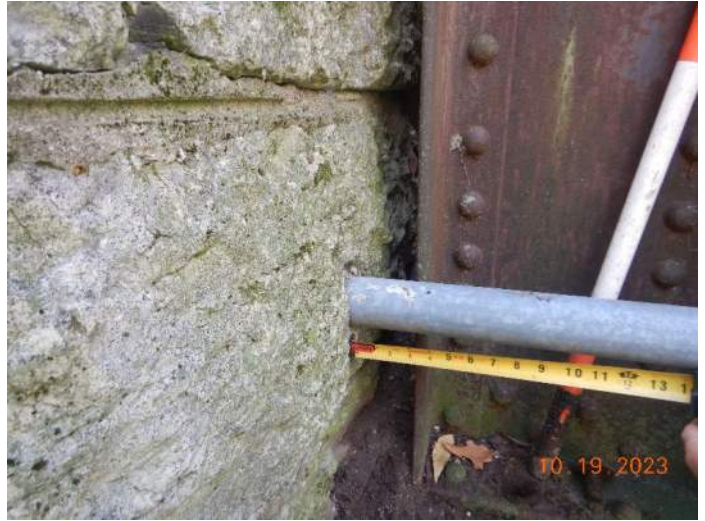
Through girder with minimal gap at backwall in NW quadrant

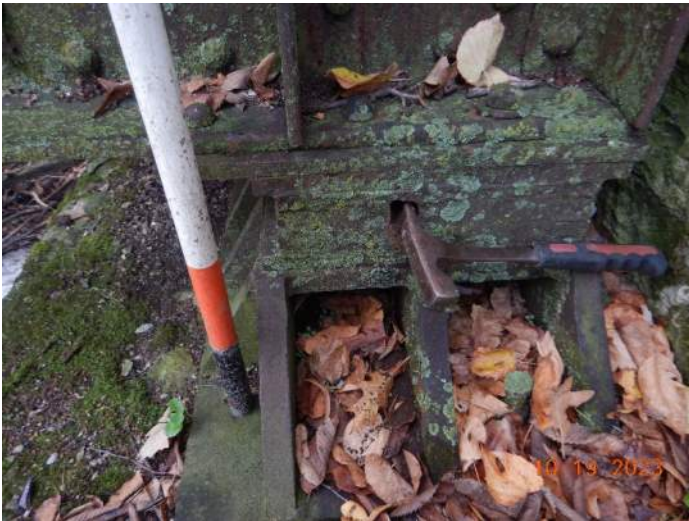
Hole in filler plates at SW bearing.

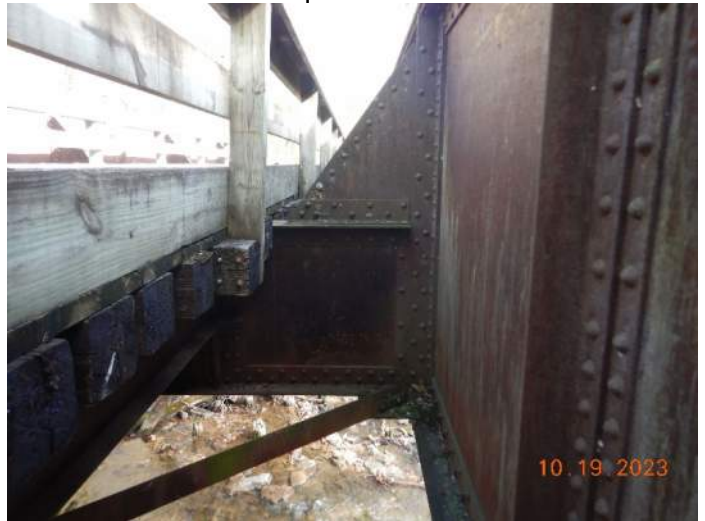
Typical minor surface corrosion of all steel members. Overview of floor beam through truss connection.

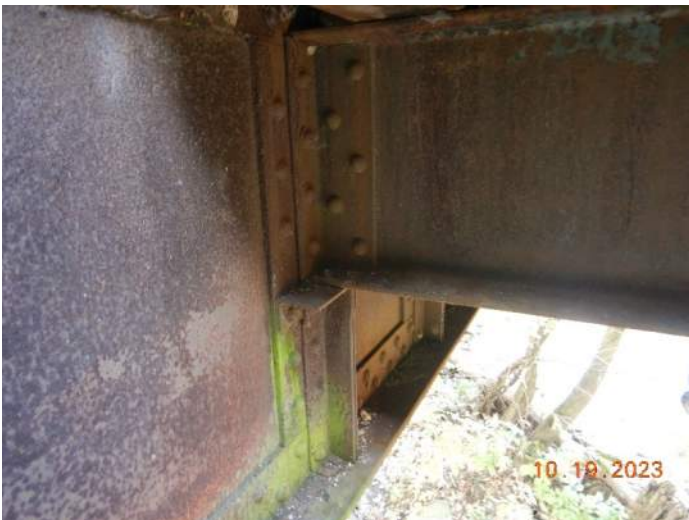
Typical floor beam to stringer connection.

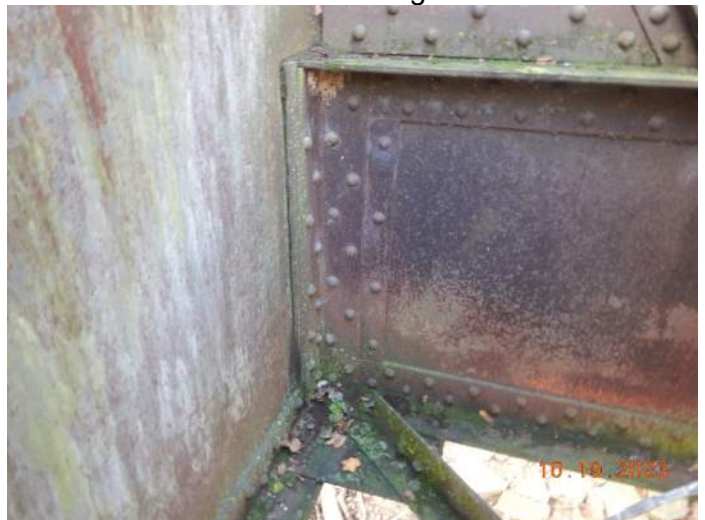
Typical through girder, floor beam, lateral bracing connection.

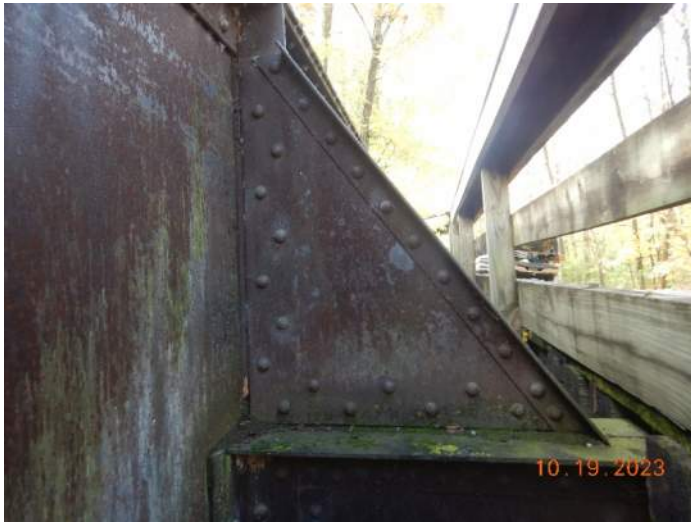
Typical triangular connection to through girder and floor beam.

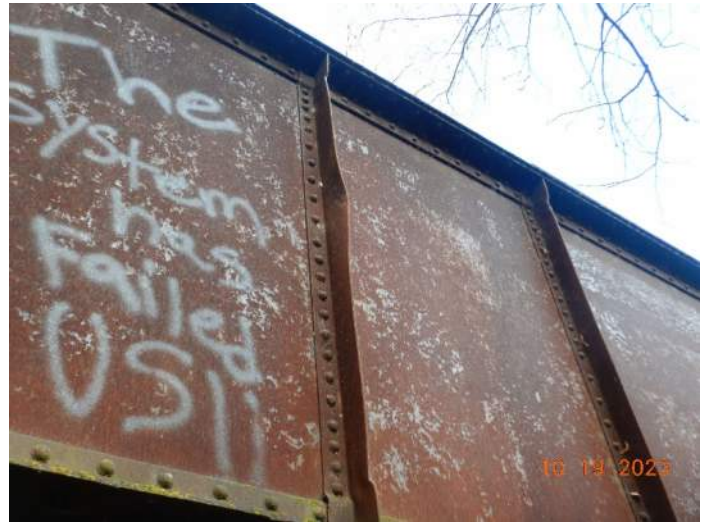
Bent outside stiffener east through girder south end.

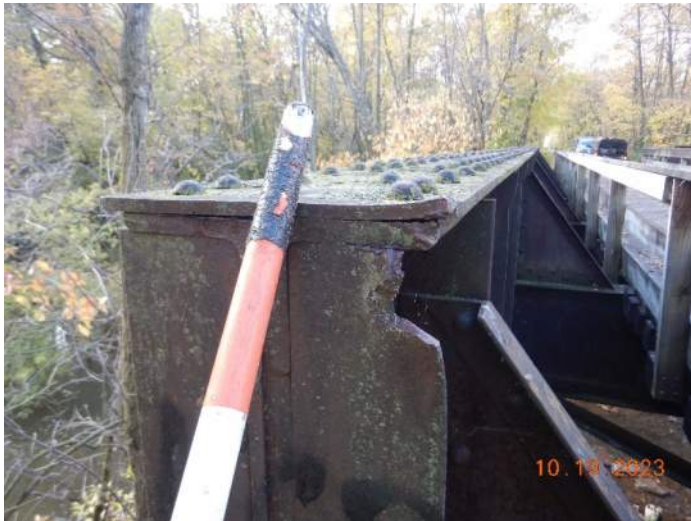
Minor damage to through girder NE quadrant.

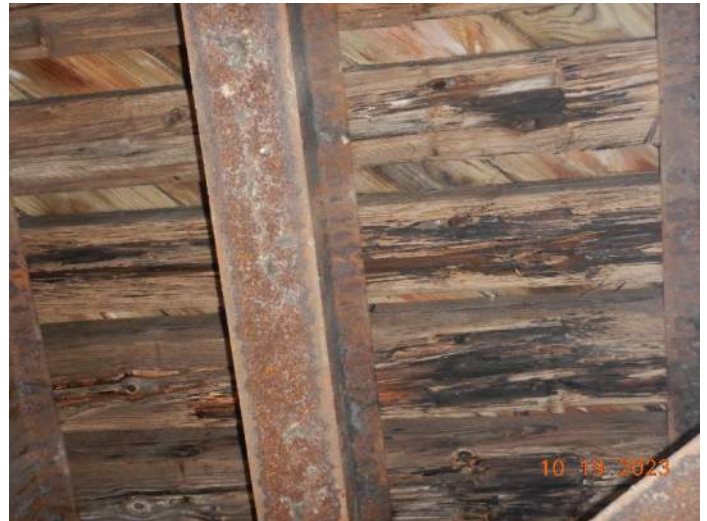
Typical deterioration of timber railroad ties.

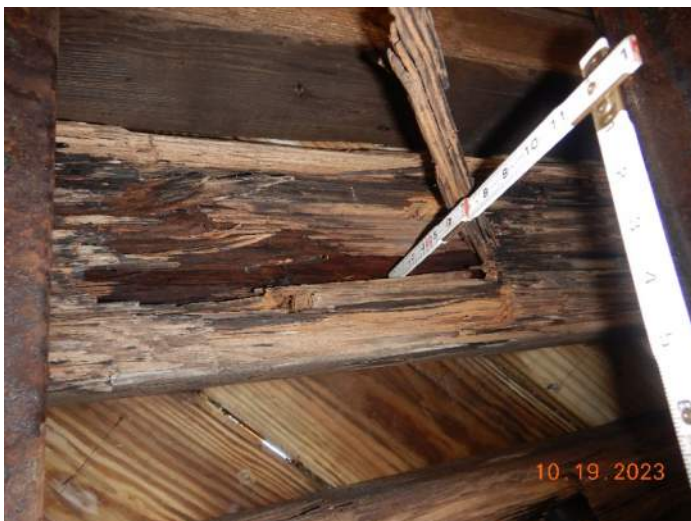
Typical deterioration, severe rot, and section loss of timber railroad ties.

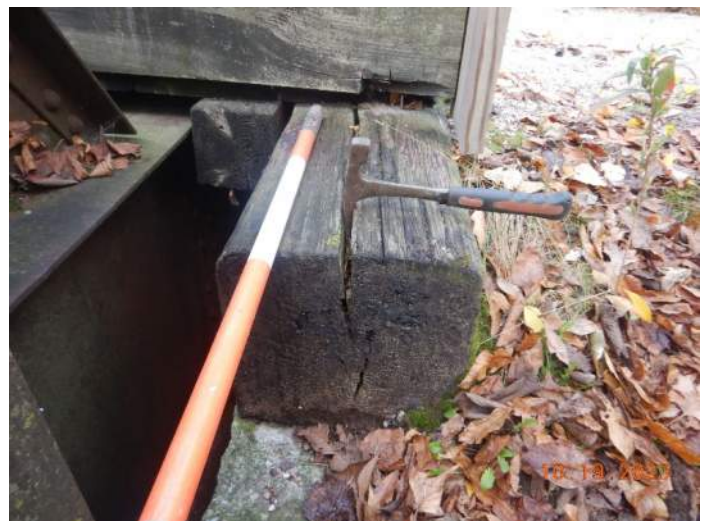
Typical timber cap split and rotten (NE quadrant shown).

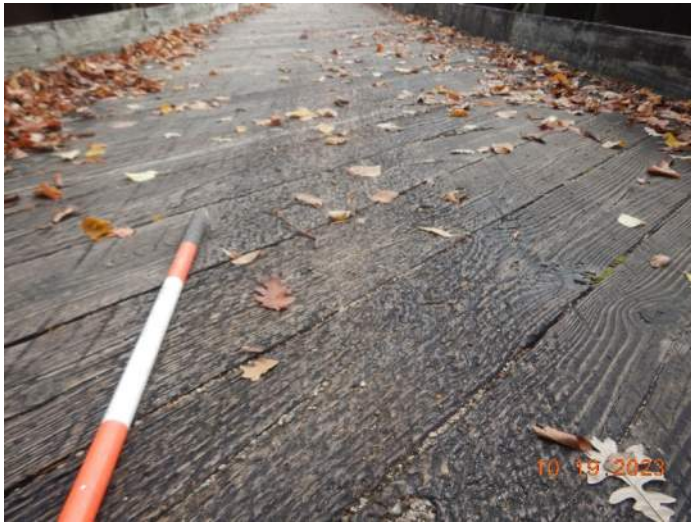
Moderate to heavy wear of deck boards down centerline.

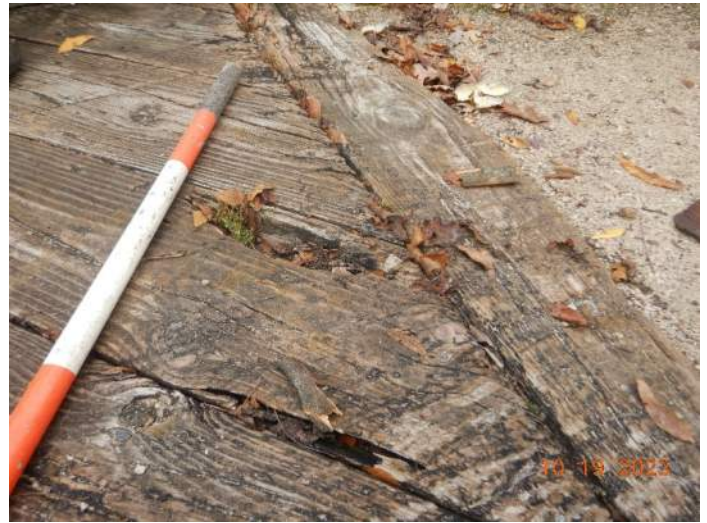
Rotten timber deck boards with minor section loss at north end.

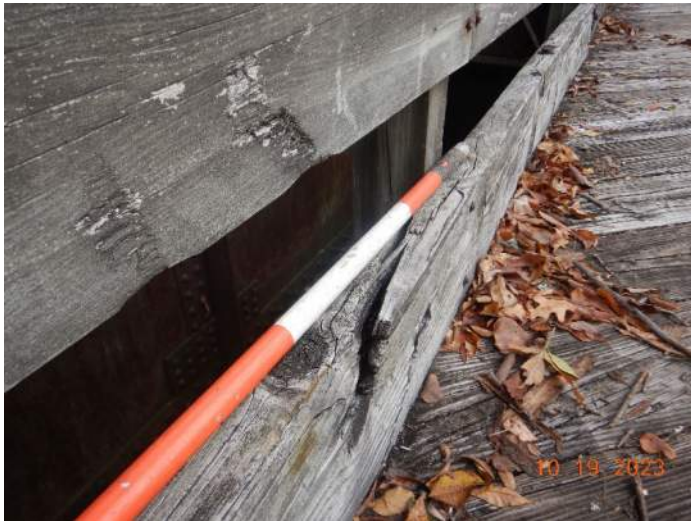
Split toe rail in the NE quadrant.

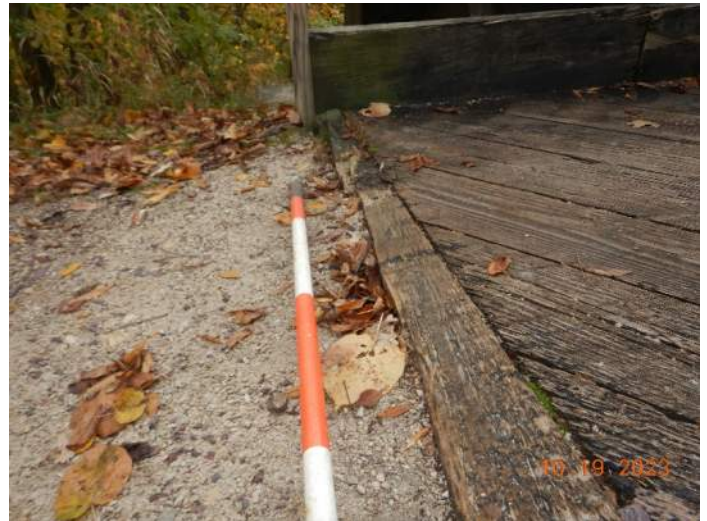
Split and portion missing timber header at north approach.

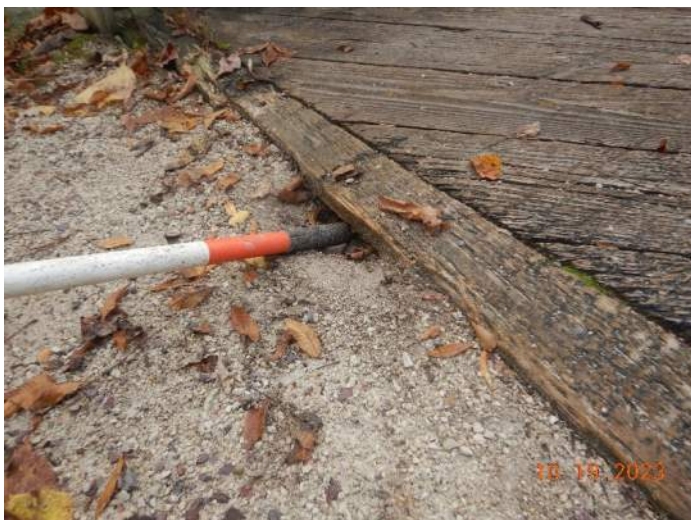
Minor sinkhole at the north approach.

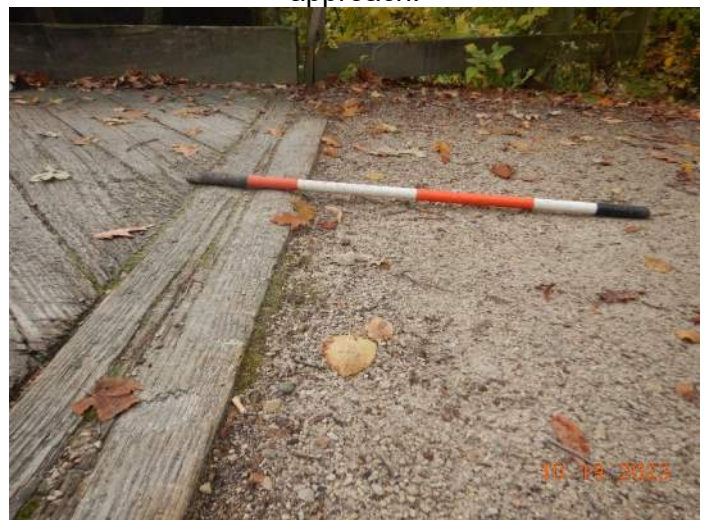
Typical settlement of gravel approaches (south shown).

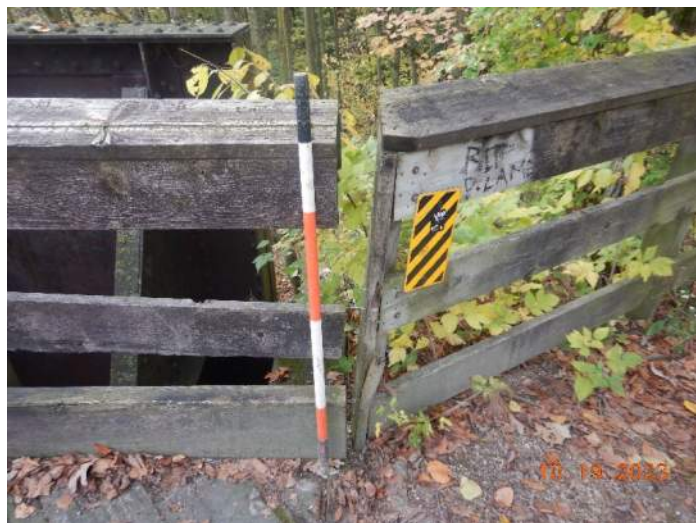
Typical approach rail in south approach not connected to structure.

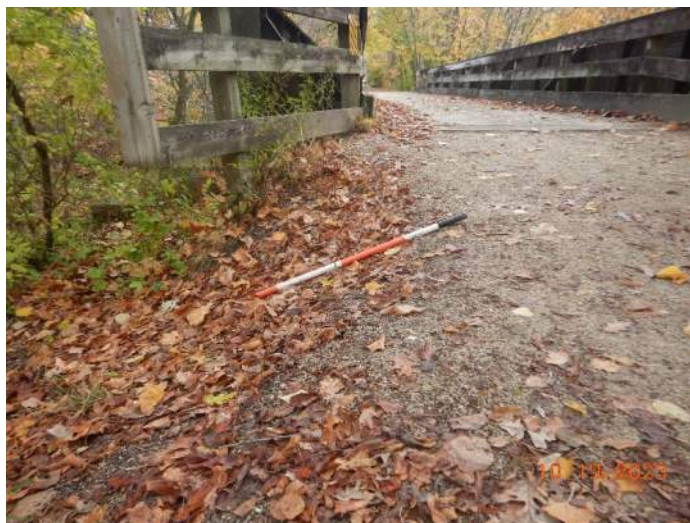
Erosion and settlement of shoulder and approach slope in SW quadrant.

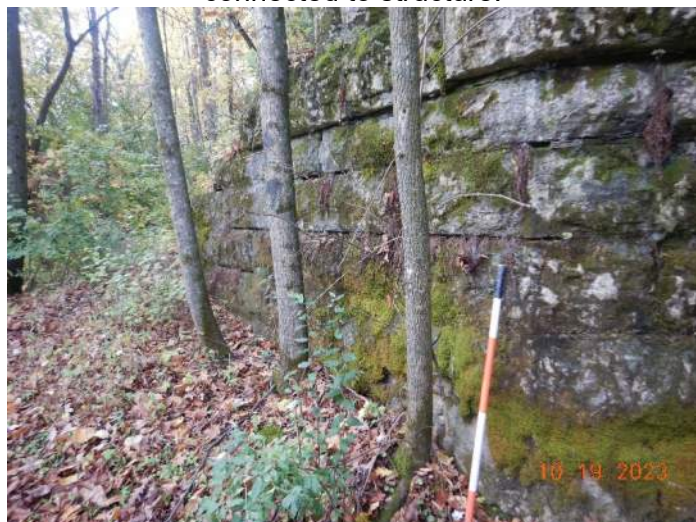
Typical tree growth along wingwalls (fascia similar).

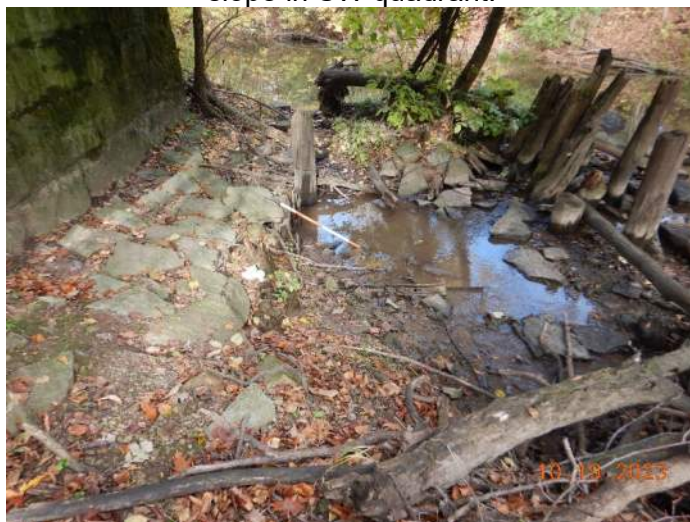
Minor to moderate scour in front of south abutment.
