S-11 Fond du Lac Wild Goose State Trail Bridge Rehab

State of Wisconsin
 Department of Natural Resources
dnr.wi.gov

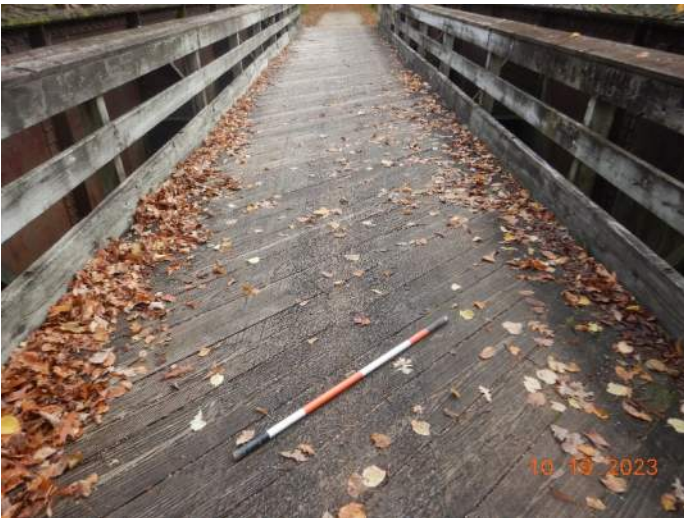
Typical wearing surface.

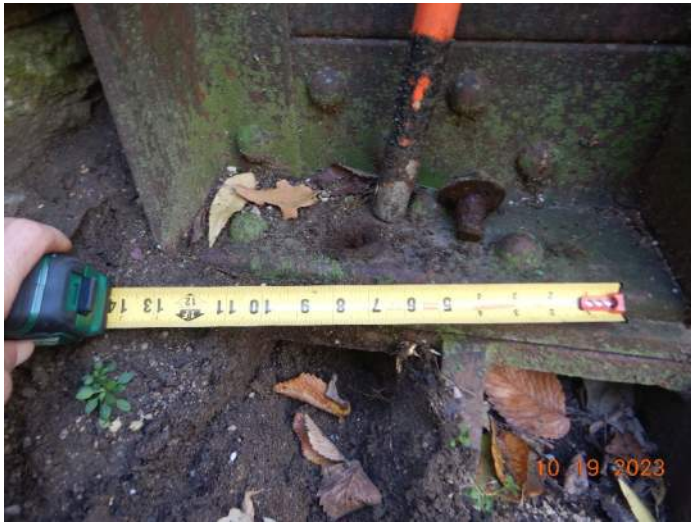
Broken keeper rod at the NW bearing

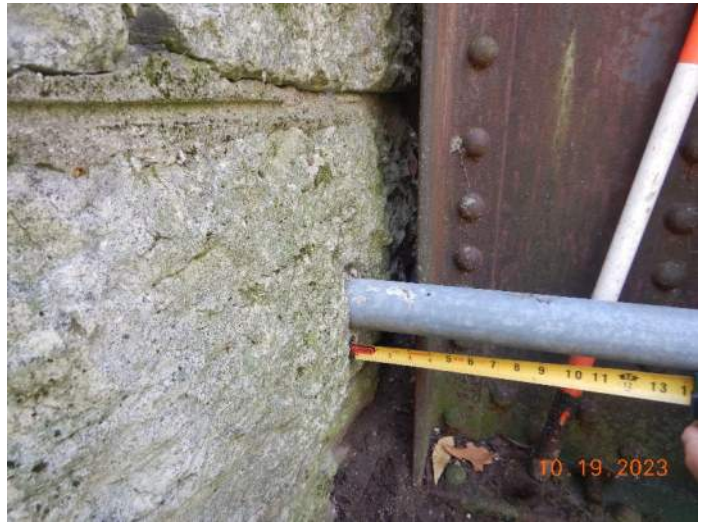
Through girder with minimal gap at backwall in NW quadrant

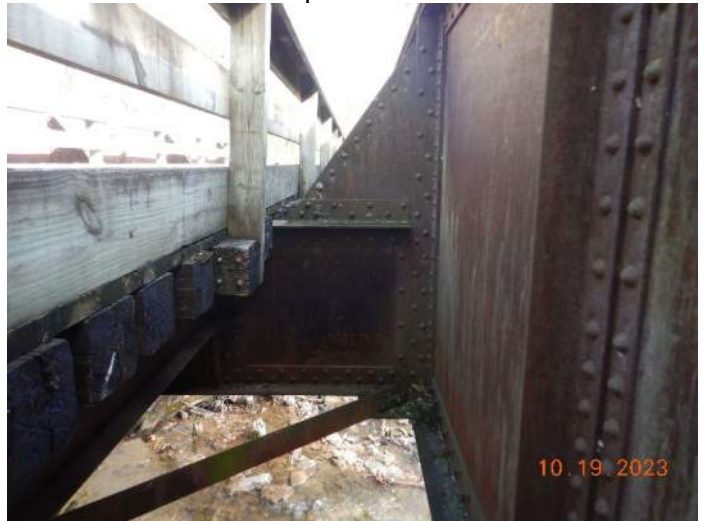
Typical minor surface corrosion of all steel members. Overview of floor beam through truss connection.

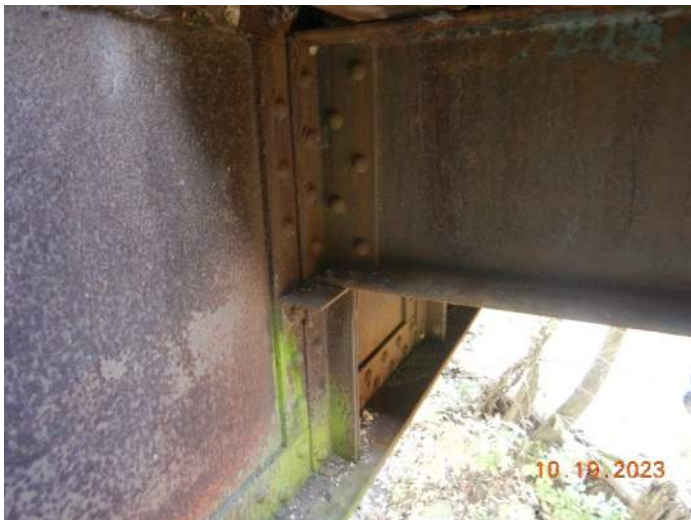
Typical floor beam to stringer connection.

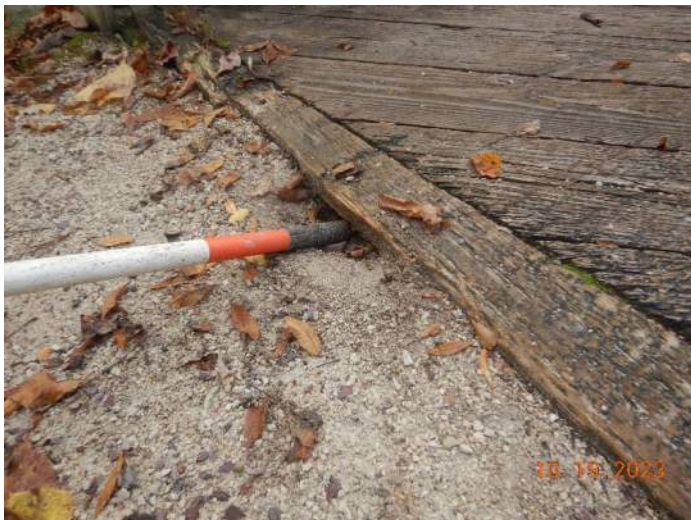
Minor sinkhole at the north approach.
