S-13 Tri Co (Cheese Country) Bridge #40

Project Title Cheese Country Trail Bridge #40 Replacement					Current Funded Miles	New Miles (if applicable)
County Green	Township 01 N	Range 6	Section 5	¼ ¼ SE	¼ SW	GPS Coordinates: Lat. 42.580256 Long. -89.809841

Bridge ID / Structure No.  <b>Bridge #40</b>	<b>Inspection Date:</b>	11.20.2025
	<b>Inspection TL:</b>	Nate Miller, PE
	<b>NBI Project No:</b>	2503501

Inspection Report for  
**Bridge #40**  
Cheese Country Trail over Pecatonica River

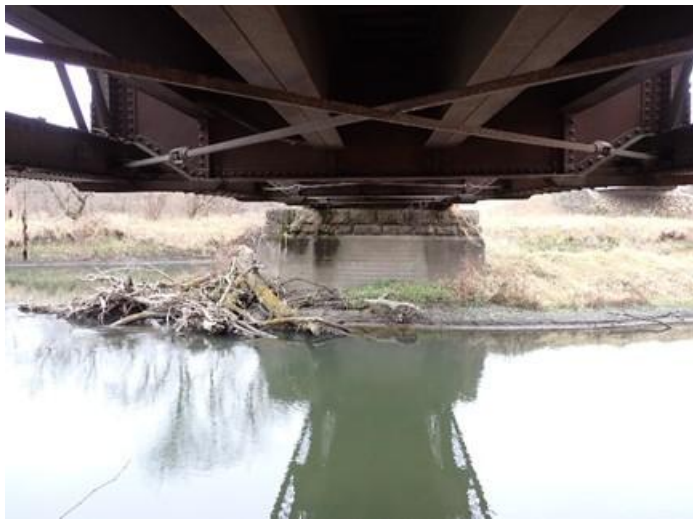
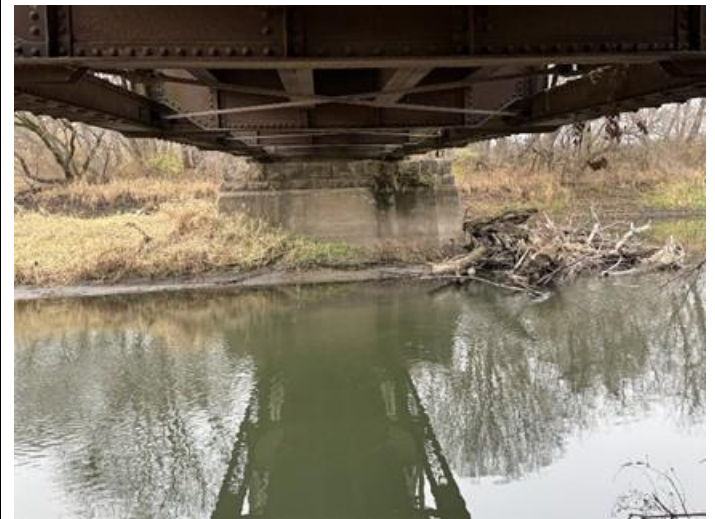
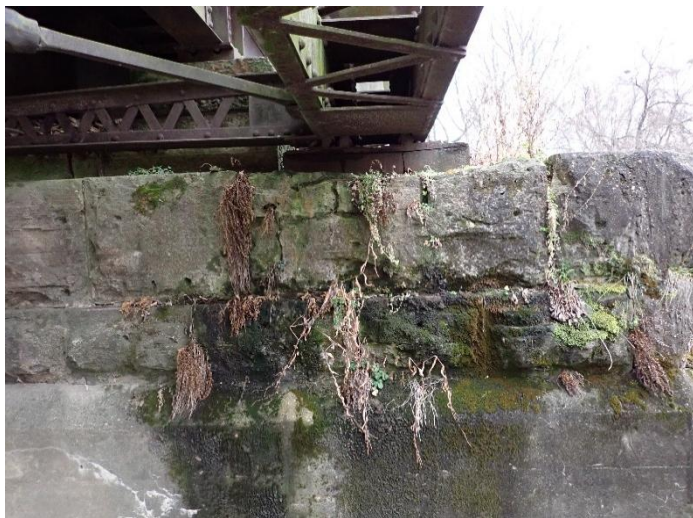
1. Stone Block Masonry/Cast-In-Place Concrete Pier Wall. Limited Inspection Due to Access Limitations. **Unknown bearing conditions.**
2. General deterioration throughout with widespread areas of map cracking with efflorescence and missing mortar in joints.

- 1. Streambed Scour: Unable to verify scour conditions on upstream end of Pier W1 due to flood debris accumulation. Remaining substructure units beyond channel flow during inspection.

- a. Comprehensive concrete/masonry repair of the west abutment, and piers W1 and W2.
- b. Complete replacement of piers W3, W4, and the east abutment.

- c. Complete additional inspections of pier W1 after removal of built-up flood debris to assess the physical and scour conditions of, and adjacent to, the pier not readily accessible during this inspection.
- d. Complete an unknown foundation/scour analysis.

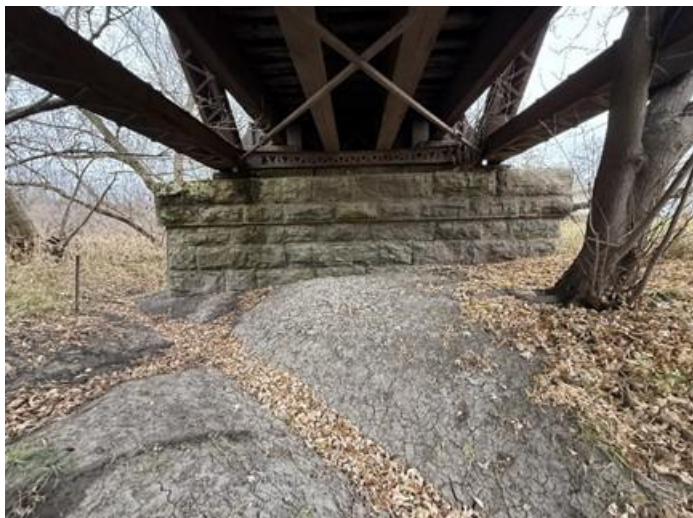
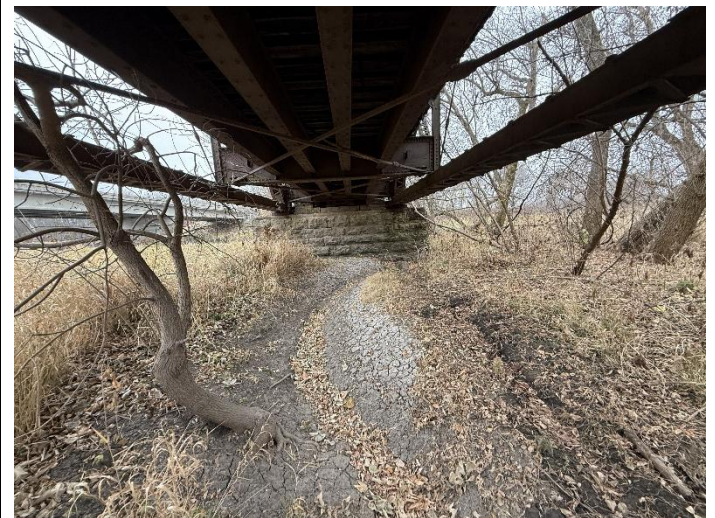
1. Stone Block Masonry Pier Wall w/ 5"-6" Cast-In-Place Concrete Leveling Course Under Span W3 Truss Bearings.
2. General deterioration throughout masonry with areas of horizontal cracking and surface spalling of blocks, and missing mortar throughout joints.
3. General deterioration throughout leveling course with widespread areas of exposed aggregate, concrete is largely free from moderate/wide width cracking

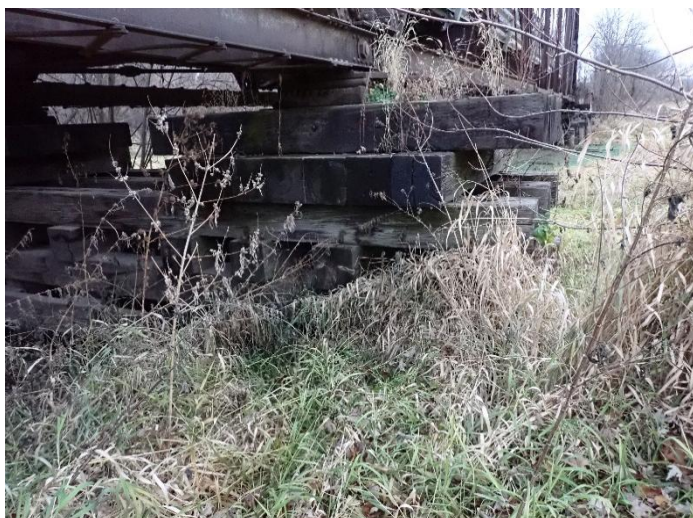
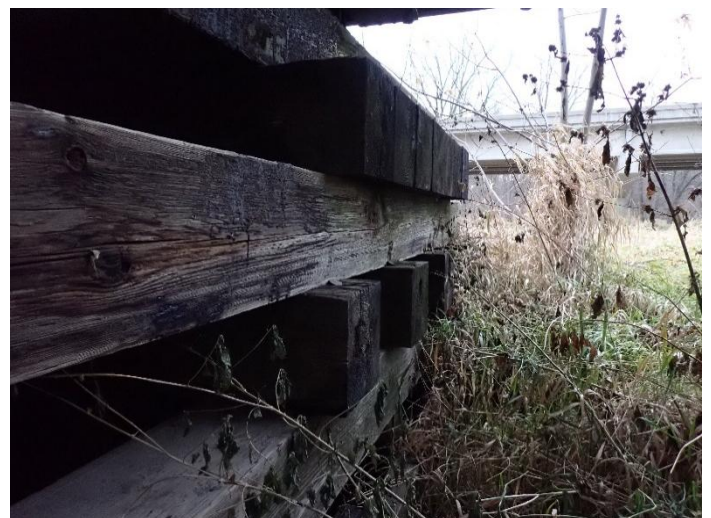
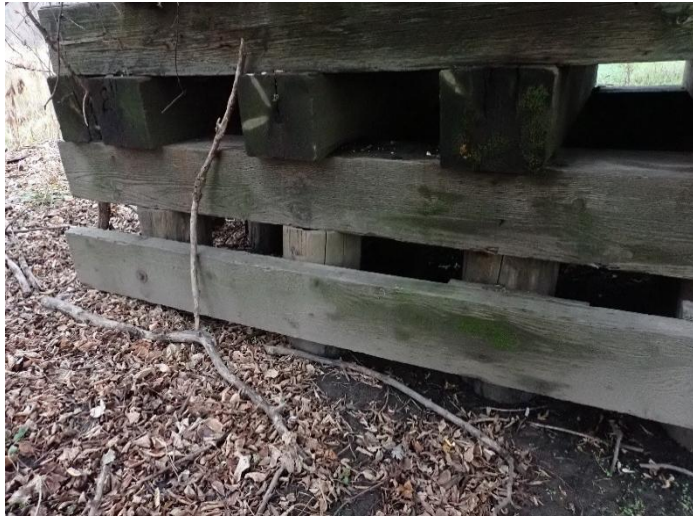
1. Driven timber piles with timber cribbing/pile caps.
2. Decayed timber components throughout with initial signs of crushing.
3. Caps are decayed 75%-90% throughout with widespread cracking and splitting. Components generally appear hollow when sounded with soft/easily dented outer shells. Decay and splitting is more pronounced at the ends of cribbing.
4. Piles: Bearing piles sound hollow with an estimated 75%-90% loss of section.

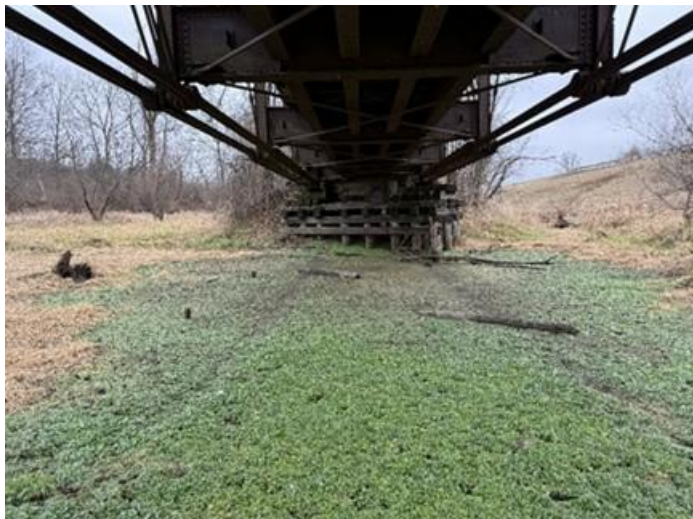
- Multiple piles, pile caps, and blocking components are severely decayed and crushed in Pier W4.
- Advanced decay with initial signs of crushing timber in Pier W3.
- Rollers bearing assemblies are displaced in multiple bearings.

1. Driven timber piles with timber cribbing/pile caps.
2. **Decayed timber components throughout with readily evident signs of crushing. Multiple piles and caps are completely split/crushed. Pier is unstable.**

1140 <b>CS4: Piles sound hollow throughout with prominent vertical checking/splitting. Estimated 75%-100% decay/section loss of piles. Pile shells soft/easily damaged. Multiple piles in Pier W4 are completely split and are unstable.</b>							
		4000 Settlement No readily visible signs of settlement.		EA					
		6000 Scour Piers W3 & W4 beyond channel flow during inspection.		EA					
		Protective Coatings: CS4: Timber preservative treatment ineffective.

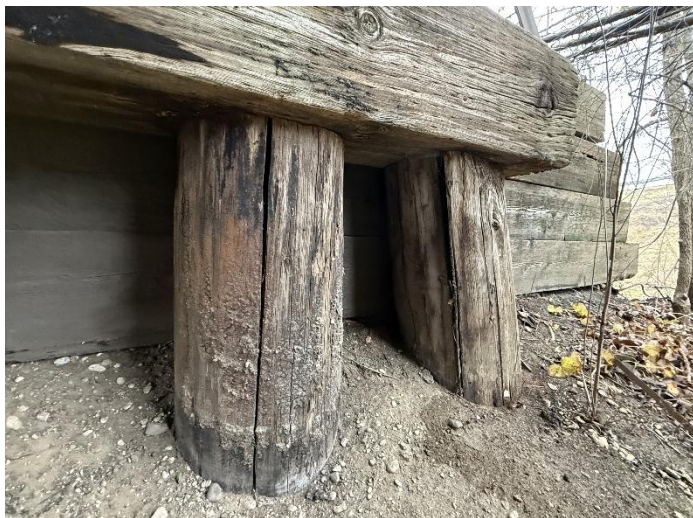
1. Driven timber piles, timber pile caps, and timber backwall plank.
2. Decayed timber components throughout with no readily evident signs of crushing.
3. Caps are decayed 75%-90% throughout with widespread minor checking and generally appear hollow when sounded. More advanced decay throughout north half of cap with full depth vertical splitting of cap.
4. Piles: Bearing piles sound hollow with an estimated 75%-90% loss of section. Multiple piles split vertically.

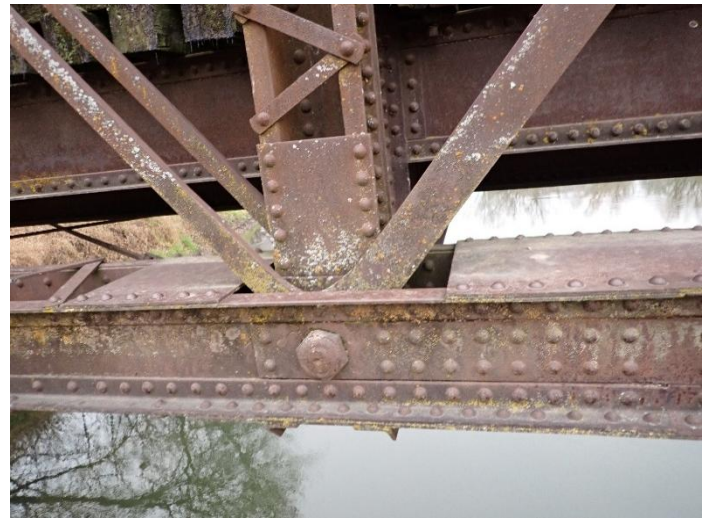
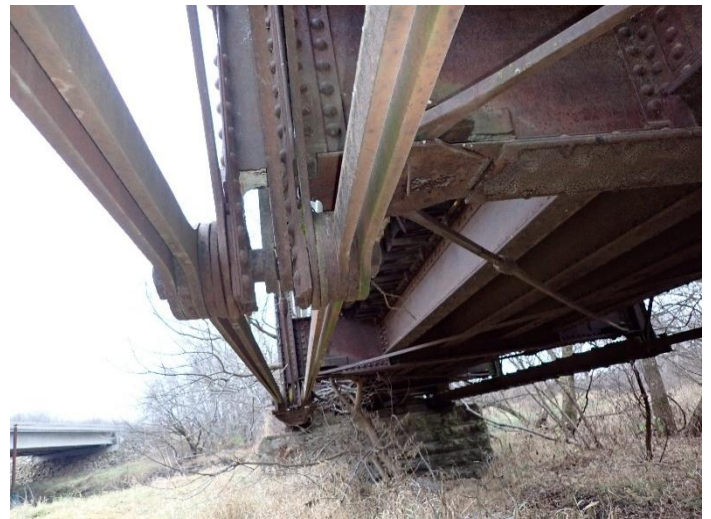
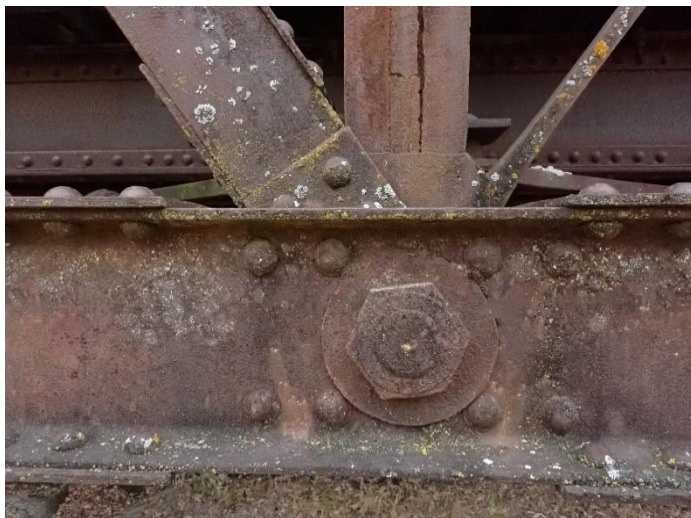
1. Spans W1-W4: Steel Pin-Connected Through Truss.
2. Surface corrosion throughout length of truss spans with isolated areas of section loss (pitting) and pack rust.
3. Pack rust with isolated areas of deformation of built-up members.
4. Widespread areas of minor damage to various truss members and floor beams.
5. Coating system has failed and offers no effective protection to steel elements.

Evaluate economic feasibility of comprehensive superstructure rehabilitation and replacement. Efforts required to return bridge to service to include at least the following (additional investigations would be required to develop a complete rehabilitation plan):
