### #15 Kewaunee Krok Creek Bridge

**Motorized Recreation Grant Application**

#### **Bridge Project Detailed Description**

### **BRIDGE INSPECTION REPORT**

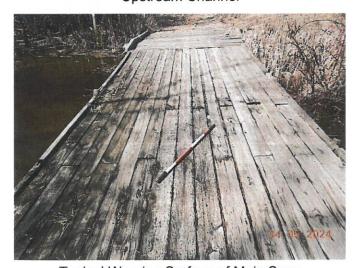
Typical Wearing Surface of Main Span

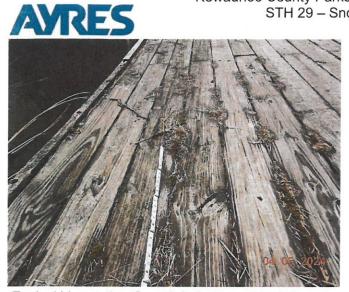
Typical Vegetation Growth in between Deck Boards

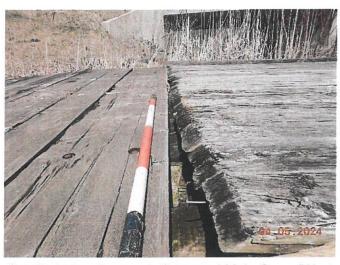
Gap Between Approach Span and Main Span (West Shown)

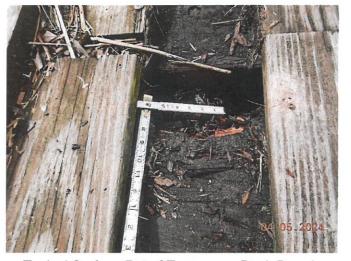
Typical Surface Rot of Transverse Deck Boards

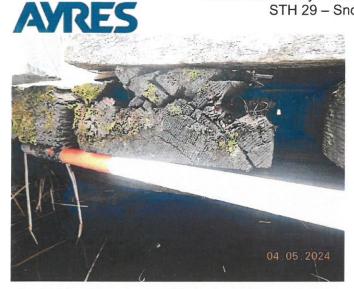
Typical Deterioration of the Transverse Deck Board Ends

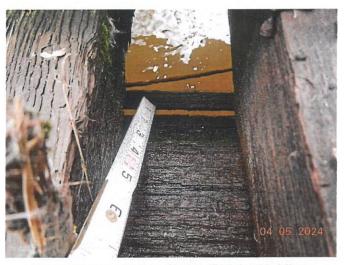
South Fascia Timber Girder (Pole) with Minor Splinter and Section Loss

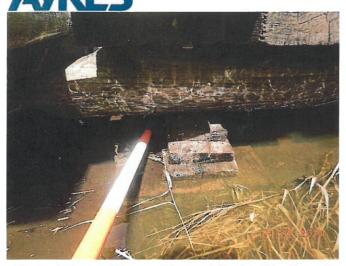
Typical Timber Pier on Channel Banks (Southwest Quadrant Shown)
