S-15 Tri Co/Cheese Country Bridge #45

Project Title Cheese Country Trail Bridge #45 Replacement					Current Funded Miles	New Miles (if applicable)
County Green	Township 01 N	Range 6	Section 2	¼ ¼ SW SW	¼ SW	GPS Coordinates: Lat. 42.578134 Long. -89.759829

Inspection Report for

Cheese Country Trail over Allen Road

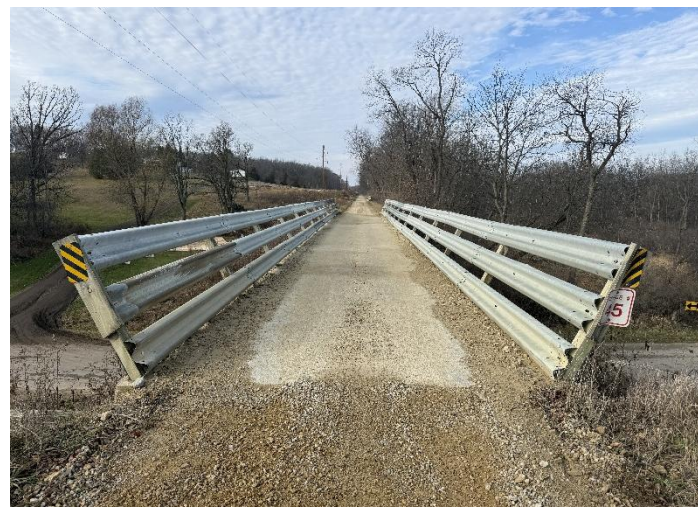
Photo 1 – Trail View Looking West.

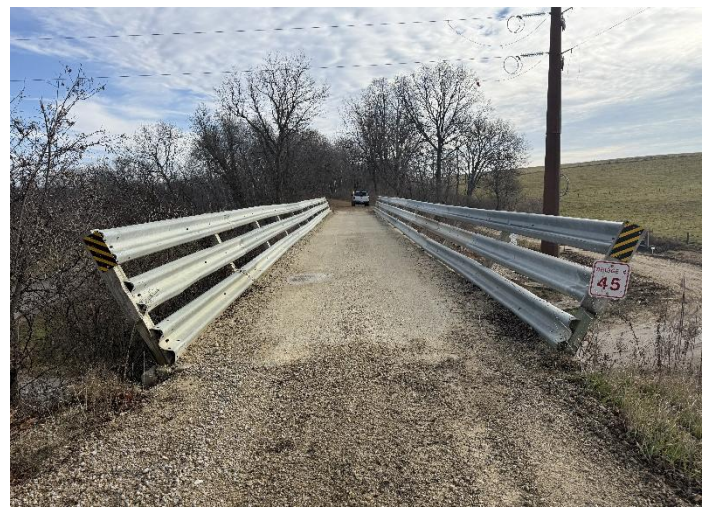
Photo 2 – Trail View Looking East.

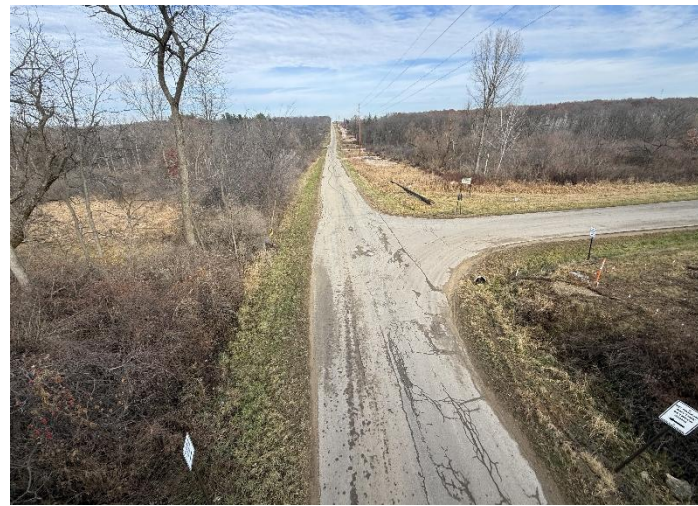
Photo 3 – Allen Road Looking North.

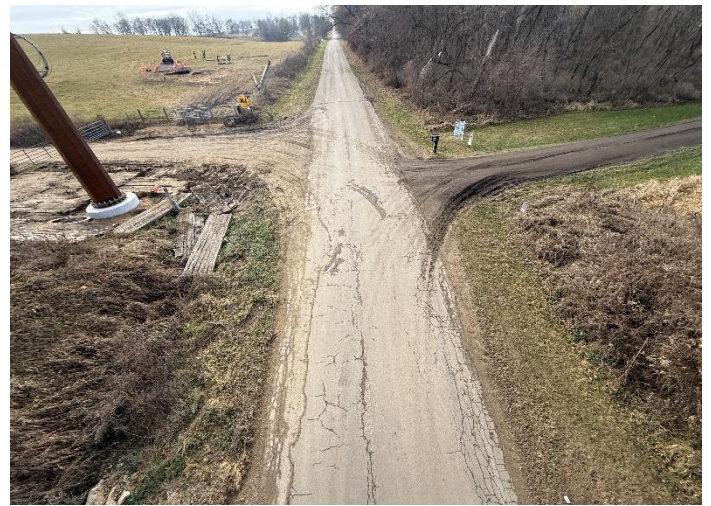
Photo 4 – Allen Road Looking South.

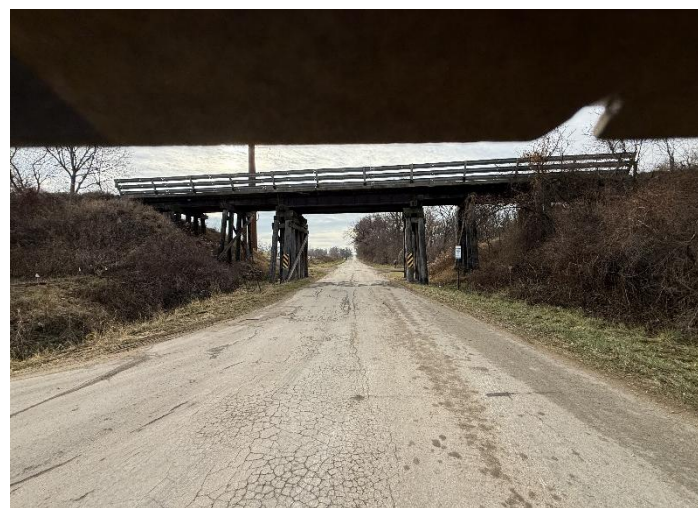
Photo 5 – Side View Looking South.

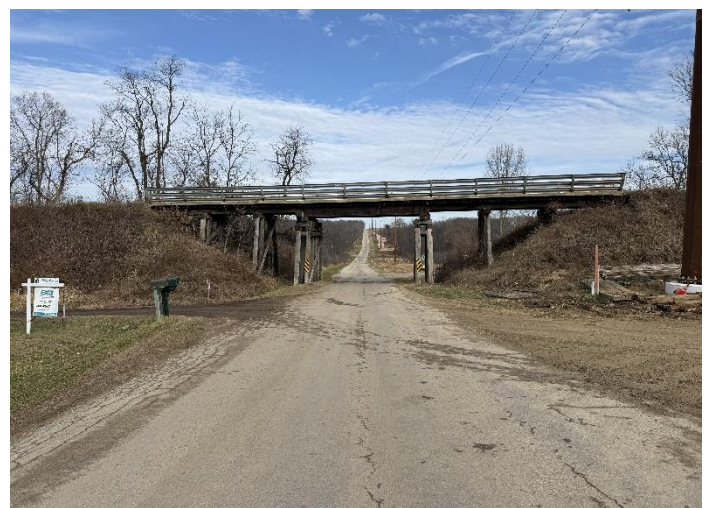
Photo 6 – Side View Looking North.

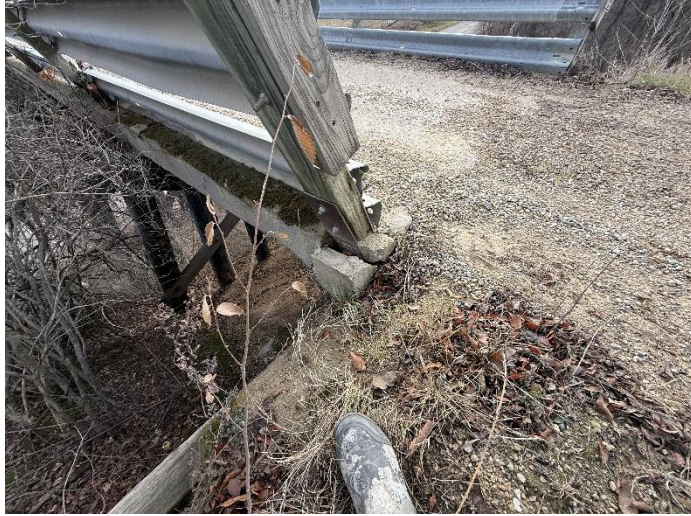
1. (3) rows of W-beam bridge rail supported by angled timber posts.
2. Initial signs of incipient decay of timber components. Timber preservative treatment appears marginally effective.
3. Widespread areas of minor damage to w-beam rails. Ends of curb rails damaged.
4. Northwest rail post anchorage/deck embedment failed.

Photo 7 – Northwest Corner of Deck.

Repair damaged rail post anchorage.

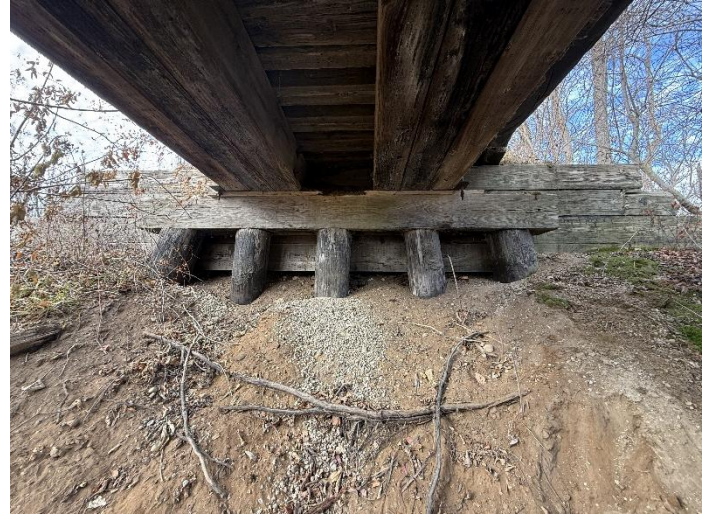
1. Driven timber piles, timber pile caps, and timber backwall plank.
2. Decayed timber components throughout with no readily evident signs of crushing.
3. Caps are decayed +/- 75% throughout with widespread minor checking and generally appear hollow when sounded. Areas of more advanced decay and splitting at ends of caps.
4. Piles: Exposed bearing piles are starting sound hollow with an estimated 75%-90% loss of section.

Photo 8 – West Abutment.

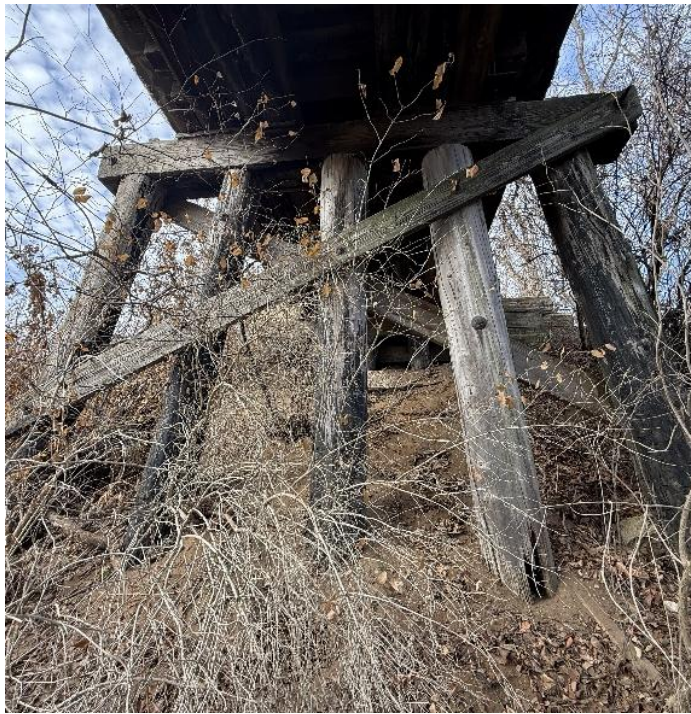
Photo 9 – Pier W1 Looking West.

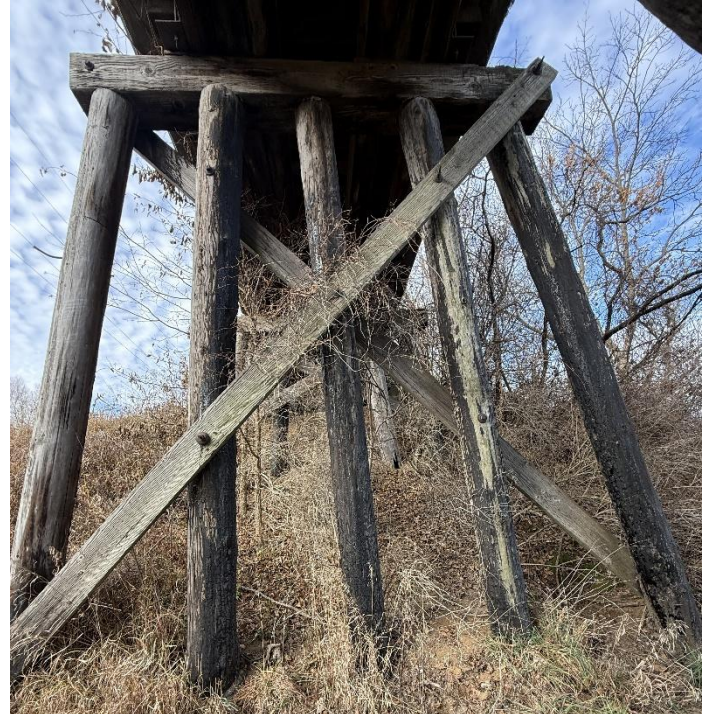
Photo 10 – Pier W2 Looking West.

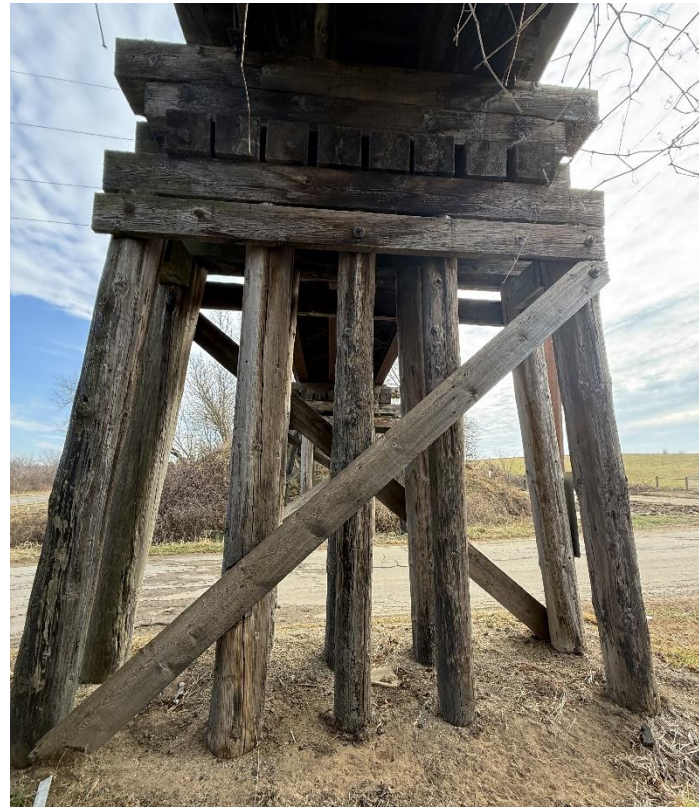
Photo 11 – Pier W3 Looking West.

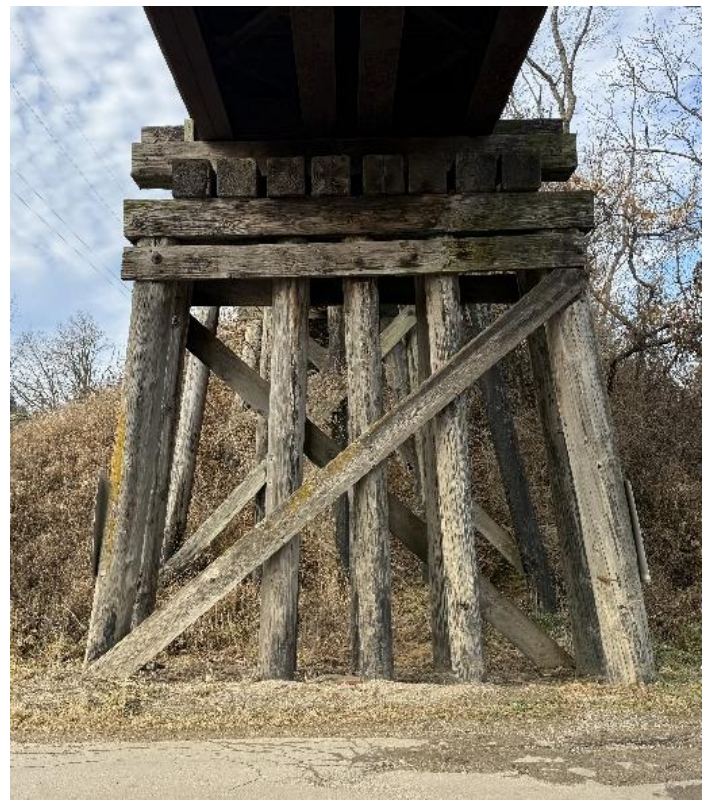
Photo 12 – Pier W3 Looking East.

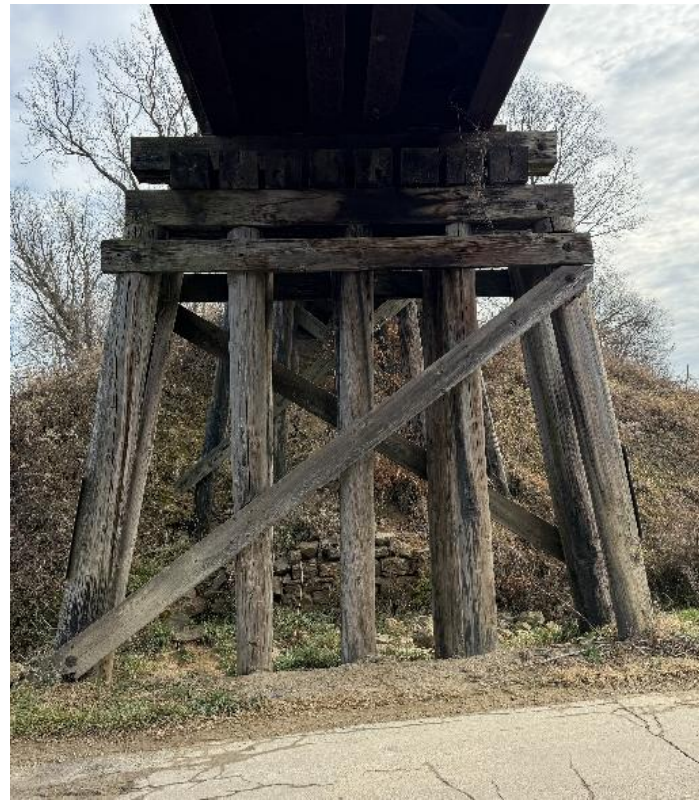
Photo 13 – Pier W4 Looking East.

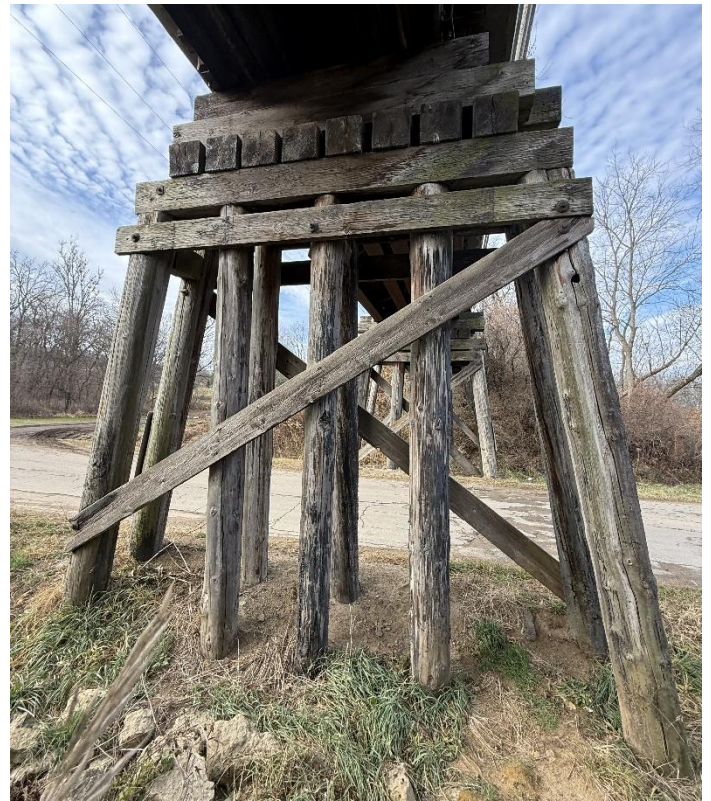
Photo 14 – Pier W4 Looking West.

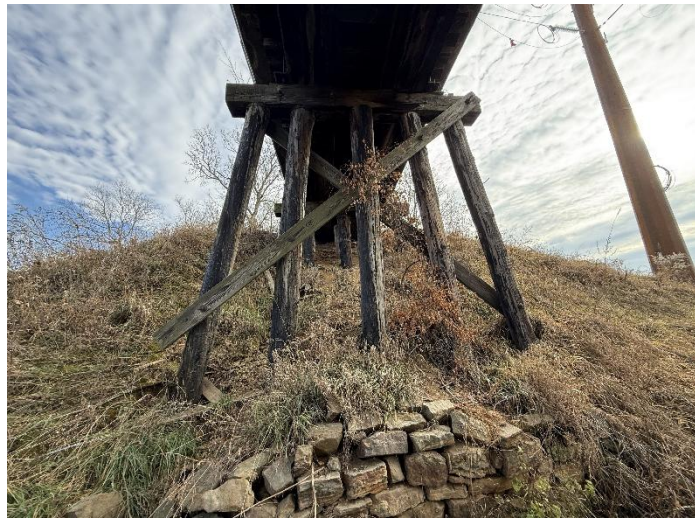
Photo 15 – Pier W5 Looking East.

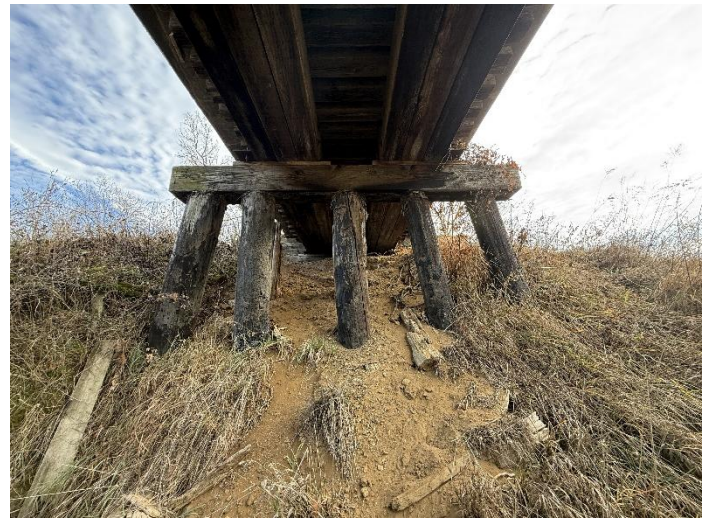
- **Multiple beam ends crushed over piers and abutments. Advanced decay and splitting of pier piles and caps. One pile crushed in Pier W6.**
- Additional overload damage may require immediate closure.

Photo 16 – Pier W6 Looking East.

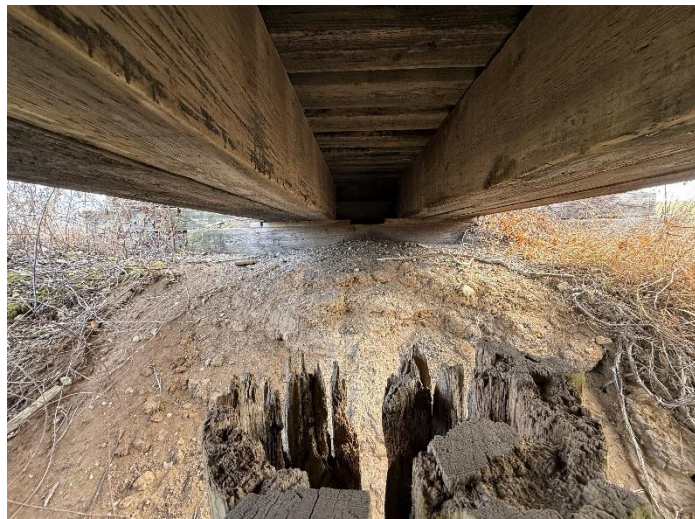
1. Embankment Erosion: Loose sandy berms at both abutments are prone to erosion. Top of 1:1 berms are within 5ft of both abutments. Erosion at east abutment berm (2ft gully at north edge of bridge). West backwall plank undermined.
2. Drift: | N/A | Not Applicable.
3. Channel Change: | N/A | Not Applicable.
4. Adequacy of Opening: | N/A | Not Applicable.

Photo 17 – East Abutment.

Installation of embankment stabilization/armoring would reduce likelihood of future erosion issues. Embankment stabilization may not be feasible, and/or recommended, given the expected longevity of the structure and current observed conditions.

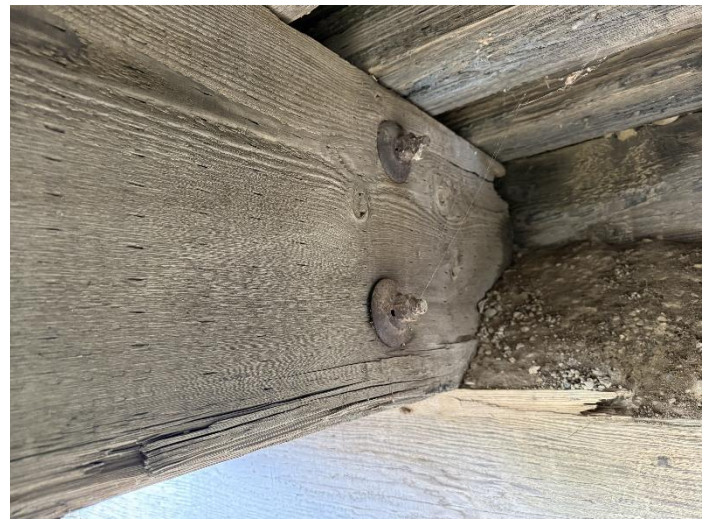
Photo 18 – Span W1-S. Beam-N. Face Over W. Abut.

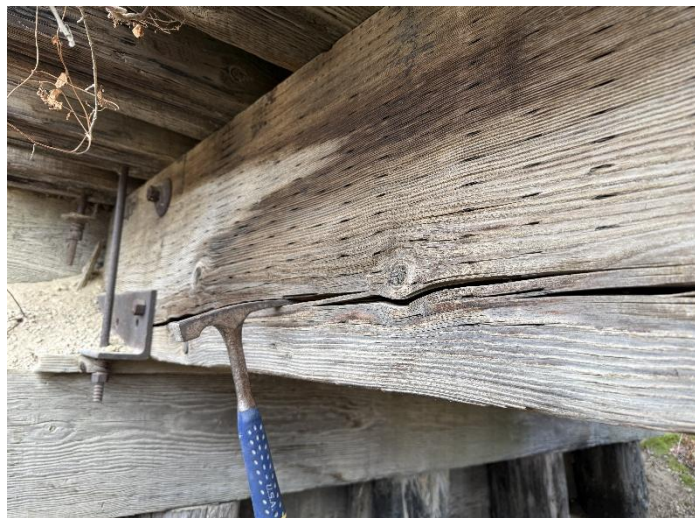
Photo 19 – Span W1-S. Beam-S. Face Over W. Abut.

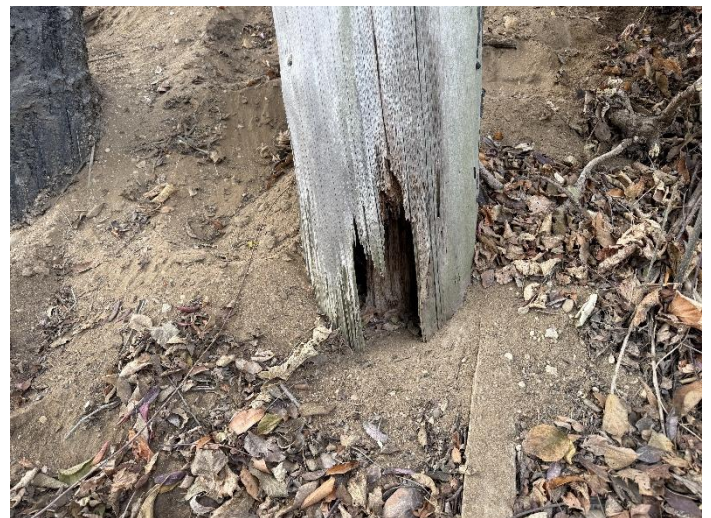
Photo 20 – Pier W1-Pile S4.

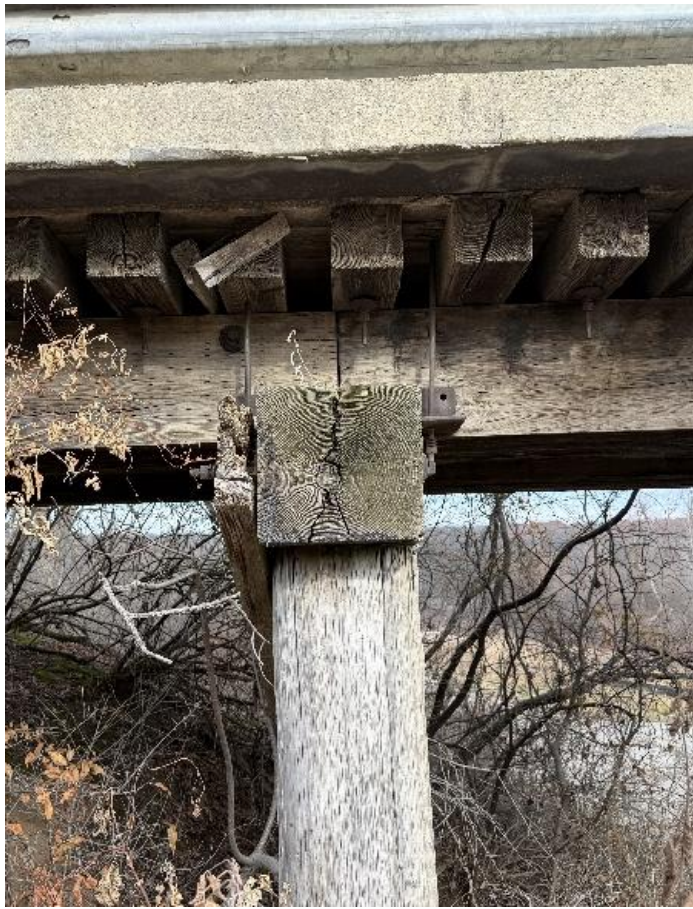
Photo 21 – Pier W1 Cap Looking North.

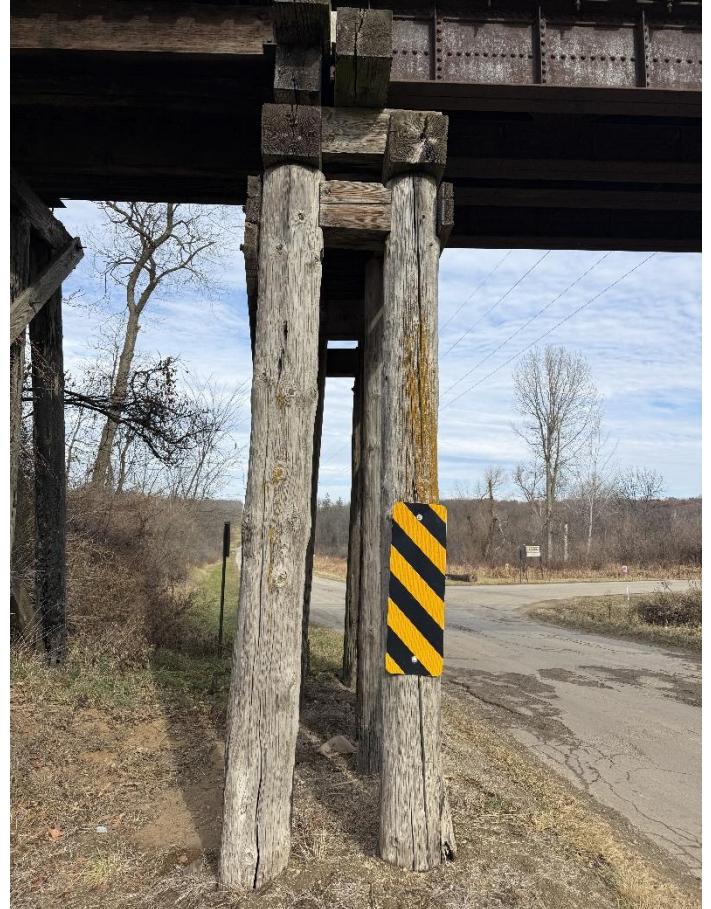
Photo 22 – Pier W3 Looking North.

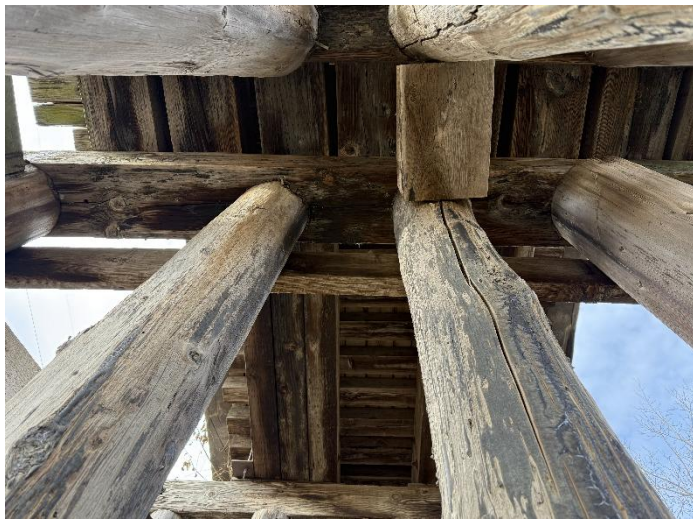
Photo 23 – Pier W3.

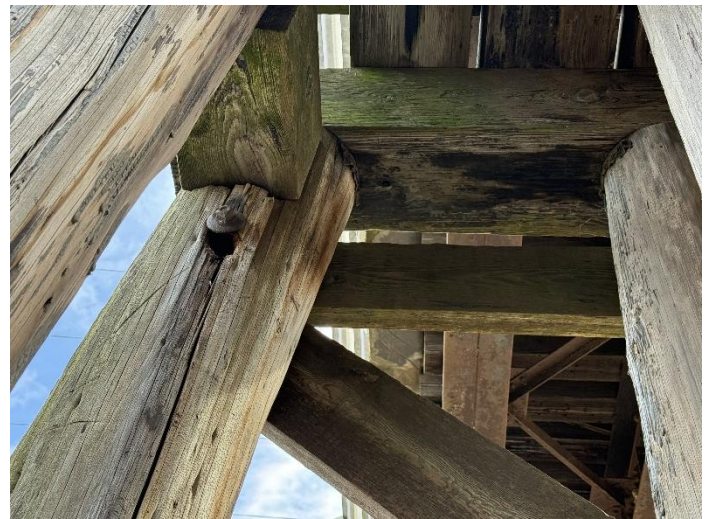
Photo 24 – Pier W3.

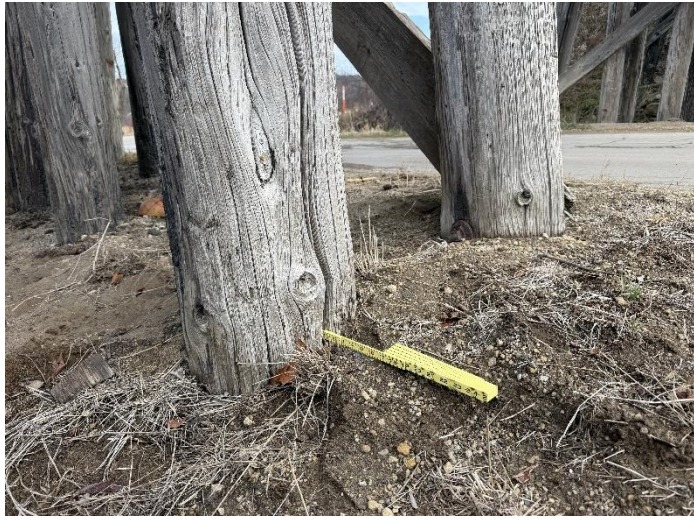
Photo 25 – Pier W3-E. Row-Pile S5.

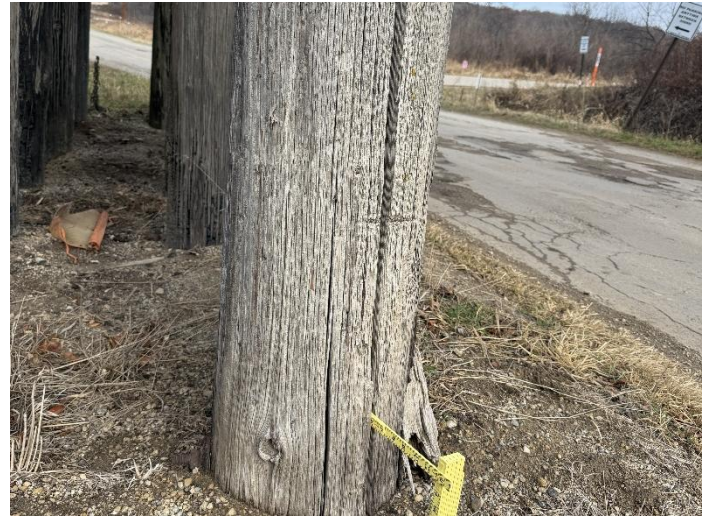
Photo 26 – Pier W3-E. Row-Pile S1.

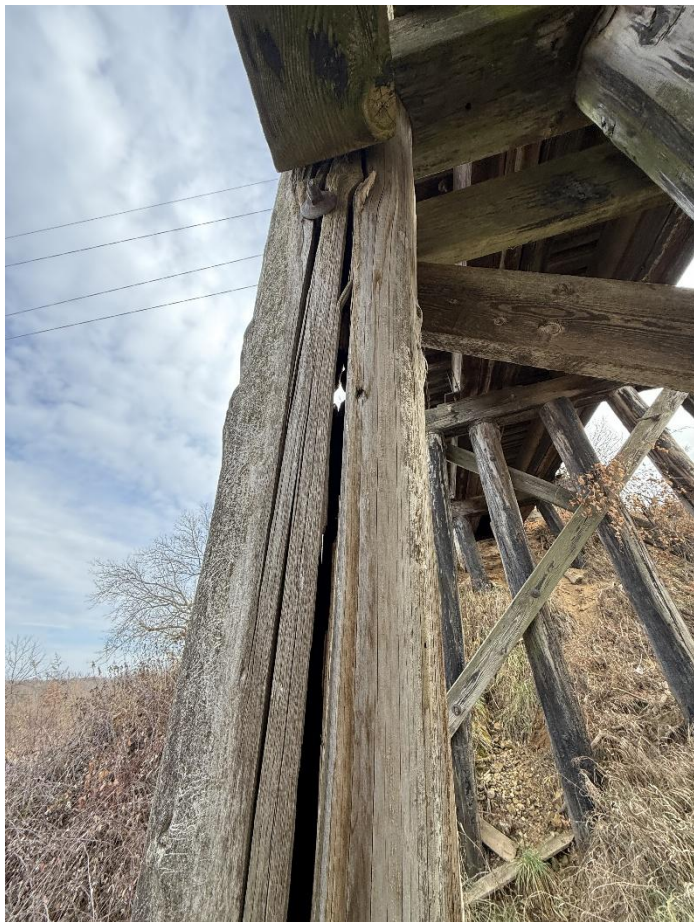
Photo 27 – Pier W4-E. Row-Pile S5.

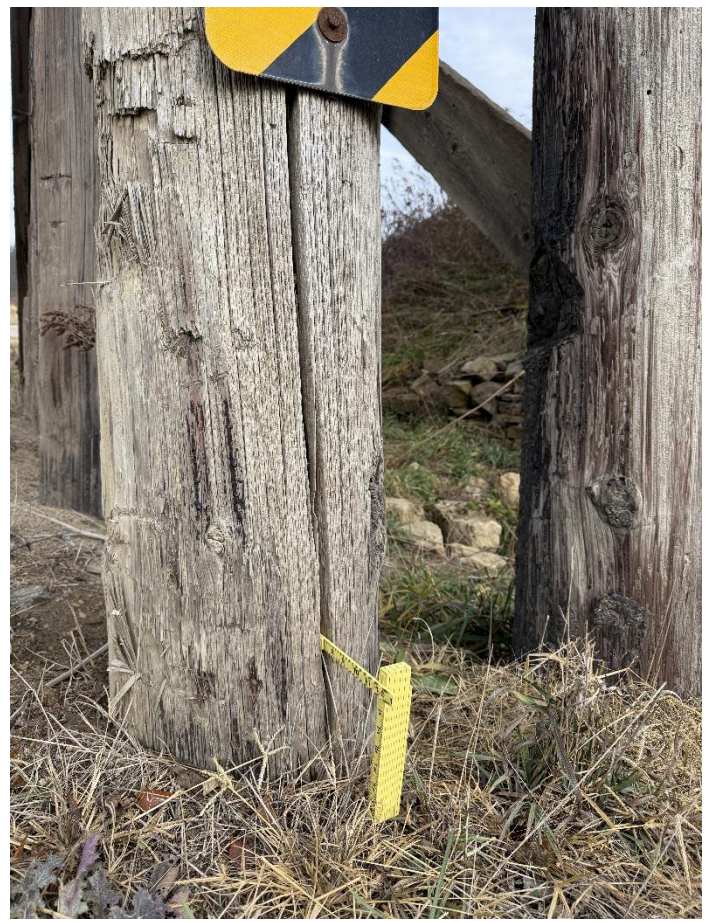
Photo 28 – Pier W4-E. Row-Pile S1.

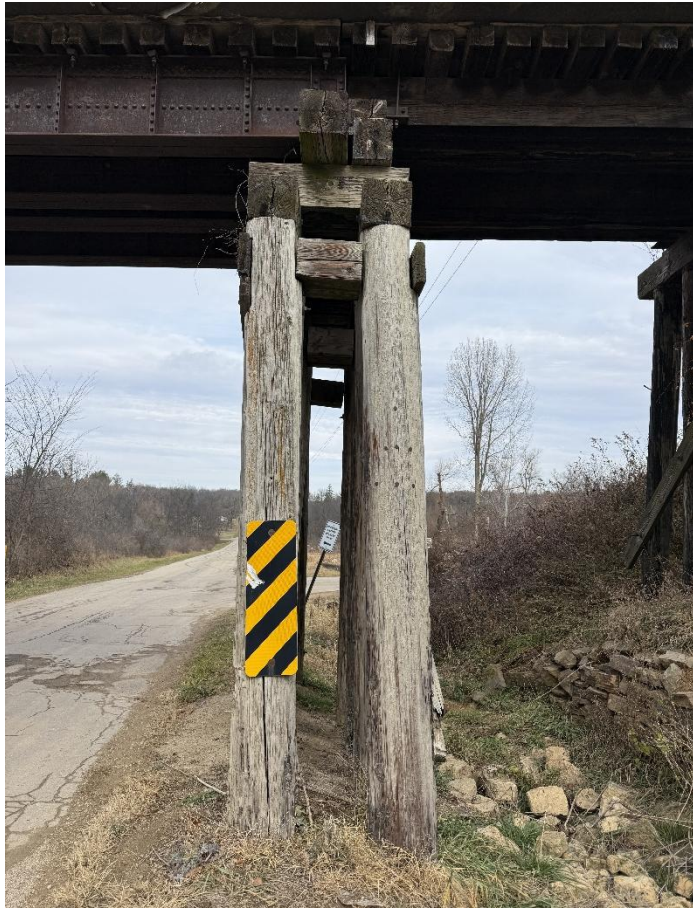
Photo 29 – Pier W4 Looking North.

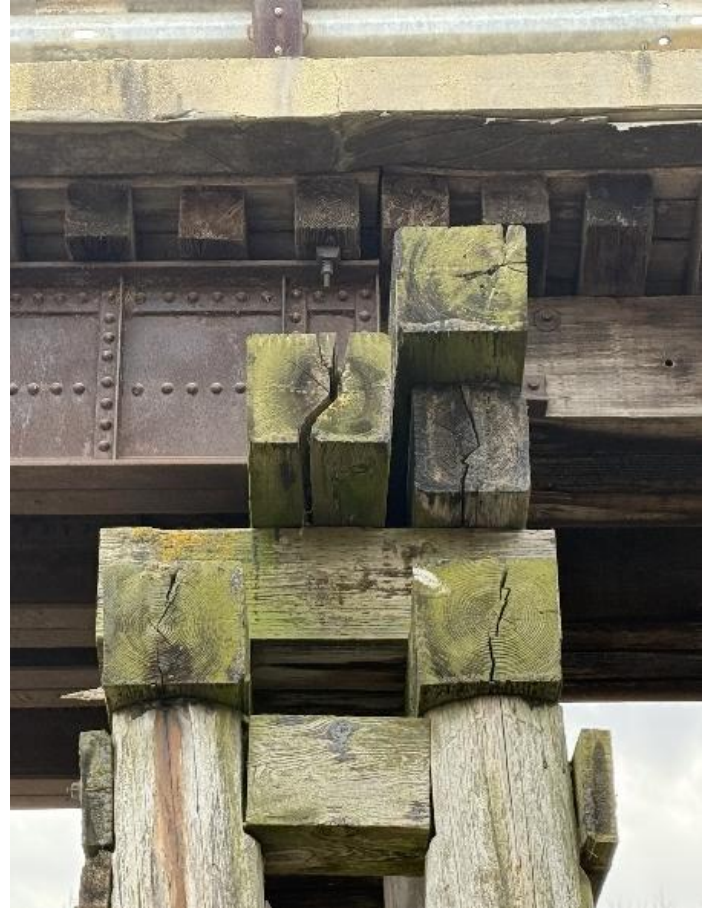
Photo 30 – Pier W3 Looking South.

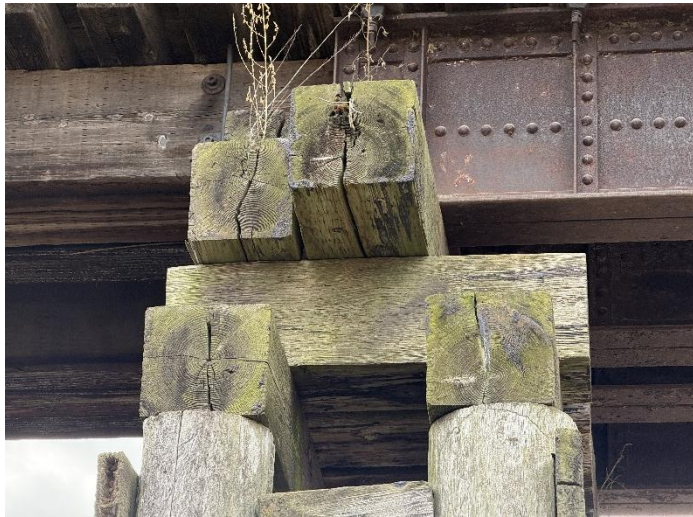
Photo 31 – Pier W4 Looking South.

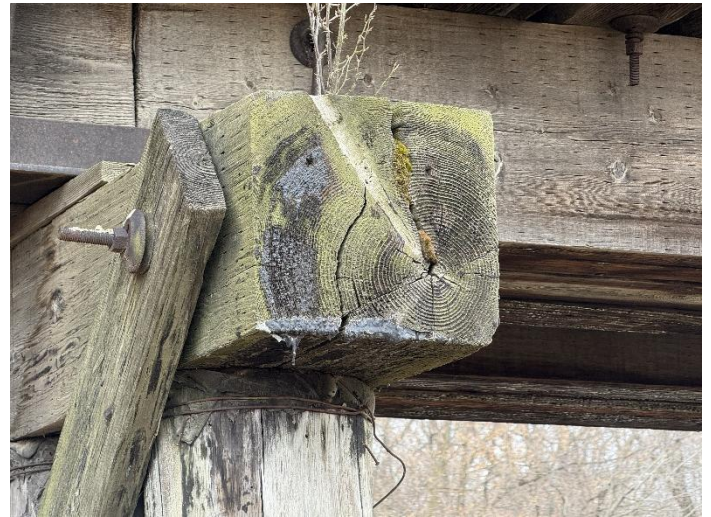
Photo 32 – Pier W5 Looking South.

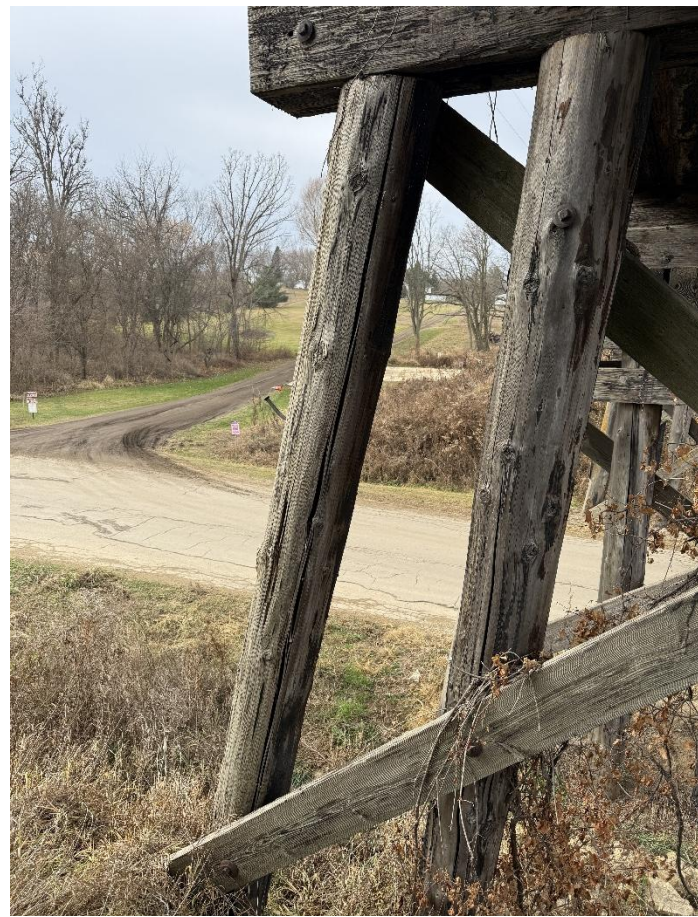
Photo 33 – Pier W5-Pile S1 Looking East.

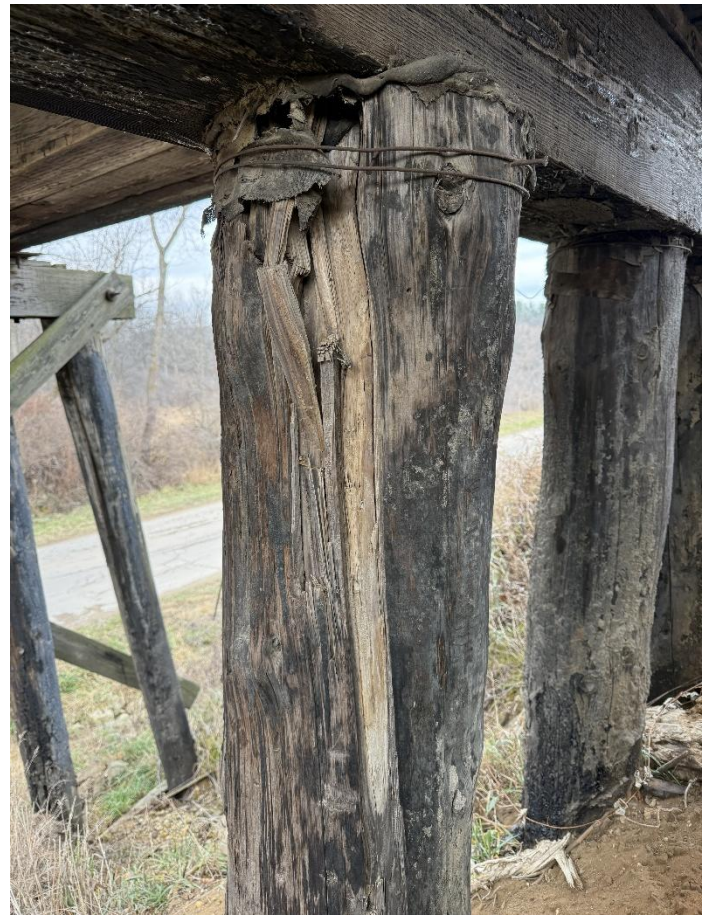
Photo 34 – Pier W6-Pile S3.

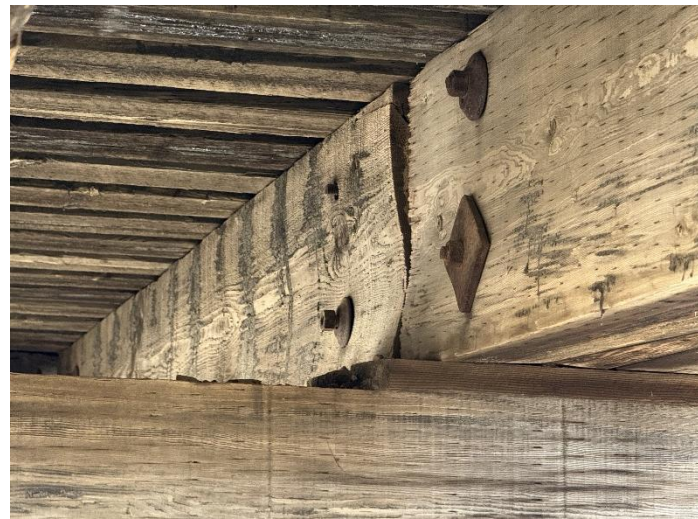
Photo 35 – N. Beam-S. Face Over Pier W5.

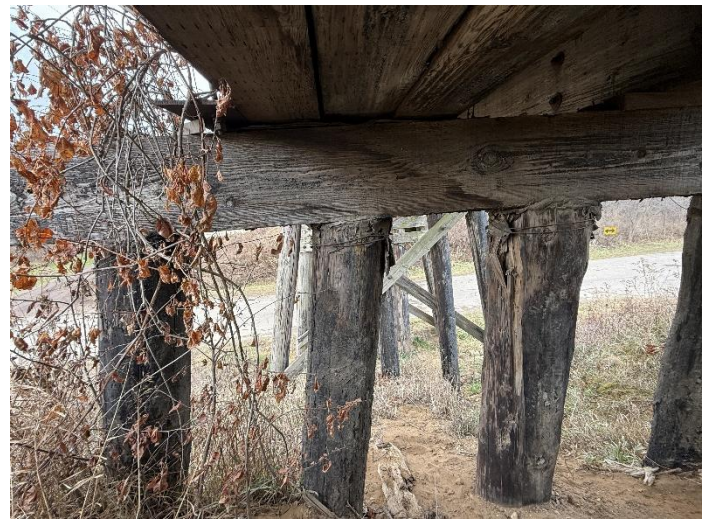
Photo 36 – Pier W6-Piles S1-S3 Looking West.

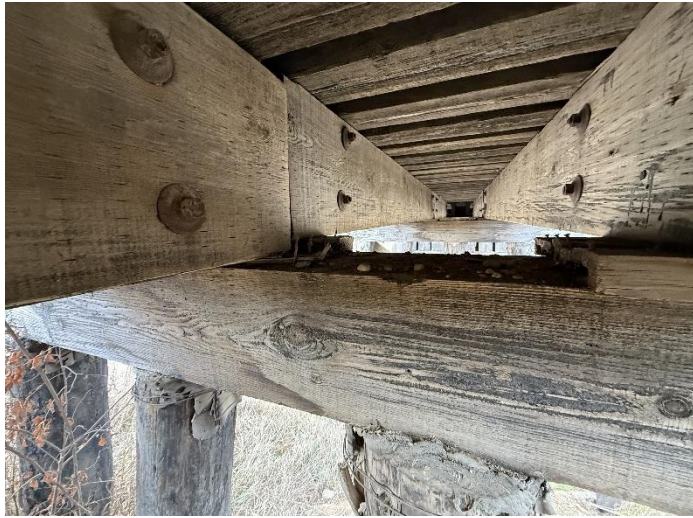
Photo 37 – Beams Over Pier W6 Looking West.

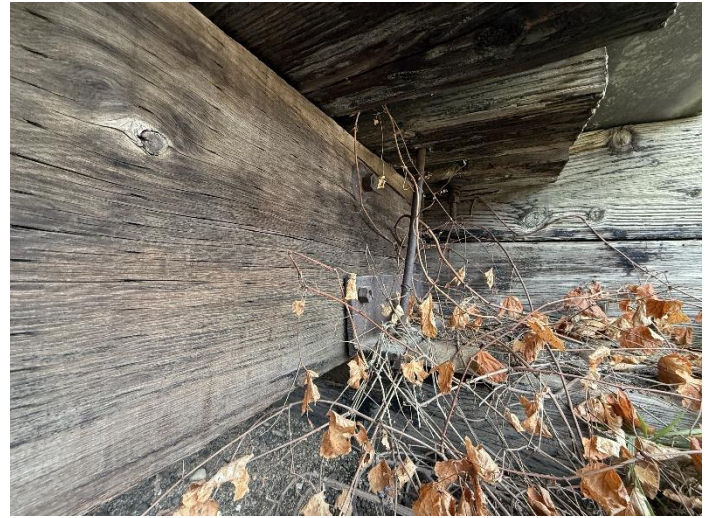
Photo 38 – South Beam Over East Abutment.

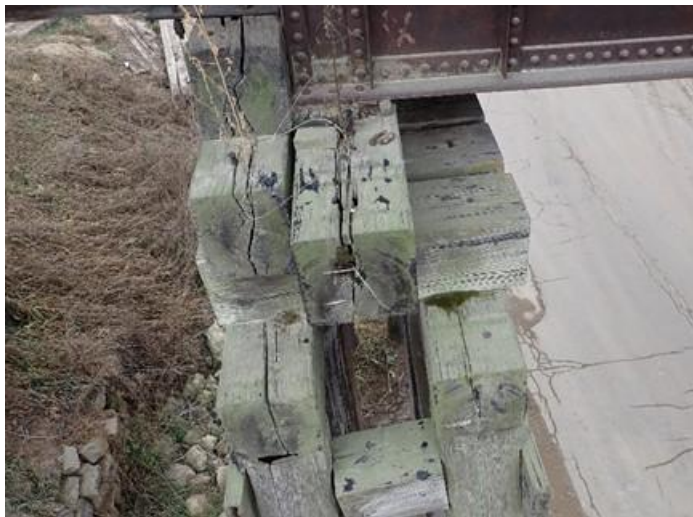
Photo 39 – Pier W4 Looking South.

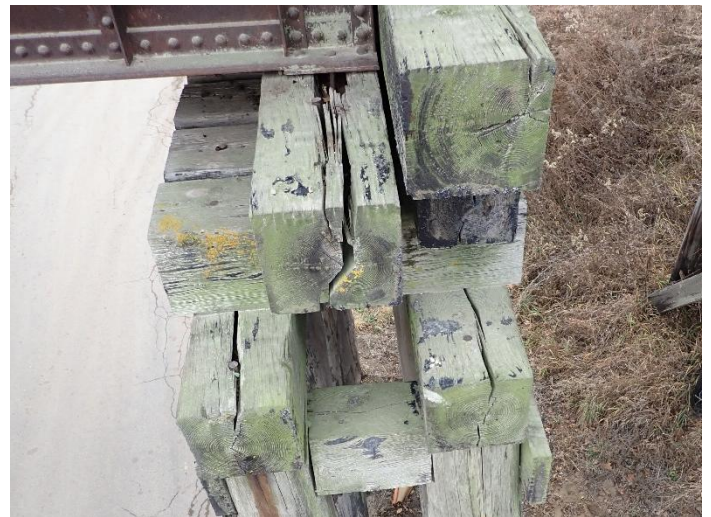
Photo 40 – Pier W3 Looking South.

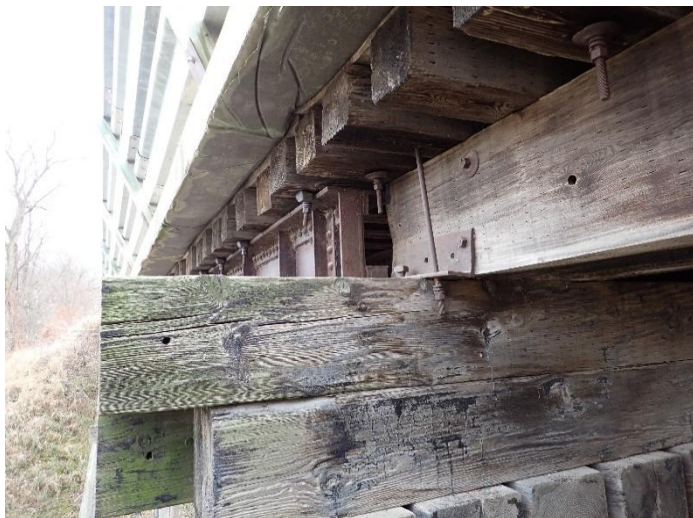
Photo 41 – Span W3-South Beam Looking East.

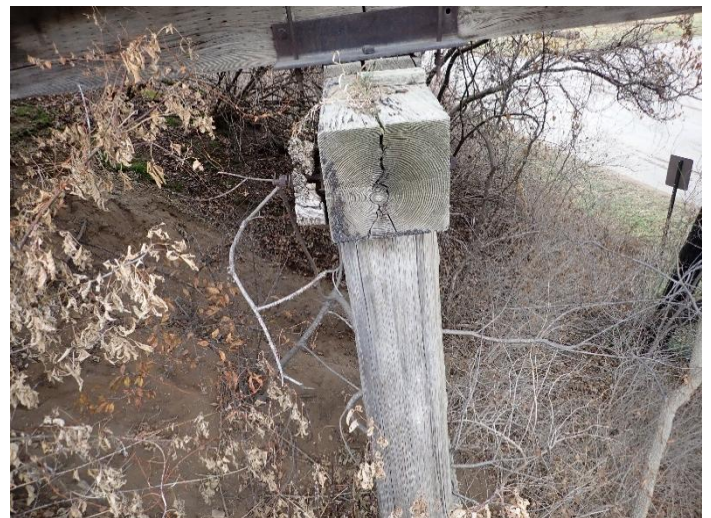
Photo 42 – Pier W1 Looking North.

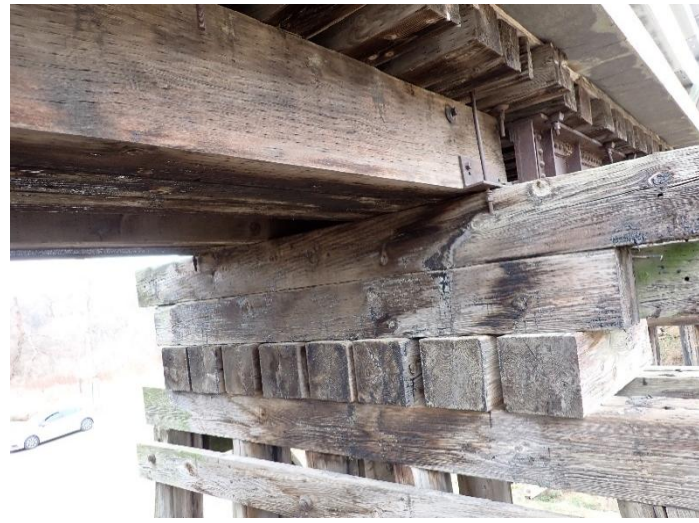
Photo 43 – Pier W3 Looking East.

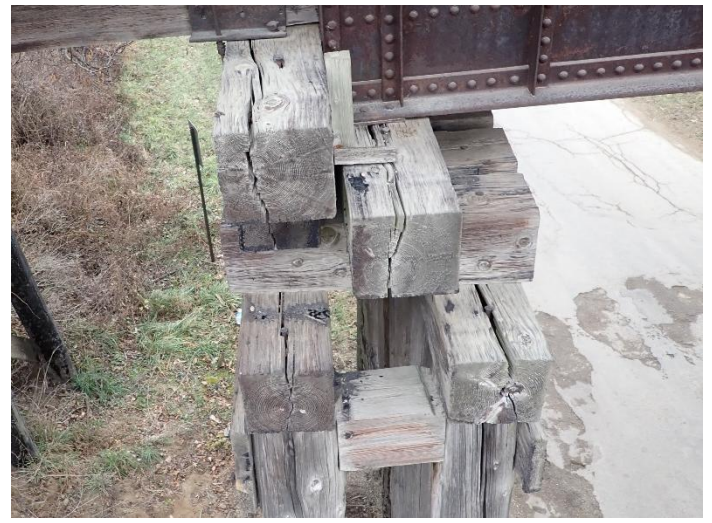
Photo 44 – Pier W3 Looking North.

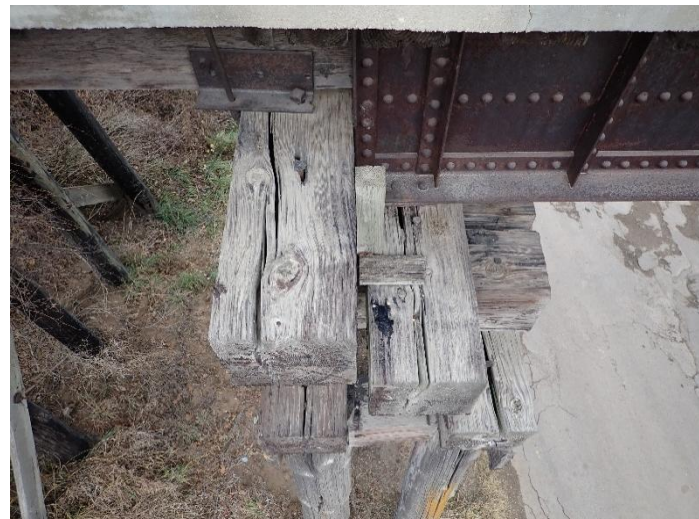
Photo 45 – Pier W3-South End.

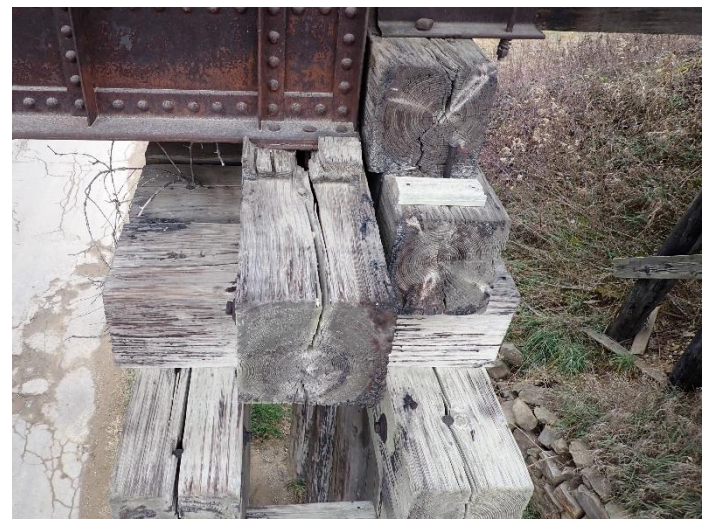
Photo 46 – Pier W4-South End.

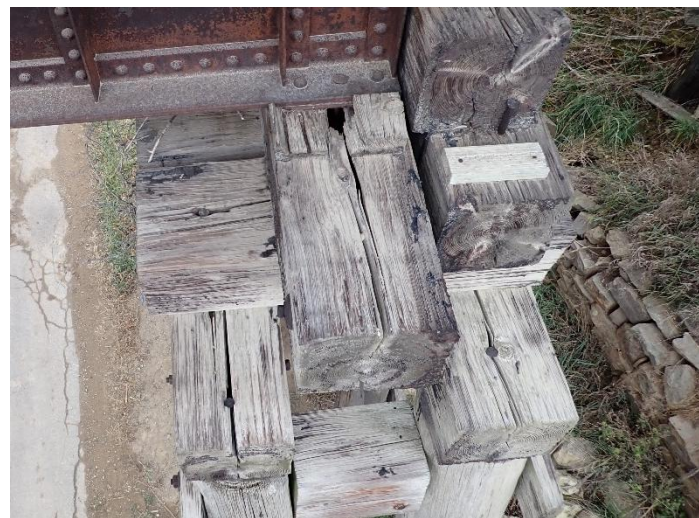
Photo 47 – Pier W4-South End.

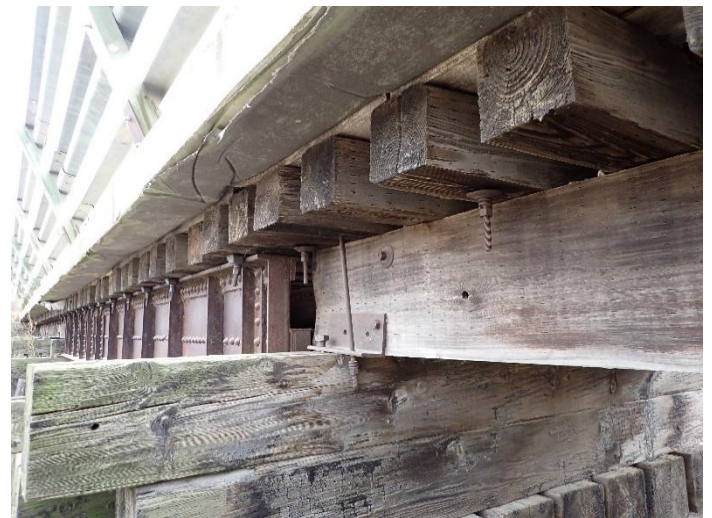
Photo 48 – Span W5-South Beam Looking East.
