S-17 Tri Co/Cheese Country Bridge #32

**Motorized Recreation Grant Application**

Project Title Cheese Country Trail Bridge #32 Replacement					Current Funded Miles	New Miles (if applicable)
County Lafayette	Township 01 N	Range 5	Section 6	¼ ¼ UN	¼ UN	GPS Coordinates: Lat. 42.586527 Long. -89.950638

<b>Bridge ID / Structure No.</b>		<b>Bridge 32</b>		<b>Inspection Date:</b>	05.19.2025
				<b>Inspection TL:</b>	Nate Miller, PE
				<b>NBI Project No:</b>	2503500
<b>Inventory Data</b>	Location Desc: Cheese Country Trail 1,500' East of Larse Road (West of Sargent Road)				
Feature On:	Cheese Country Trail	Feature Under: Unnamed Wetland/ Marsh Area			
Orientation	Traffic Direction: EB – WB	Channel Flow: Upstream: N Downstream: S			
<b>Structure Type</b>	No. Spans: 4	Wearing Surface: 1" Crushed Stone			
Deck	8" Concrete over 7.5" Square Cross Ties				
Superstructure	3-Ply 17.5"x9.5" Timber Beams	No. Beam Lines: 2			
Substructure	Abutments: Timber Pile Bent	A01 Height: 5.5'	A02 Height: 3.6'		
	Pier(s): Timber Pile Bent	P01 Height: 9.2'	P02 Height: 9.4'	P03 Height: 8.7'	
<b>Geometric</b>	Deck Length (O-O): 62.0'	Span Length(s): 14.5', 15.5', 14.5', 15.0'			
	Width (O-O): 12.0'	Width (C-C

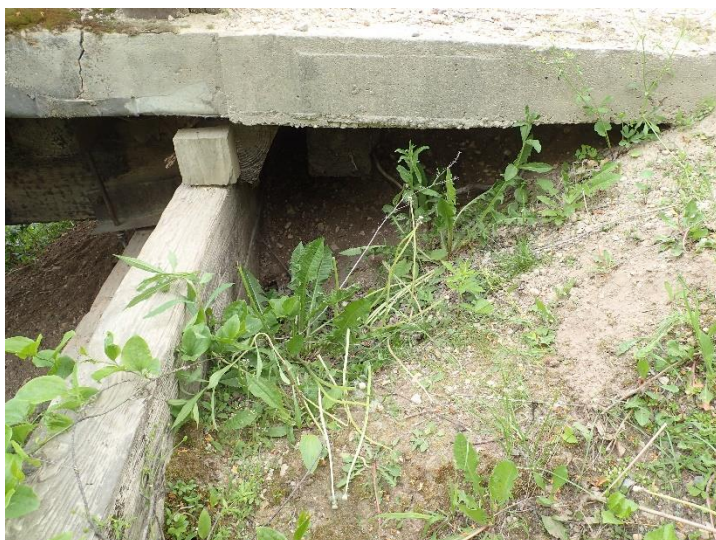
Photo 3 – East Approach

South edge of concrete slab undermined behind east abutment at east approach.

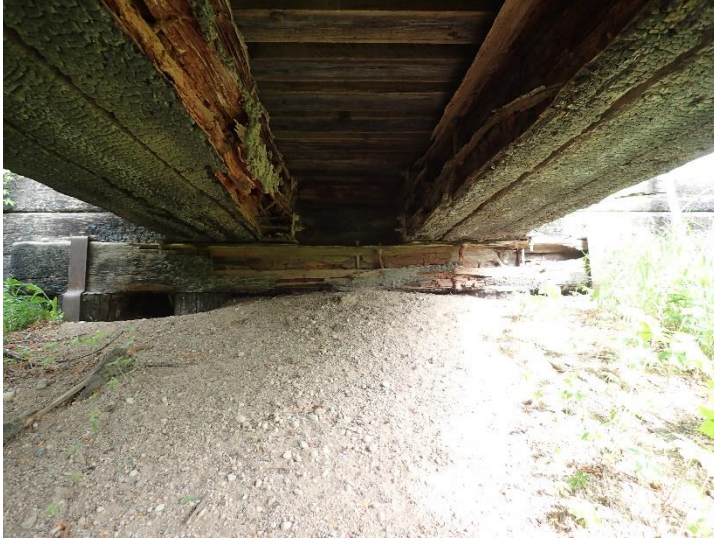
Photo 4 – West Abutment

1. Scour Susceptible: No			
2. Caps: Timber – Advanced decay with approx. 90% loss of section. Outermost 1/2" fire damaged.			
3. Wings: Timber lagging plank fire damaged.

Underside of bridge looking west. Advanced decay with section loss of beams and west abutment pile cap readily visible.

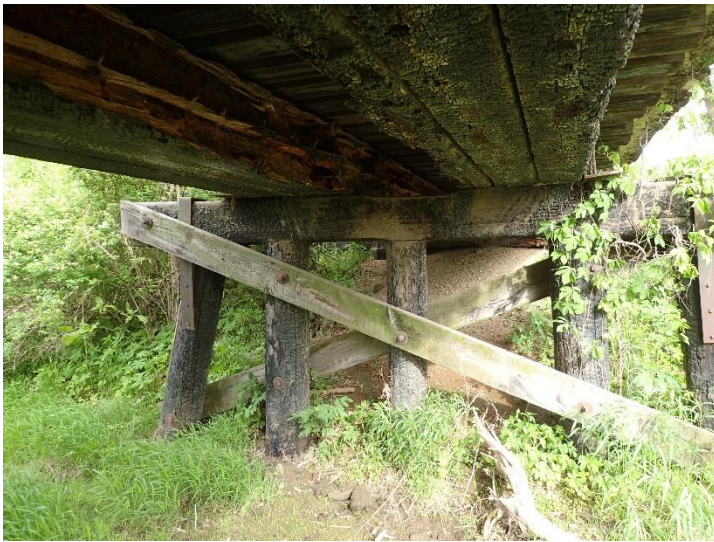
Photo 5 – Pier E3

Underside of bridge looking west. Fire damage to west pier and beams. Advanced decay with section loss of north face of southern beam line readily visible.

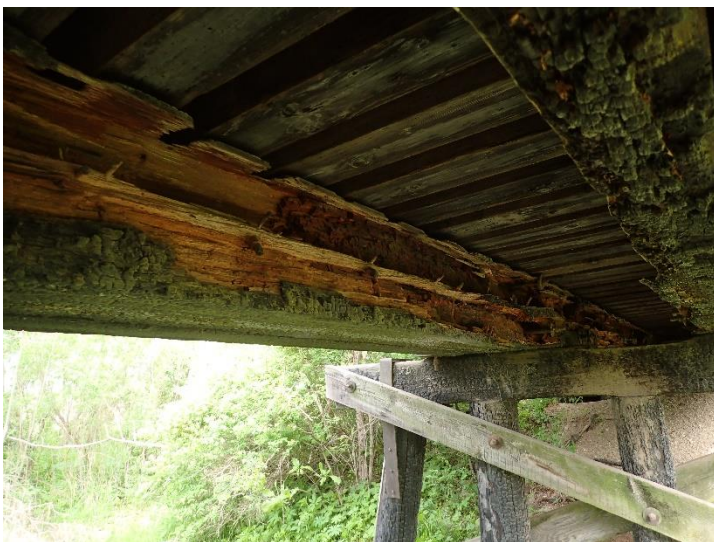
Photo 5 – Span E3 Looking West

Underside of bridge looking southwest. Fire damage to west pier and beams. Advanced decay with section loss of north face of southern beam line readily visible.

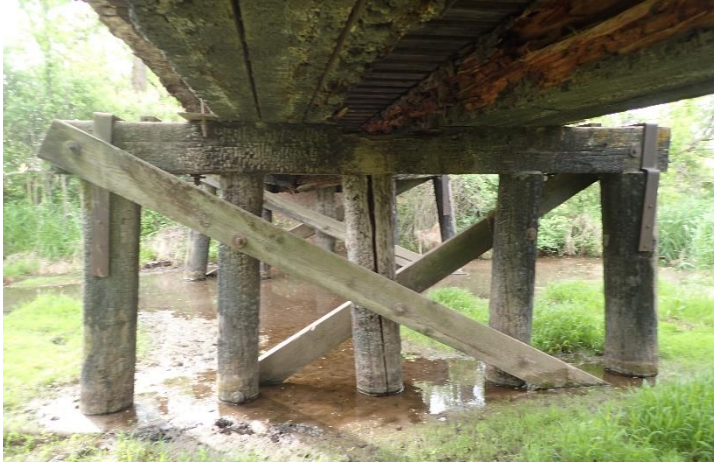
Photo 6 – Pier E2 Looking East

3. Footing: N/A.			
4. Piles: Driven timber piles – outmost 1/2" fire damaged. All bearing piles sound hollow with an estimated 50%-75% loss of section throughout. Several piles split vertically through the entire width of pile.

Underside of bridge looking east. Fire damage to center pier and beams. Center pile in pier bent split vertically through full depth of pile.

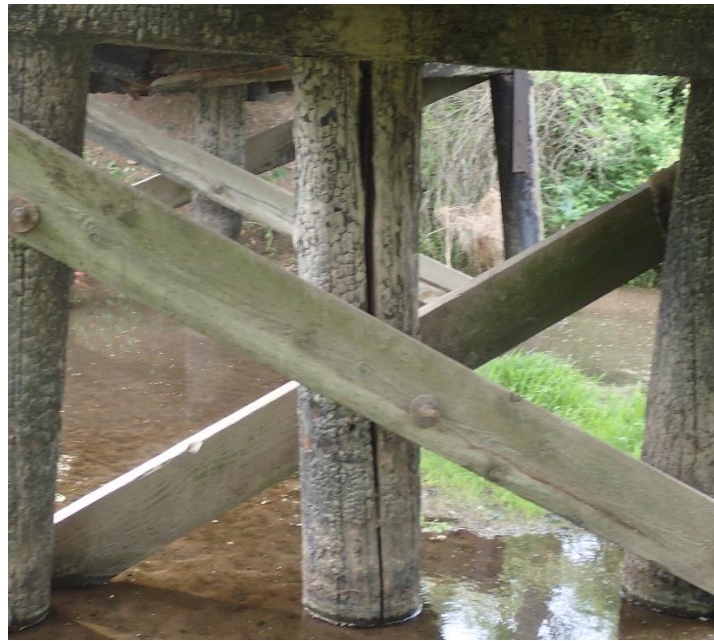
Photo 7 – Pier E2 Looking East

Underside of bridge looking east. Center pile in pier bent split vertically through full depth of pile.

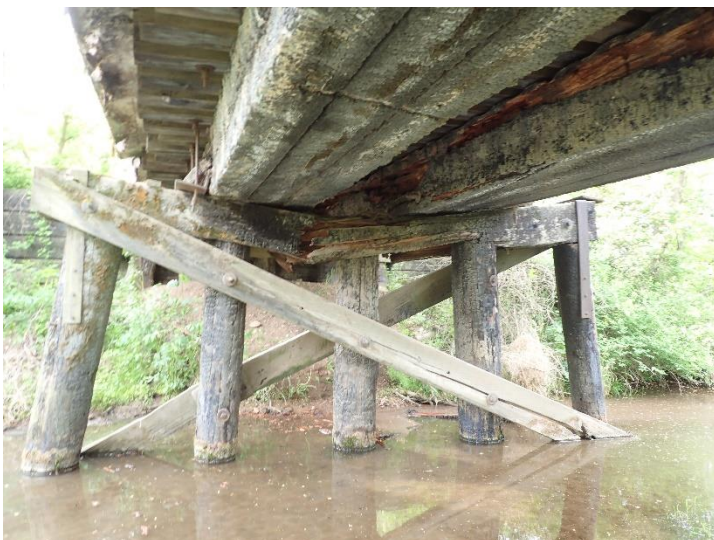
Photo 8 – Pier E1 Looking East

1. Scour Susceptible: No			
2. Caps: Advanced decay of pile caps with >90% loss of section. Readily evident signs of overload distress in east pier cap (vertical crushing). Outermost 1/2" fire damaged.

Underside of bridge looking east. Pier cap crushed in east pier.

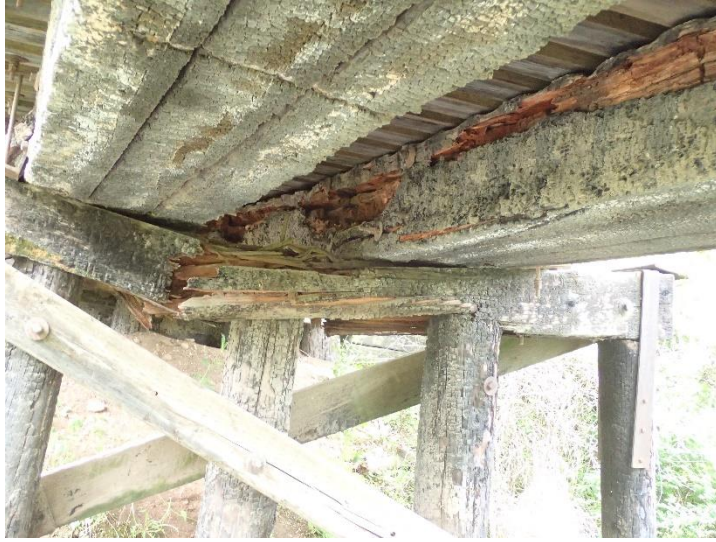
Photo 9 – Pier E1 Looking East

Underside of bridge looking east. Pier cap crushed in east pier.

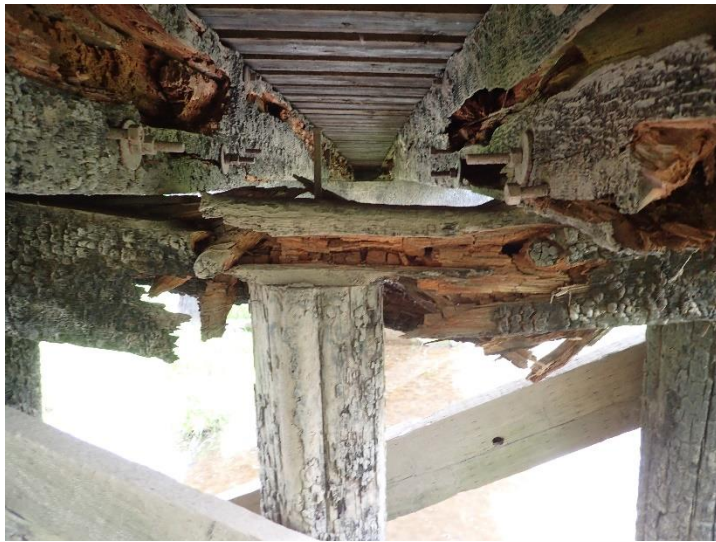
Photo 10 – Pier E1 Looking West

Underside of bridge looking west. Pier cap crushed in east pier.

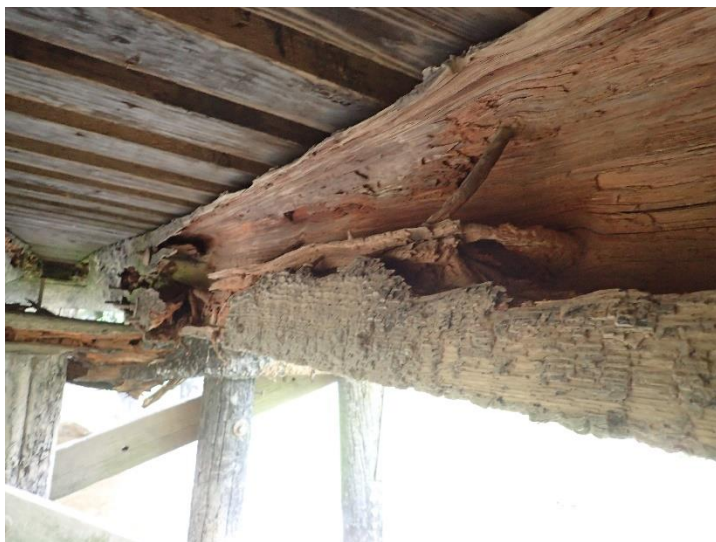
Photo 11 – Span E1 Looking Northwest

1. Bearings: N/A.			
2. Beams: Advanced decay of timber beams with >90% loss of section. Beams cracked and fractured over east pier. Fire damaged timber throughout appears to have compromised outermost 1/12" of timber cross section.

Underside of bridge looking northwest. North beamline crushed and fractured near east pier.

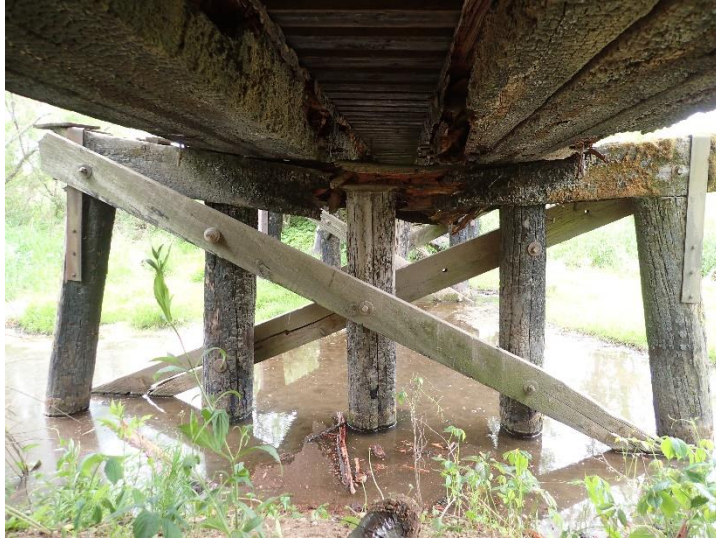
Photo 12 – Pier E1 Looking West

Underside of bridge looking west. Pier cap crushed in east pier.
