S-18 Tri Co/Cheese Country Bridge #41

Inspection Report for

Bridge #41

Cheese Country Trail over Skinner Creek

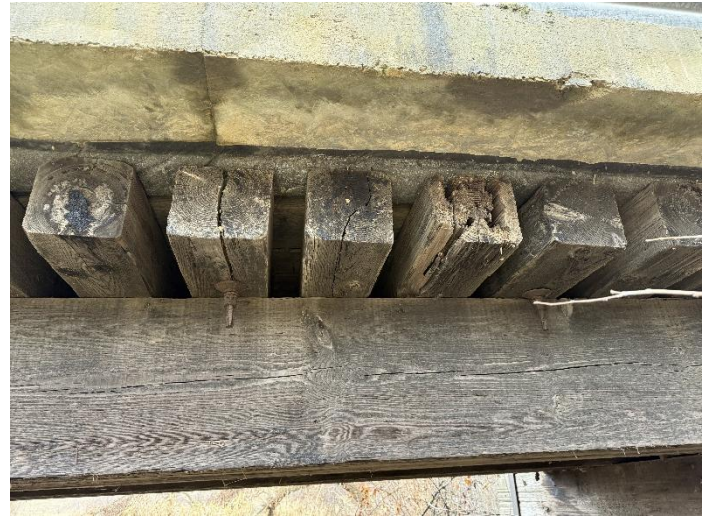
Photo 8 – North Edge of Deck in Span W1.

1. Concrete slab (wearing surface) over timber crossties(deck).
2. Minor wear of concrete throughout wearing surface, most pronounced along wheel lines. Multiple unsealed moderate/wide width transverse cracks throughout concrete slab.
3. Timber crossties decayed and split at ends. Signs of decay throughout all timber components. Timber preservative treatment is no longer effective.

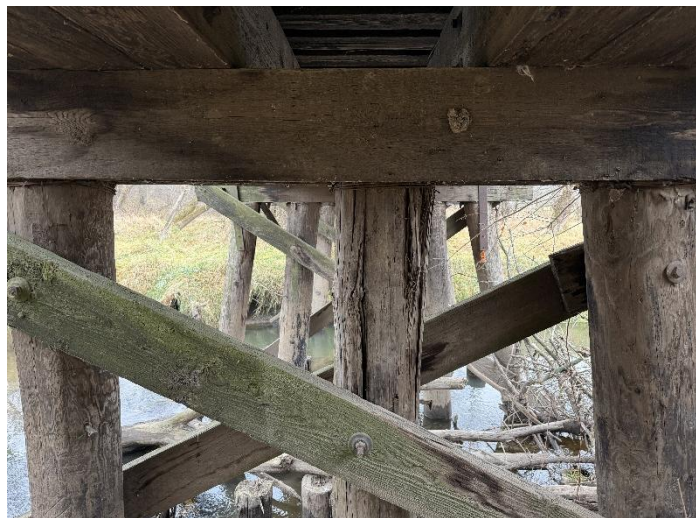
Photo 11 – Pier W1-Pile S3.

1. Driven timber piles and timber pile caps.
2. Decayed timber components throughout with **isolated crushing of pier piles.**
3. Caps are decayed +/-75% throughout with widespread minor checking and generally appear hollow when sounded. Areas of more advanced decay and splitting at ends.
4. Piles: Bearing piles sound hollow with an estimated 50%-90% loss of section. Multiple piles splitting vertically.

No feasible rehabilitation options to strengthen or extend longevity of component.

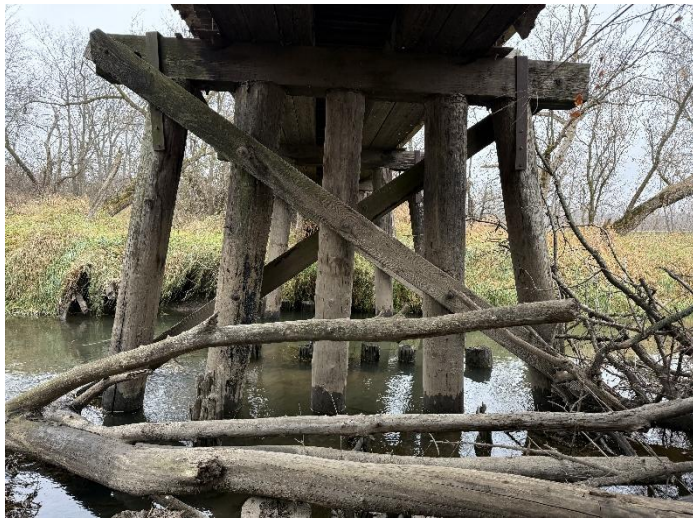
Photo 13 – Pier W2 Looking East.

1. Streambed Scour: Soft/silty streambed is prone to scour. 2ft-3ft of local scour observed at Piers W2 & W3.

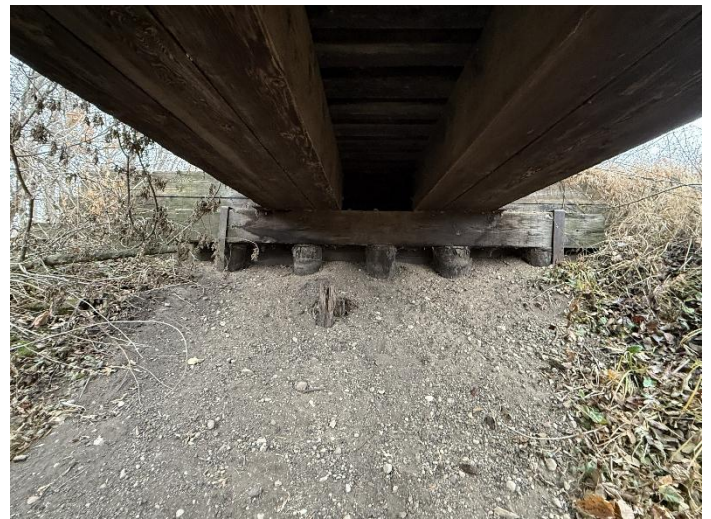
Photo 28 – East Abutment.

1. Driven timber piles, timber pile caps, and timber backwall plank.
2. Decayed timber components throughout with no readily evident signs of crushing.
3. Caps are decayed 50%-75% throughout with widespread minor checking and generally appear hollow when sounded. Isolated areas of more advanced decay and splitting at ends.
4. Piles: Bearing piles sound hollow with an estimated 50%-90% loss of section.
