S-19 Tri Co/Cheese Country Bridge #35

**Motorized Recreation Grant Application**

## Inspection Report for

**Bridge #35**

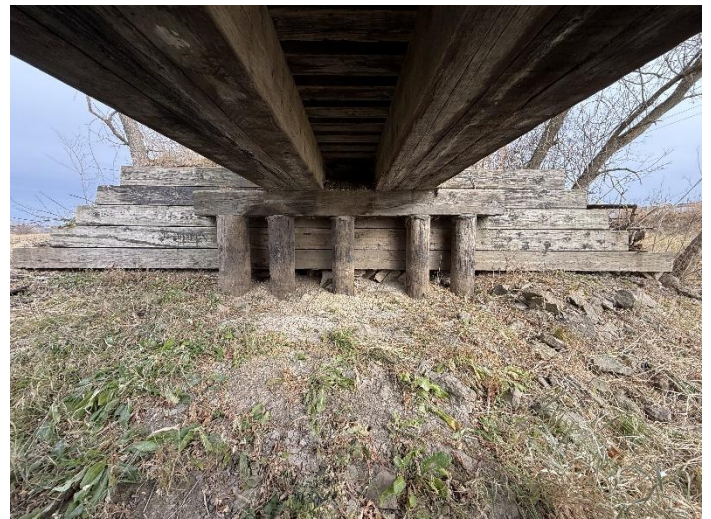
Photo 16 – East Abutment.

- Erosion at both abutments has undermined the backwall plank.
