S-20 Tri Co/Cheese Country Bridge #36

Project Title Cheese Country Trail Bridge #36 Replacement					Current Funded Miles	New Miles (if applicable)
County Lafayette	Township 01 N	Range 5	Section 12	¼ ¼ UN	¼ UN	GPS Coordinates: Lat. 42.572812 Long. -89.856157

**Bridge #36**

## Cheese Country Trail over Unnamed Stream

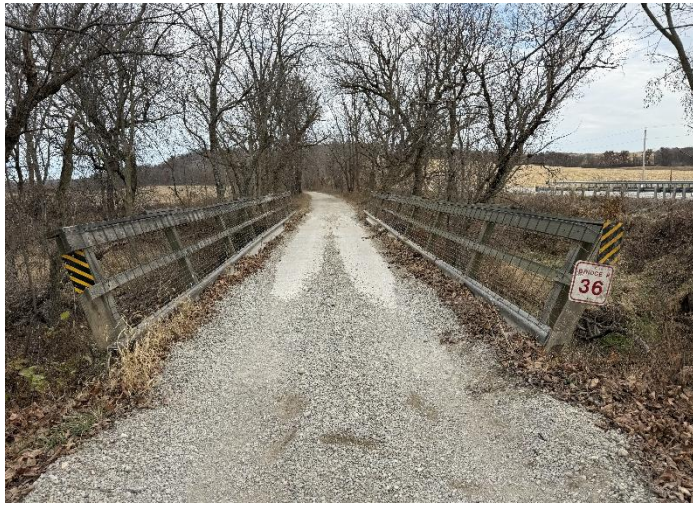
Photo 1 – Trail View Looking East.

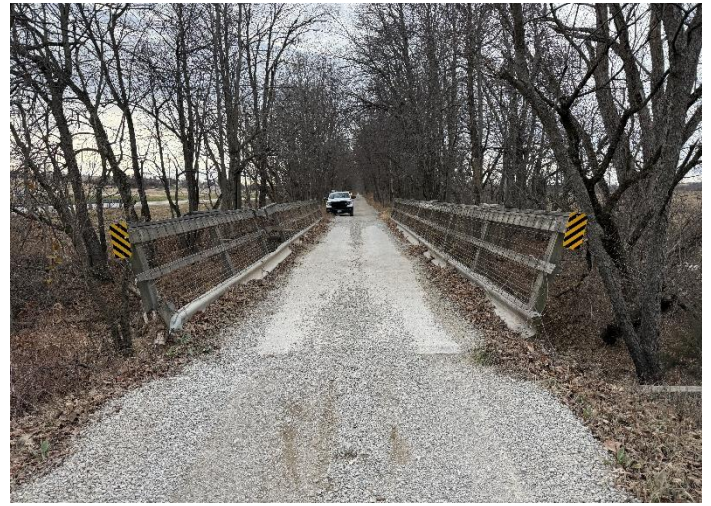
Photo 2 – Trail View Looking West.

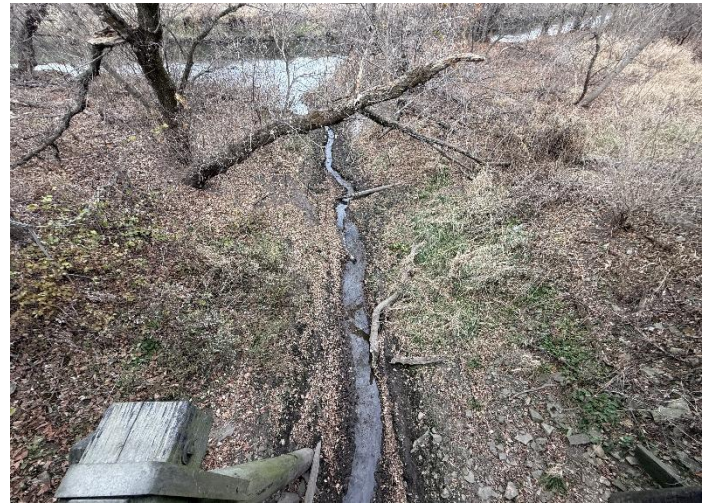
Photo 4 – Downstream Looking North.

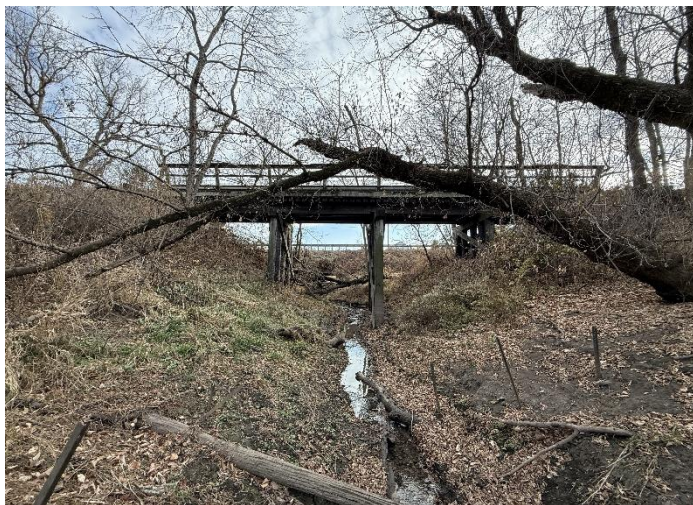
Photo 5 – Side View Looking South.

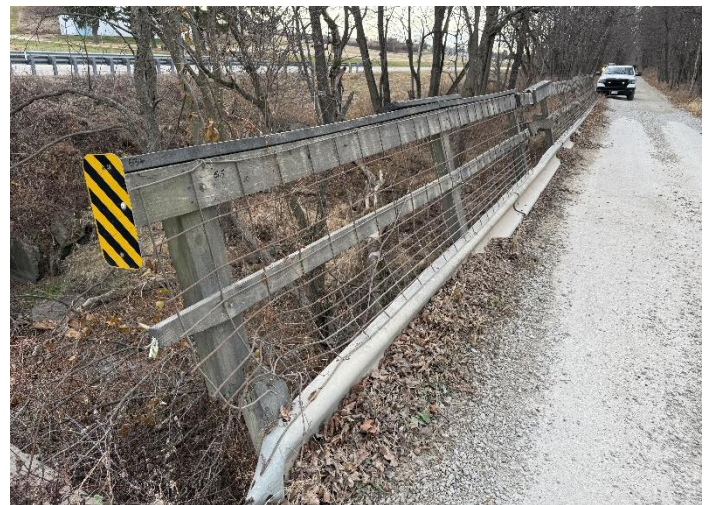
Photo 6 – South Rail Looking West.

1. Hog panel fencing supported by dimensional timber rails with angled timber posts. W-beam bridge rail curbs.
2. Initial signs of incipient decay of timber components. Timber preservative treatment appears marginally effective.
3. Widespread areas of severe damage to hog fencing, timber rails, and timber posts.
4. Multiple cracked/broken rail posts.

Repair damaged rail components.

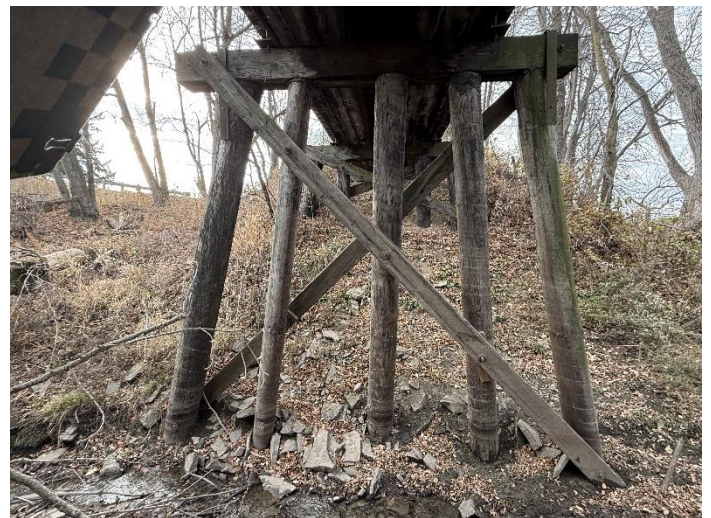
Photo 12 – Pier W2 Looking West.

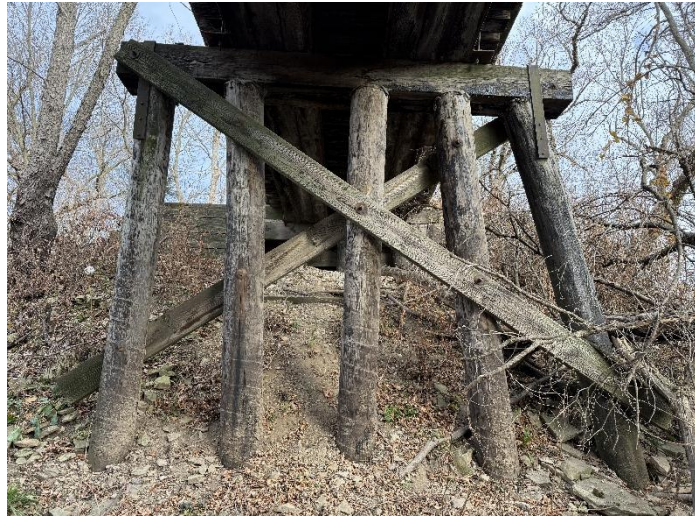
Photo 13 – Pier W3 Looking East.

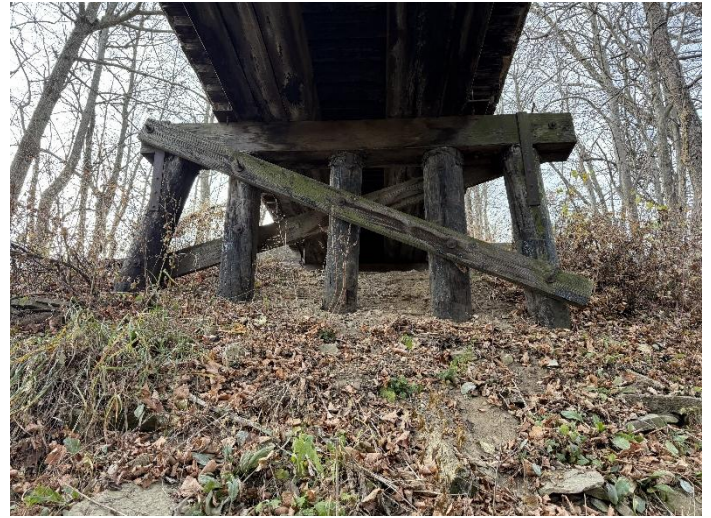
Photo 14 – Pier W1 Looking West.

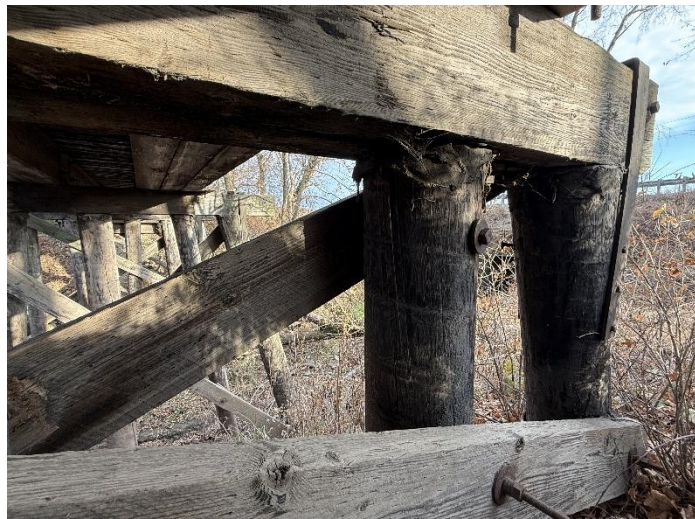
Photo 15 – Pier W1-Pile S2.

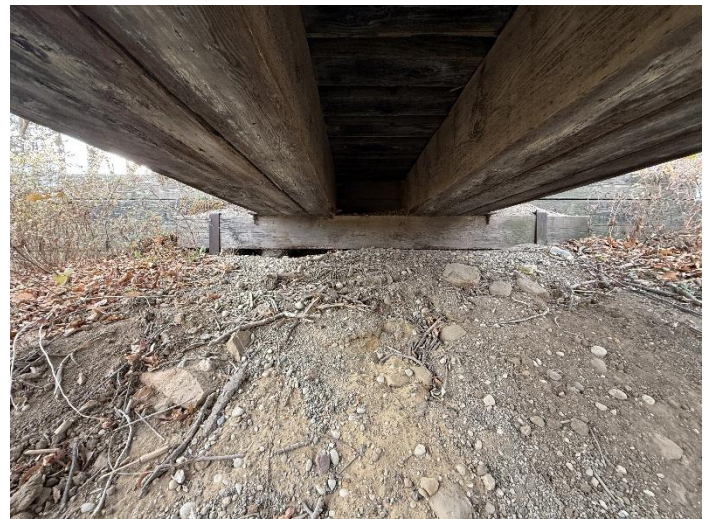
Photo 16 – West Abutment.

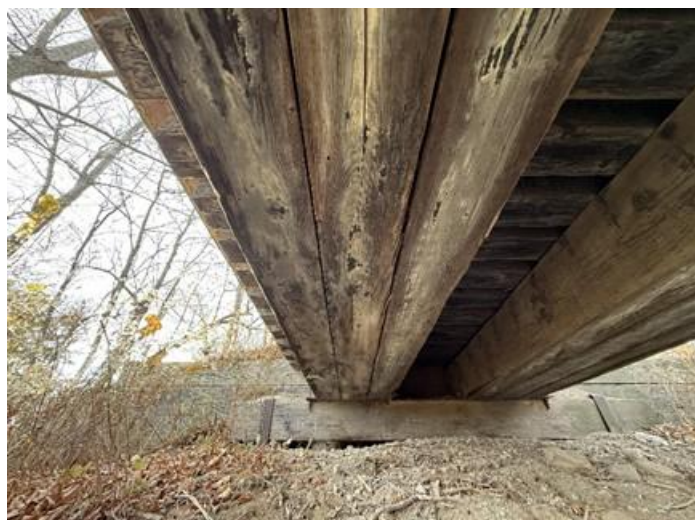
Photo 17 – West Span-South Beam Looking East.

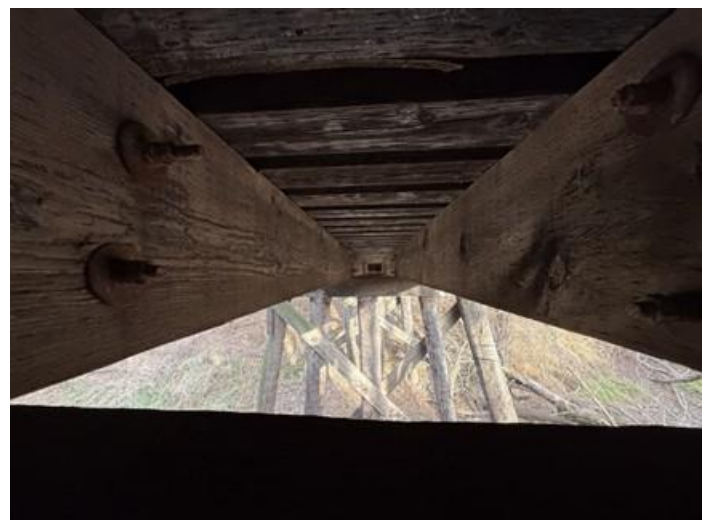
Photo 18 – Span W2 Looking East.

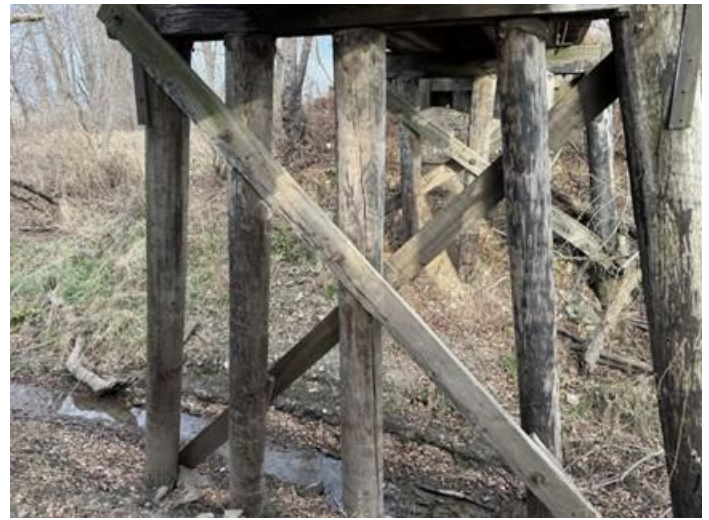
Photo 19 – Pier W2 Looking East.
