#21 Vilas Co Lynx Creek Bridge

Project Title Lynx Creek Bridge Replacement					Current Funded Miles 499.6	New Miles (if applicable)
County Vilas	Township 43 N	Range 6	Section 12	1/4 1/4 NE	1/4 NE	GPS Coordinates: Lat. _____ Long. _____

Trail Bridge Inspection

Bridge Inspection Report

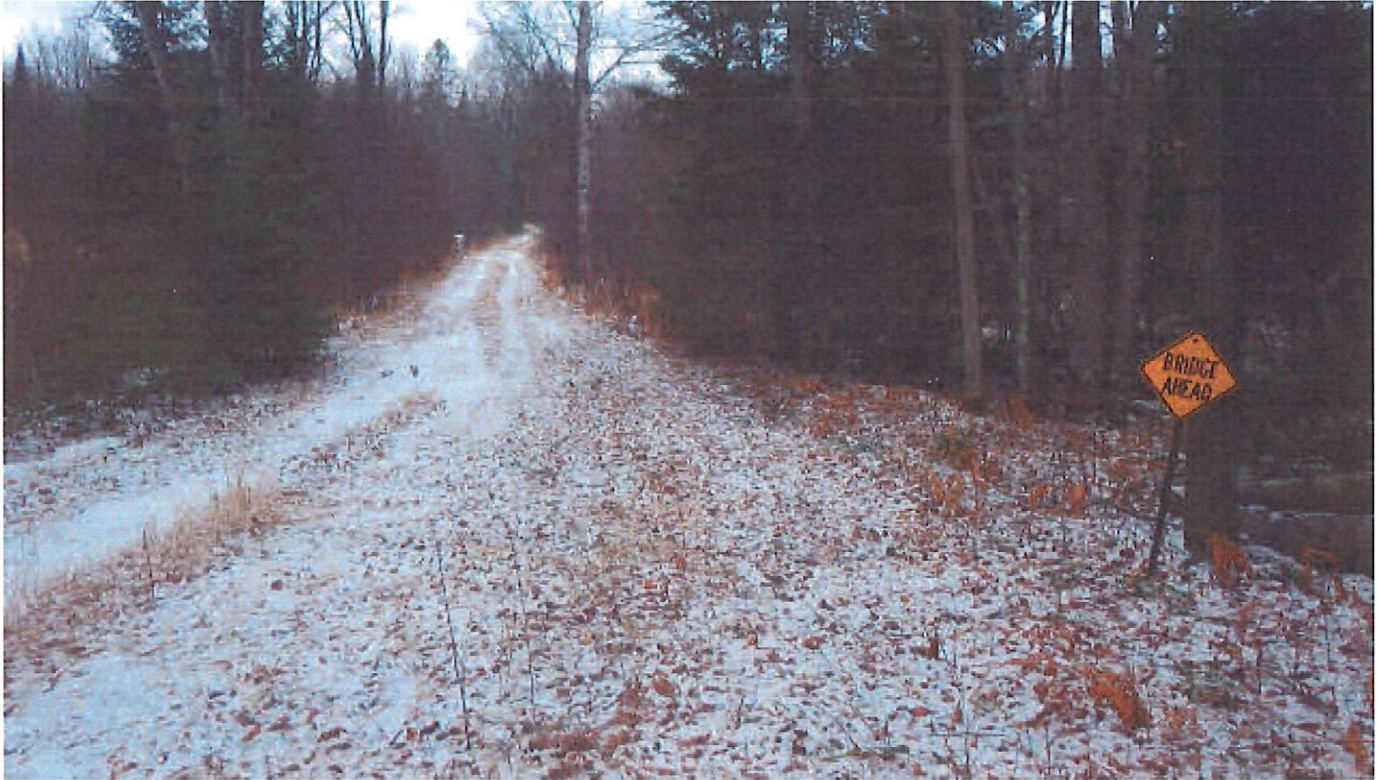
1 bridge ahead sign, West missing, East Good.

East bridge ahead sign

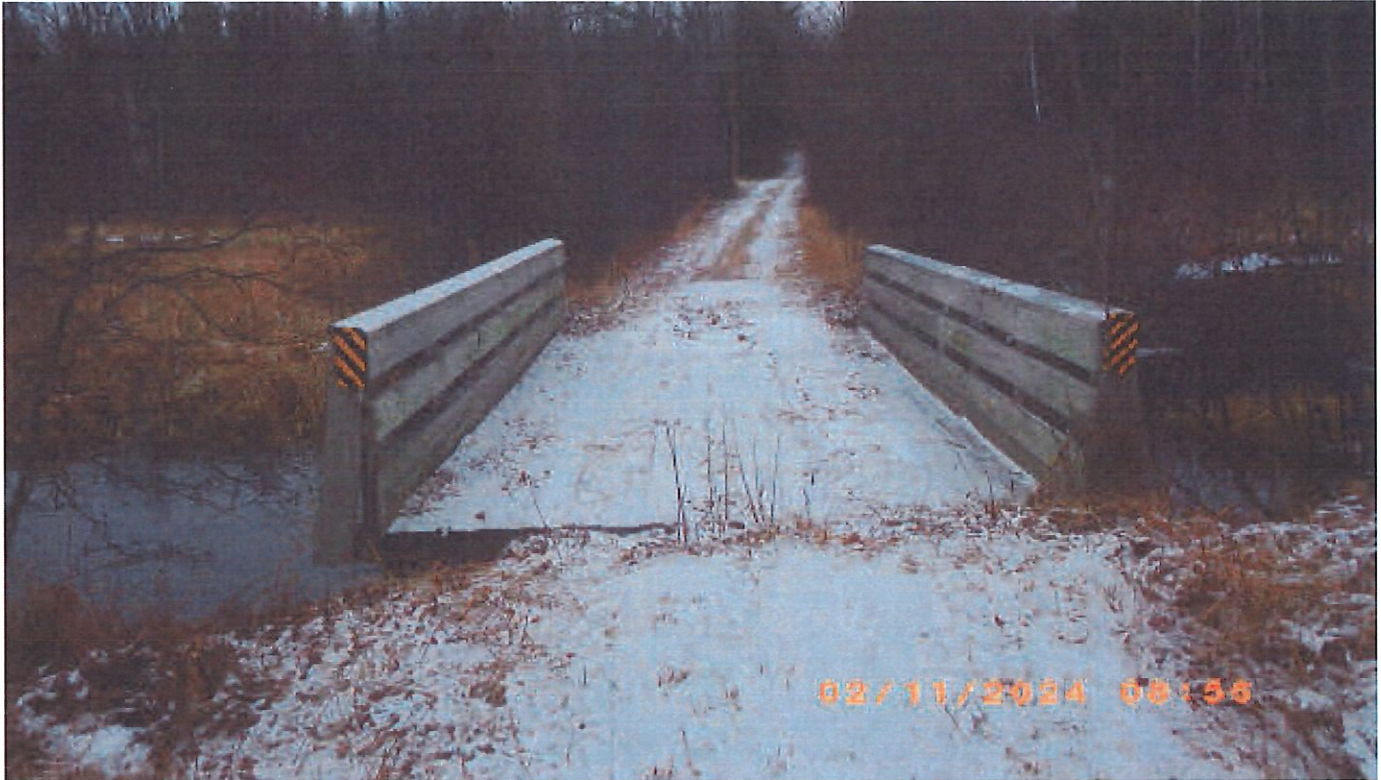
Approaches have a 3' x 3' hole in SE corner, 1' x 1' hole in SW corner, approaches are 6-12" higher than bridge. Poor condition.

East approach

- *****High importance-Monitor the sinking NW corner of the abutment.
Clean the sills off.
- *****High importance-Consider a load rating for base line. 3 girder system and the girders appear undersized and insufficient quantity.
Clean the deck.
Brush around bridge.
Fill sinkholes / erosion in approaches.
Replace west bridge ahead sign.
Level footings and add riprap to both abutments.

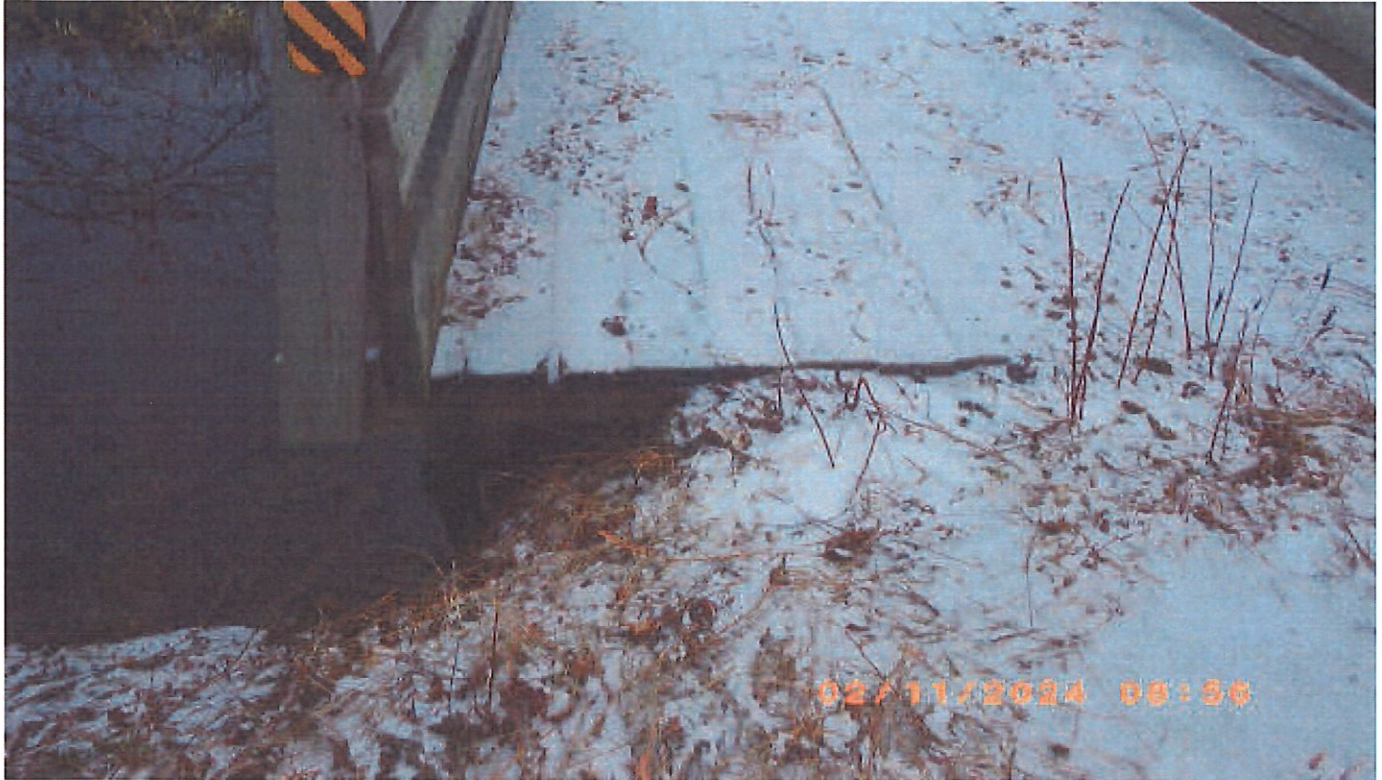
3' x 3' hole in SE corner

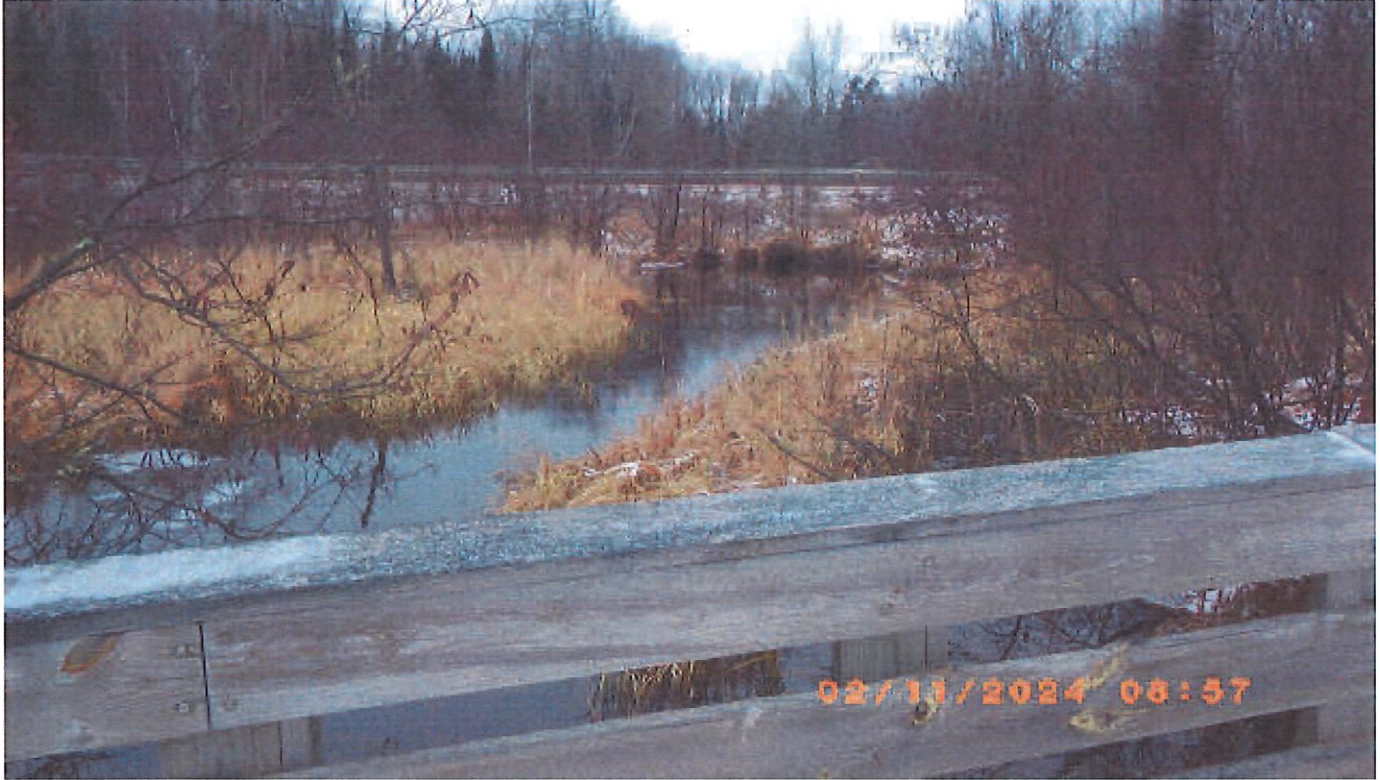
Channel has logs / debris under bridge, fair.

Looking upstream

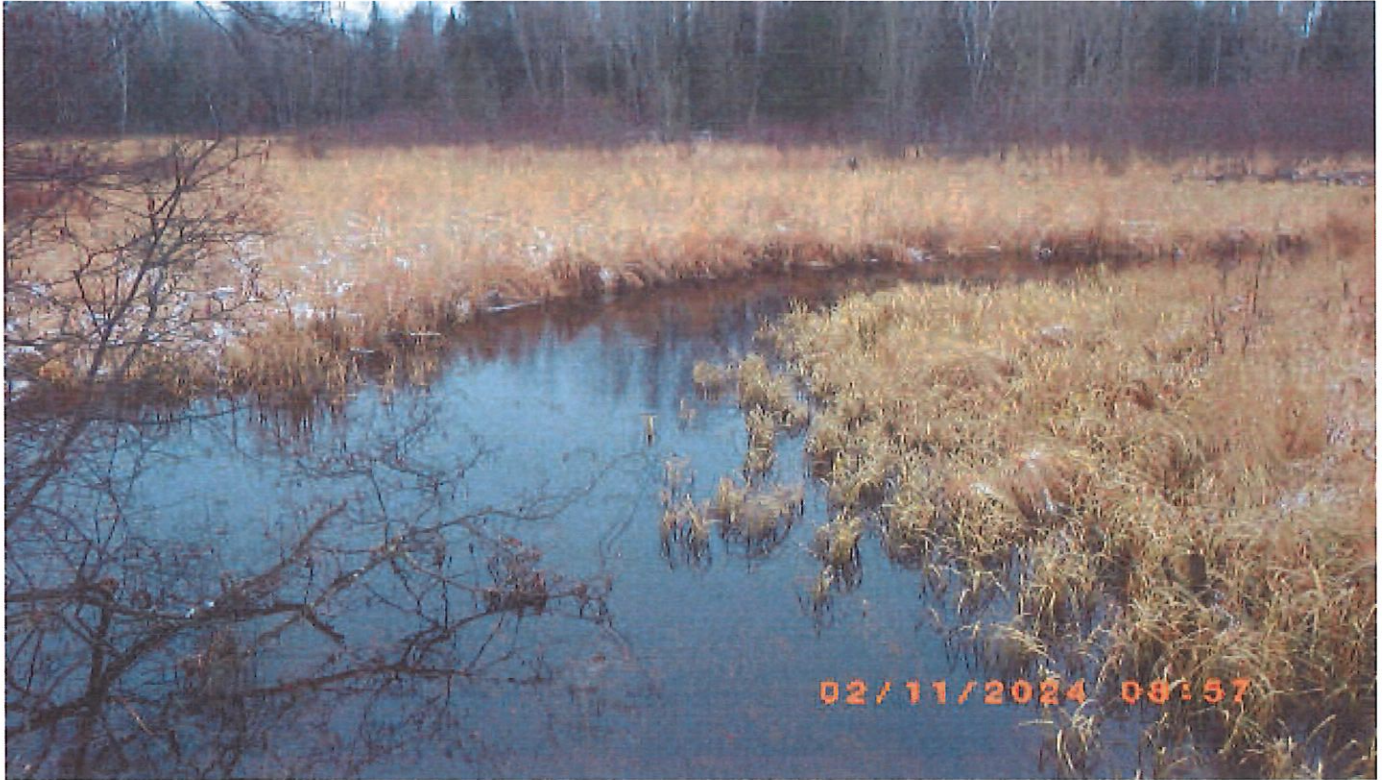
Looking downstream

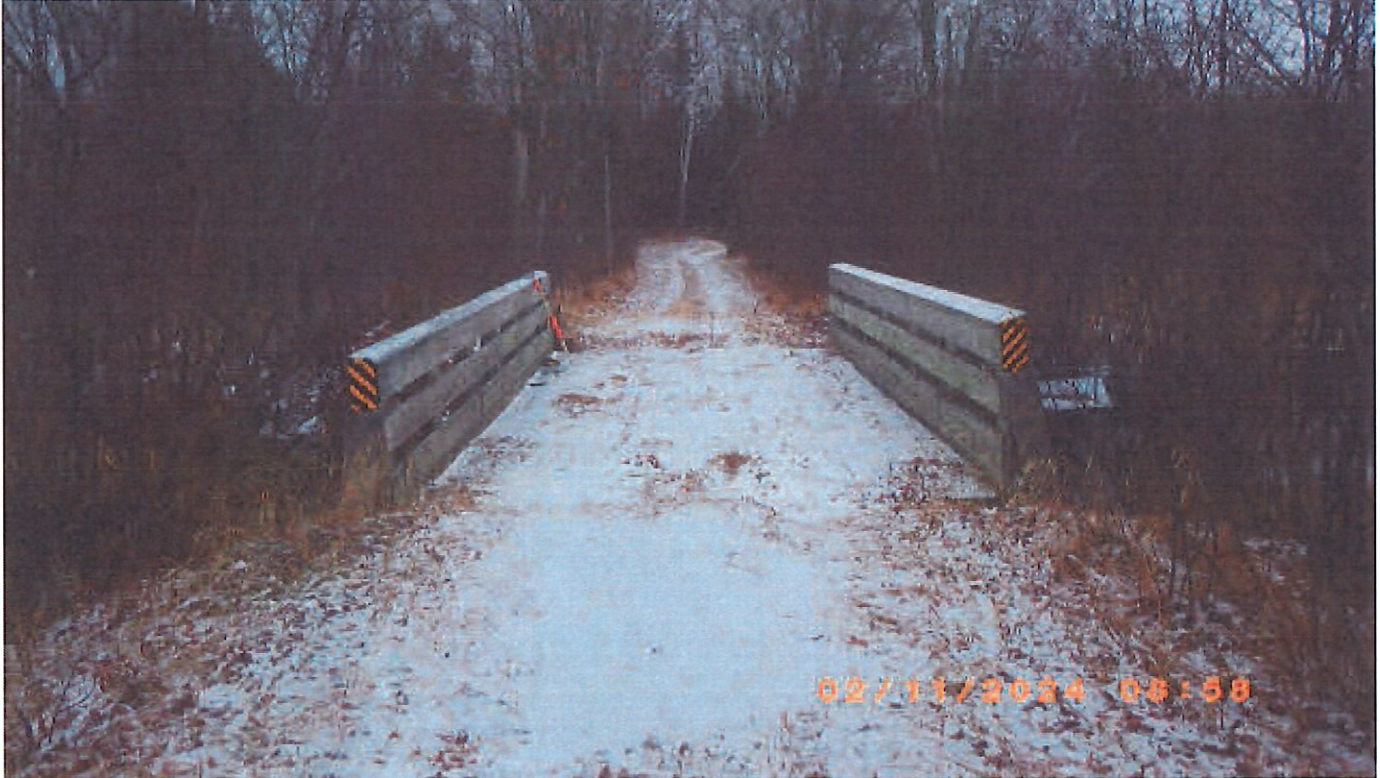
West approach

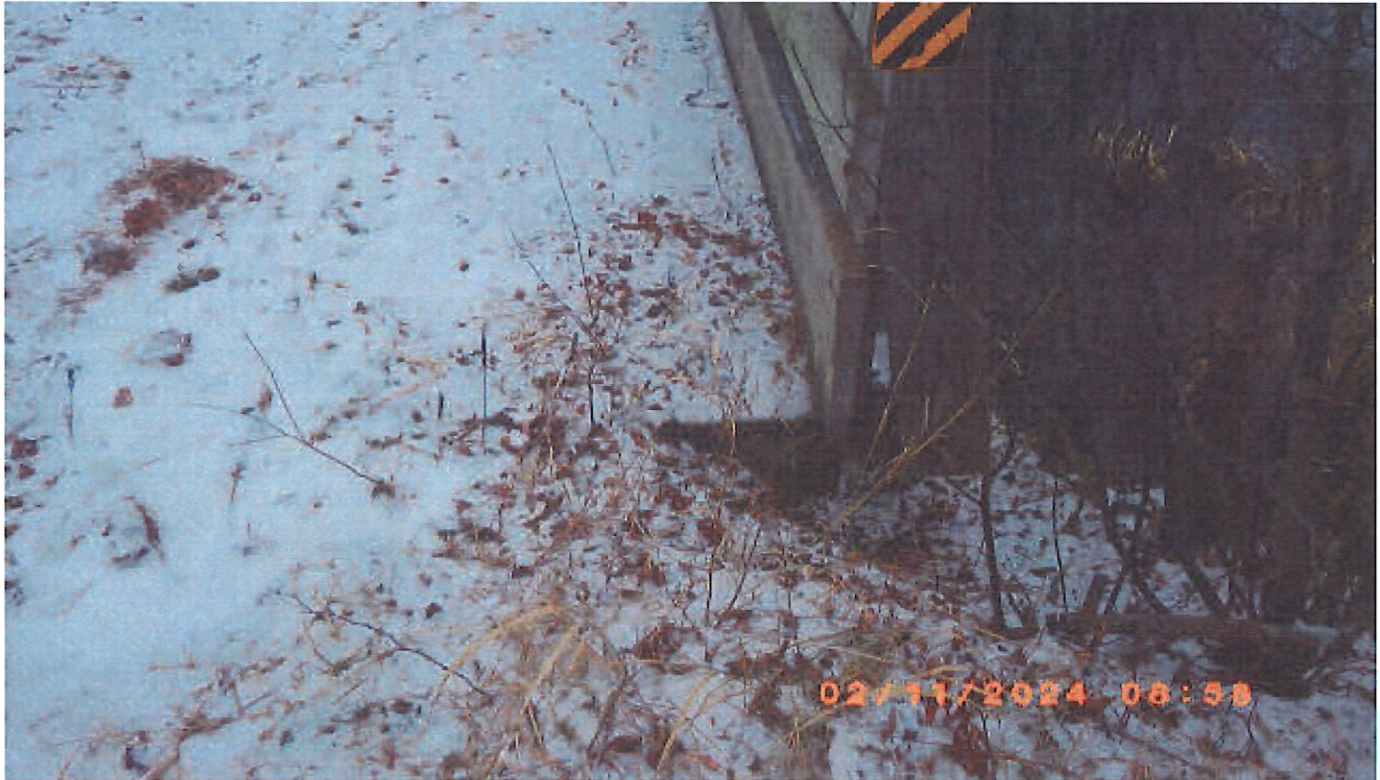
1' x 1' hole in SW corner

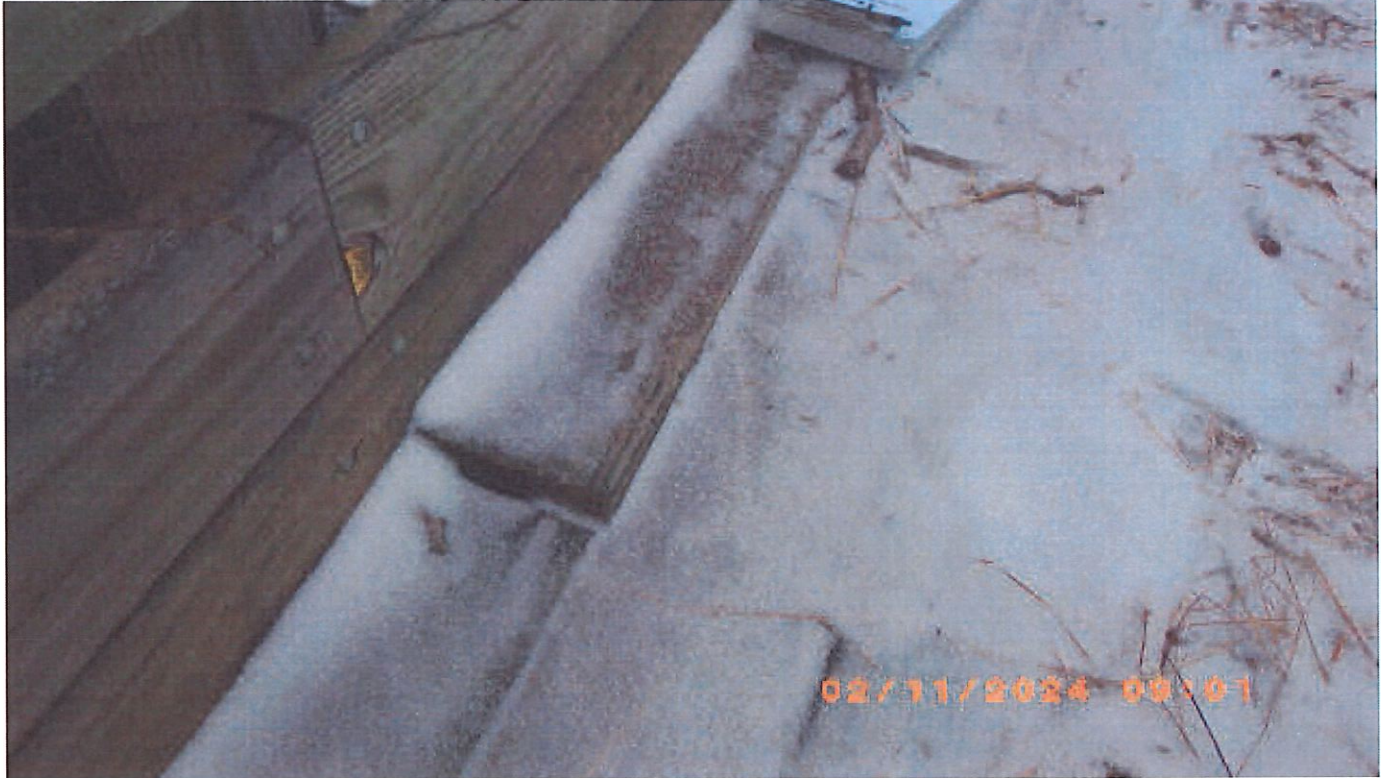
Timber wearing surface, 1 board is loose and coming up. Some areas covered in soil / vegetation. Fair.

Wear plank loose and coming up

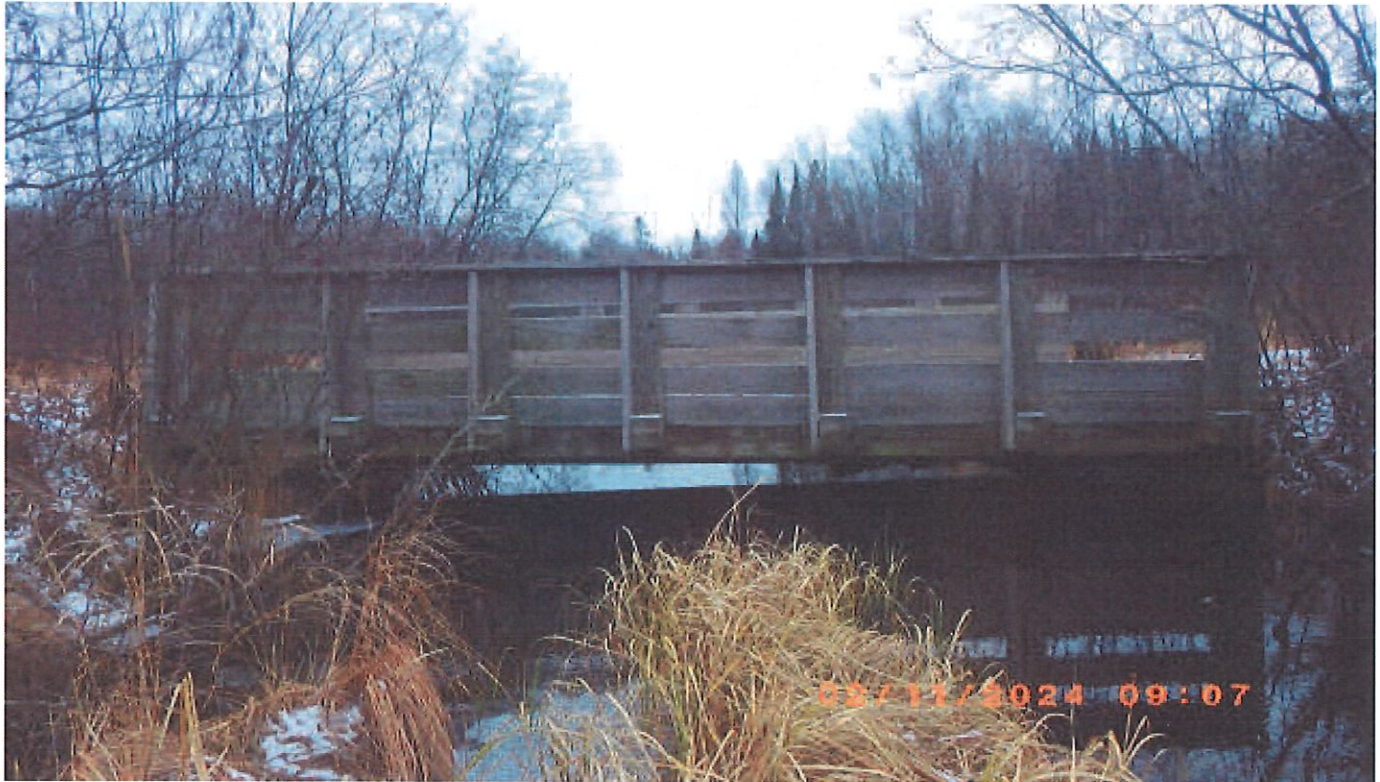
Elevation view from upstream

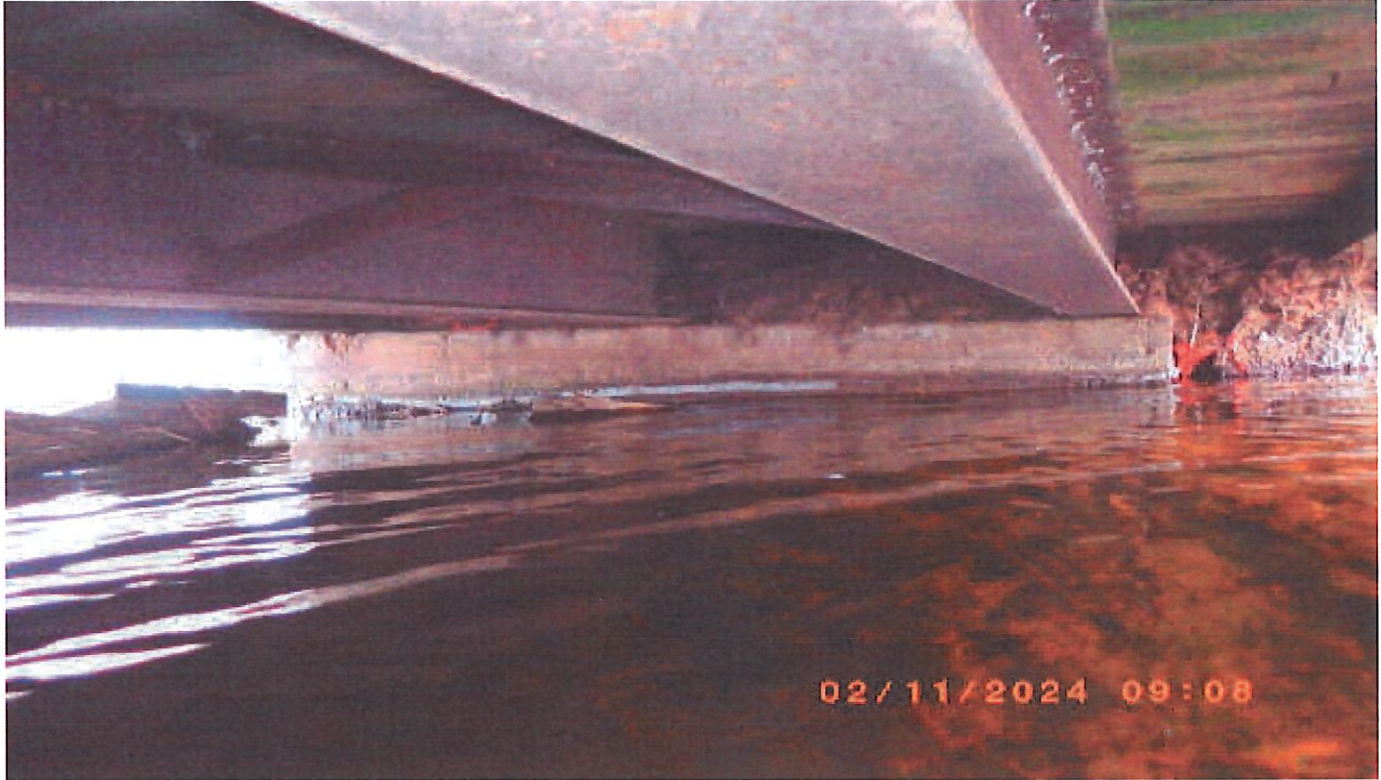
Concrete footings, scaling present and moderate spalling on west footing. Large crack in east sill. East sill undermined up to 12" deep at south end. NW corner is sinking and putting a twist in the bridge. Poor condition.

West footing

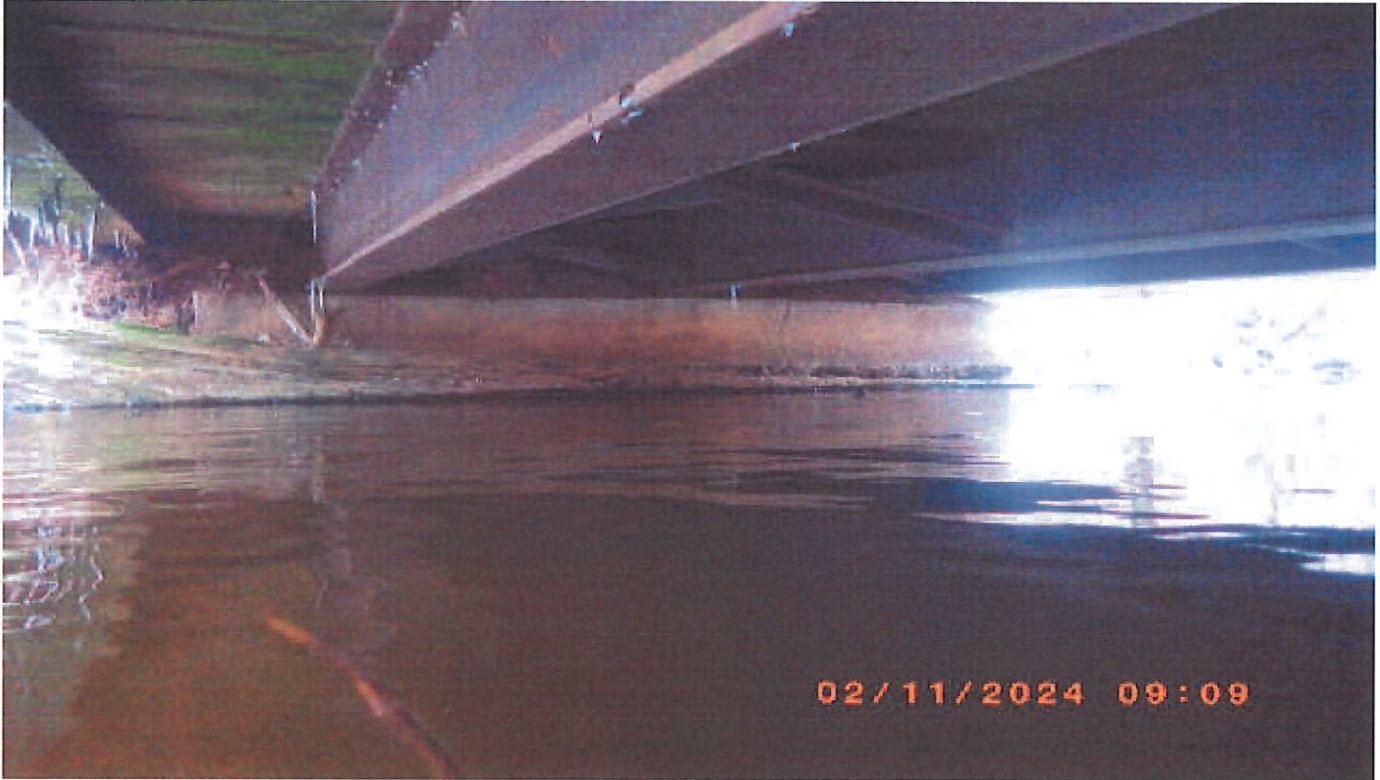
East footing

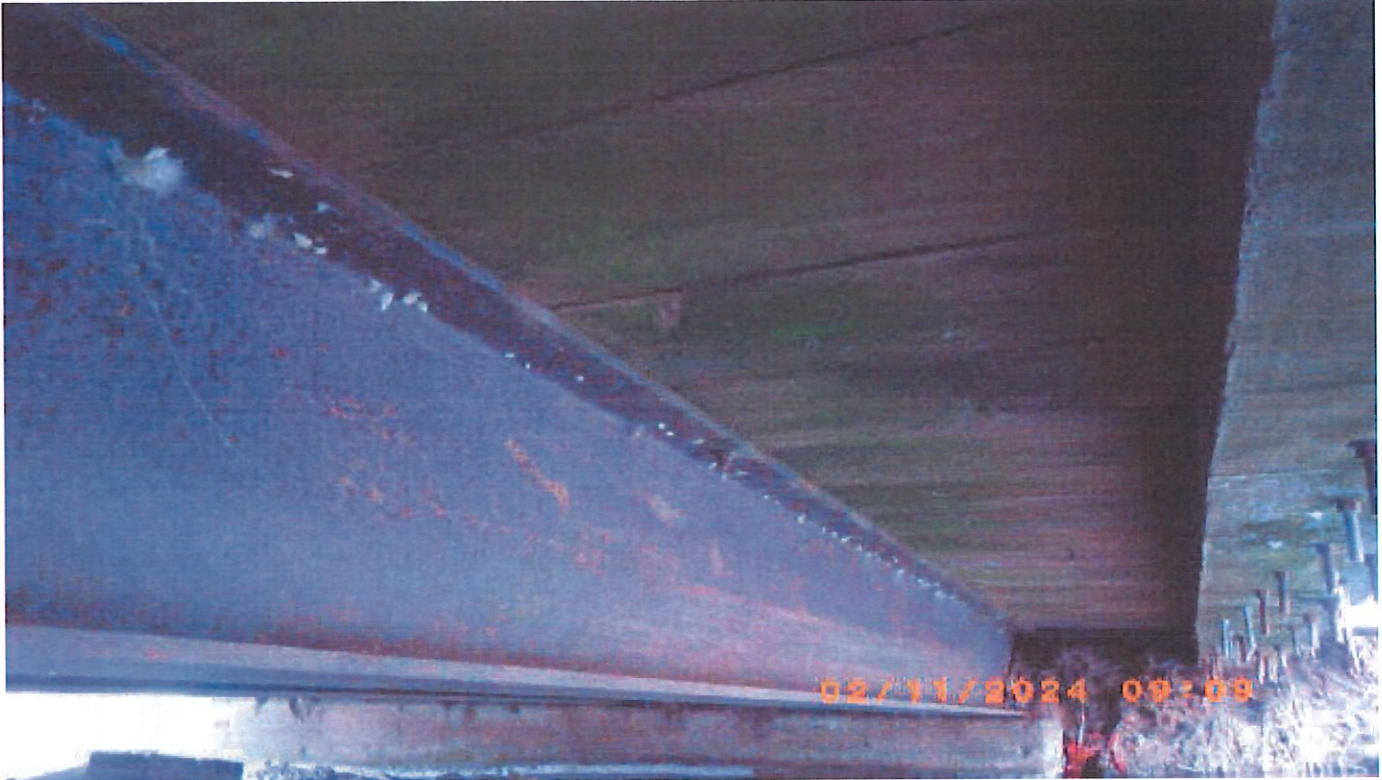
Deck is 4"x8" transverse planks, some decay, widespread green mold on underside. Fair.

Typical underside of deck / green mold

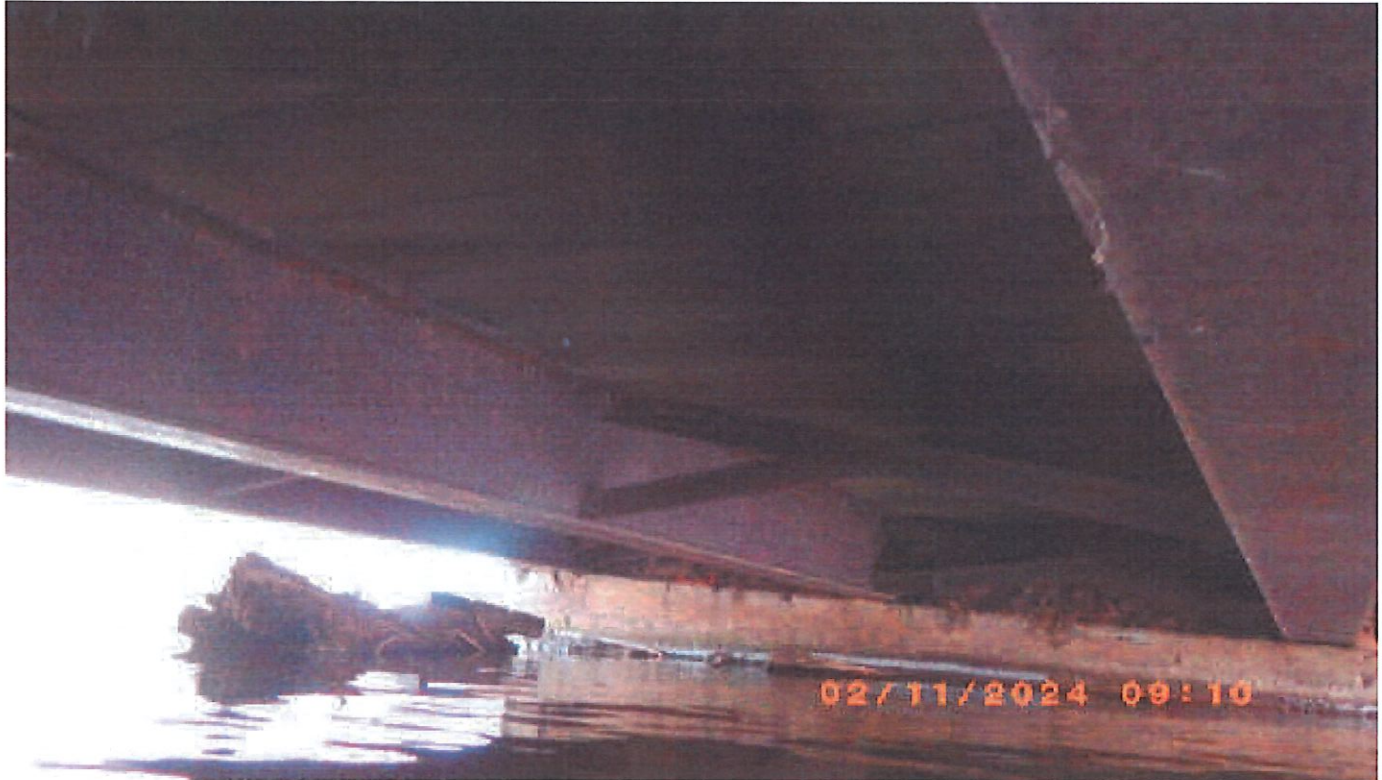
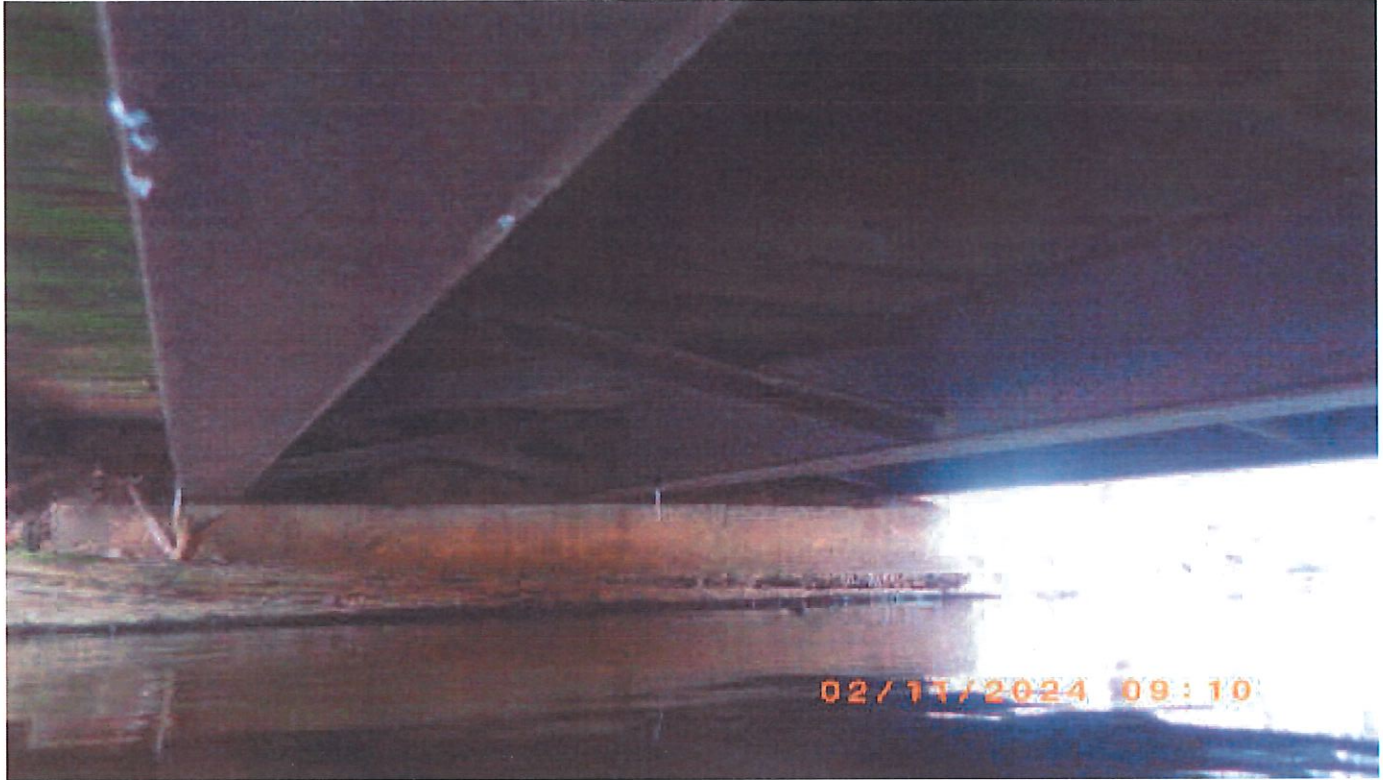
Typical underside of superstructure / x bracing at ends plus 1/4 pts

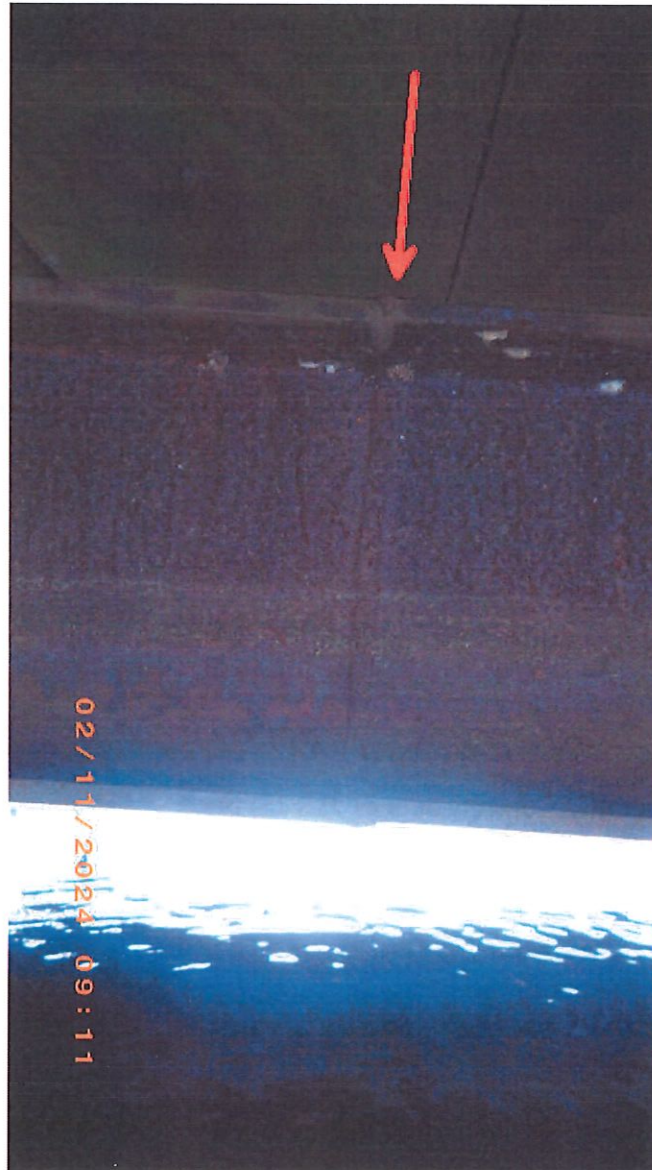
3 Steel girders, surface rust, welded splice near east 1/4 point of north girder. Fair.

Welded splice near east 1/4 pt of north girder

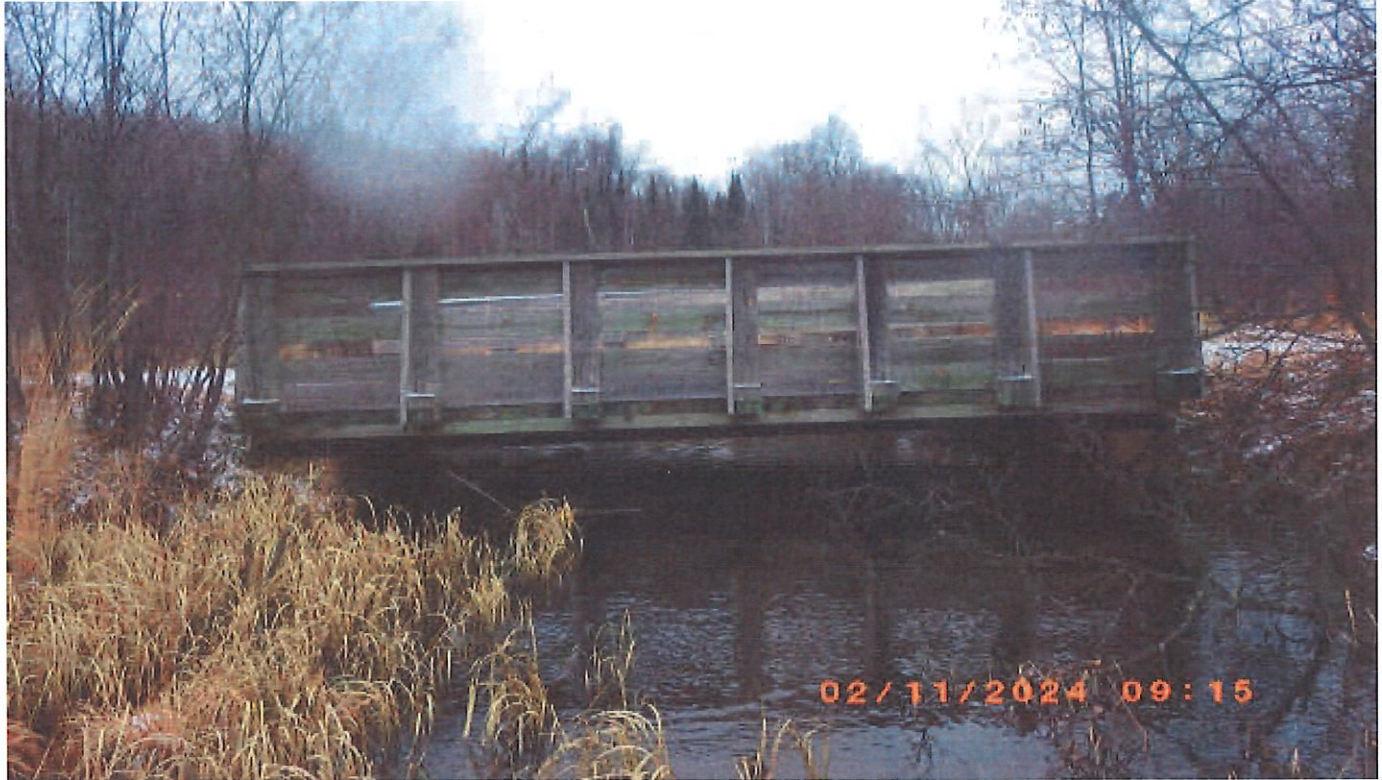
Elevation view from downstream

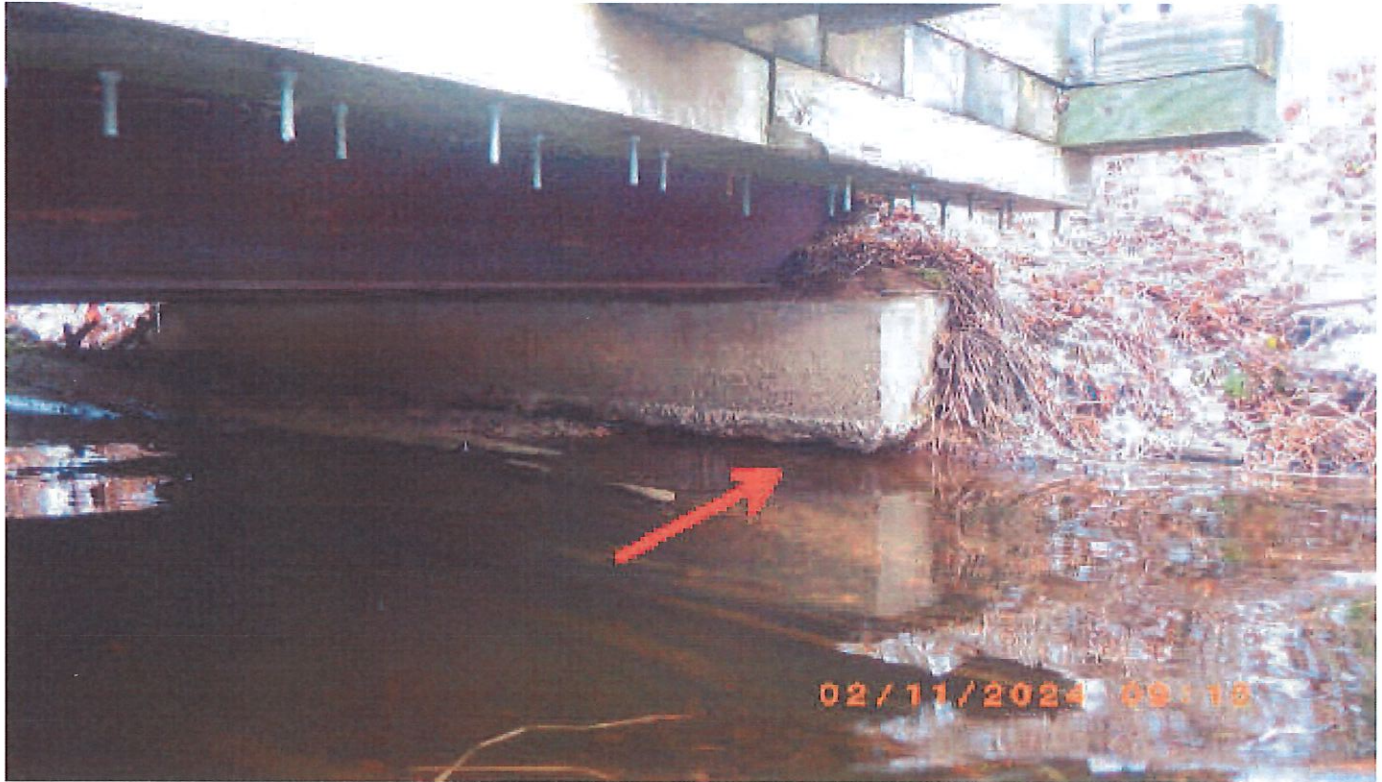
East sill undermined up to 12" deep at south end
