S-21 Tri Co/Cheese Country Bridge #28

Project Title Cheese Country Trail Bridge #28 Replacement					Current Funded Miles	New Miles (if applicable)
County Lafayette	Township 01 N	Range 4	Section 2	¼ ¼ UN	¼ UN	GPS Coordinates: Lat. 42.588625 Long. -89.990923

Inspection Report for

Cheese Country Trail over Tributary to Pecatonica River

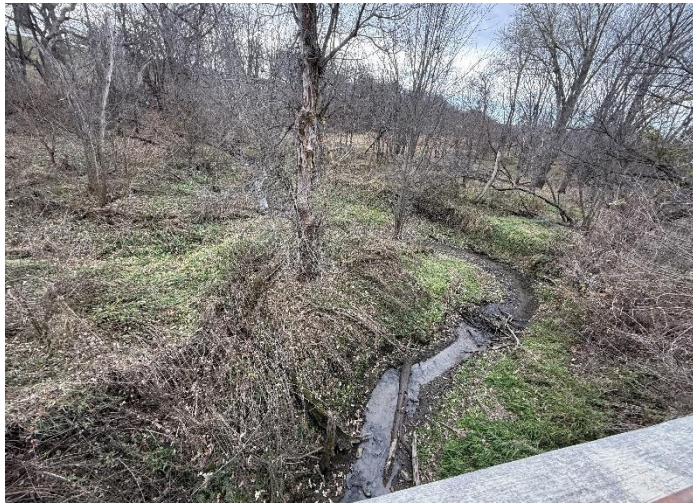
Photo 3 – Upstream Looking South.

1. Embankment Erosion: Natural earth berms at both abutments appear relatively stable. 6 ft vertically cut embankments throughout channel.
2. Drift: No significant deposits in channel.
3. Channel Change: Waterway flows through span W3. Upstream channel meandering, downstream relatively straight.
4. Adequacy of Opening: No readily visible signs of overtopping.

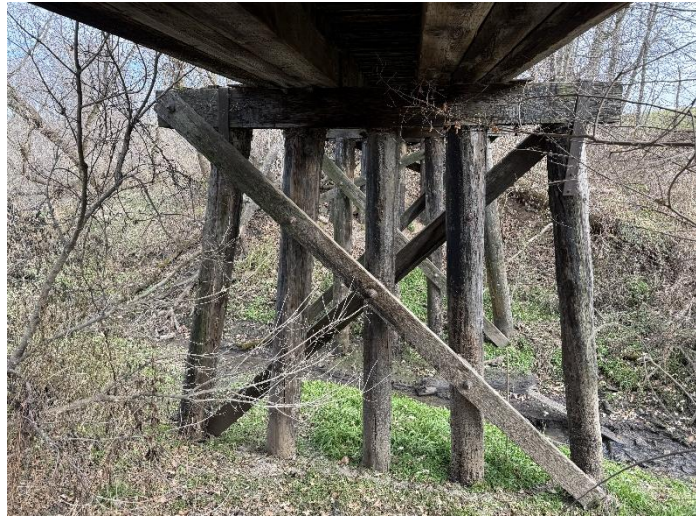
Photo 7 – Pier W2 Looking East.

1. Driven timber piles and timber pile caps.
2. Decayed timber components throughout with potential signs of initial overload distress (brooming/springy pile shells) at base of isolated piles.
3. Caps are decayed 50%-75% throughout with widespread minor checking and generally appear hollow when sounded. Isolated areas of more advanced decay and splitting at ends. Full depth vertical splitting of caps in piers W2 & W4.
4. Piles: Bearing piles sound hollow with an estimated 50%-90% loss of section.
5. Pier piles and caps are highly susceptible to overload damage.
