S-22 Tri Co/Cheese Country Bridge #5

Inspection Report for

Bridge #5

Cheese Country Trail over Furnace Creek

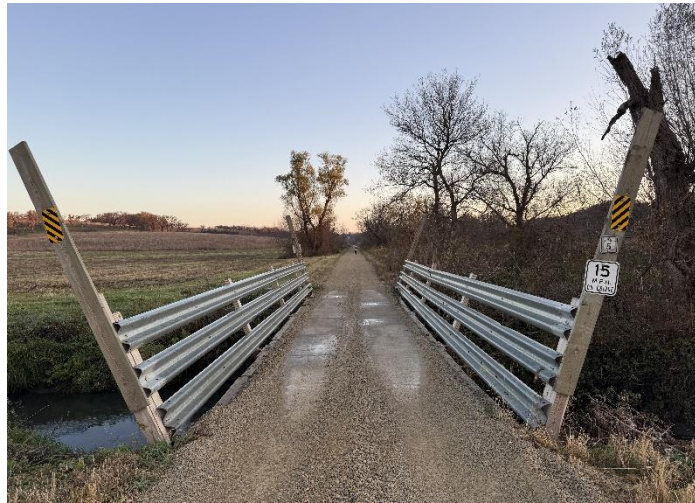
Photo 1 – Trail View Looking North.

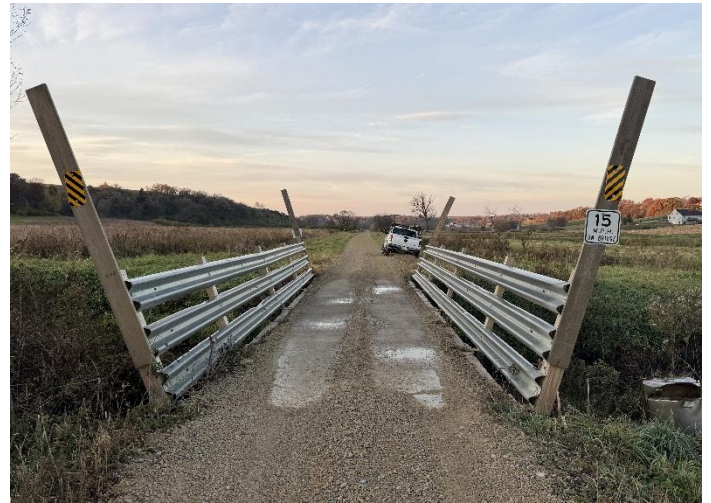
Photo 2 - Trail View Looking South.

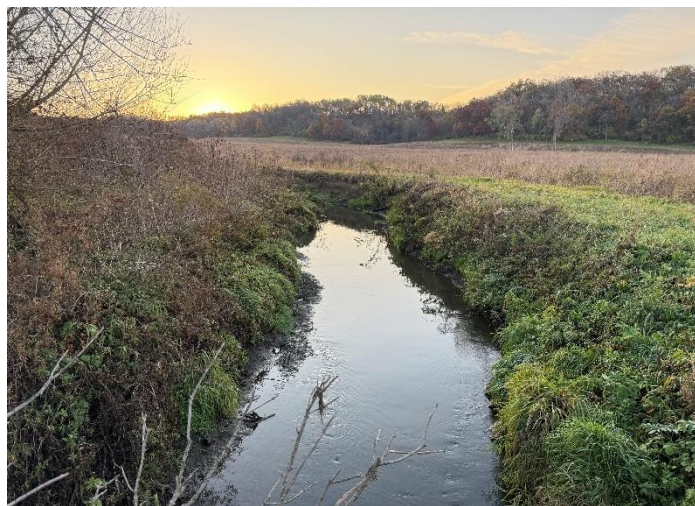
Photo 3 – Upstream Looking East.

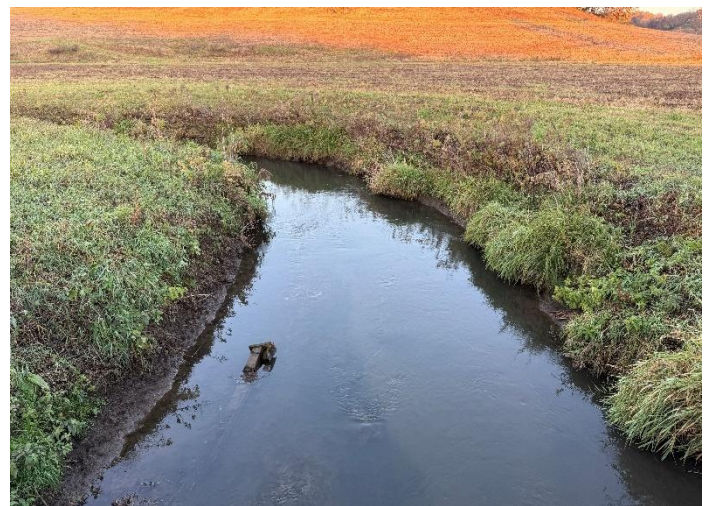
Photo 4 – Downstream Looking West.

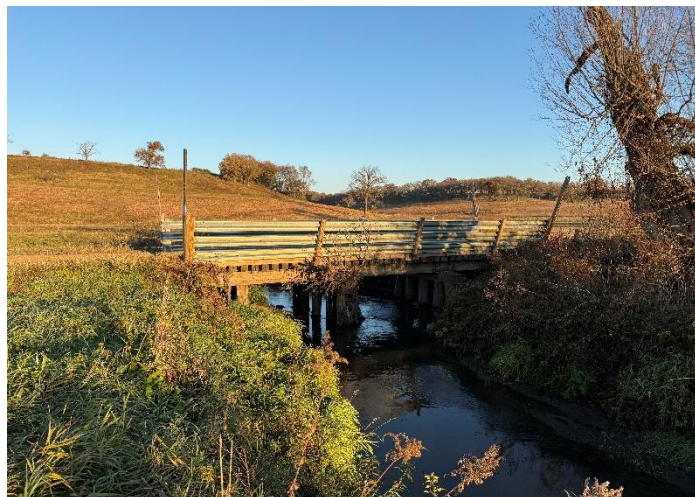
Photo 5 – Side View Looking West.

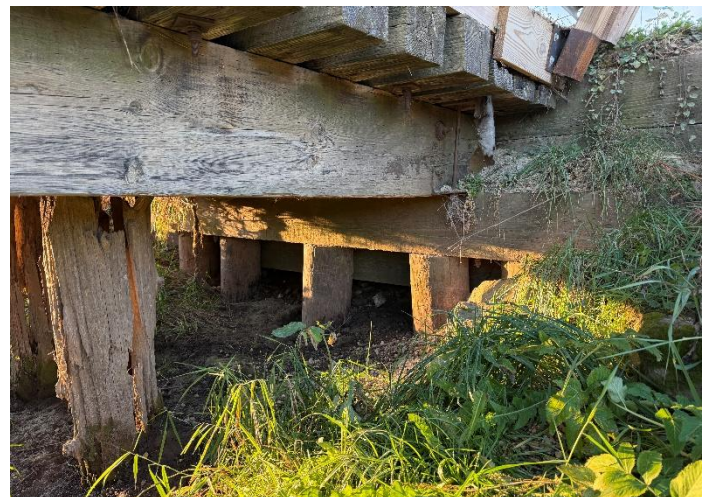
1. Driven timber piles, timber pile caps, and timber backwall plank.
2. South backwall plank undermined.
3. Decayed timber components throughout. Backwall piles checking w/ signs of decay and section loss. All bearing piles sound hollow with an estimated 25%-50% loss section. No signs of lateral/overload distress observed.

1. Embankment Erosion: Erosion at the south embankment has undermined the south abutment backwall plank. Vertical cut embankments throughout channel.
2. Drift: Flood debris built-up on south pier.
3. Channel Change: Channel favors south side of opening. Waterway flows through center span, north ¼ of south span. Both piers within channel flow during inspection with less than 2ft max water depth.
4. Adequacy of Opening: Debris on south pier cap may be evident of low member submergence.

Photo 6 – South Abutment.

- Remove flood debris.
- Repair erosion/undermining of south abutment backwall plank.

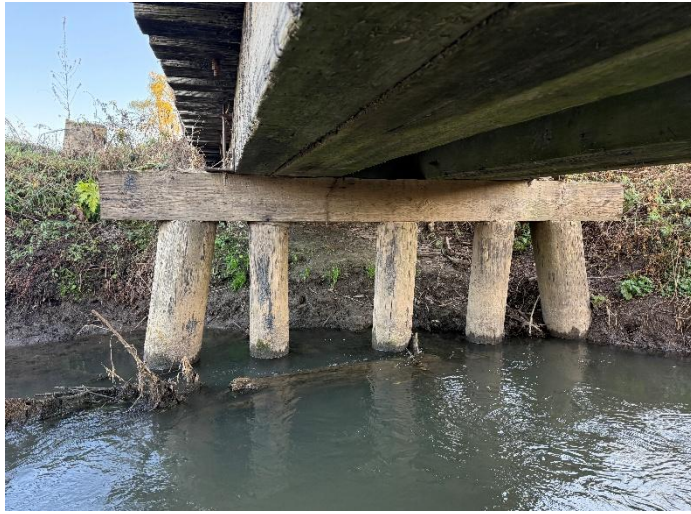
1. Driven timber pile bent piers.
2. Decayed timber components throughout with no readily evident signs of crushing.
3. Caps are decayed throughout and generally appear hollow when sounded. Widespread checking and throughout length of caps. Areas of more advanced decay and full depth splitting at ends of pile caps.
4. Piles are starting to sound hollow with an estimated 25%-50% loss of section. Piles are checking throughout with initial signs (<1/4") vertical splitting.

Photo 7 – North Pier Looking North.

No feasible rehabilitation options to strengthen or extend longevity of component.

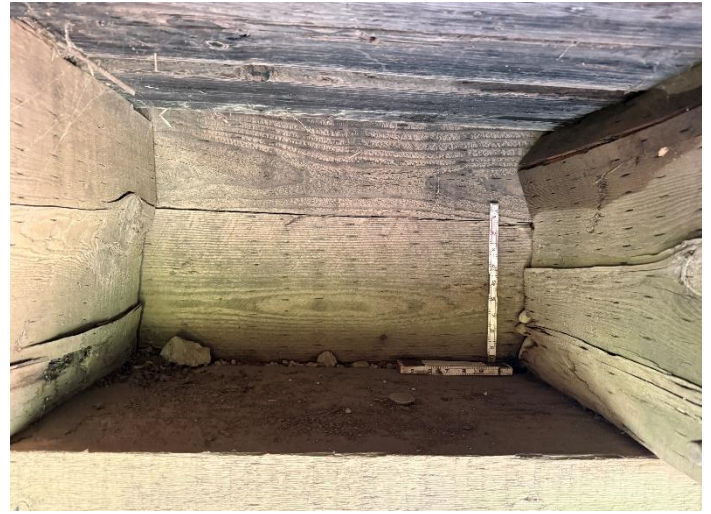
1. (2) lines of timber beams each comprised of (3) through-bolt connected laminations.
2. Beams are decayed throughout with prominent checking and portions appear hollow when sounded.
3. **Beams are showing signs of overload distress** (crushing) over the south abutment. Condition is indicative that the strength/performance of the bridge has been compromised, and the structure is unable to support the existing loads.

Photo 8 – Beams Crushing Over South Abutment.

No feasible rehabilitation options to strengthen or extend longevity of component.

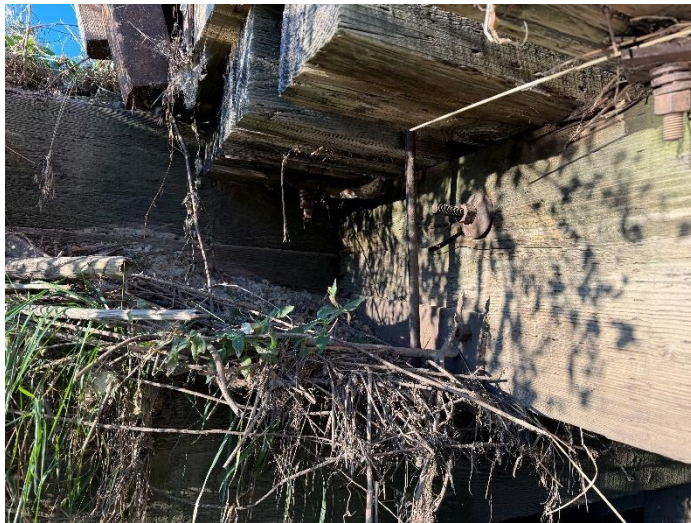
Photo 9 – East Beam Over South Abutment.

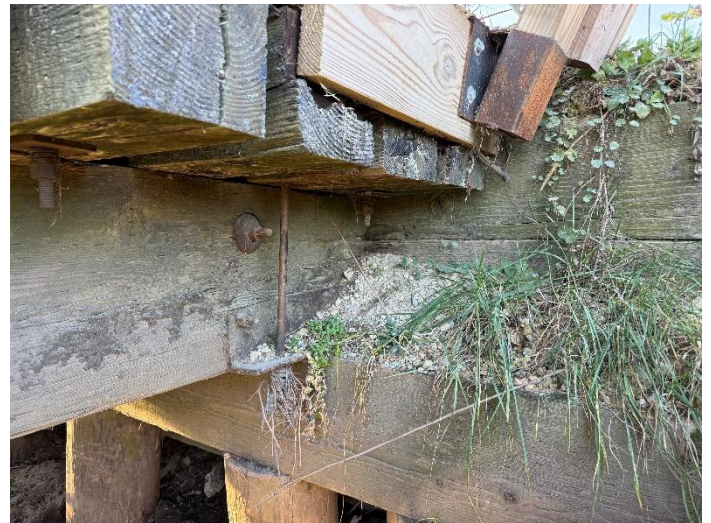
Photo 10 – West beam Over South Abutment.

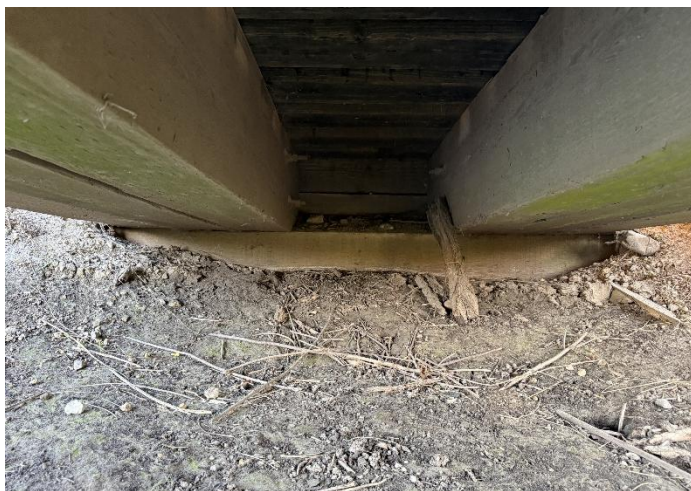
Photo 11 – North Abutment.

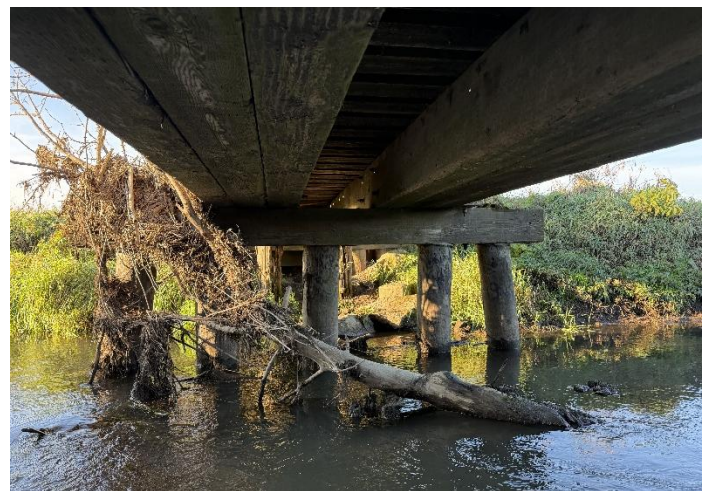
Photo 12 – South Pier Looking South.

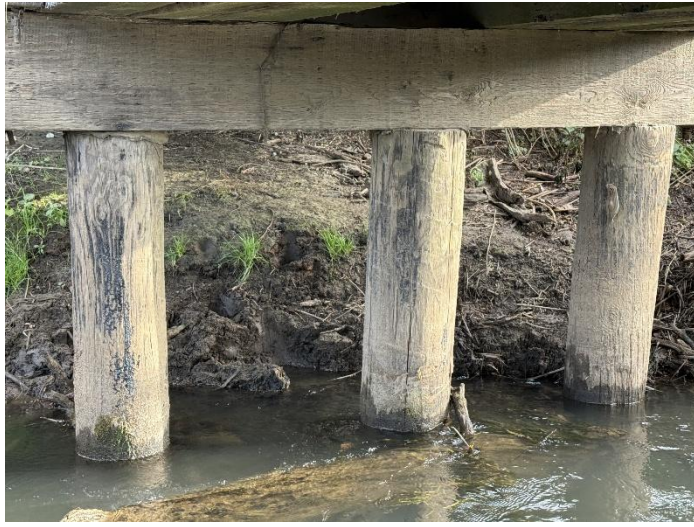
Photo 13 – North Pier Looking North: Piles W2-W4.

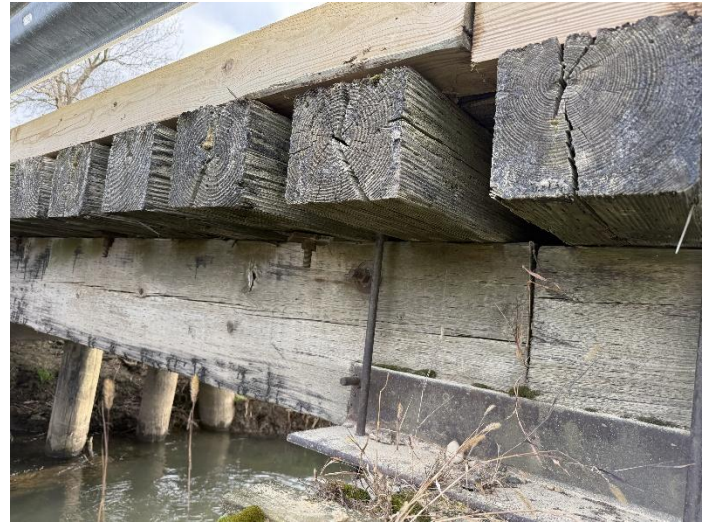
Photo 14 – West Beam/Edge of Deck-Center Span.

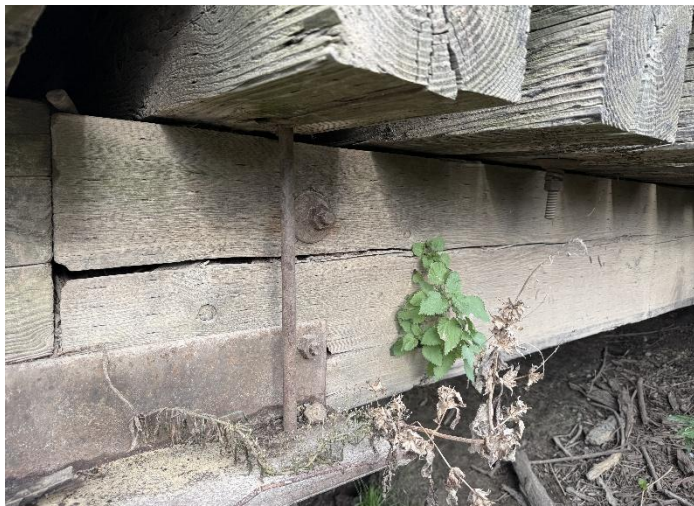
Photo 15 – East Beam-North Span Over North Pier.
