S-22 Tri Co/Cheese Country Bridge #7

Motorized Recreation Grant Application

Inspection Report for

Cheese Country Trail over Unnamed Stream

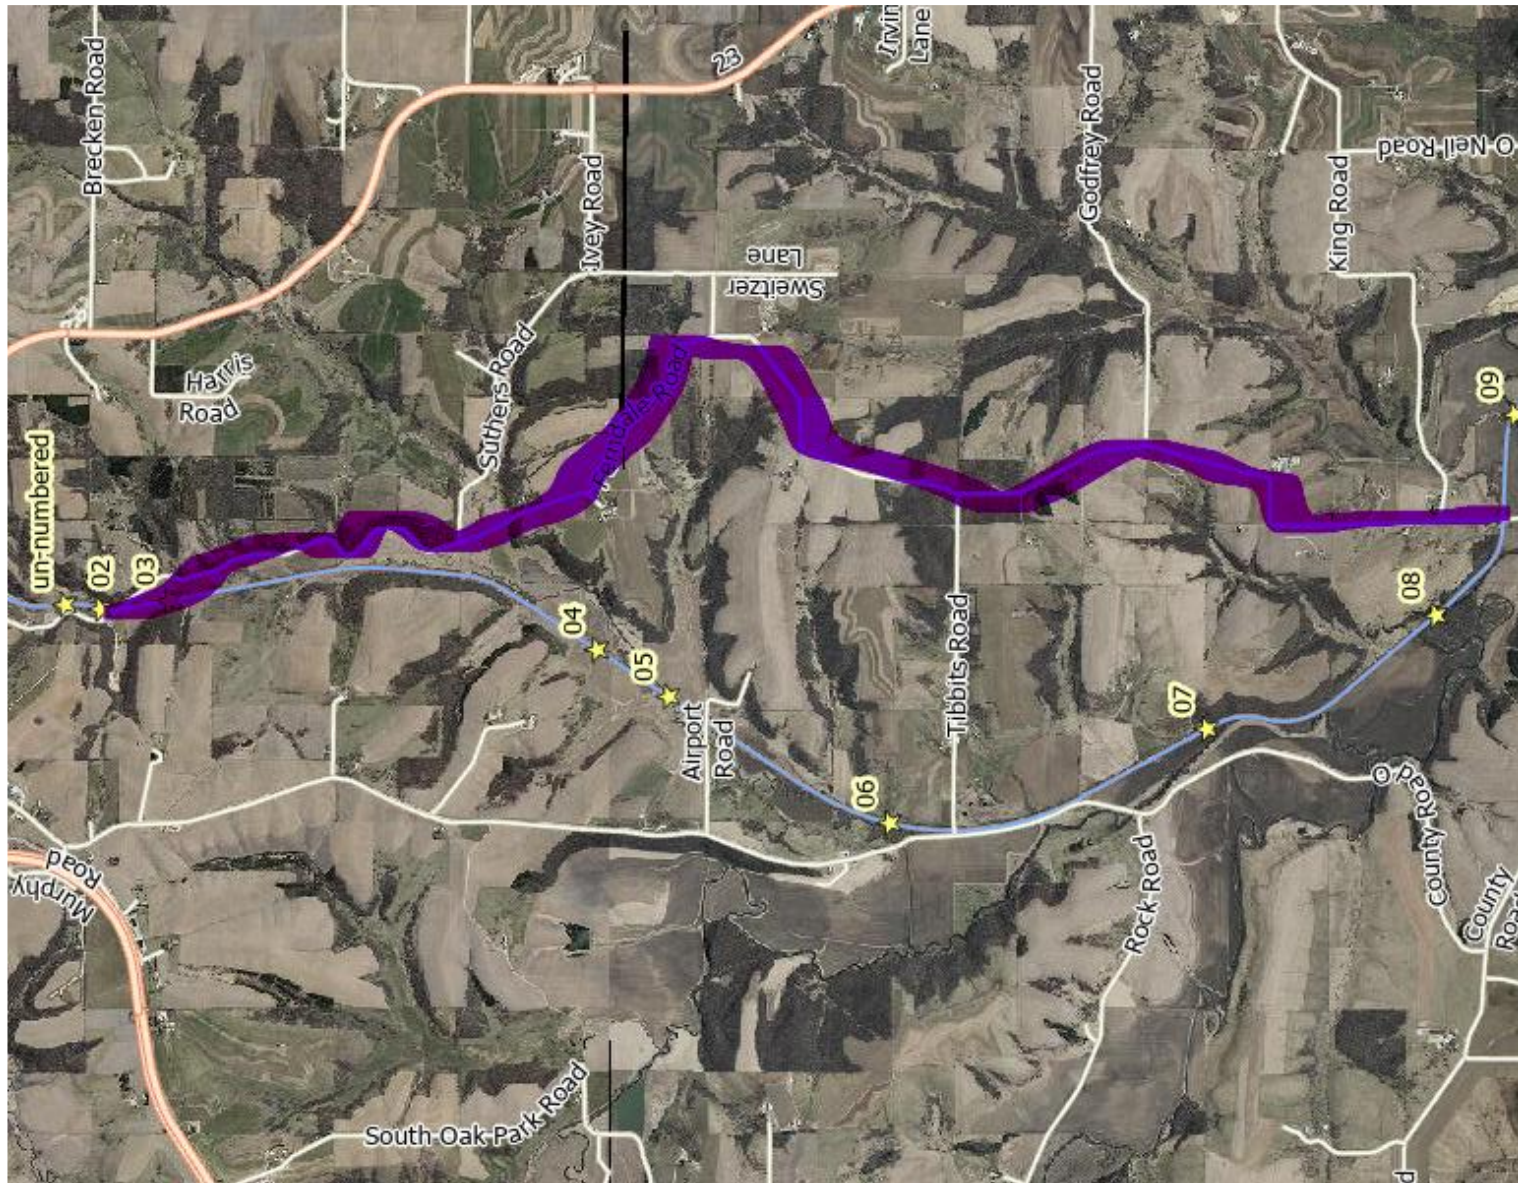
Trail re-route if bridge 7 would have to close.

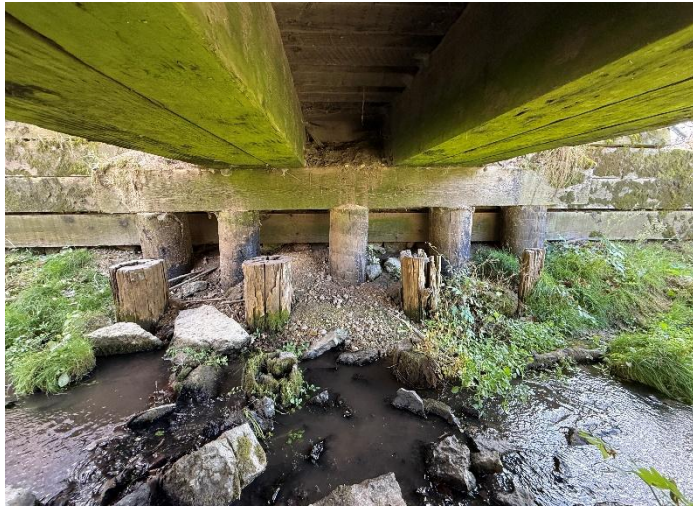
Photo 7 – South Abutment.

- Erosion at the south abutment has undermined the wingwall plank.

1. Embankment Erosion: Erosion has undermined the full-length south abutment backwall plank and approximately 8ft of the north abutment backwall plank.
2. Drift: No significant deposits in channel.
3. Channel Change: Channel flows through the center of the opening.
4. Adequacy of Opening: No readily visible signs of overtopping. Low clearance opening is susceptible to overtopping during high flow events.

Repair erosion/undermining of south abutment backwall plank.

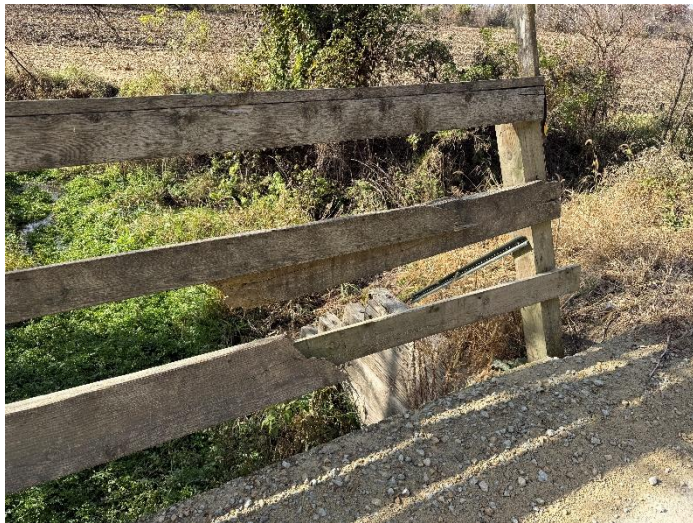
Photo 9 – North End of West Rail.

1. (3) rows of dimensional timber bridge rail supported by angled timber posts.
2. Patched collision damage to rails. Posts and rail decayed/loosely connected. Timber preservative treatment appears marginally effective.

Repair damaged railing components.

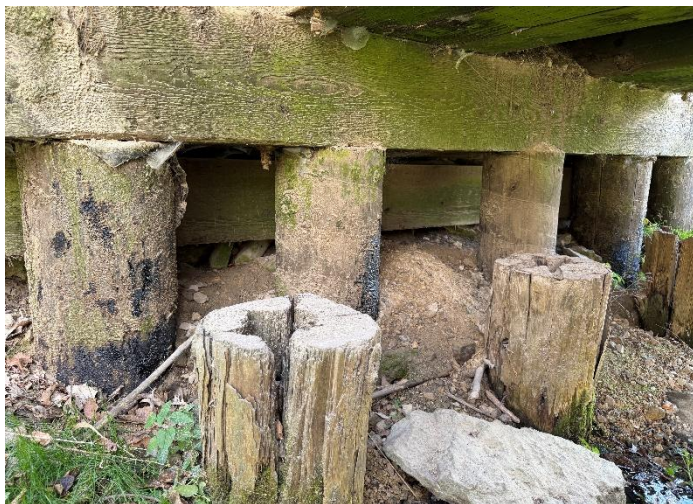
Photo 11 – South Abutment

1. Driven timber piles, timber pile caps, and timber backwall plank.
2. South backwall/wingwall plank undermined and separating. Portion of north backwall plank undermined.
3. Decayed timber components throughout. Backwall piles checking w/ signs of decay and section loss. All bearing piles sound hollow with +/- 50% loss section. No signs of lateral/overload distress observed.
