INSPECTION REPORT FOR

Oconto River State Trail Bridge

Over Little River

January 2026

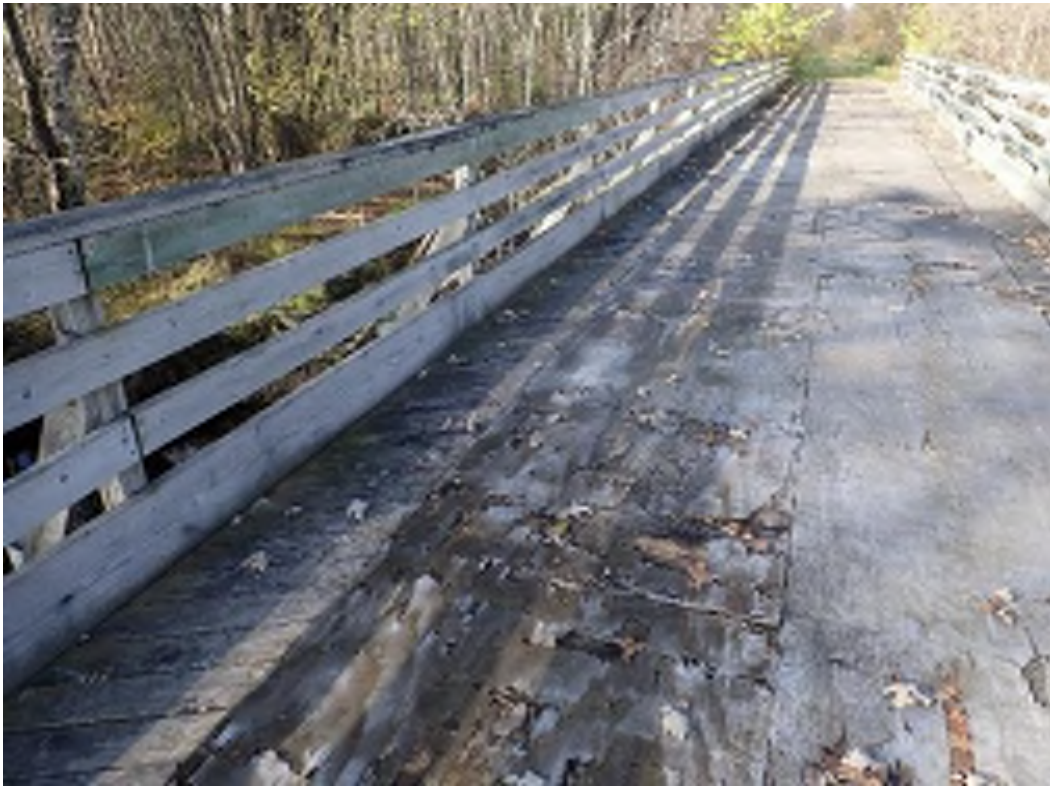
332		Timber Bridge Railing	LF	414		402	12		There was graffiti present on both rails, black paint.
	1150	Checks/Shakes/Cracks/Splits/ Delamination				397			Minor to moderate checks and splits throughout all railings
	1020	Connection					10	2	There are 2 locations on the north railing where the rail was disconnected from the rail post. There is also a broken, disconnected top rail on the east end of the bridge on the north rail.
	1900	Distortion				5			Multiple boards were warped along both rails, however were still connected to the rail posts.
510		Wearing Surfaces (Other)	SF	1336	401		935		Timber wearing surface comprised of 4ftx8ft plywood boards. Covered in ice and snow at time of inspection. Comments and ratings based on photos taken in October 2025.
	1150	Checks/Shakes/Cracks/Splits/ Delamination					935		About 75% of the wearing surface has deteriorated and delaminated.
8000		Wearing Surface Bare	SF	651		651			Exposed top surface of the deck timber

Typical wearing surface deterioration, looking southwest (taken Oct 2025)

<i>Item</i>	<i>Priority</i>	<i>Recommended By</i>	<i>Date Added</i>	<i>Status Date</i>
Repair Pier 11W piles	High	MSC	October 2025	
Fix railing connections and replace broken rails	High	MSC	October 2025	
Repair erosion for east abutment backwall	Med	MSC	October 2025	
Remove debris from upstream channel	Med	MSC	October 2025	
Repair moderate checks on pier caps and railings	Med	MSC	October 2025	
Remove graffiti on bridge railing	Low	MSC	October 2025	
Replace wearing surface on deck	Low	MSC	October 2025

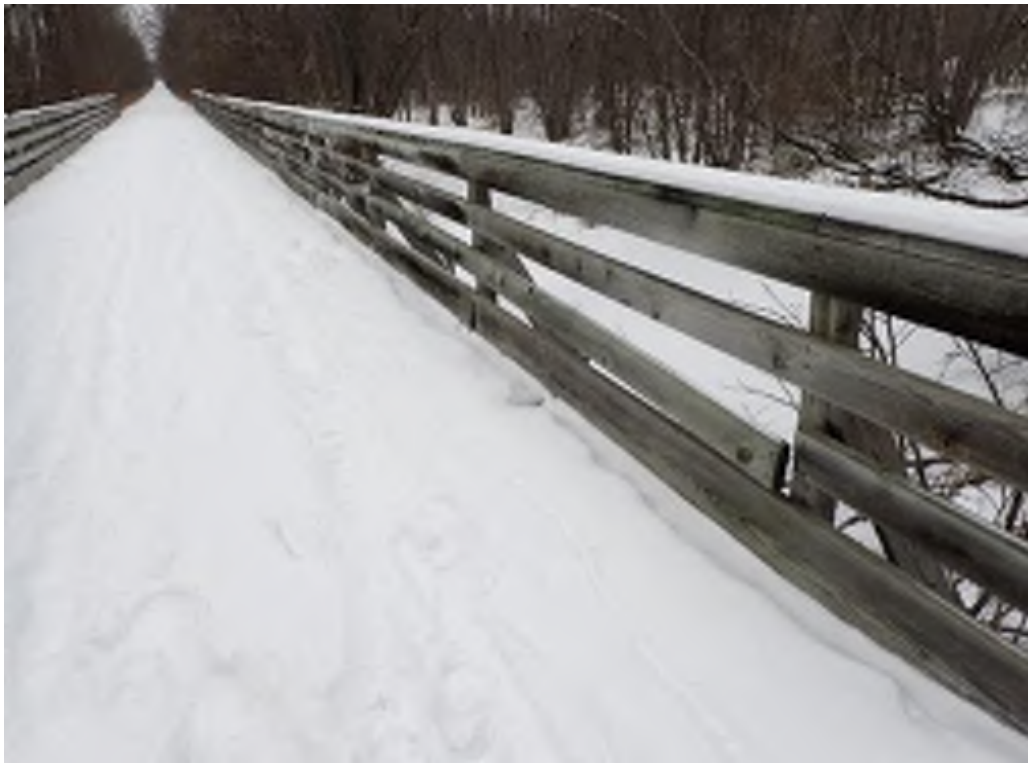
Broken rail connections on north rail, looking northwest (taken Jan 2026)

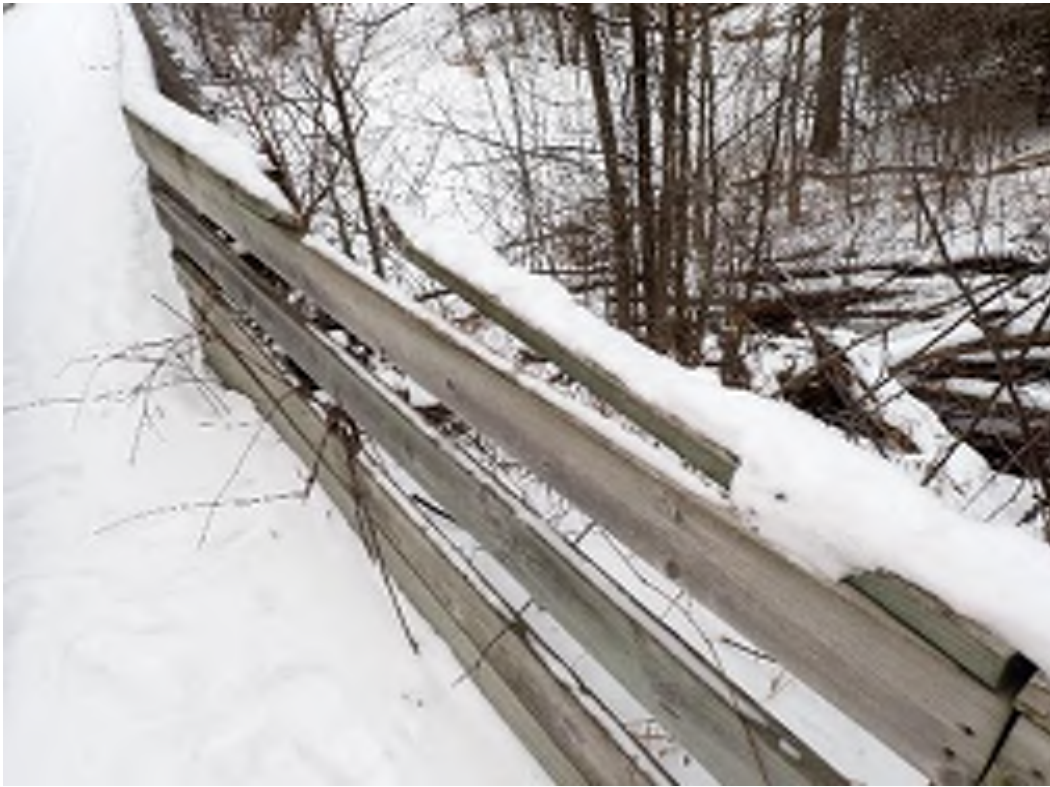
Broken top rail on east end, north side, looking west (taken Jan 2026)

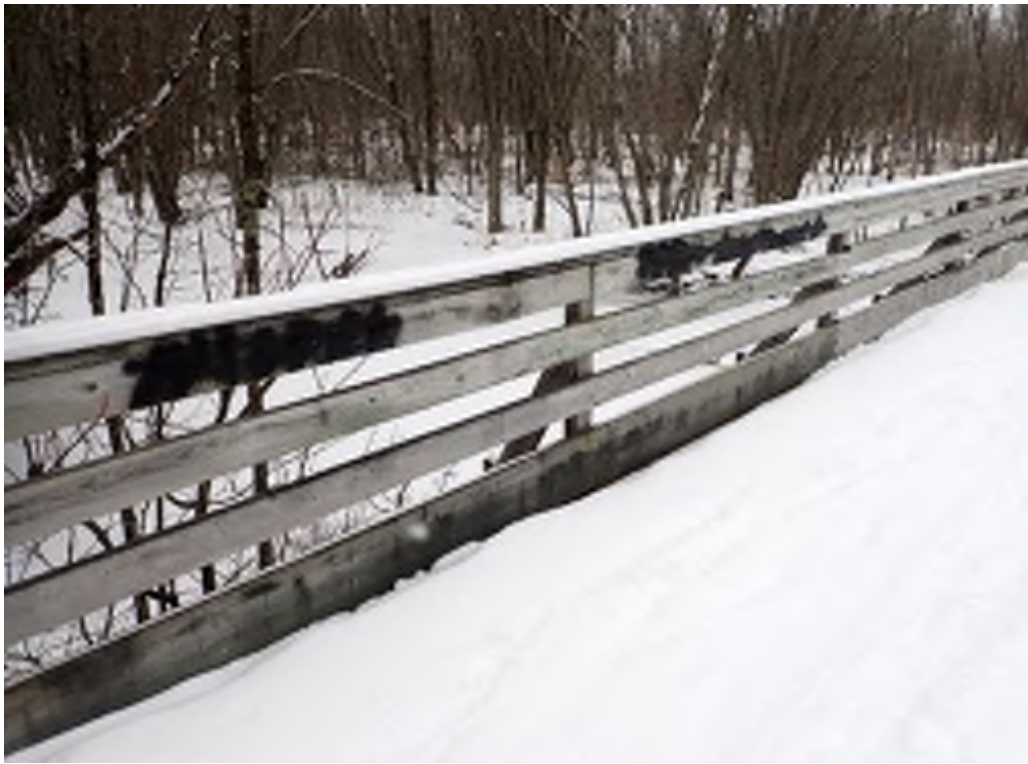
Typical graffiti, looking southeast (taken Jan 2026)

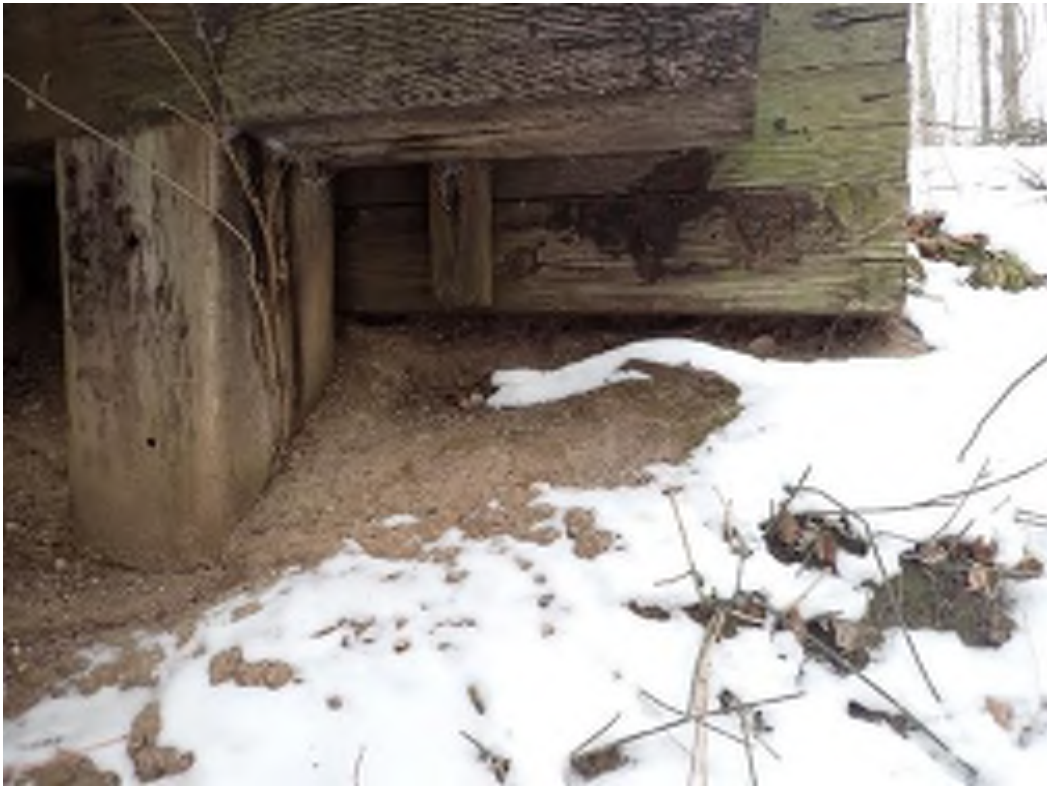
East abutment backwall erosion, looking east (taken Jan 2026)

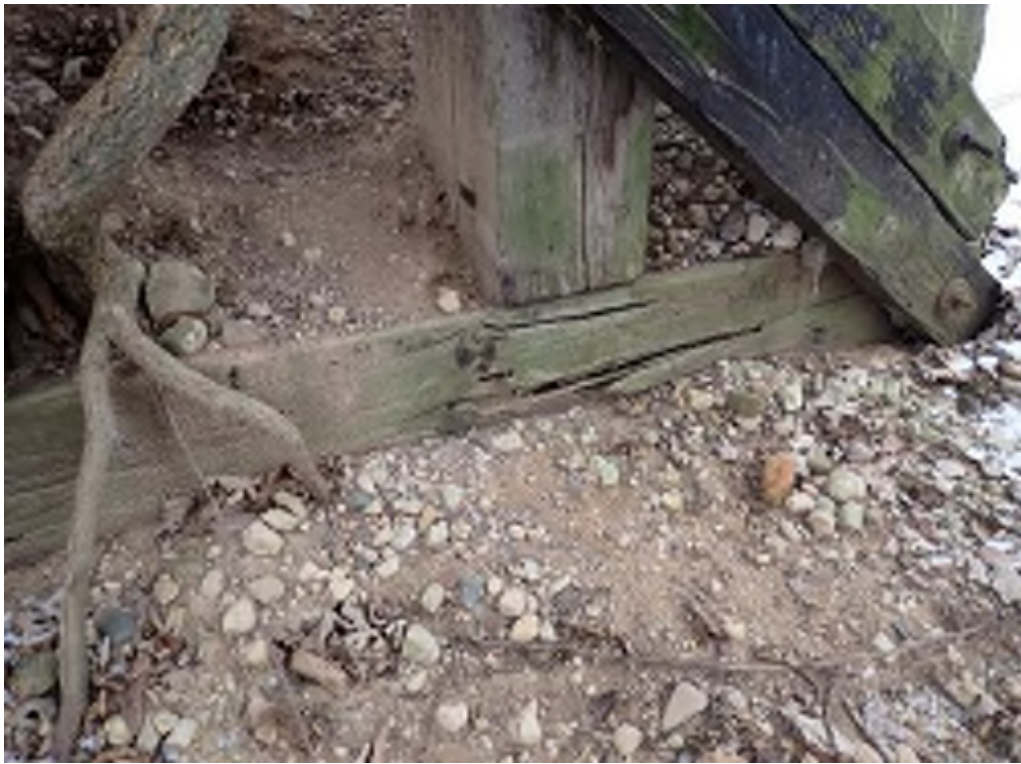
235		Timber Pier Cap	LF	168		168			
	1150	Checks/Shakes/Cracks/Splits/ Delamination				168			Minor to moderate checks and splits were present at the ends of all pier caps. Splits extended up to 1ft in length.
236		Other Material Pile Cap (Timber)	LF	384		192	192		Pile cap near waterline/groundline. For piers 1W, 11W and 12W, there was a 14LF cap on top of the piles. For the rest of the piers, there was a 14LF top cap and 18LF bottom cap with a 4in gap comprised of 4in H x 8in W spacers. Pier 1W, 11W, and 12W were partially buried in soil, the rest were under water or ice at time of inspection.
	1150	Checks/Shakes/Cracks/Splits/ Delamination				192			Visible portions of the pile caps exhibited minor to moderate splits and checks throughout. Near the groundline and waterline, there were some areas of delamination present.
	1140	Decay/Section Loss/Abrasion/Wear						192	There were some areas where decay of the pile cap was present, near groundline and waterline, about 50% of all pile caps.

Typical pile cap delamination / decay, looking southeast (taken Jan 2026)

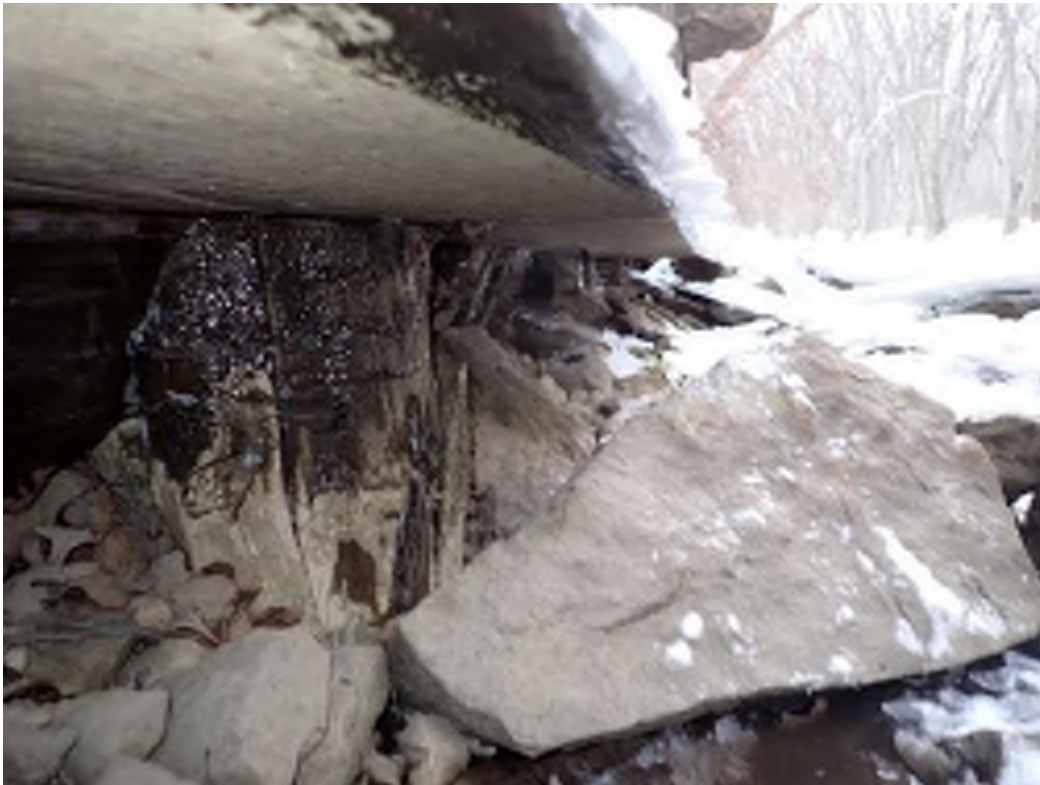
Pier 11W pile deterioration, looking south (taken Jan 2026)

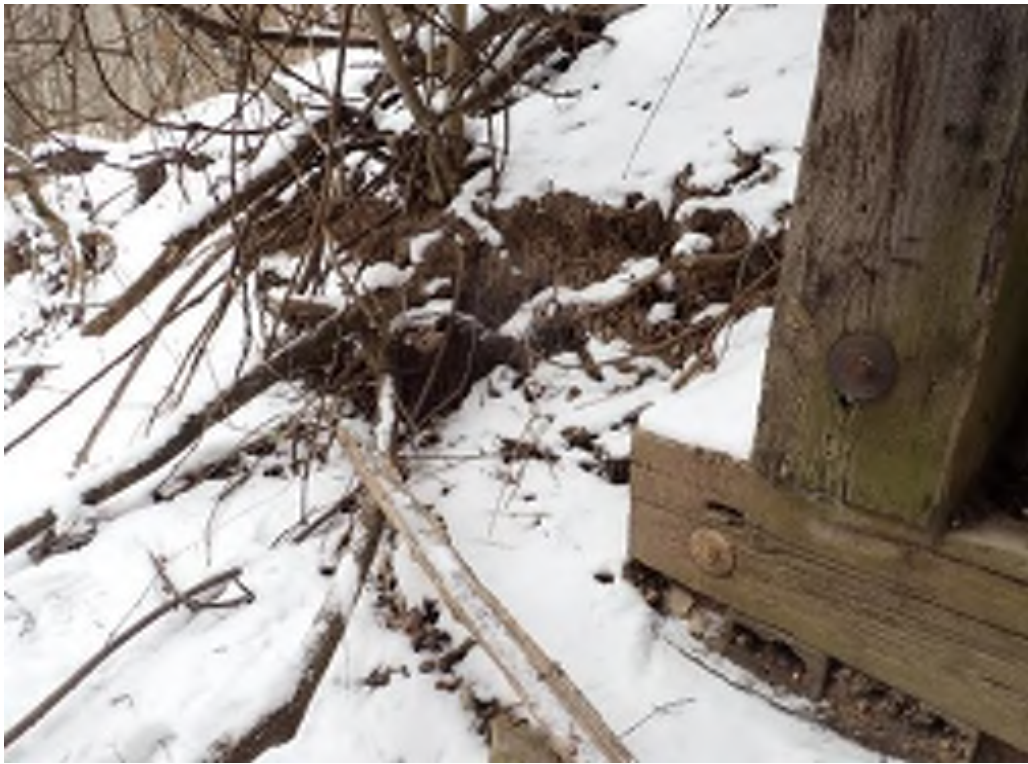
Assessment	Description	UOM	Total	1	2	3	4	Comments
9001	Drainage - Ends of Structure	EA	4	2	2			Some minor erosion observed at the east side corners.
9041	Slope Prot. - Bare	EA	2		2			Both slopes appeared to have sloughing and bank erosion near the high water line.
9169	Lateral Bracing	EA	16		16			8 lateral bracings per fascia. Some minor splits and checks throughout. A faint green alga was observed on all timber.
9250	Crash Walls/Web Walls/Cross Bracing or Struts	EA	12		12			Minor checks and splits observed throughout all bracing elements on pier faces.
9324	Approach Roadway - Gravel	EA	2	2				Covered in snow and ice at time of inspection. No defects observed in Oct 2025.

Typical bank erosion on west side, looking southwest (taken Jan 2026)

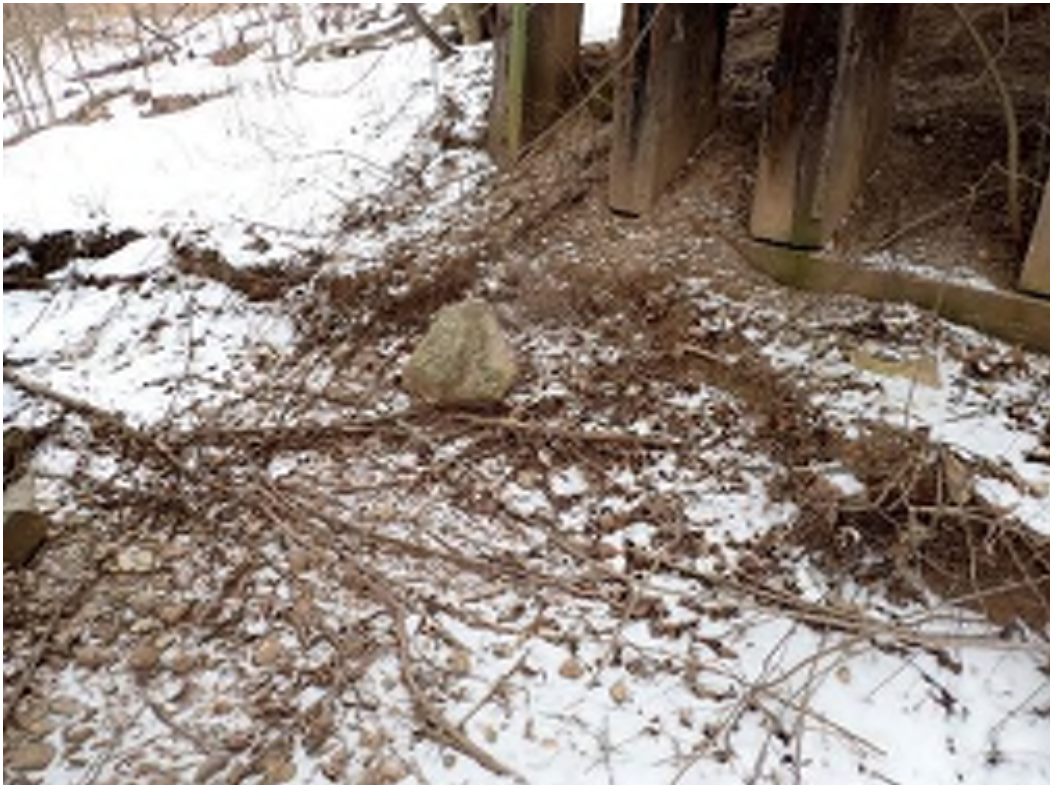
Typical bank erosion on east side, looking northeast (taken Jan 2026)

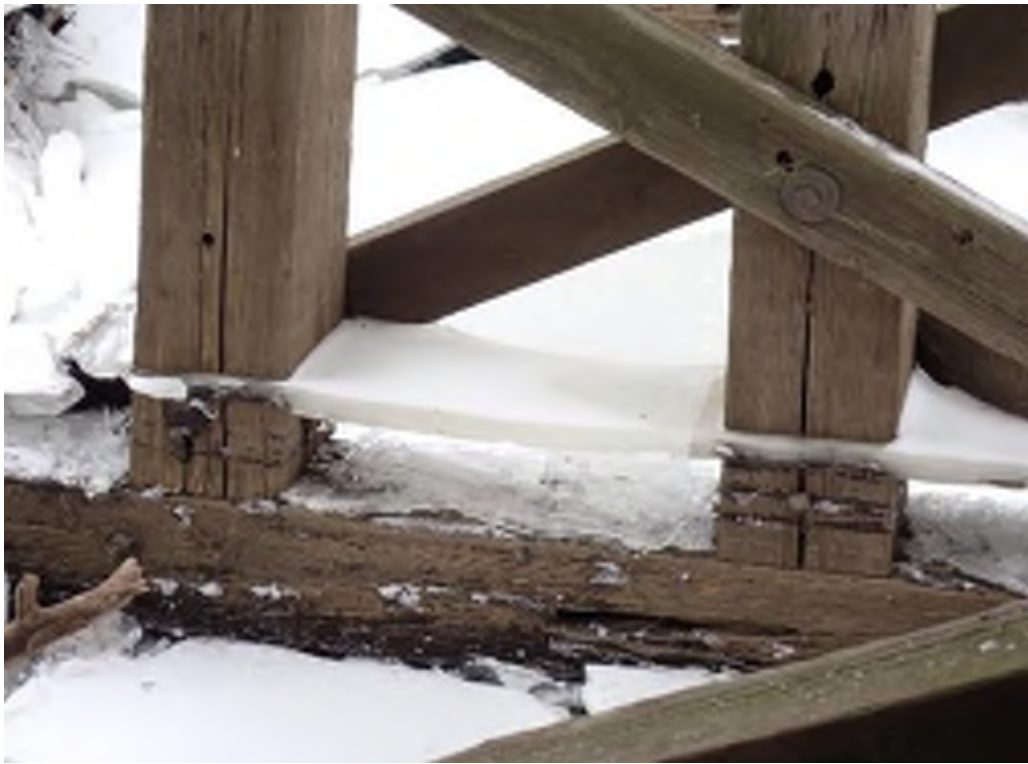
206		Timber Column	EA	56	28	28			
	1150	Checks/Shakes/Cracks/Splits/ Delamination				28			Some columns exhibited minor to moderate checks and splits, up to 2in deep, on 50% of all columns. No signs of decay present near waterline or groundline.
216		Timber Abutment	LF	34		34			Timber pile embedded in soil with timber backwall. No wingwalls present. Area of erosion on east abutment, on the south side back wall. Soil was seeping form behind the backwall.
	1150	Checks/Shakes/Cracks/Splits/ Delamination				34			Minor to moderate checks and splits throughout all abutments
228		Timber Pile	EA	56					All piles were covered by either being buried, or under snow and ice, except piles under Pier 11W. Where possible, piles were probed underwater through the ice.
	1150	Checks/Shakes/Cracks/Splits/ Delamination				31	20		Probing revealed some piles had minor to moderate checks and splits.
	1220	Deterioration						5	All piles under Pier 11W were heavily deteriorated. 4 of the 5 piles were missing. These piles would be in the water during high water events. Support of the pier appeared to be a combination of the existing single pile and the surrounding groundline

Typical splits in columns near pile cap, looking southwest (taken Jan 2026)

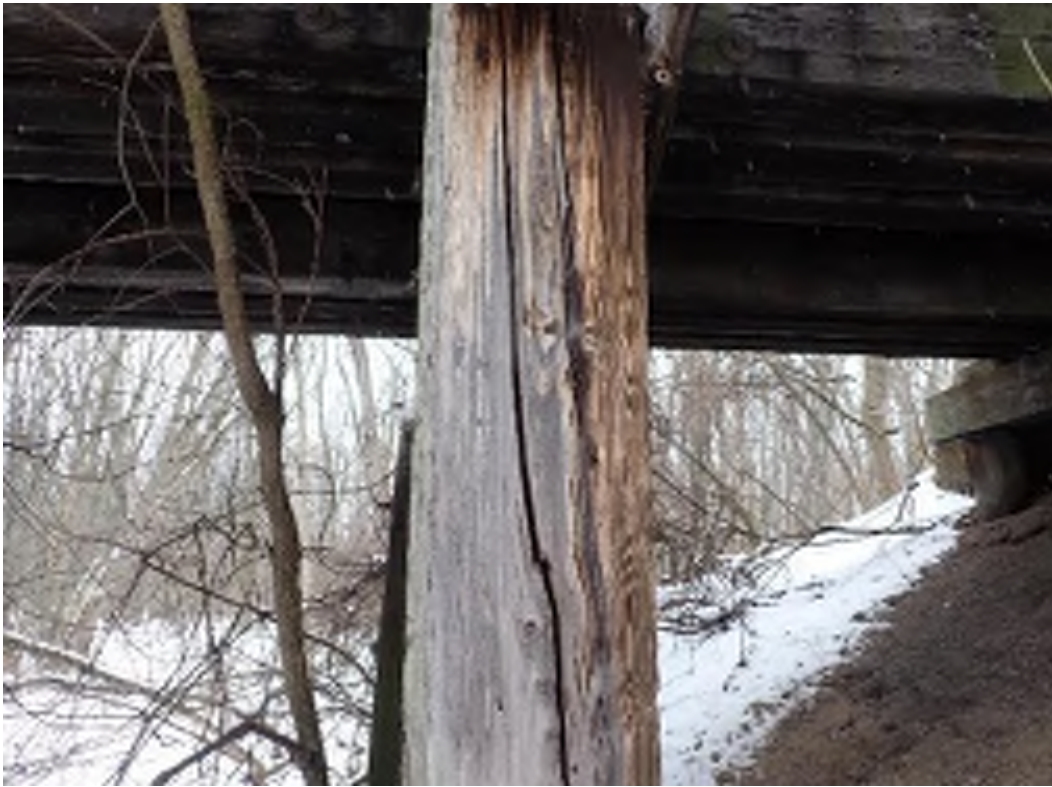
Typical column splits in pier, looking north (taken Jan 2026)

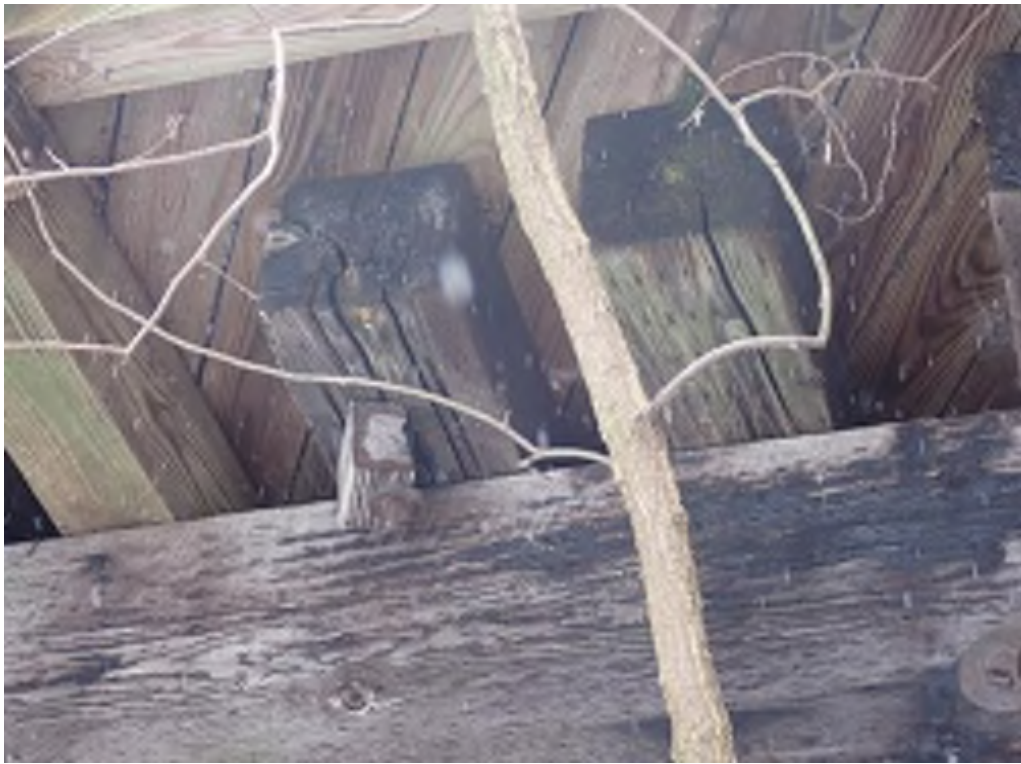
Element	Defect	Description	UOM	Total	1	2	3	4	Comments
31		Timber Deck	SF	1987		1987			Deck was covered in ice and snow at time of inspection. Comments and ratings based on photos taken in October 2025.
	1150	Checks/Shakes/Cracks/Splits/ Delamination				1987			Minor checks and splits observed on the bottom face throughout
111		Timber Open Girder/Beam	LF	1002	1002				Comprised of a 8inx15in timber girder in a bundle of 3 on each side, with metal spacers between.
	1150	Checks/Shakes/Cracks/Splits/ Delamination			1002				Minor to moderate checks and splits observed throughout all girders. No signs of crushing at the abutments or piers.
117		Timber Stringer	LF	1200	720	480			Comprised of 8in high railroad ties, approximately 10 per span, and approximately 10ft long
	1150	Checks/Shakes/Cracks/Splits/ Delamination				480			Some minor to moderate splitting on stringer ends throughout, about 40% of all stringers. Splits extend up to 1ft in length.

Typical splits in timber stringer ends, looking northwest (taken Jan 2026)

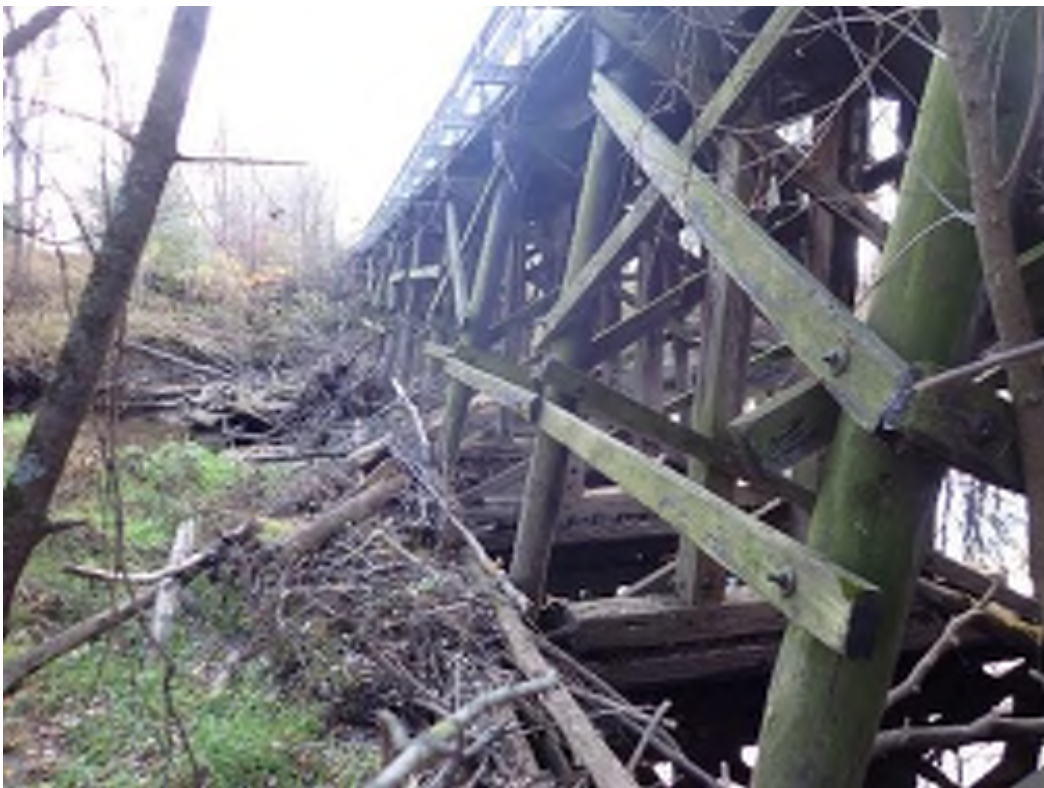
There is a large debris dam present on the north side of the structure that is affecting water flow. The dam spans the entire width of the waterway.

Debris on north side, looking southeast (taken Oct 2025)
