# **Adventures In Sub-Slab Sampling**

# Vapor intrusion sampling was conducted at two sites in the Wausau area

- A DERP site that is currently being used as a thrift store.
- VPLE site at a closed industrial facility.

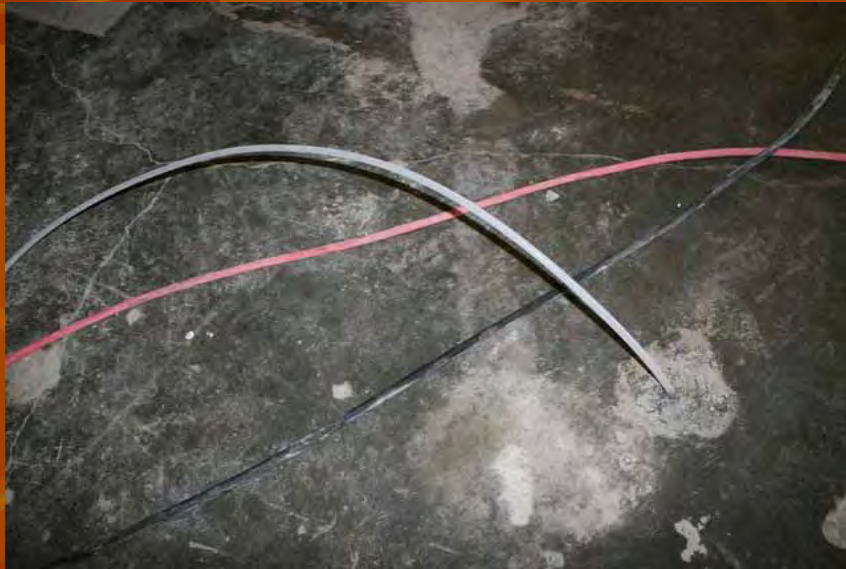
# 1<sup>st</sup> Attempt with Temporary Samplers

- A teflon tube is installed through the concrete and sealed.
- Vapors are drawn through the tube.
- Sounds reasonable...  
Right?

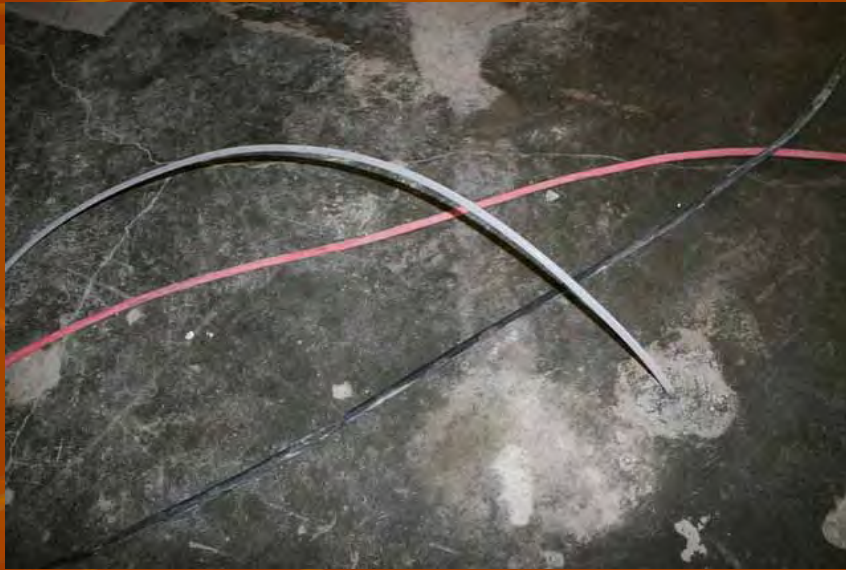
# Problems with Sealing Temporary Sample Ports

- Sealing material is usually some sort of pliable material such as modeling clay, play do, bees wax, etc.
- Sealing material doesn't actually bond to the tube.
- Small gaps can form when tubing is moved/wiggled.

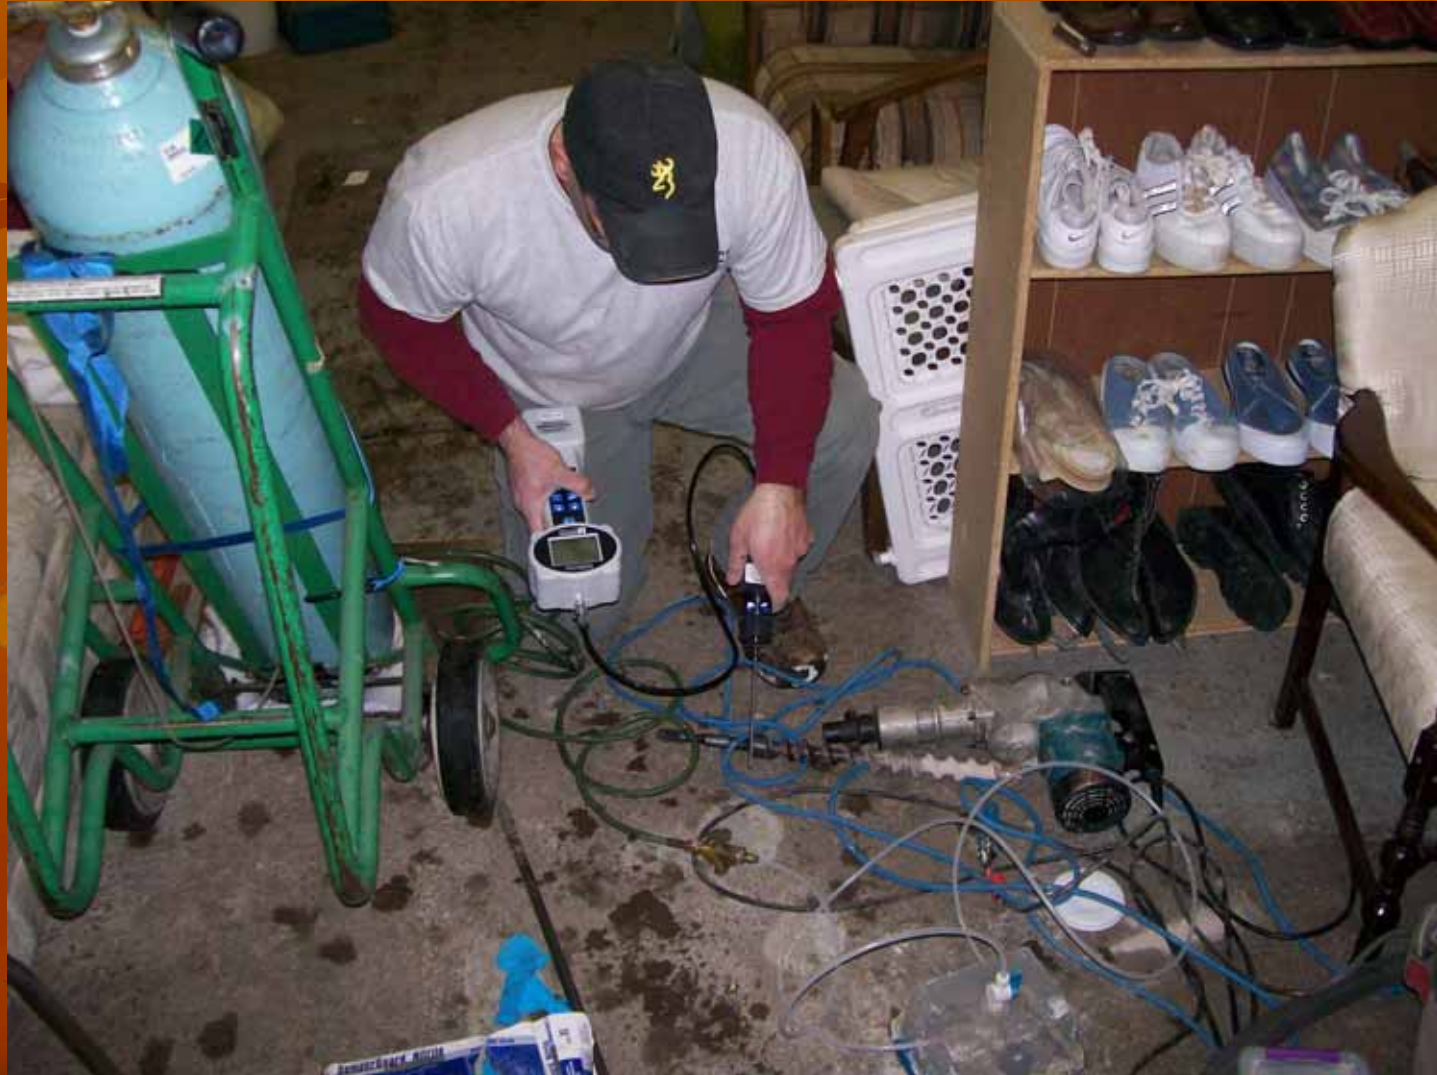
# Sample location that failed the leak test, again

- The ambient air registered about 10 units with the helium meter.
- The Teflon tubing registered a couple hundred units with the helium meter.
- Leak testing at the first sampling point detected helium at tens of thousands of meter units.
- Leak testing at the other sampling locations detected helium at equipment background readings.

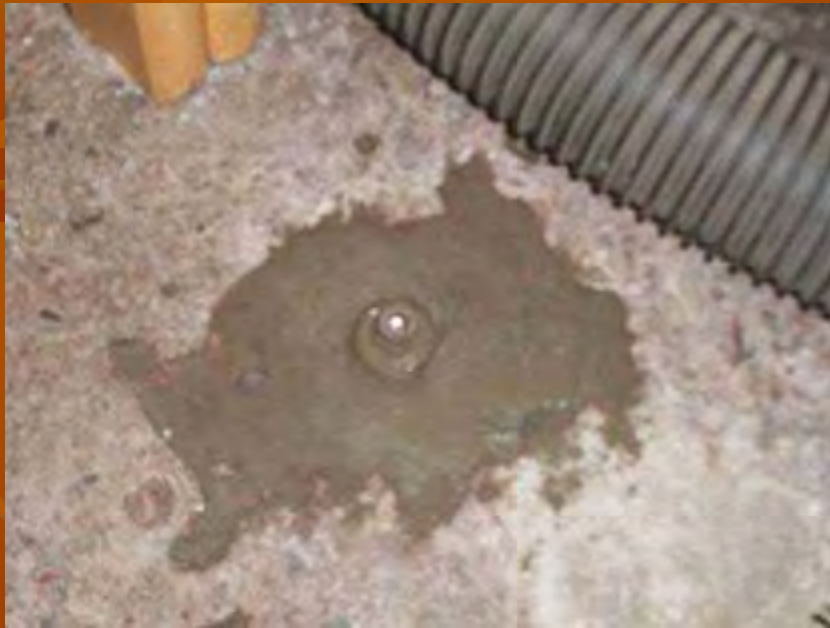
- Foot traffic may have jarred the sample port breaking the seal between the sample port and concrete

# Sealing the thumbwheel to the floor solved the problem
