March 27, 2024

RE: Fall 2023 Stream C Sampling Results Summary
Reclaimed Flambeau Mine, Ladysmith, Wisconsin

This memorandum presents the activities and results from the fall 2023 Stream C monitoring.

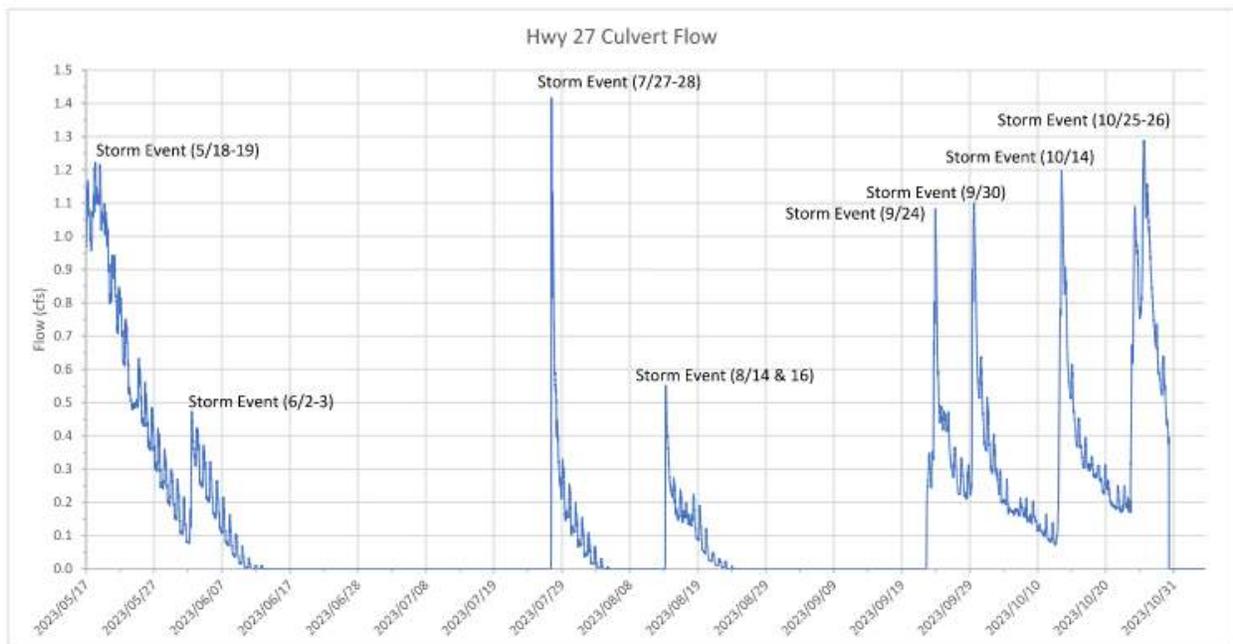
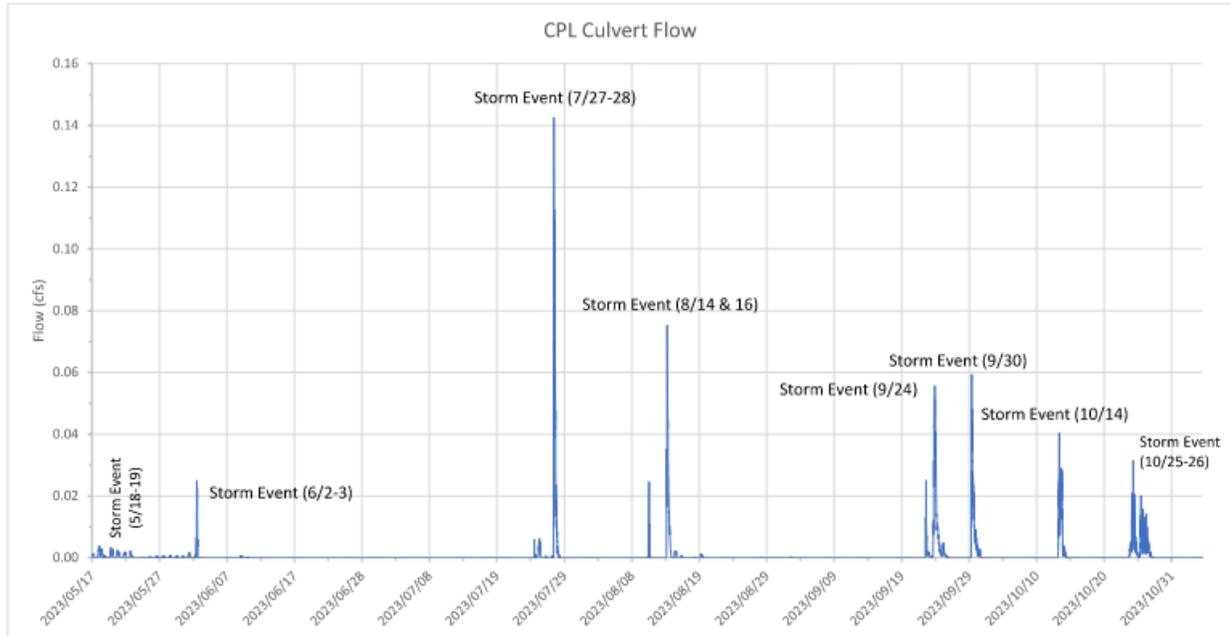
- ◆ Due to dry weather conditions, flow was noted to have stopped at Hwy 27 on June 11, 2023 through July 2, August 4 through August 14, and August 23 through September 24.

- ◆ The daily cycling observed in the Hwy 27 culvert is most likely explained by a temperature-related effect related to evapotranspiration.
- ◆ No daily cycling is observed at the Copper Park Lane culvert. This is likely because there is no standing water in or adjacent to this culvert; therefore, evapotranspiration effects are not as prominent.

- ◆ The fall storm events noted show a maximum flow of about 1.42 cubic feet per second (cfs) in the Hwy 27 culvert and are relatively short-lived with the majority of flow dissipating after 24 hours.

- ◆ The Copper Park Lane culvert shows low flow during the runoff events, and events last for only a few hours at most. The maximum flow noted was about 0.143 cfs. Zero flow is observed during non-event periods.

- ◆ The flow observed at Copper Park Lane during storm events compared to Hwy 27 suggests that flow dissipates (infiltrates, evaporates, gets lost to storage, etc.) between the two culverts.

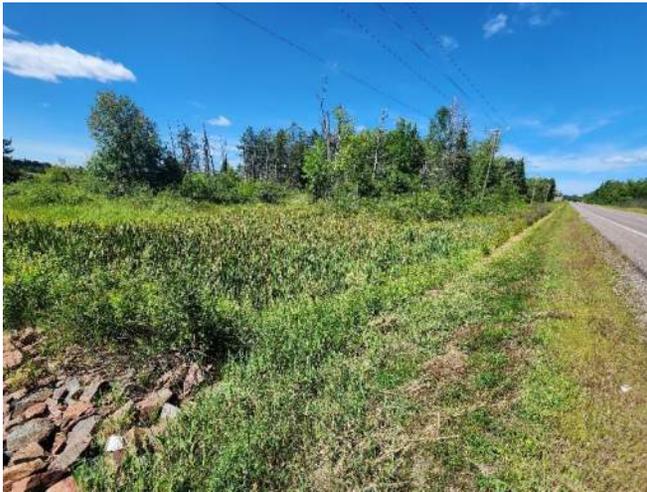
Description:
Ditch along West side of Hwy 27 north of culvert.

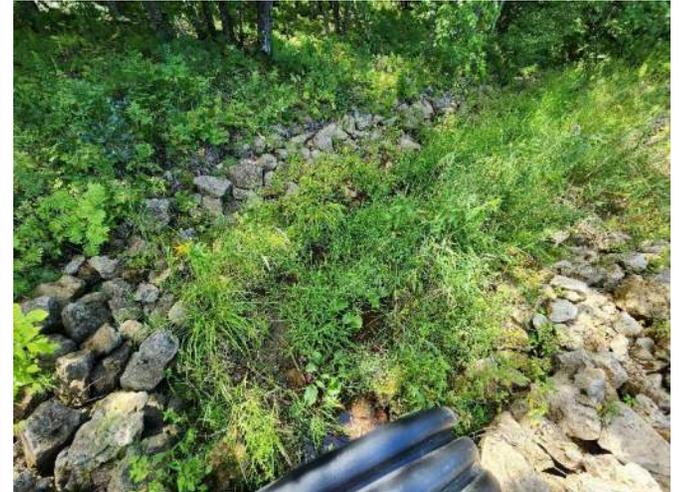
Photo No.
7

Description:
Stream C downstream of the Cooper Park Lane culvert.

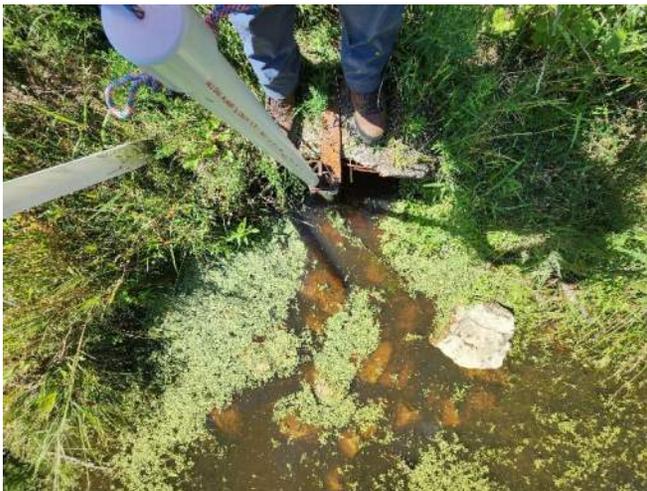
Photo No.
6

Description:
Upstream end of culvert under Hwy 27.

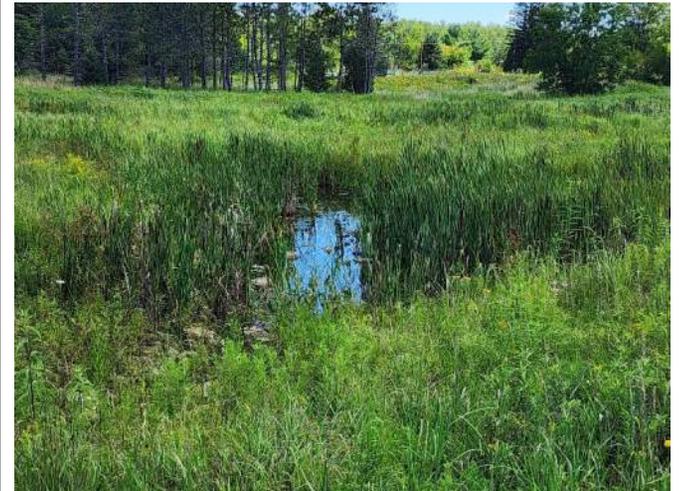
Photo No.
8

Description:
Standing water near sample point SW-NBOUT.

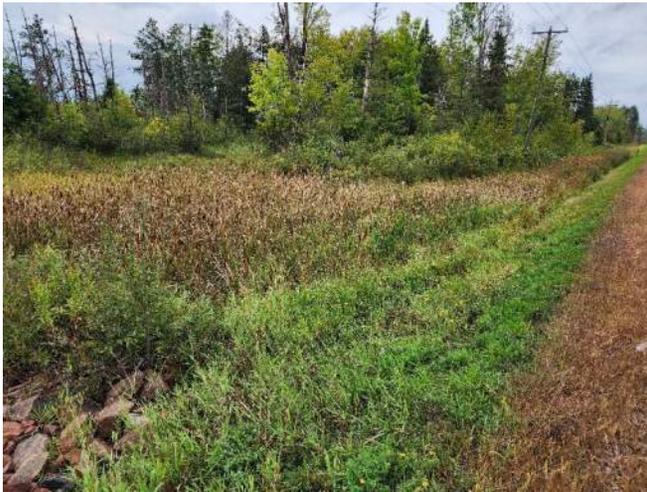
Description:
Ditch along West side of Hwy 27 north of culvert.

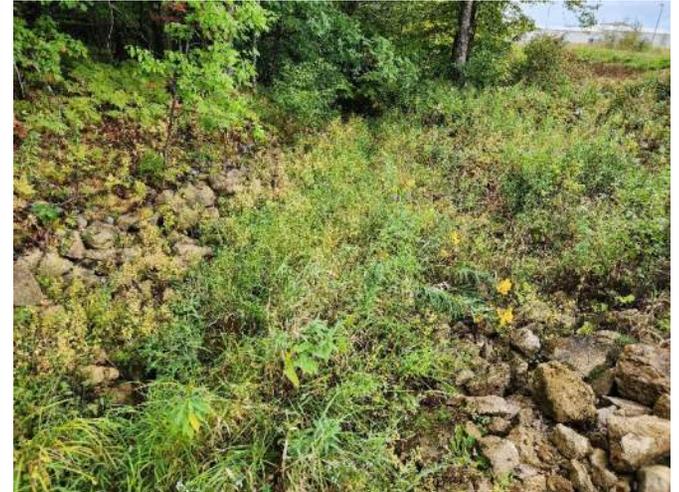
Photo No.
7

Description:
Stream C downstream of the Cooper Park Lane culvert.

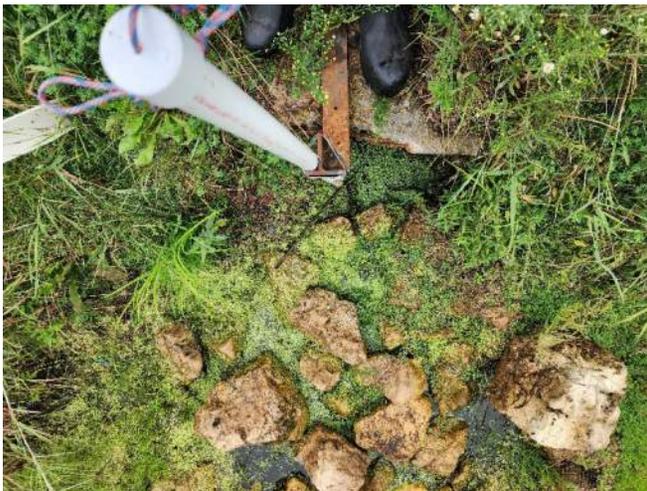
Photo No.
6

Description:
Upstream end of culvert under Hwy 27.

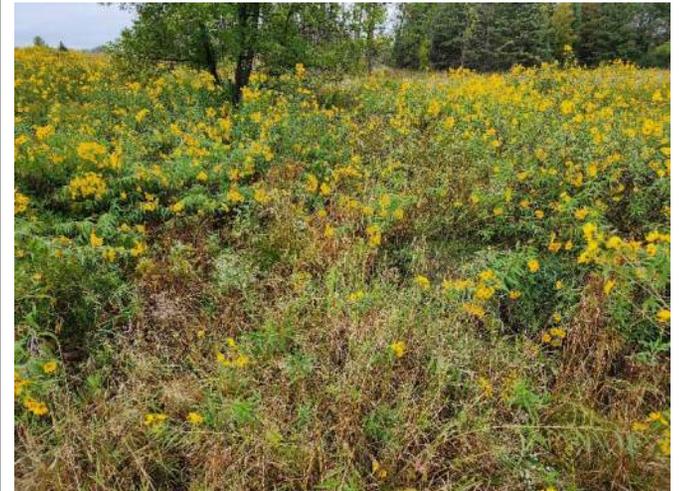
Photo No.
8

Description:
View from upstream end of culvert under Copper Park Lane.

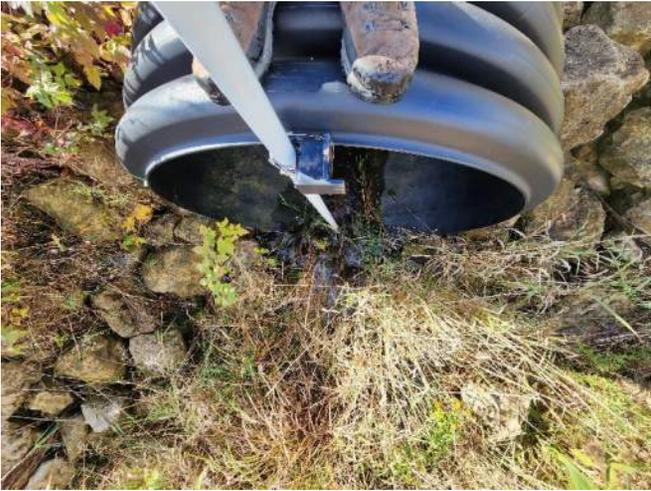
Photo No. 1	Date: 10-14-23

Direction Photo Taken: North		
Photo Taken By: Jim Engelhardt		
Description: Upstream end of culvert under Copper Park Lane.

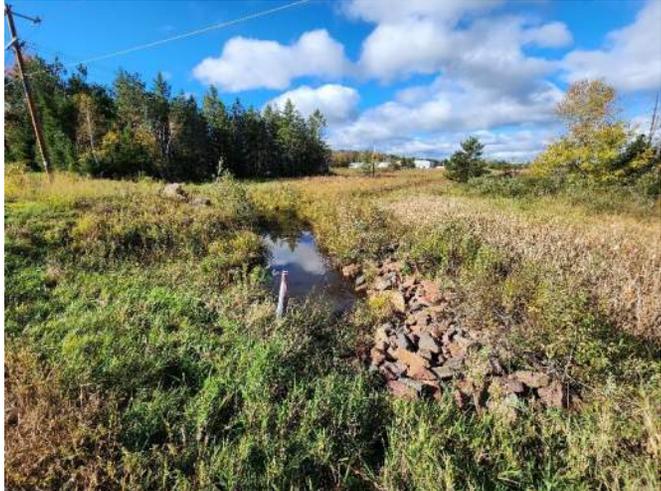
Photo No. 3	Date: 10-14-23

Direction Photo Taken: Southwest		
Photo Taken By: Jim Engelhardt		
Description: Downstream (west) end of culvert under Hwy 27.

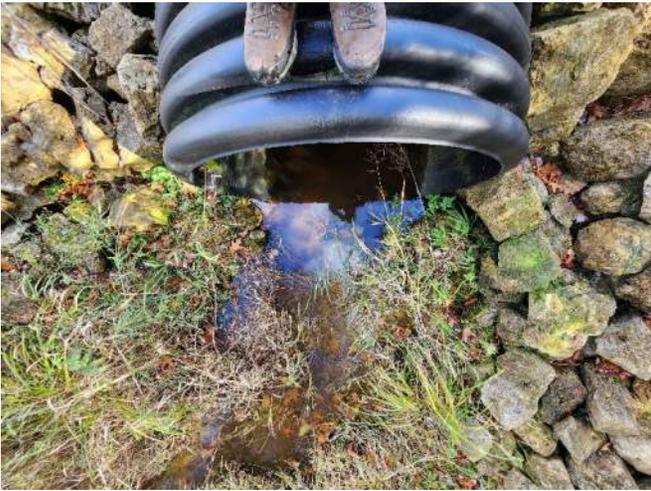
Photo No. 2	Date: 10-14-23

Direction Photo Taken: Southwest		
Photo Taken By: Jim Engelhardt		
Description: Downstream end of culvert under Copper Park Lane.

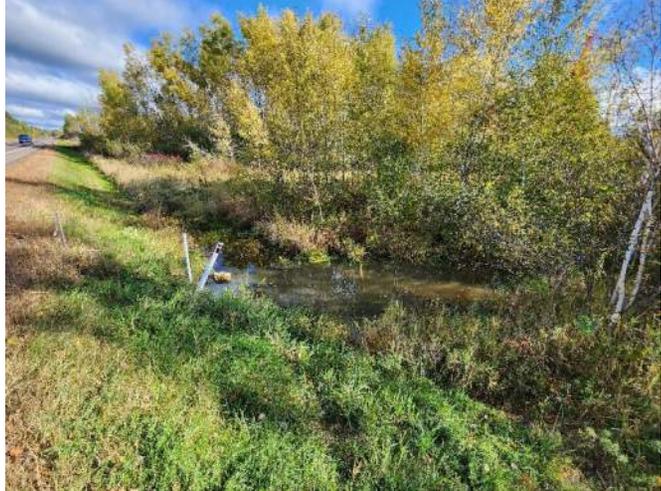
Direction Photo Taken: Northeast		
Photo Taken By: Jim Engelhardt		
Description: Upstream (east) end of culvert under STH 27.
