A-14 Forest Co WRST Swamp Creek Bridge

Project Title					Current Funded Miles	New Miles (if applicable)
WRST Swamp Creek Bridge Replacement						
County	Township	Range	Section	1/4 1/4	1/4	GPS Coordinates:
Forest	35 N	13	21			Lat. 45.5034
						Long. -88.88175

Trail Bridge Inspection

Swamp Creek

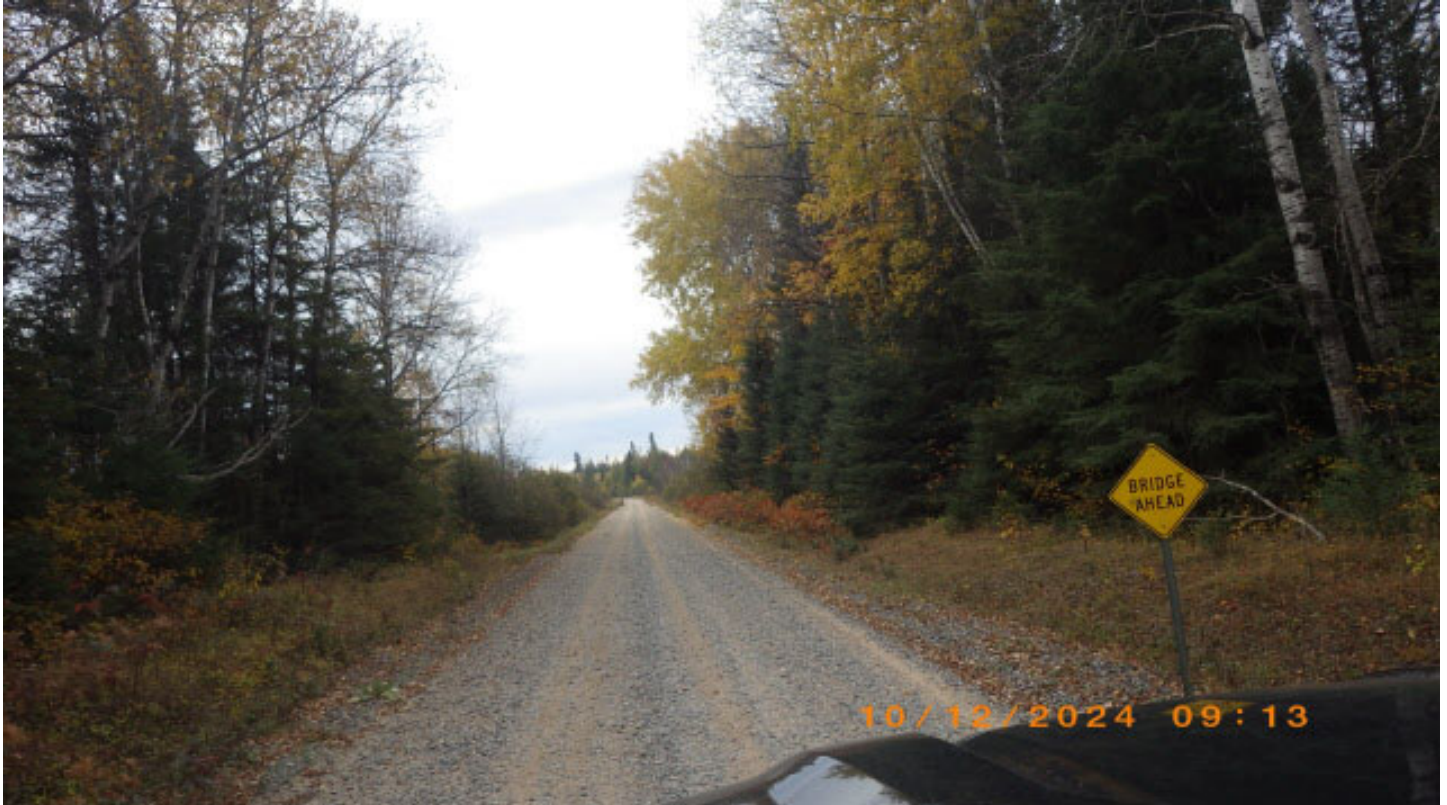
Approaches are in fair condition with steep, unstable side slopes. North bridge ahead sign CS2 scraped, south CS2 map cracked. CS1 object markers.

North bridge ahead sign

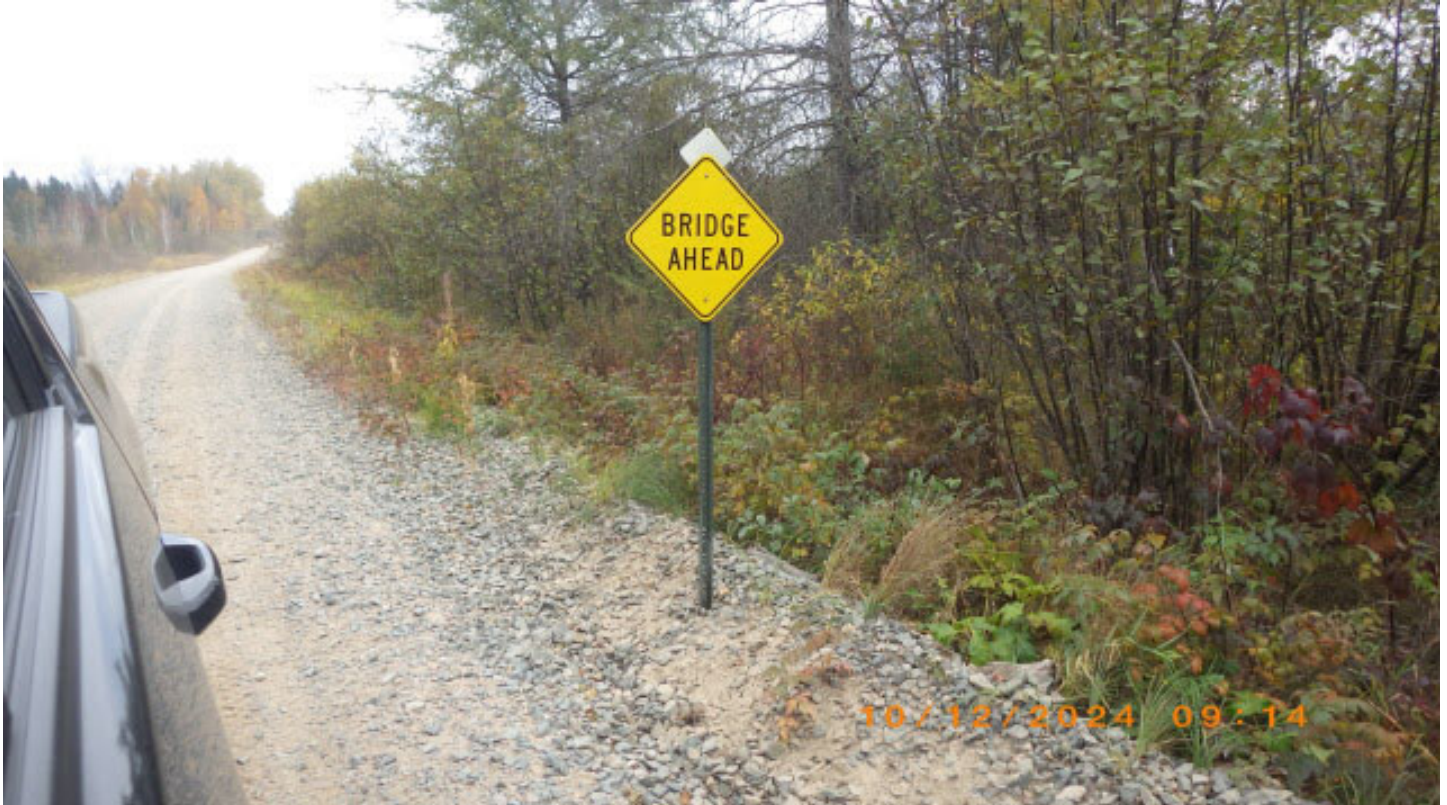
South bridge ahead sign

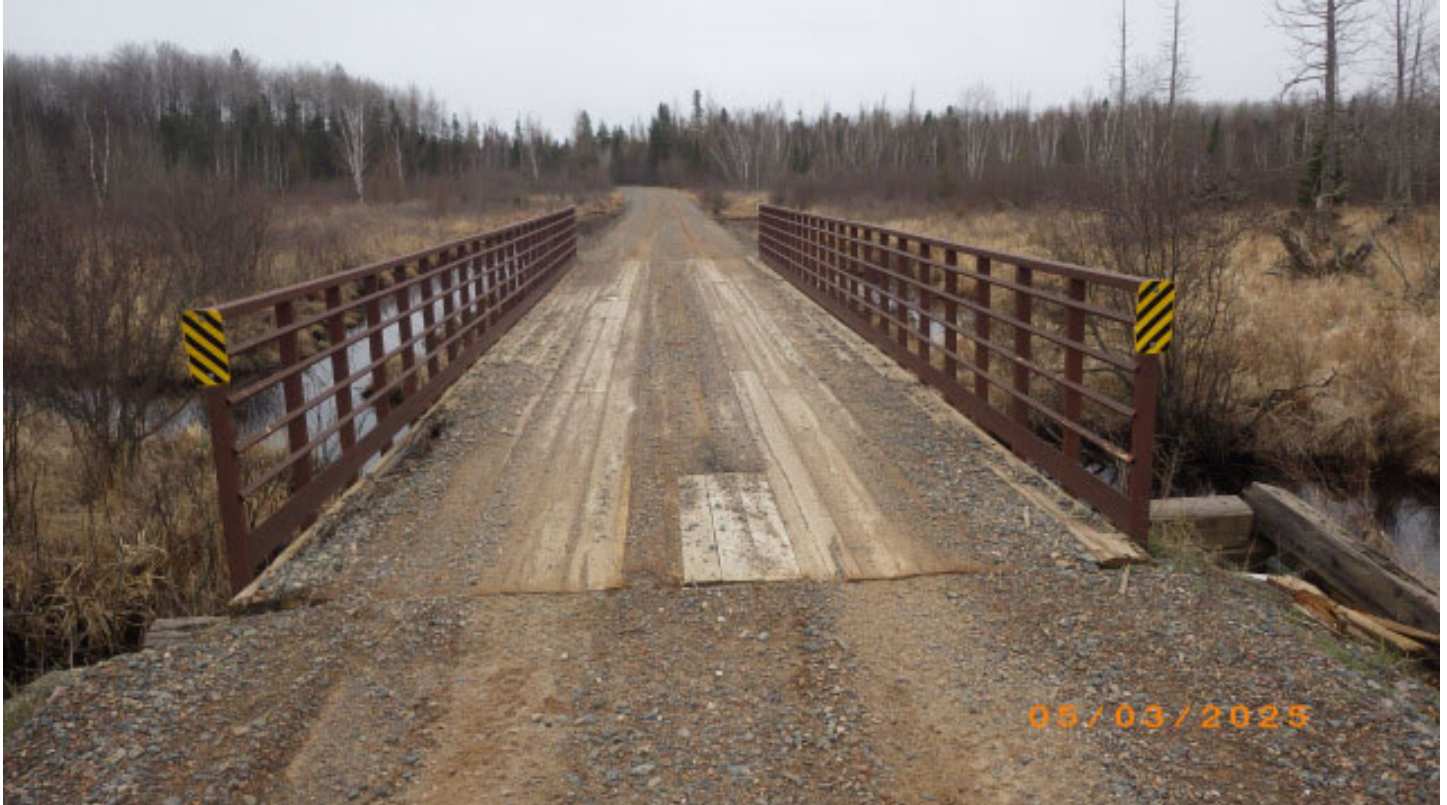
North approach

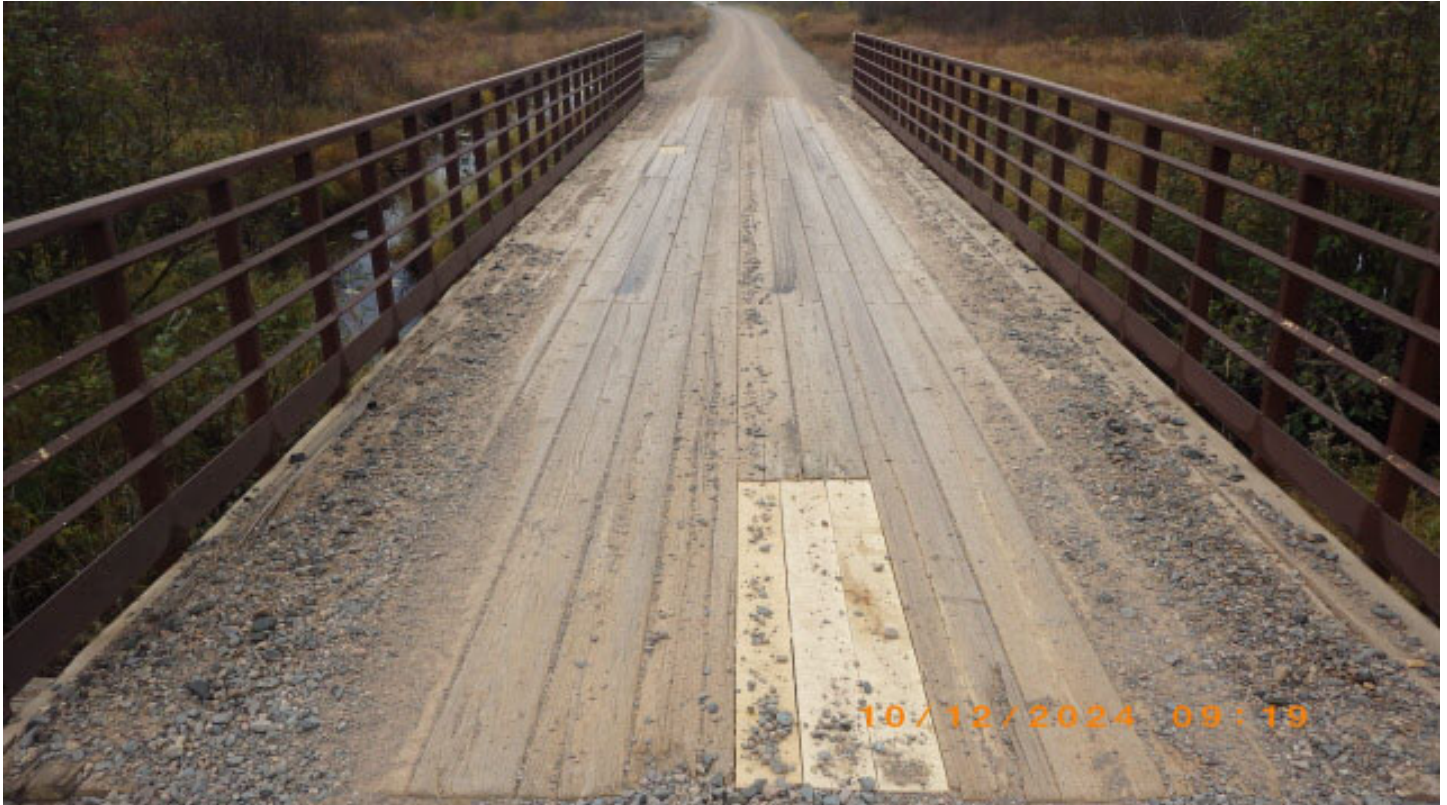
Wearing surface has some gravel cover, some moderate CS3 wear and rot in wheel paths and rotten through in NE corner, CS2 elsewhere.

Top of deck

Replace wearing surface and deck

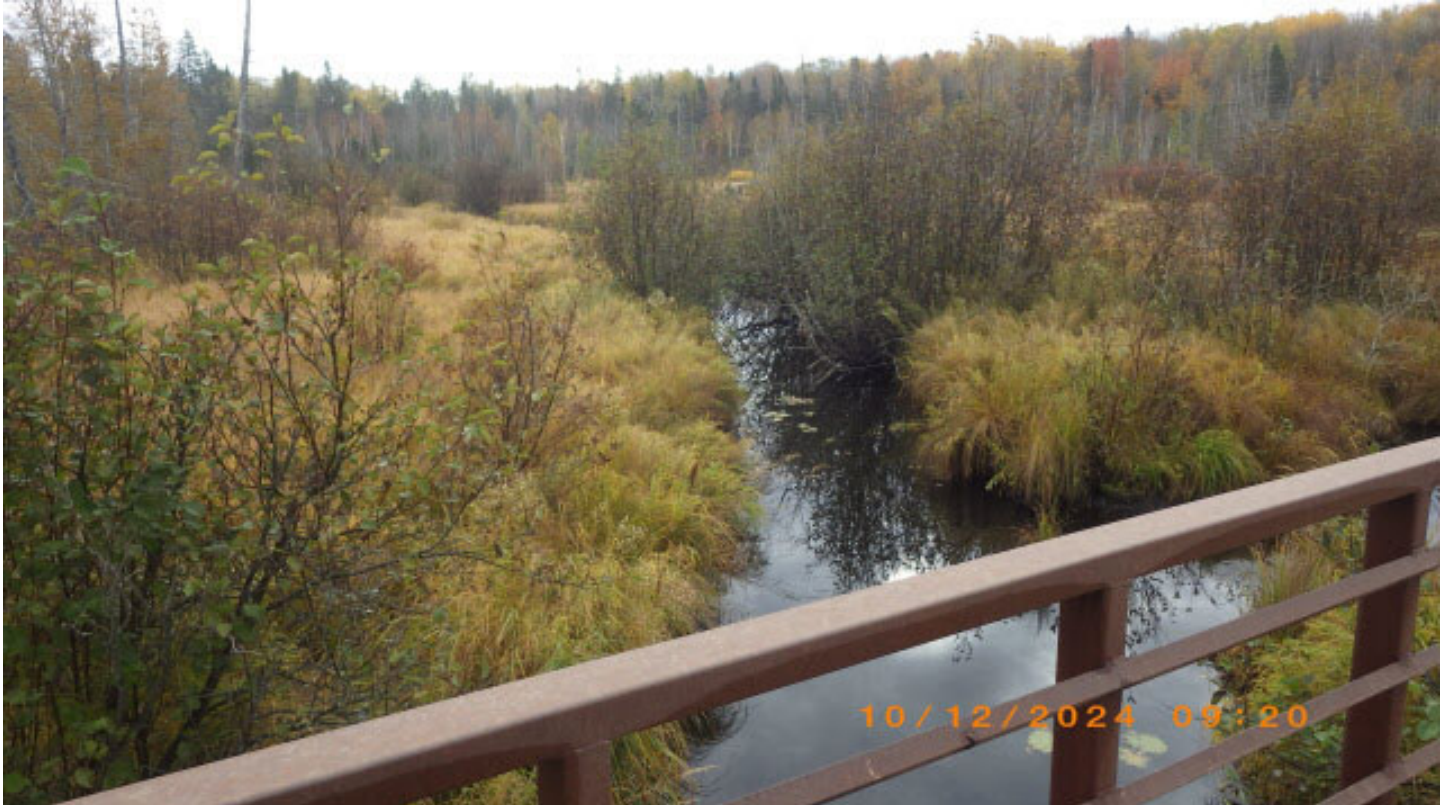
Channel is in good condition with old piles and beams scattered underneath the bridge catching debris.

Channel looking upstream

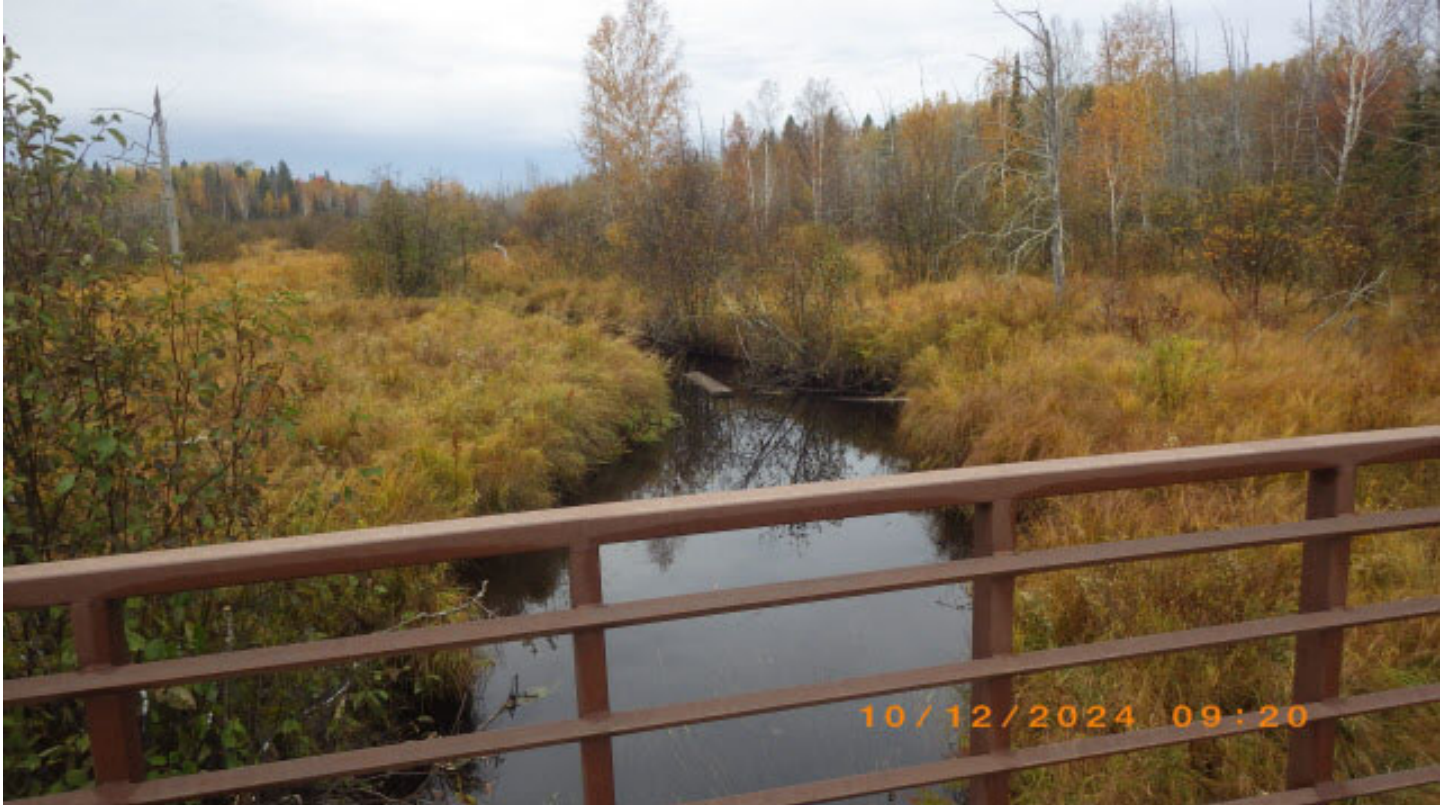
Channel looking downstream

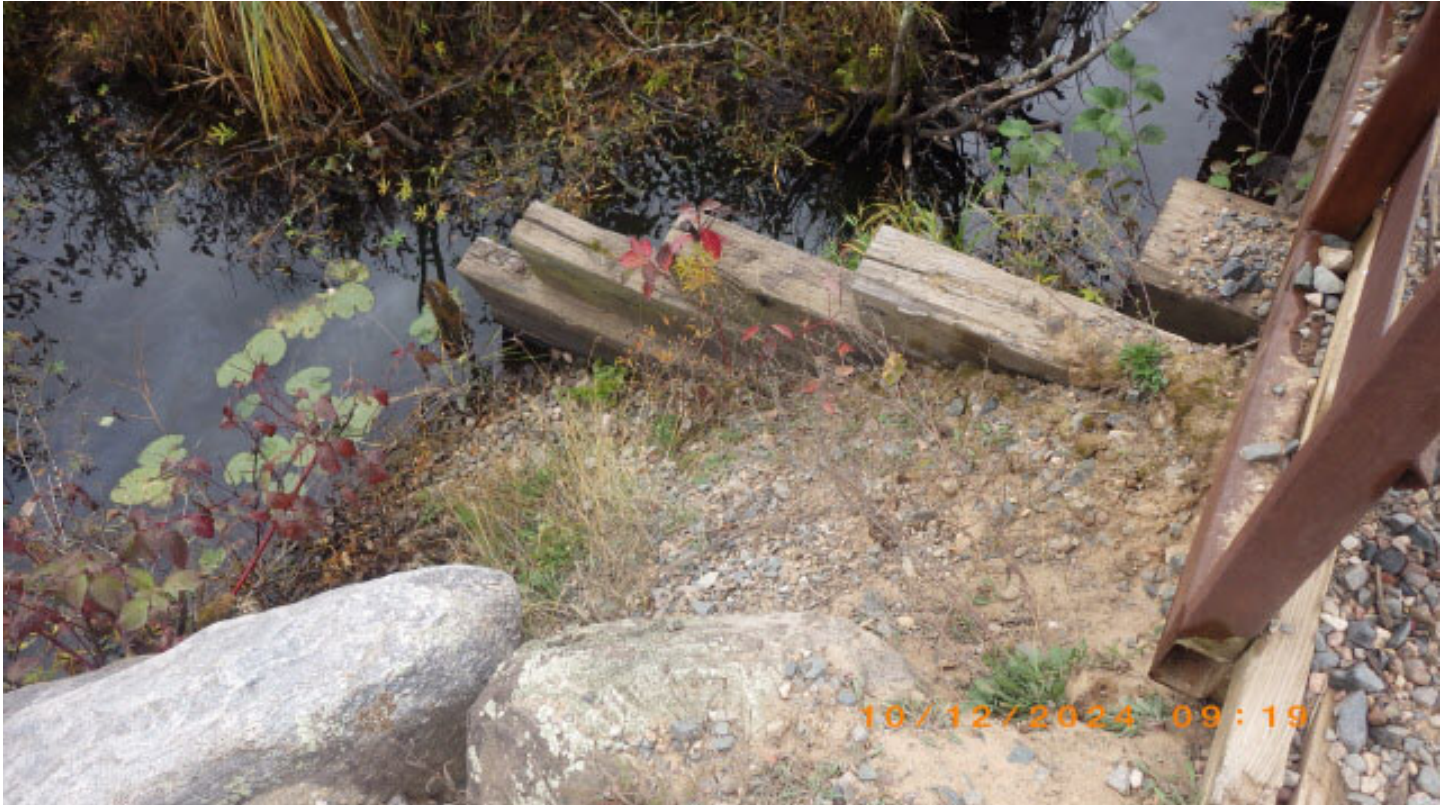
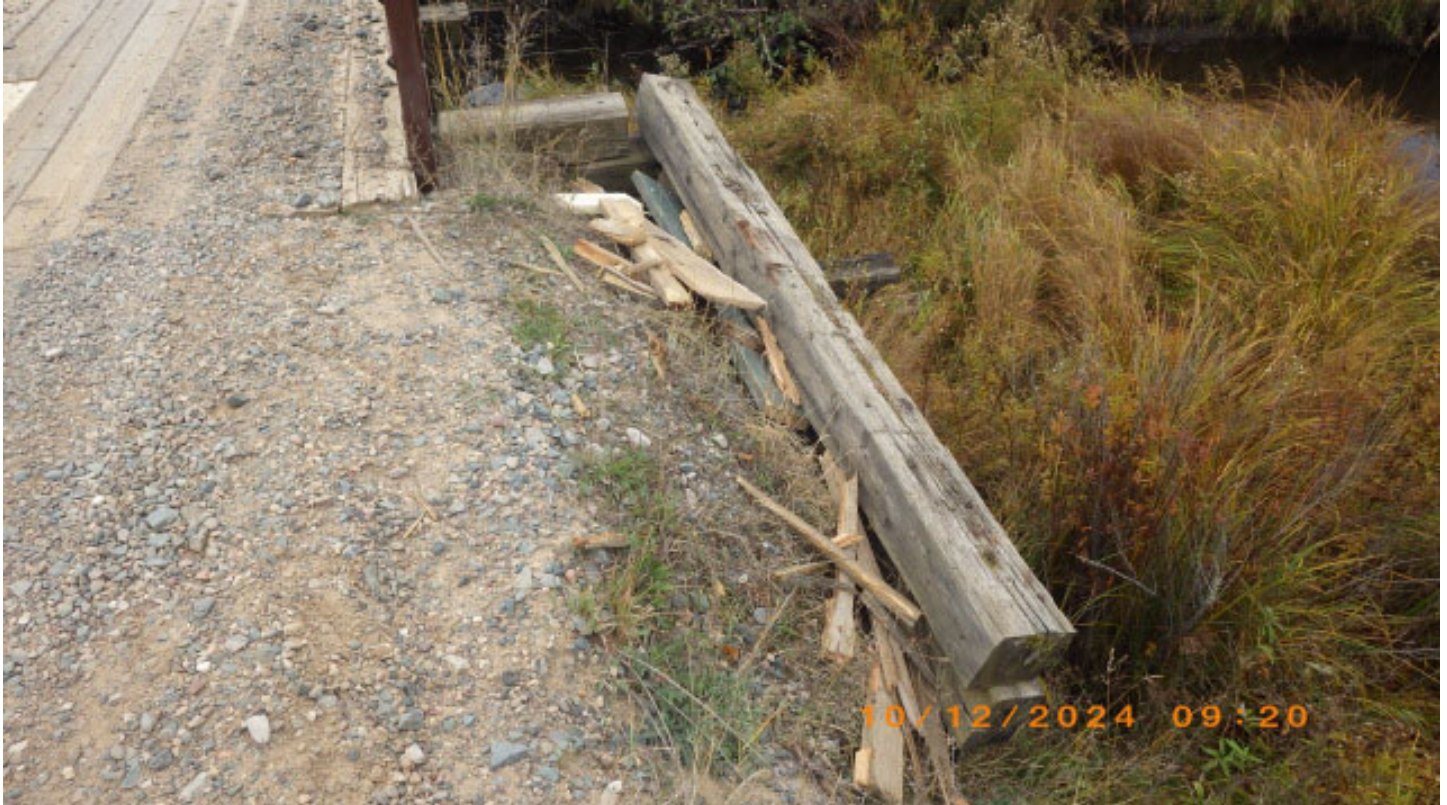
loss of nearly half of the bearing on piles. Pier 2 has no bearing on center pile. Pier 3 pile cap is rotated severely, is losing bearing on the piling, and has wide checking. All 4 wingwalls are CS3 tipping and rotten. The substructure requires close monitoring to avoid bridge closure.

All wingwalls tipping, rotten, unstable shoulders

Jack up all spans and reset substructure elements to plumb or consider complete bridge replacement in next 1-4 years.

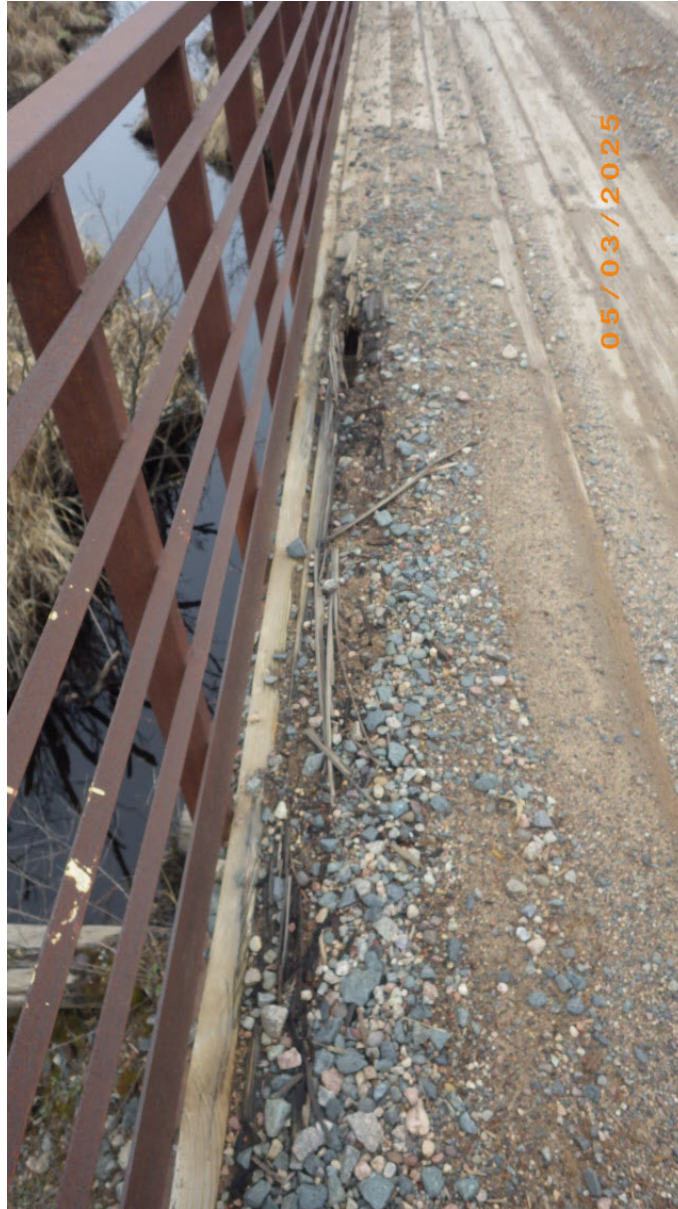
Wearing surface / deck rotten through NE corner

**Patch hole in deck / wearing surface immediately.

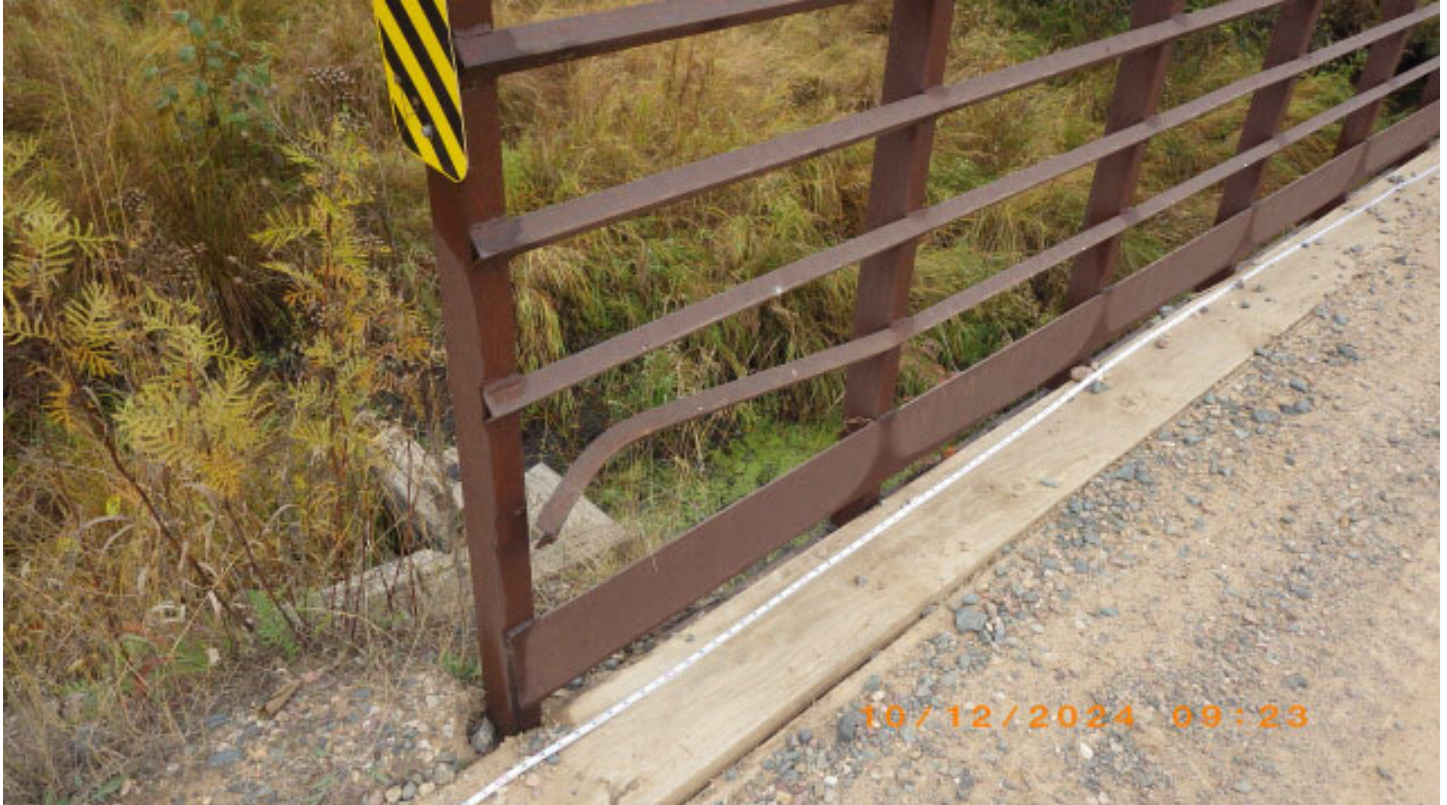
Decking has widespread black / white mold, rotten through in NE corner, CS3. The lower railing is bent in the SW corner.

Bent lower rail, SW corner

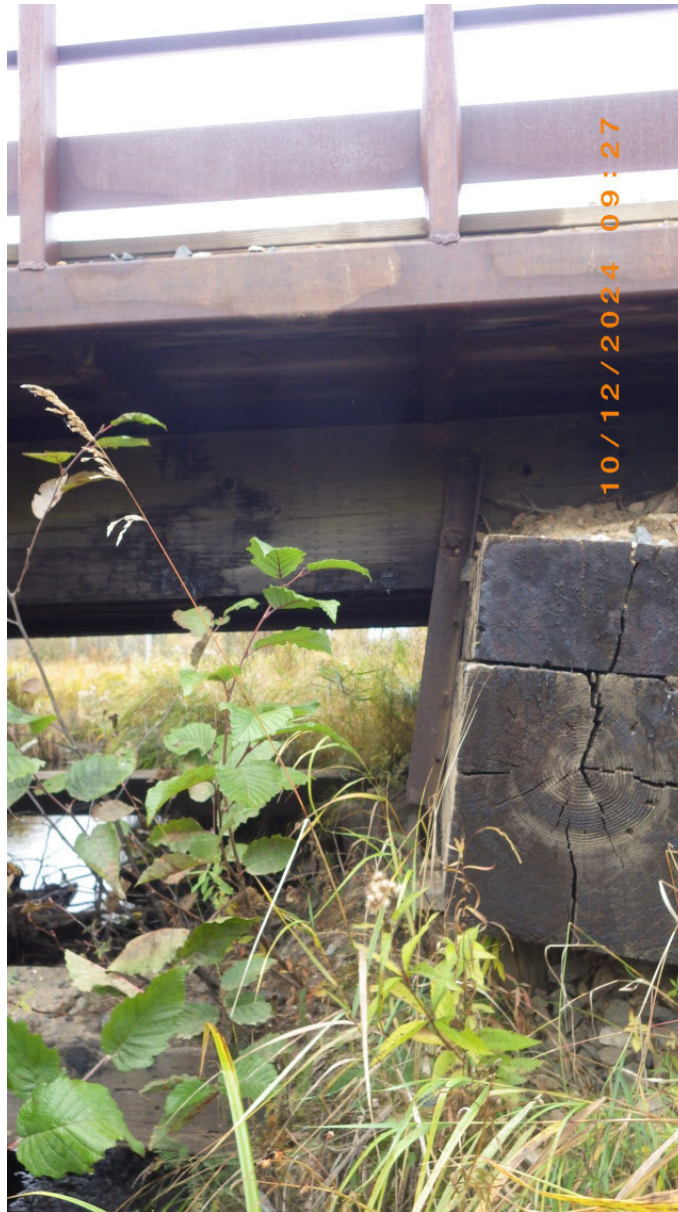
Both abutment pile caps have rotated backwards, nearly off piling. Pier 1 pile cap has moderate rotation and

North abutment pile cap tilted back

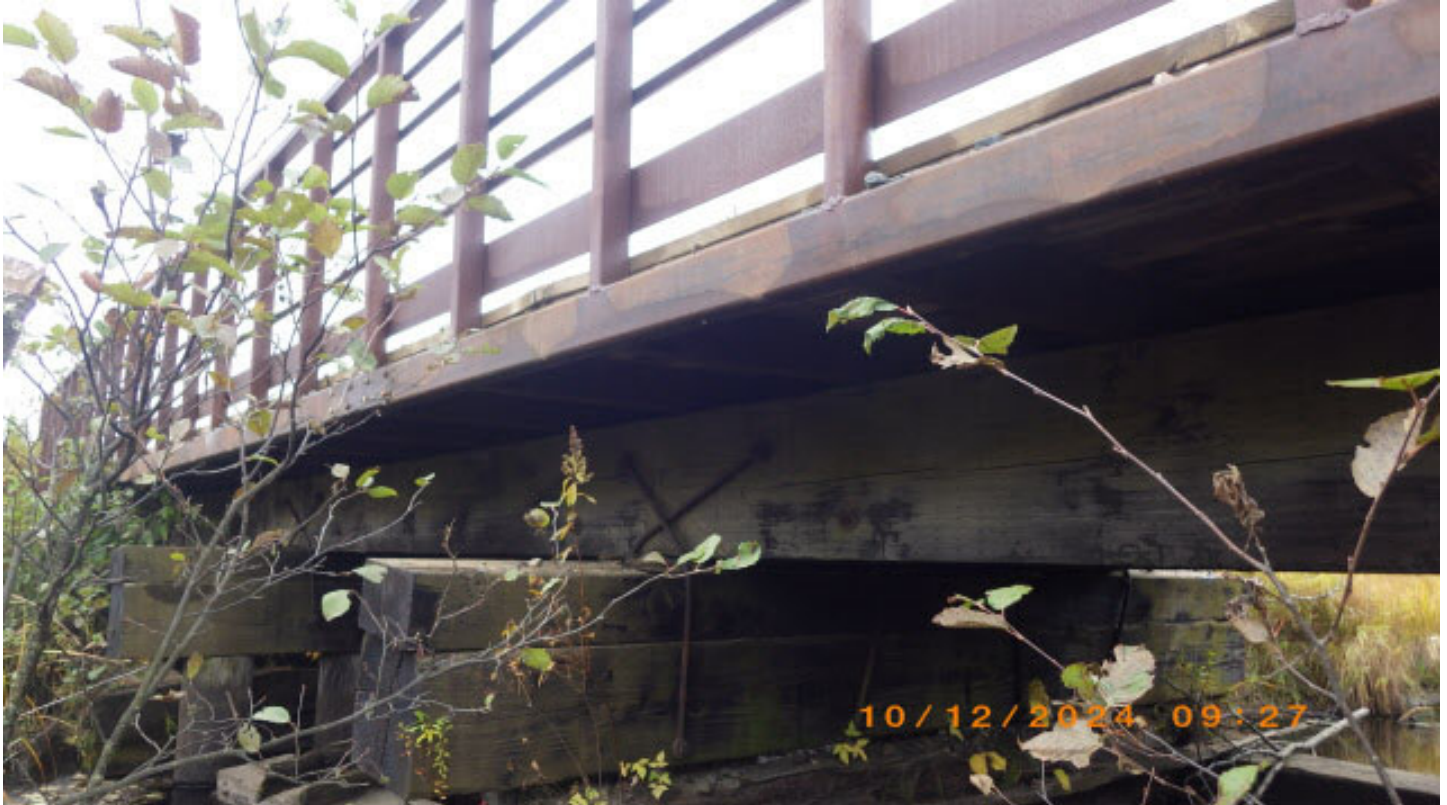
Upstream elevation view

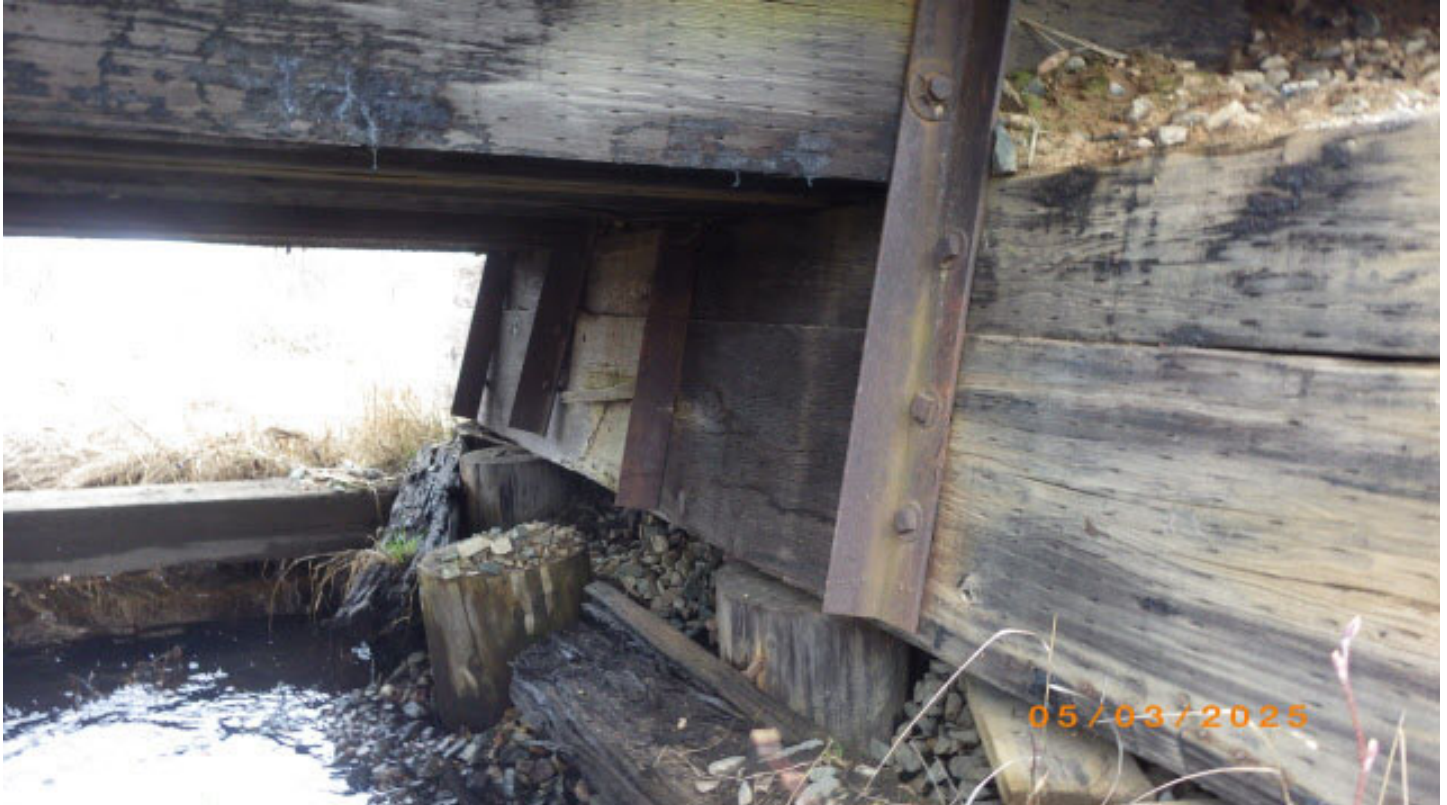
North abutment pile cap tilting back, nearly off piling, fill spilling through

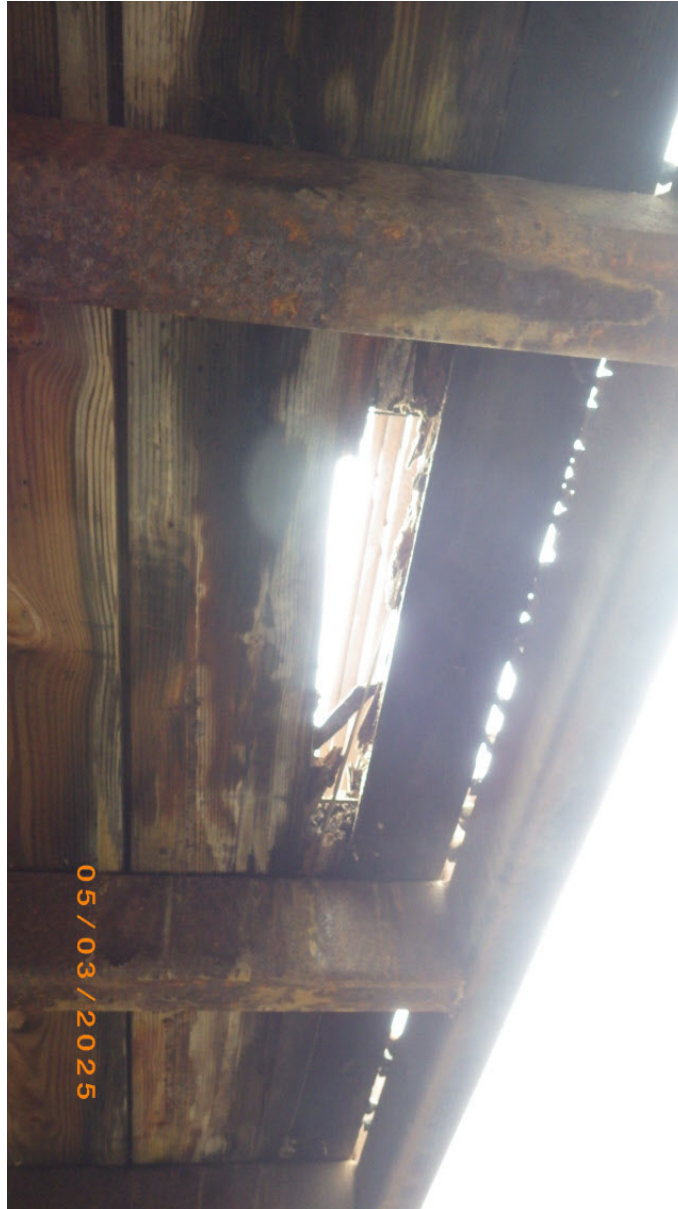
Decking rotted through, NE corner

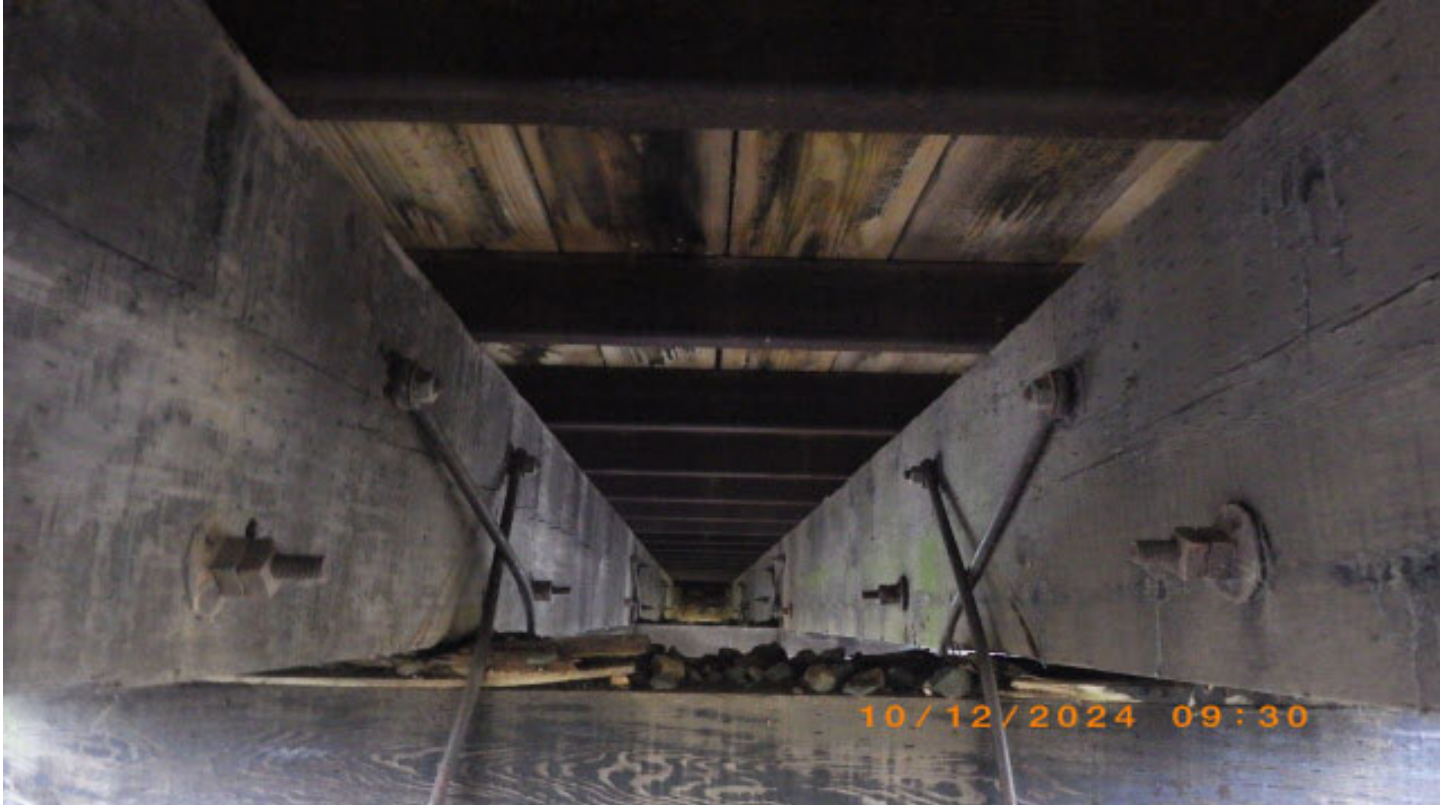
Timber girders have wide checking on fascia girders, CS2 throughout.

Typical superstructure / deck underside

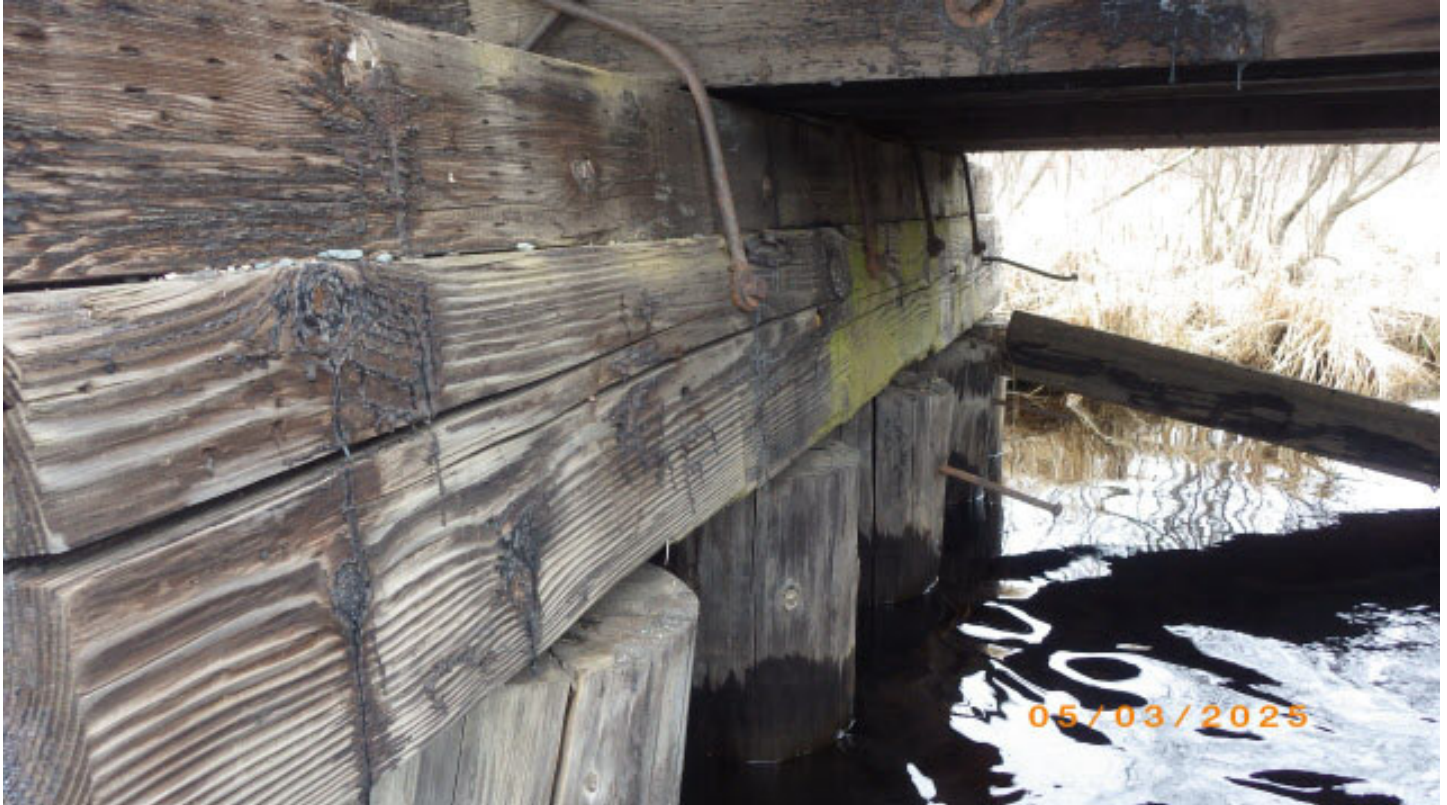
Pier 3 pile cap severe rotation

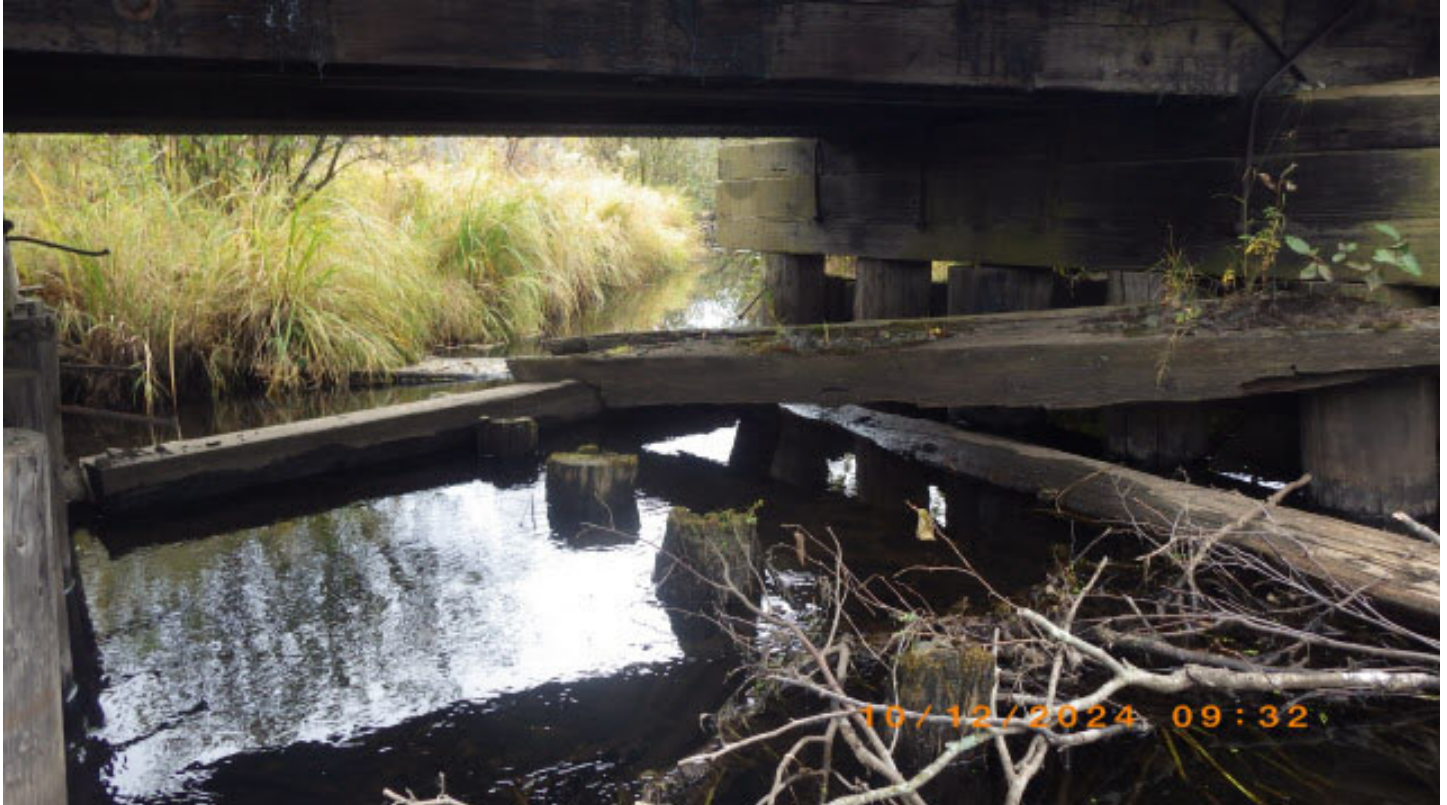
Old piling / beams catching debris in channel

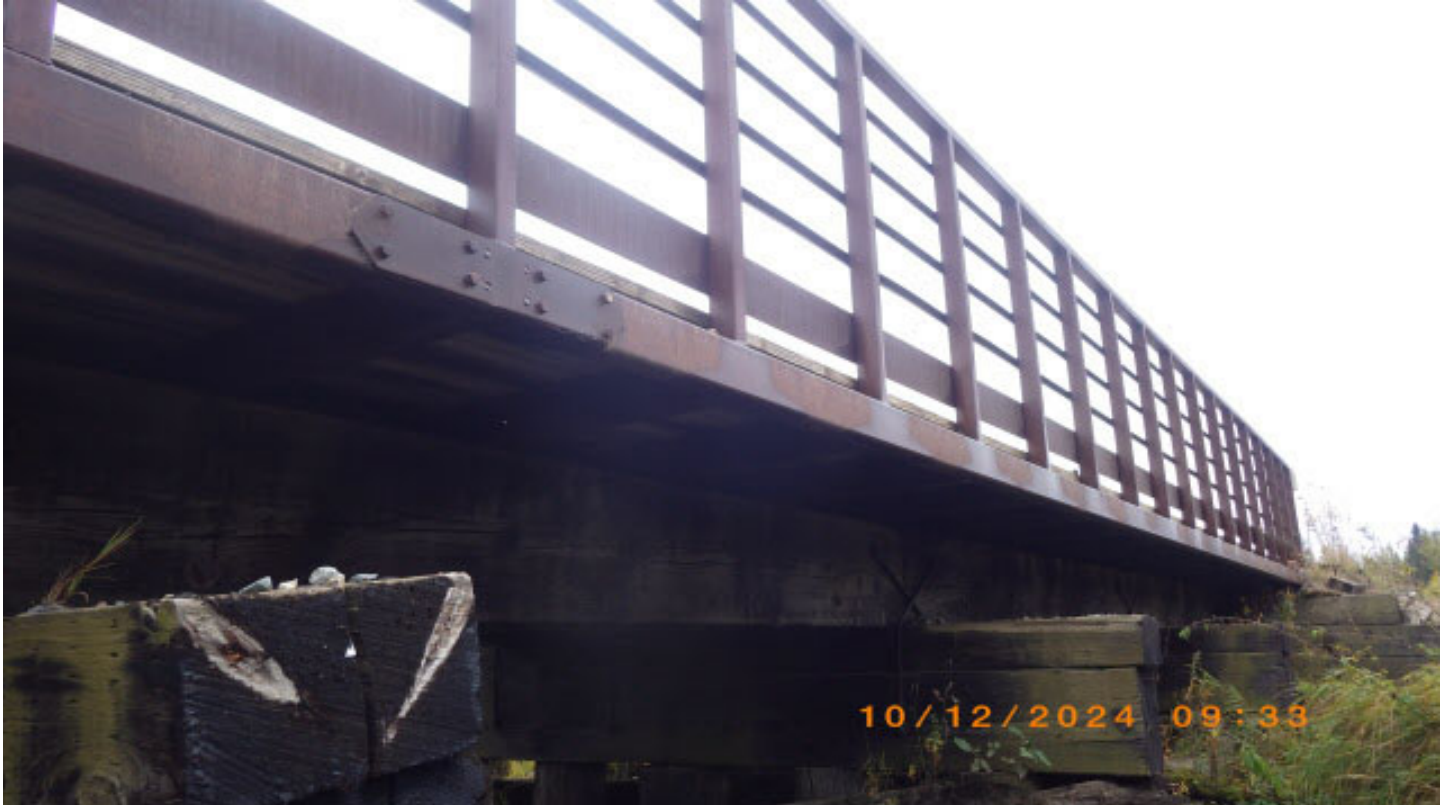
Downstream elevation view

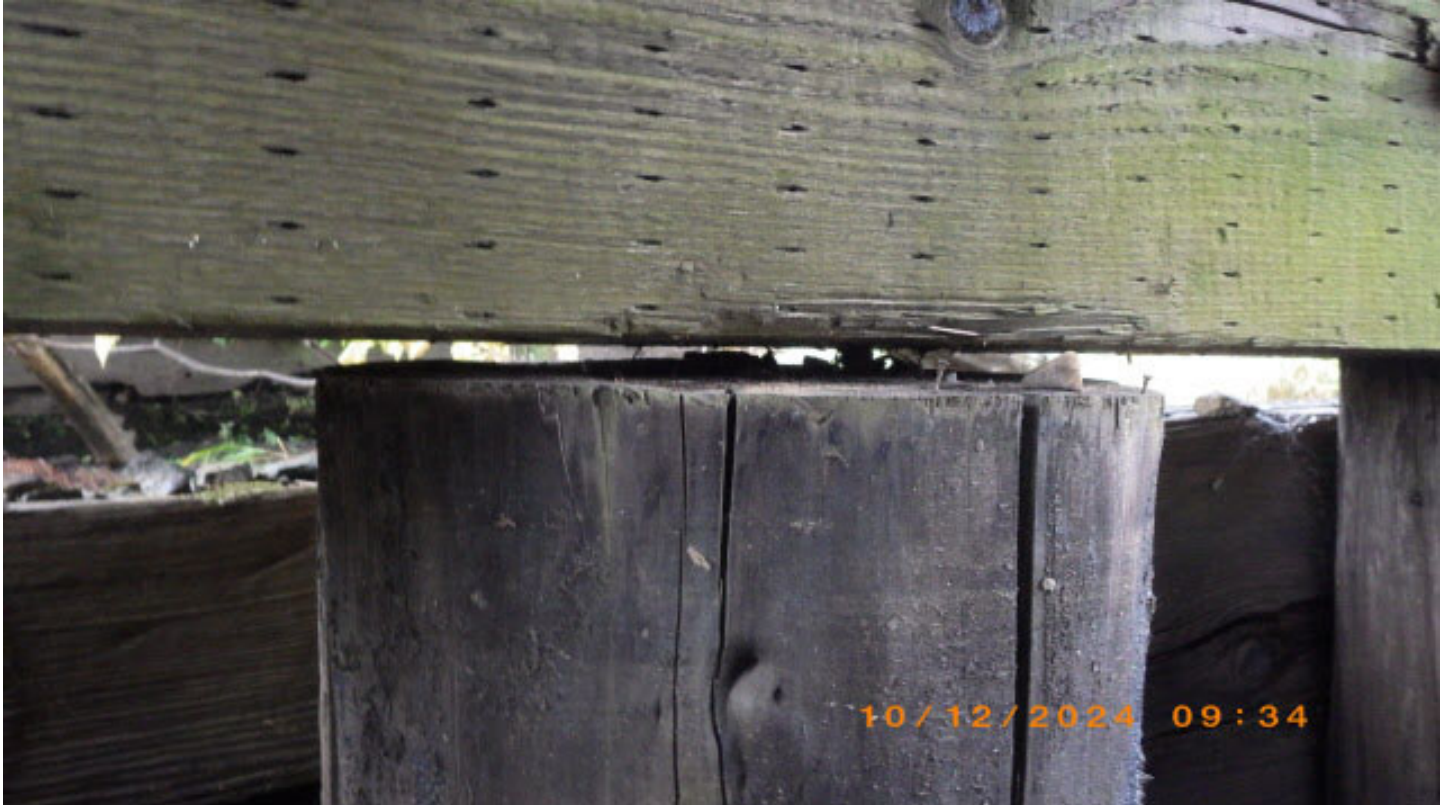
Pier 2 center pile, no bearing

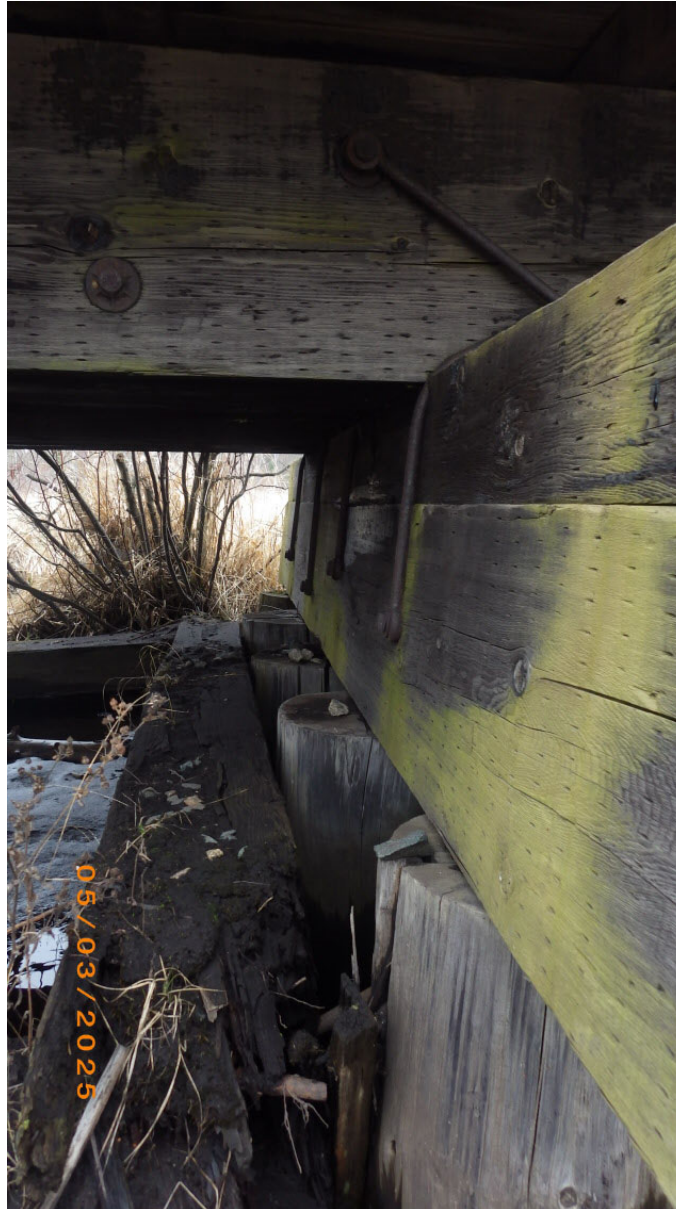
Pier 1 moderate rotation, loss of nearly half of the bearing on piling
