A-14 Forest Co WRST Swamp Creek Bridge

Project Title					Current Funded Miles	New Miles (if applicable)
WRST Swamp Creek Bridge Replacement						
County	Township	Range	Section	1/4 1/4	1/4	GPS Coordinates:
Forest	35 N	13	21			Lat. 45.5034
						Long. -88.88175

Trail Bridge Inspection

Swamp Creek

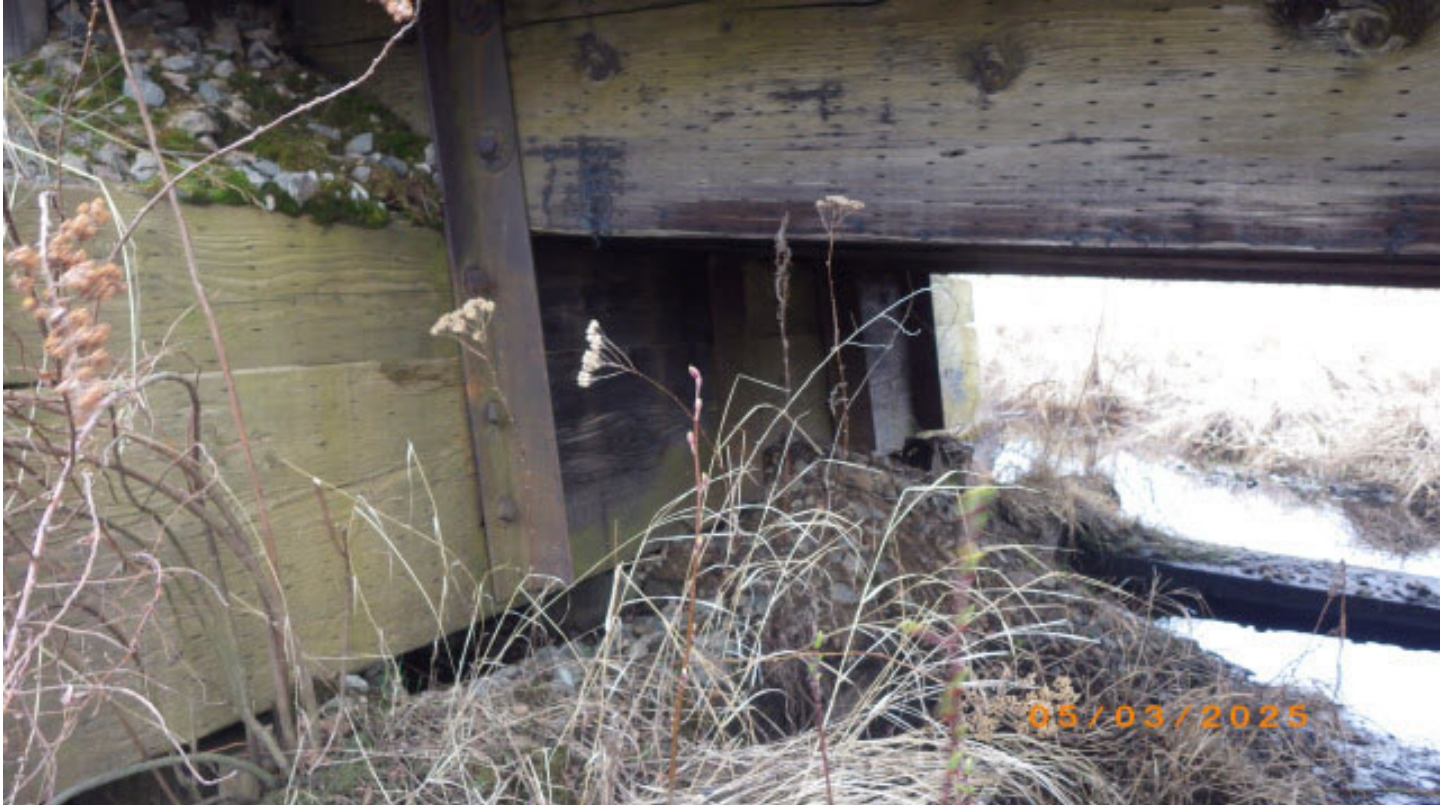
Both abutment pile caps have rotated backwards, nearly off piling. Pier 1 pile cap has moderate rotation and

South abutment, pile cap rotated back

Jack up all spans and reset substructure elements to plumb or consider complete bridge replacement in next 1-4 years.
