Redeck Stacks Bay Bridge Aerial Photo

Trail Bridge Inspection Oneida County

Bridge Name Stacks Bay

Bridge Inspection Report

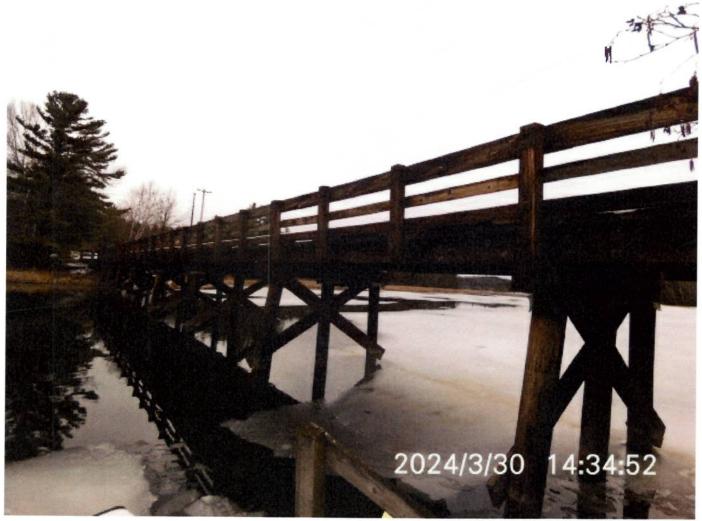
Looking East
