**S-05 Tri-Co (North) Fish Creek Bridge 2 ORIGINAL APPLICATION**

**Motorized Recreation Grant Application**

Project Title Fish Creek Bridge #2					Current Funded Miles 61.2	New Miles (if applicable)
County Bayfield	Township N	Range O E O W	Section ¼ ¼	¼	GPS Coordinates: Lat. 46.572323 Long. -90.95305

TRI-COUNTY CORRIDOR OVER S FISH CREEK

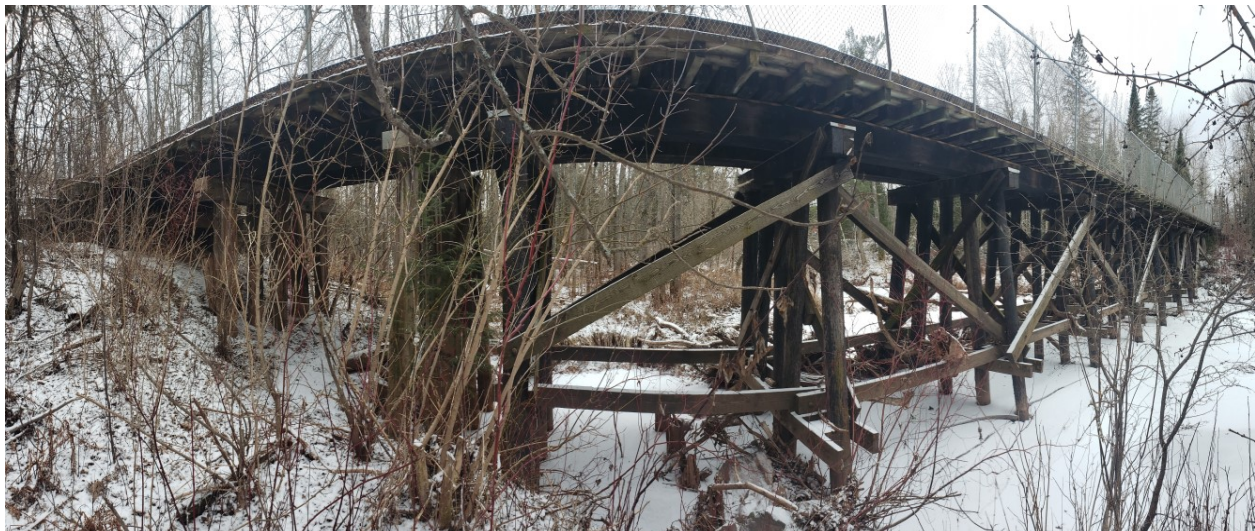
NORTH FACE FROM EAST SHORE

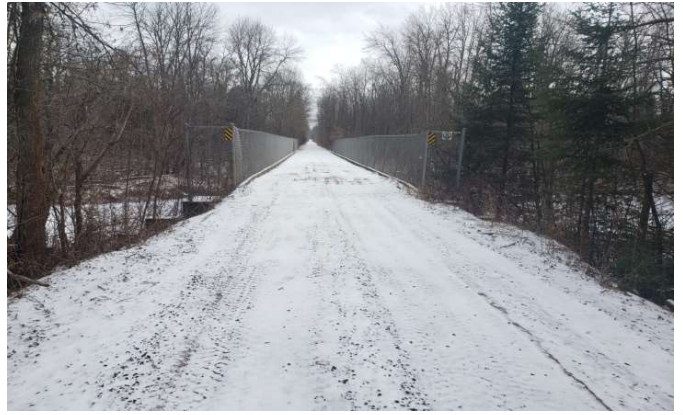
Photograph 01:

West Approach

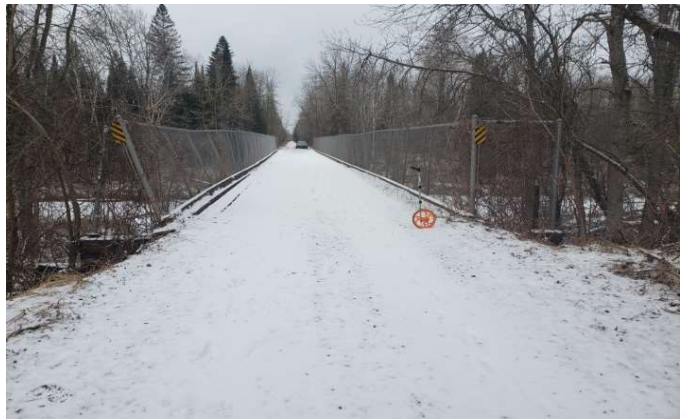
Photograph 02:

East Approach

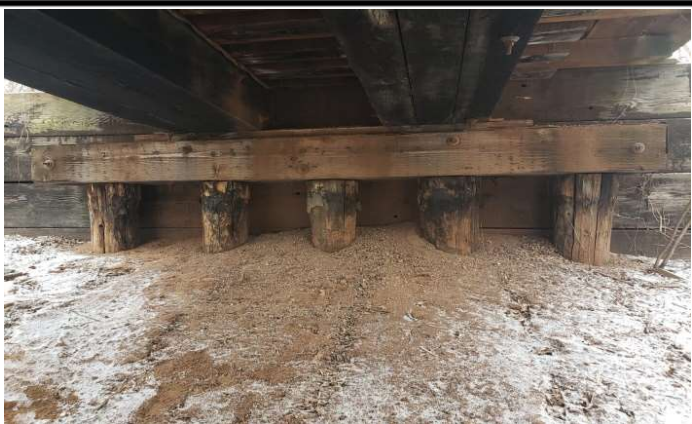
Photograph 04:

East abutment. Good to fair condition - Piles 1 & 5 thinning Cap rotating.

East Abutment

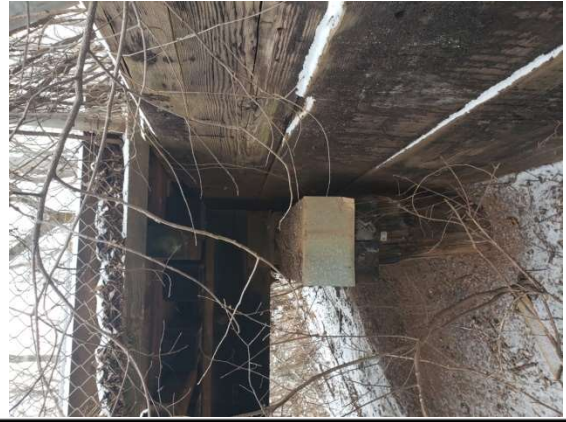
Photograph 05:

West Abutment south face

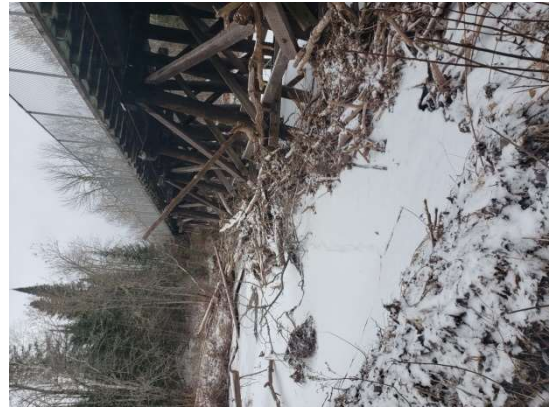
Photograph 06:

Debris buildup along South face includes trees and branches. Both embankments are scoured up to 2nd Pier likely from debris buildup. There is no Scour Plan and unknown if scour has impact on Piles.

South Face of Structure from east end

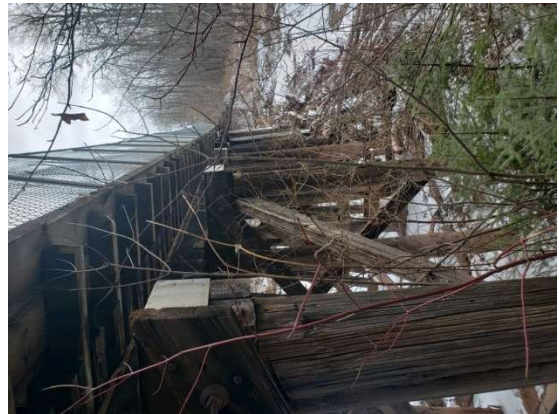
Photograph 07:

South Face of Structure from west end

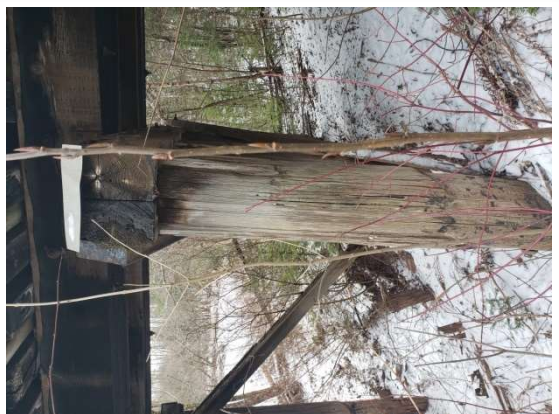
Photograph 08:

North Face of Pier 2

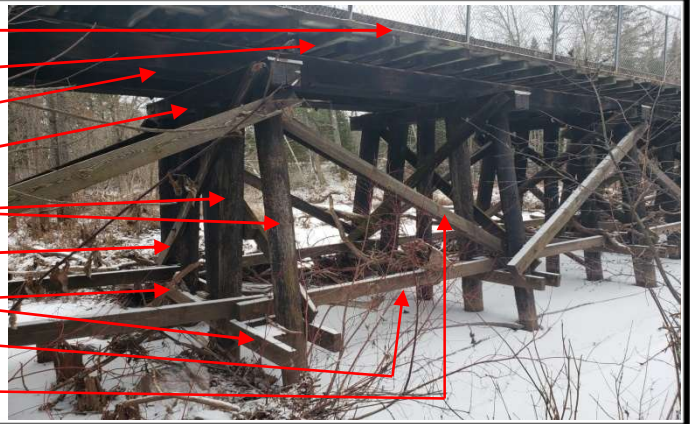
**Photograph 09:**

North Face  
Piers 9 and 10

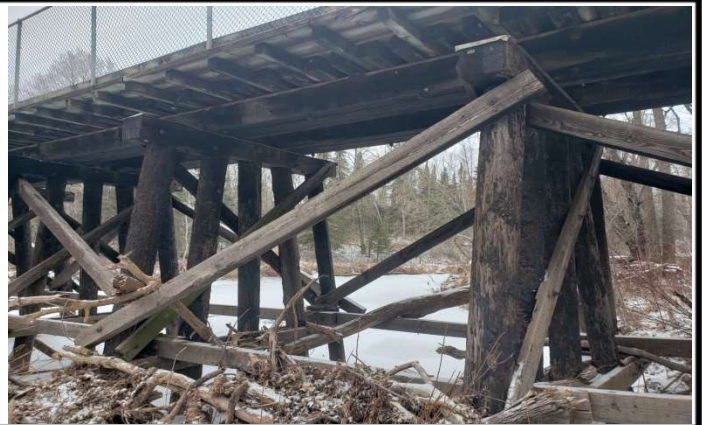
**Photograph 10:**

South Face of Piers 11 and 12.

Note scour of east bank likely from debris buildup along east face.

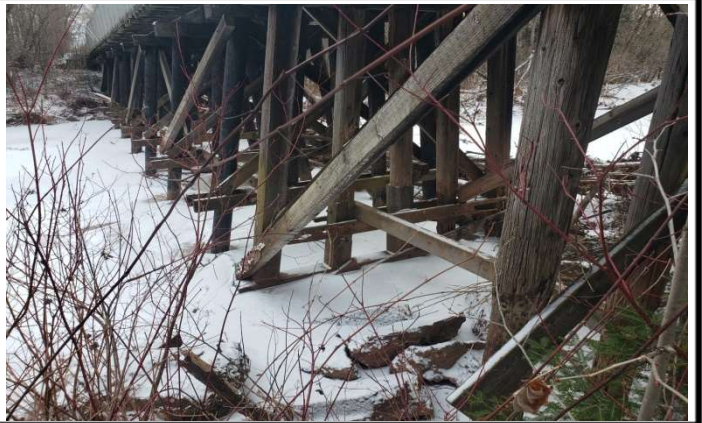
**Photograph 11:**

North Face of Piers 2, 3, and 4.

Note scour of east bank likely from debris buildup along east face.

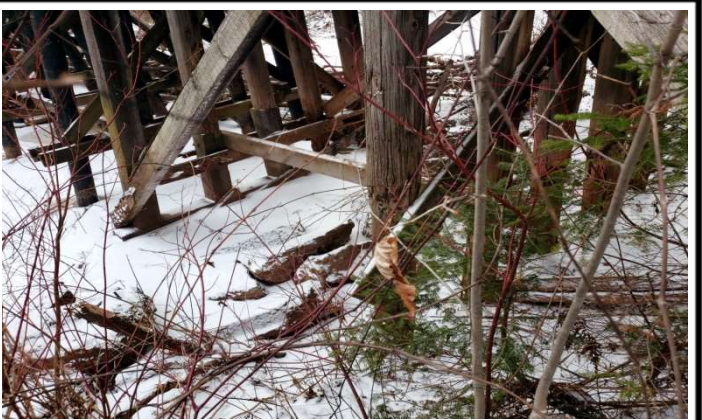
**Photograph 12:**

Piers 3 and 4 north

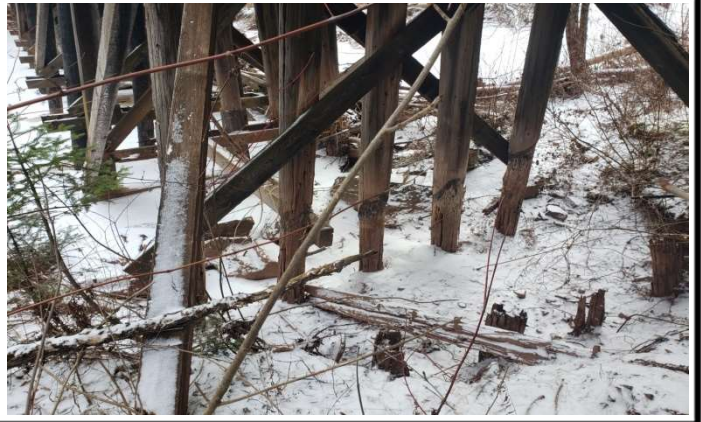
Photograph 13:

Pier 2

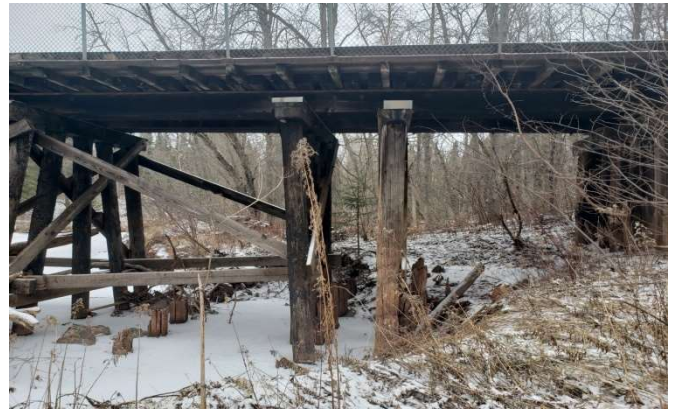
Photograph 14:

South Face of Piers 11 and 12.

Note scour of east bank likely from debris buildup along east face.
