#### S-7 Vilas Sucker Creek Culvert

# Trail Bridge Inspection Vilas County

Bridge Name Vilas 39

Prepared By KBIS, LLC

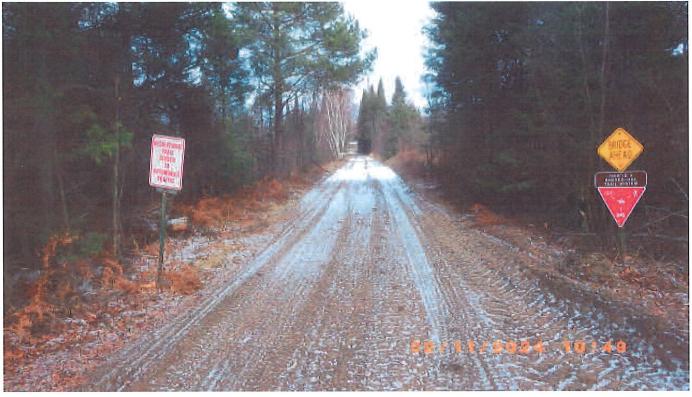
All signs have CS2 map cracking or minor damage.

South bridge ahead / other signs

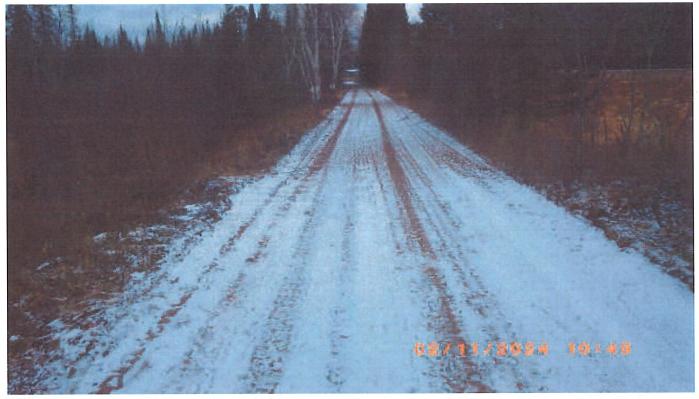
Roadway above structure has CS3 wheel ruts.

CS3 Roadway over structure

Inspect on a regular schedule of 48 months. Monitor the spalls on the West end of the structure. Maintain proper drainage above the structure on the roadway. CUT BRUSH AROUND THE ENTIRE STRUCTURE ANNUALLY

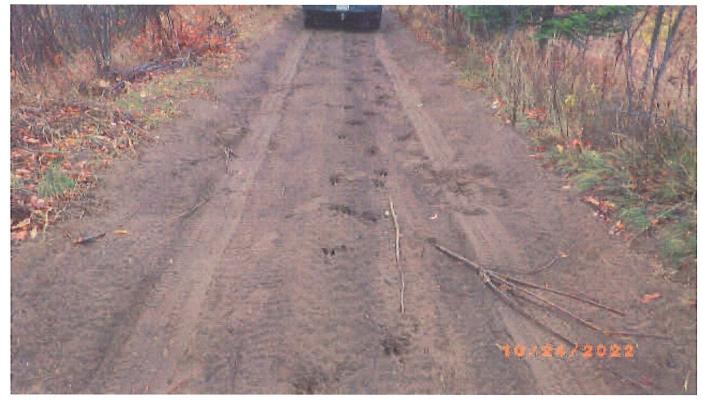
<sup>2022</sup> CS3 road way over structure.

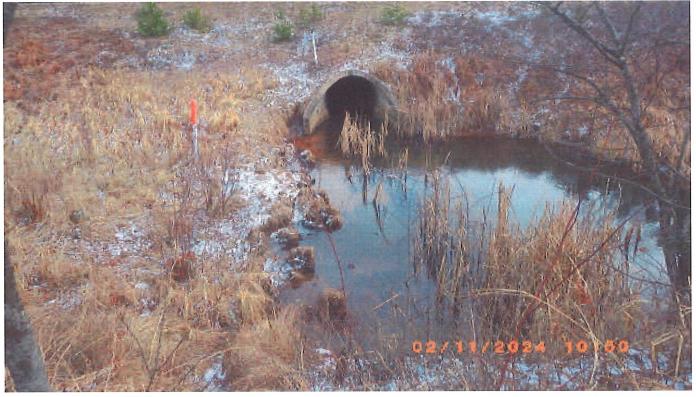
The box has CS2 scaling on the wetted perimeter. There is moderate spalling at the top of the east end of box. Channel has a highway culvert and low head dam immediately upstream.

Looking upstream (highway culvert)

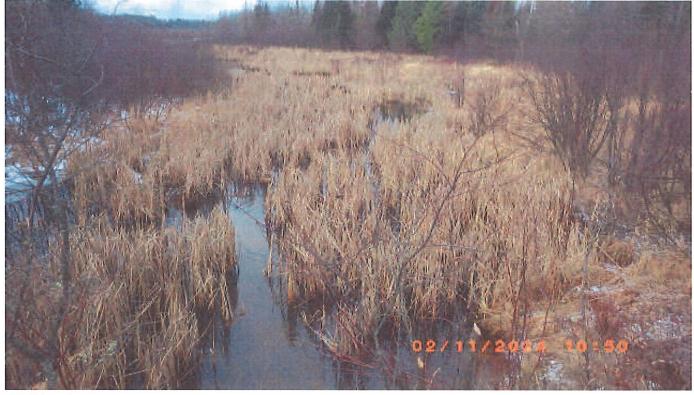
Looking downstream

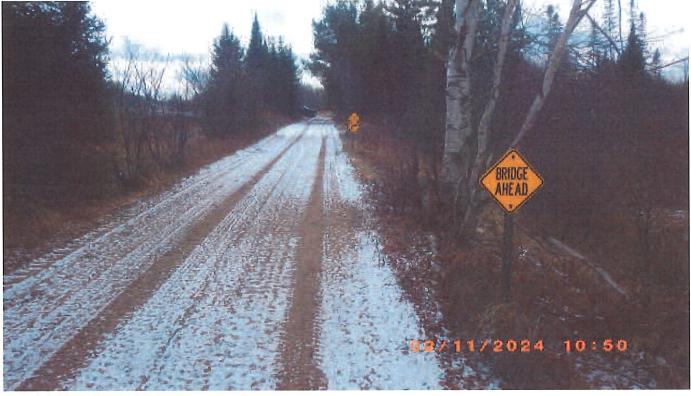
North bridge ahead sign

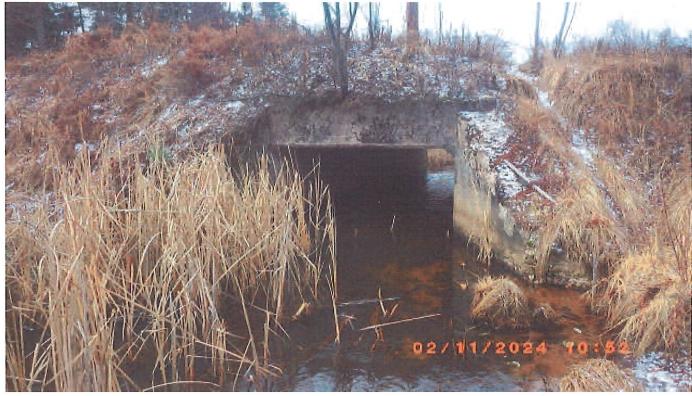
Inlet elevation view

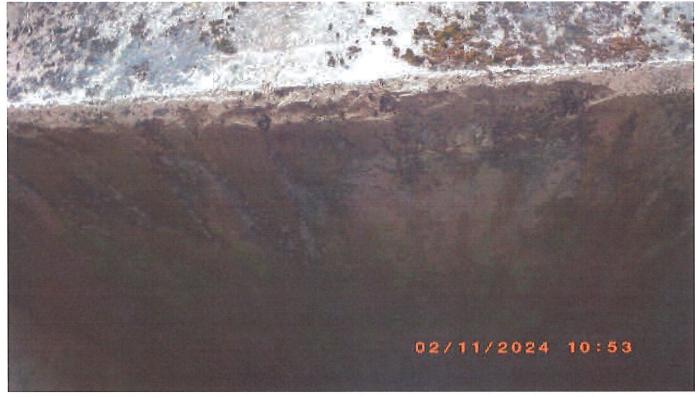
Spall on top of box, east end

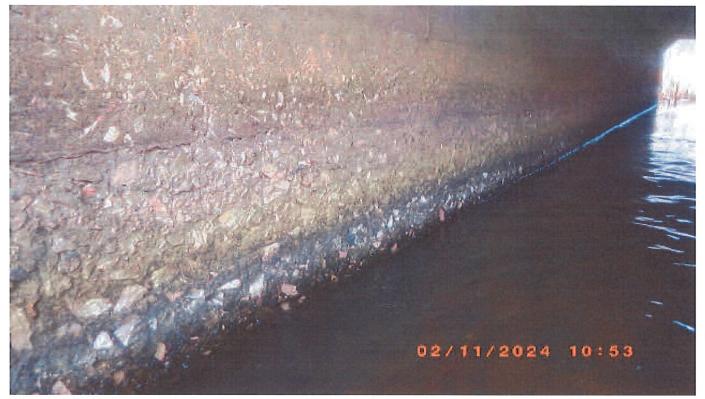
CS2 scaling on wetted perimeter of box

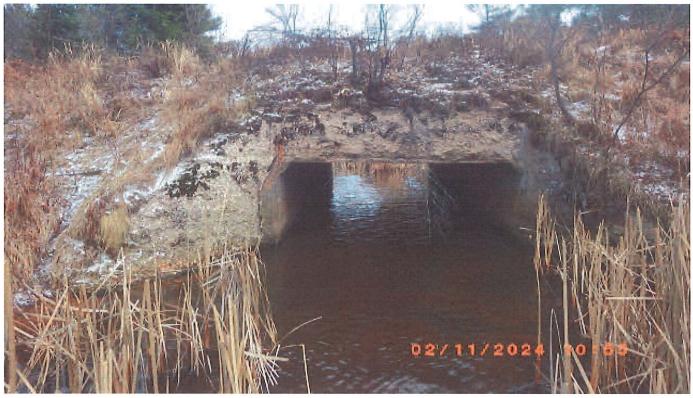
Outlet elevation view

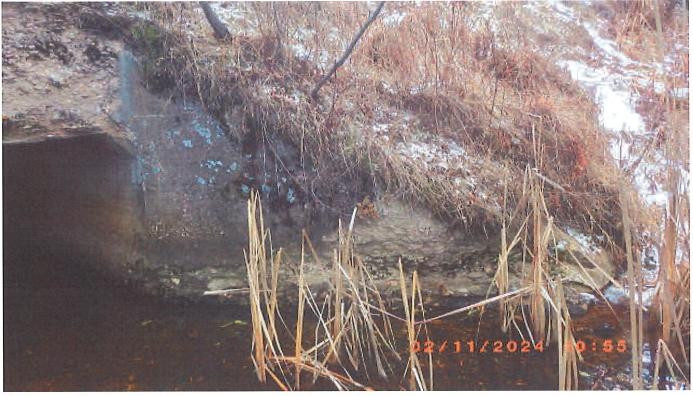
West end of the box culvert and wingwalls have extensive spalls. Borderline CS4, with the amount of section loss. NW wingwall is missing 1/2 of its thickness.

SW wingwall

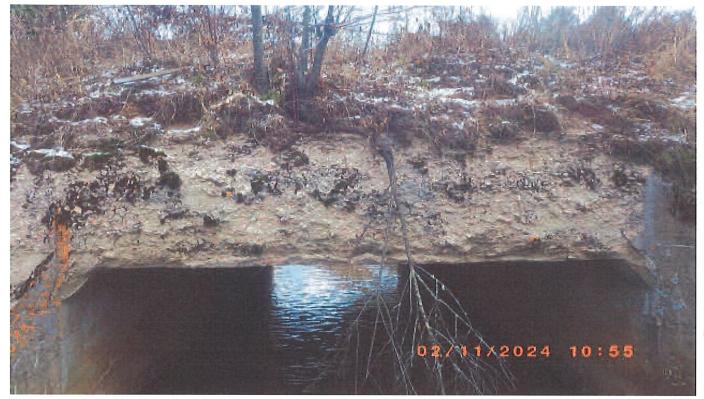
Top of box / headwall, west side

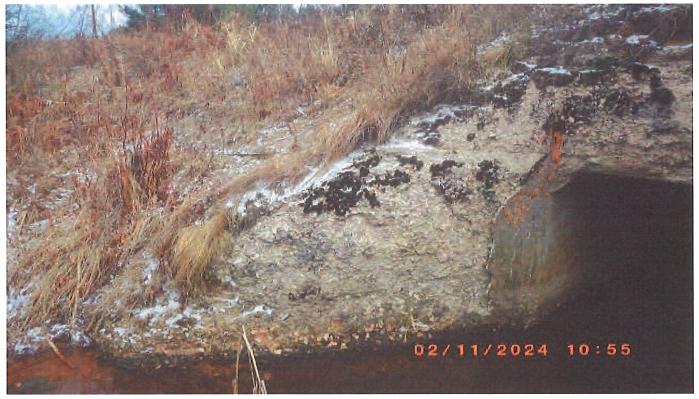
NW wingwall

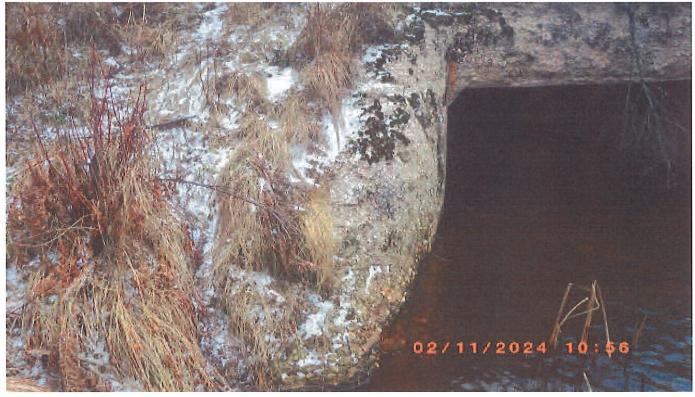
NW wingwall section loss
