S-11 Forest NST Peshtigo River Bridge

Project Title NST Peshtigo River Bridge Replacement					Current Funded Miles	New Miles (if applicable)
County Forest	Township 37 N	Range 14	<div style="display: flex; align-items: center;"> <div style="margin-right: 5px;"><input checked="" type="radio"/> E</div> <div style="margin-right: 5px;"><input type="radio"/> W</div> </div>	Section 24	1/4 1/4 1/4	GPS Coordinates: Lat. 45.68005 Long. -88.67886

Bridge Inspection Report

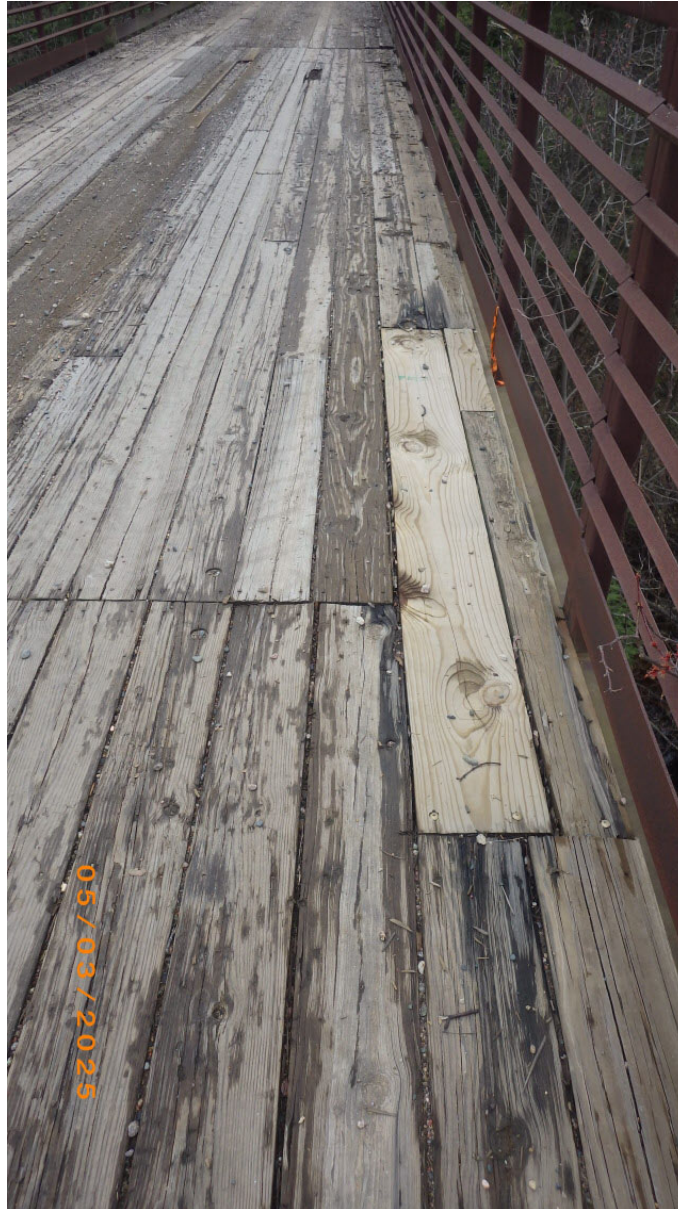
Minor gravel on deck. Scattered wear plank ends sticking up 1"+. 10-20 rotten wear planks. Both wear plank and structural deck underneath rotten through in two locations. First is a 1 SF hole at the center of the bridge and the second is a 1' x 3' hole along the east edge in span 7. The surrounding areas in these regions are rotten on the underside.

Patched hole at east edge of span 7

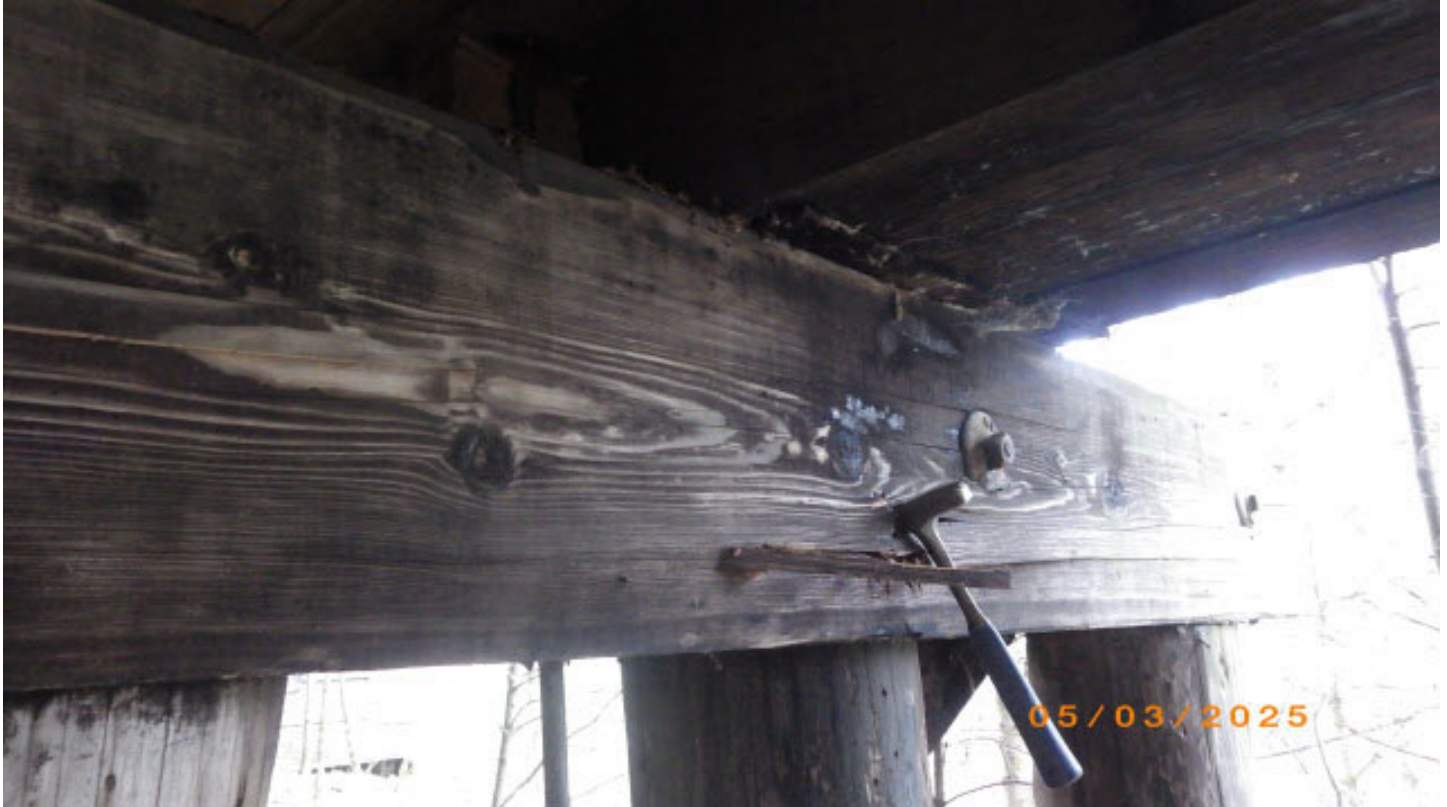
South abutment has rotten piling. Bent #1 pile cap is rotten / crushing. Bent #2 center pile is hollow. Concrete pier #3 has a very large CS3 spall on the upstream and top edge, widespread CS3 cracking with rust stained

Bent #1, cap rotten / crushing

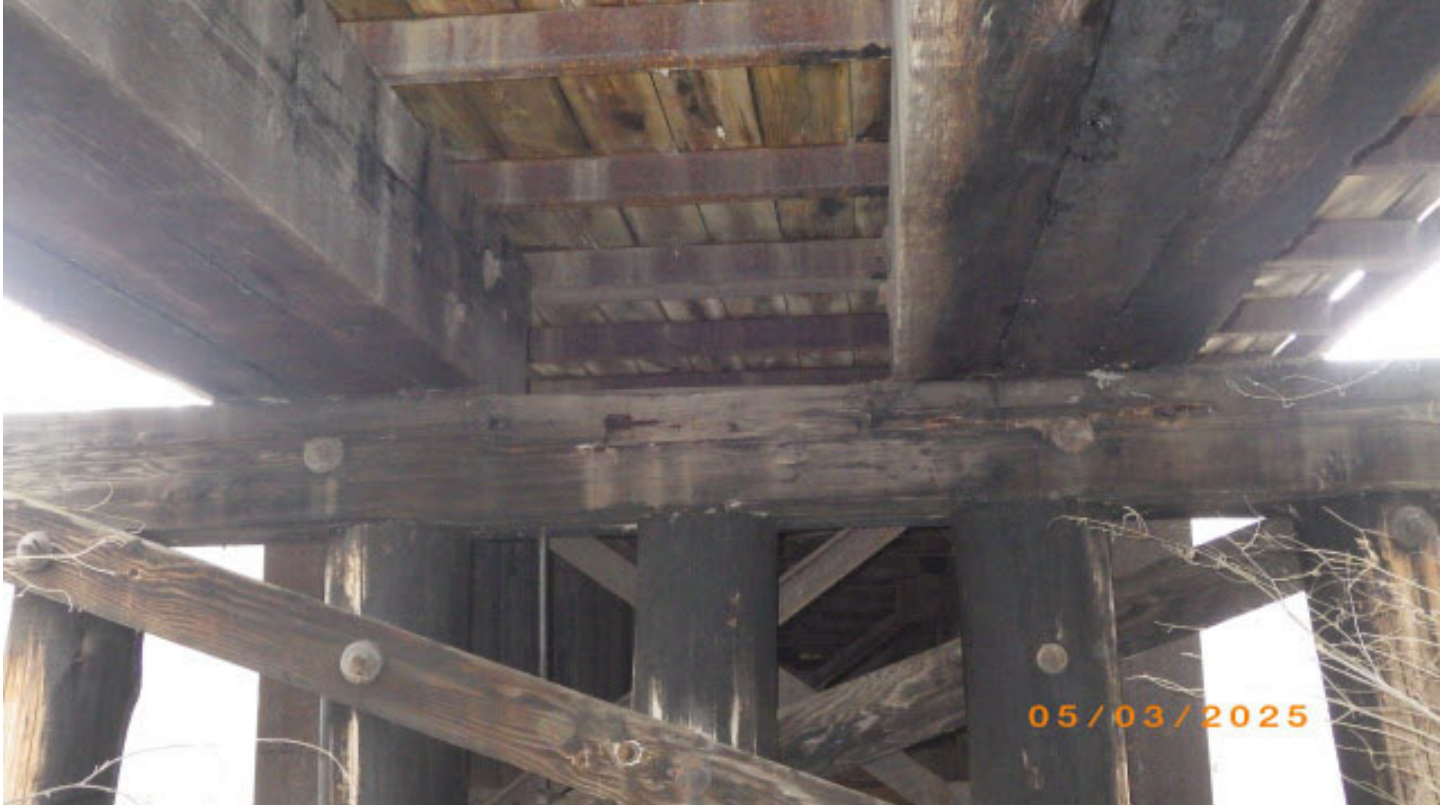
efflorescence. Top section of pier is timber and the cap is rotten / crushing. Concrete pier #4 has very large 4'x4'x1' CS3 spalls at both the upstream and downstream top edge. CS3 cracking with efflorescence throughout. Bents #5-8 in fair condition. Bent #9 cap is rotten / crushing. Bent #10 cap is rotten. Bent #11 cap ends are rotten. North abutment cap ends are rotten.

Pier #3, timber cap rotten / crushing

Pier #3, timber cap rotten / crushing (close-up)

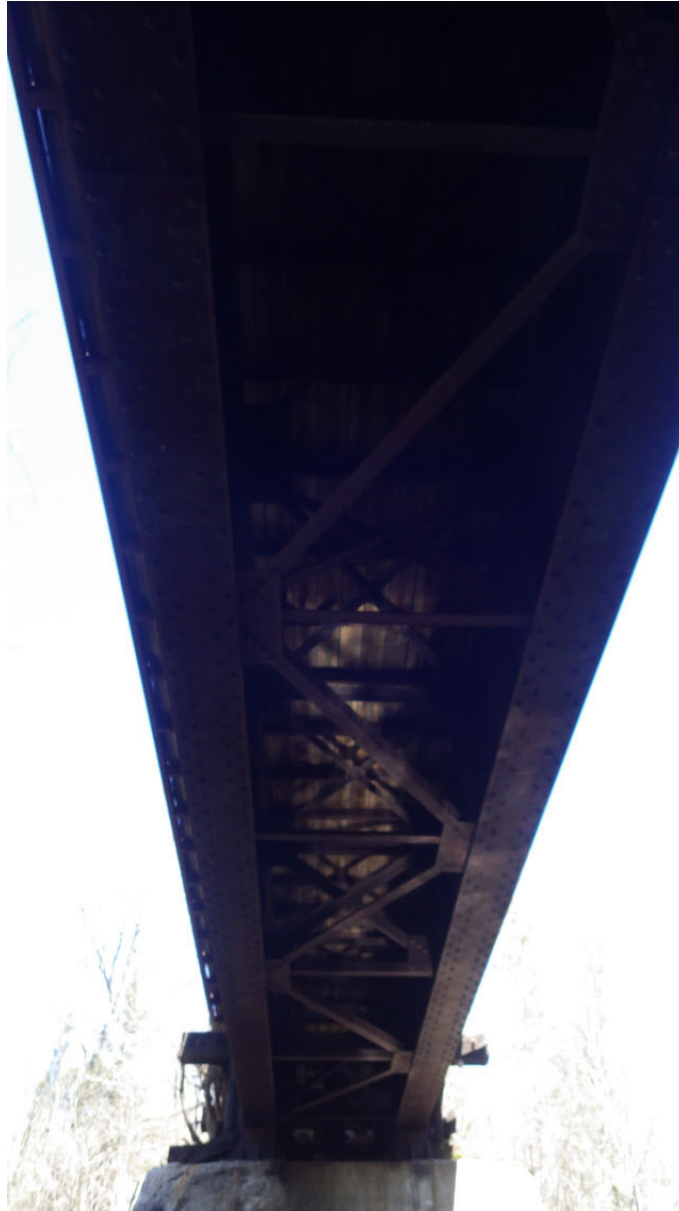
Steel main span is in fair condition (1925 construction plaque). Some exterior timber girders are punky.

Steel main span in fair condition

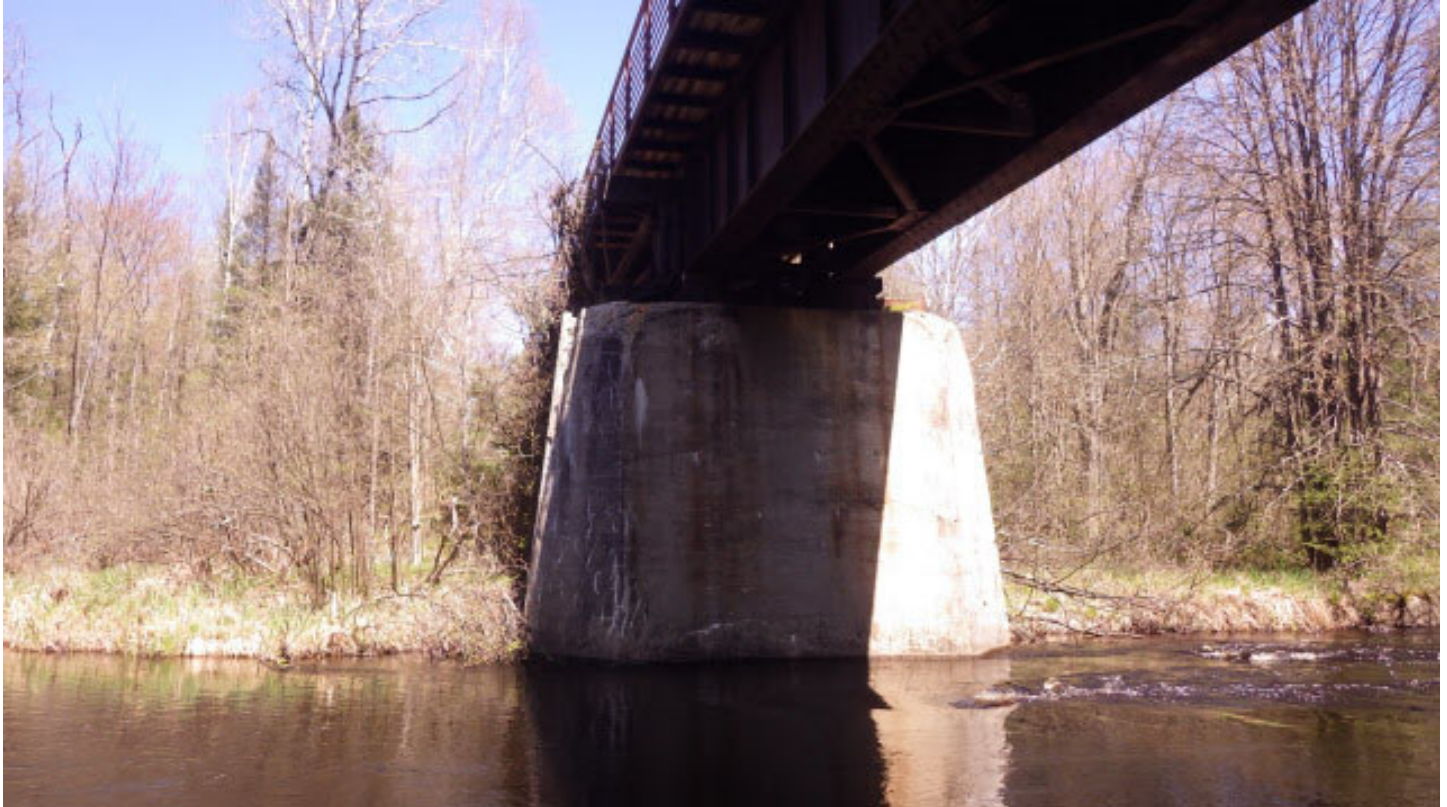
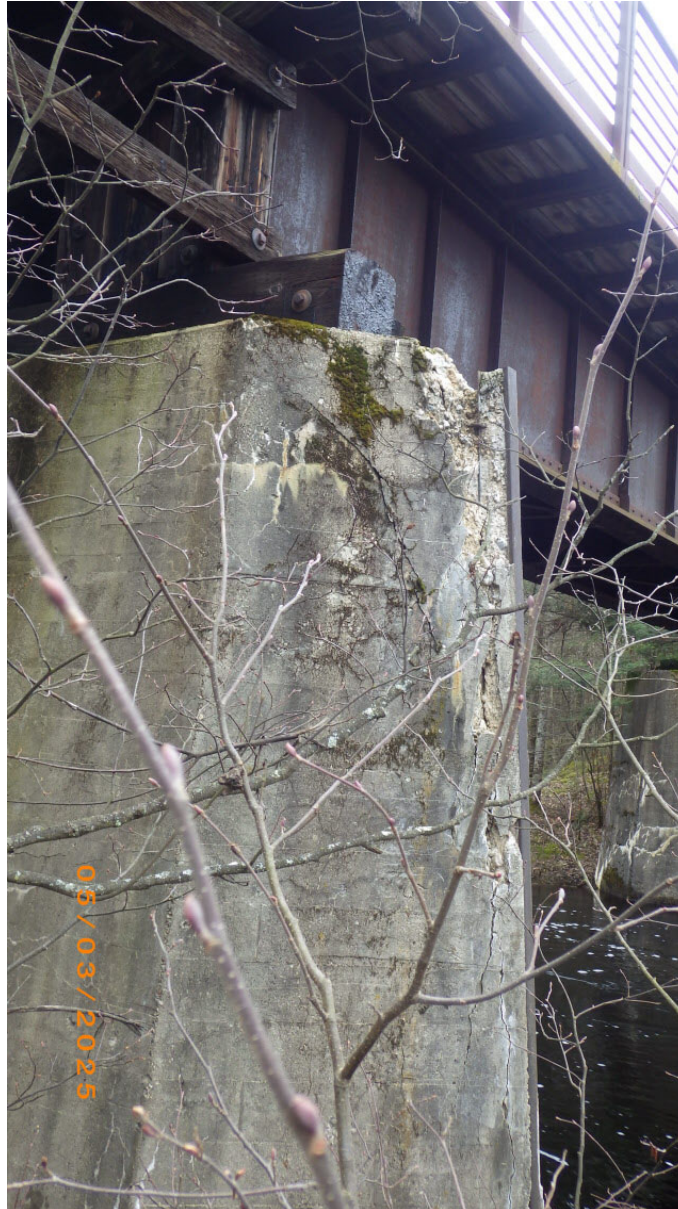
Pier #4 with very large spalls on top corners and CS3 cracking with efflorescence throughout

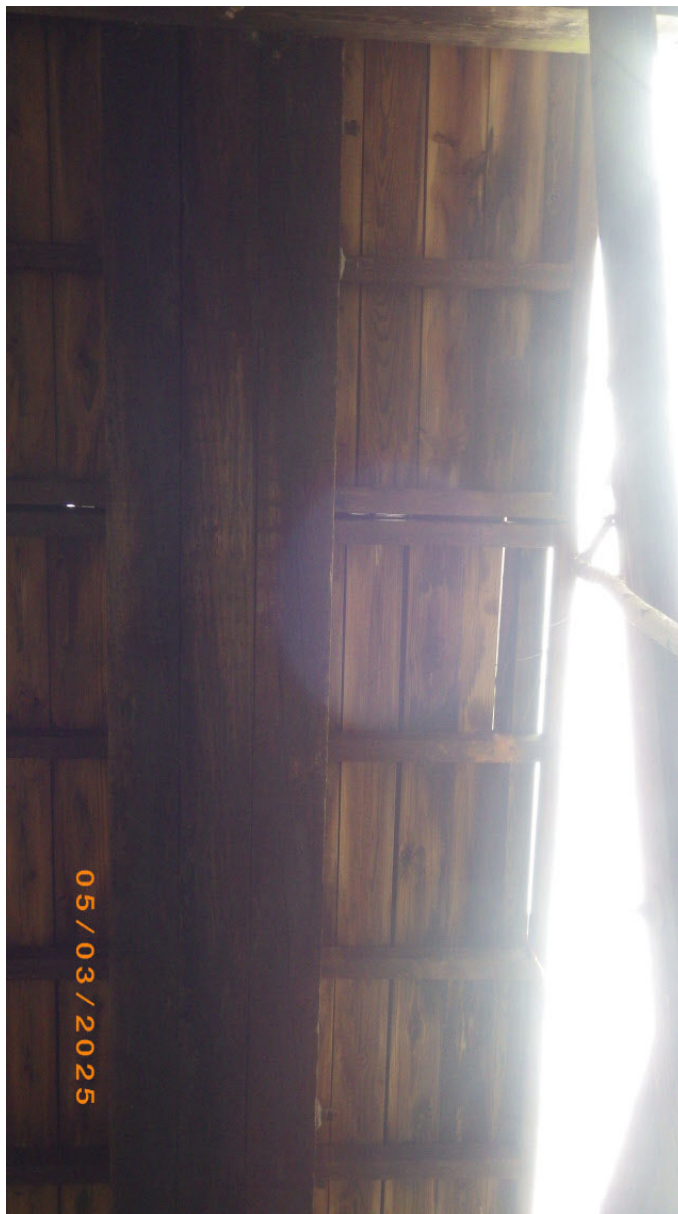
Underside of deck at hole in east edge of span 7. Note other rotten areas.
