Motorized Recreation Grant Application

Project Title					Current Funded Miles	New Miles (if applicable)
Lynx Creek Bridge Replacement					496	
County	Township	Range	Section	1/4 1/4	1/4	GPS Coordinates:
Vilas	43 N	6 <input checked="" type="radio"/> E <input type="radio"/> W	12	NE	NE	Lat. 46.22513
						Long. -89.694375

Trail Bridge Inspection

Vilas 1

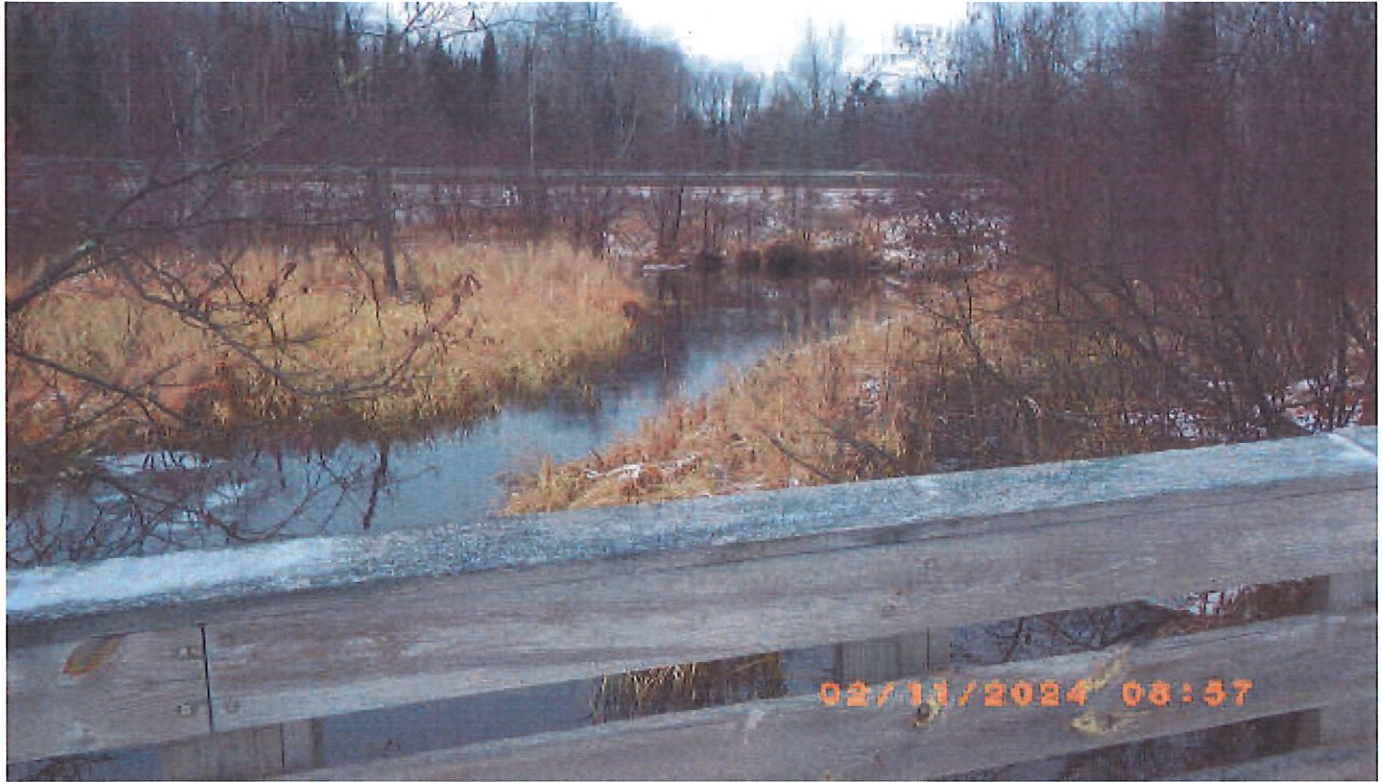
Looking upstream

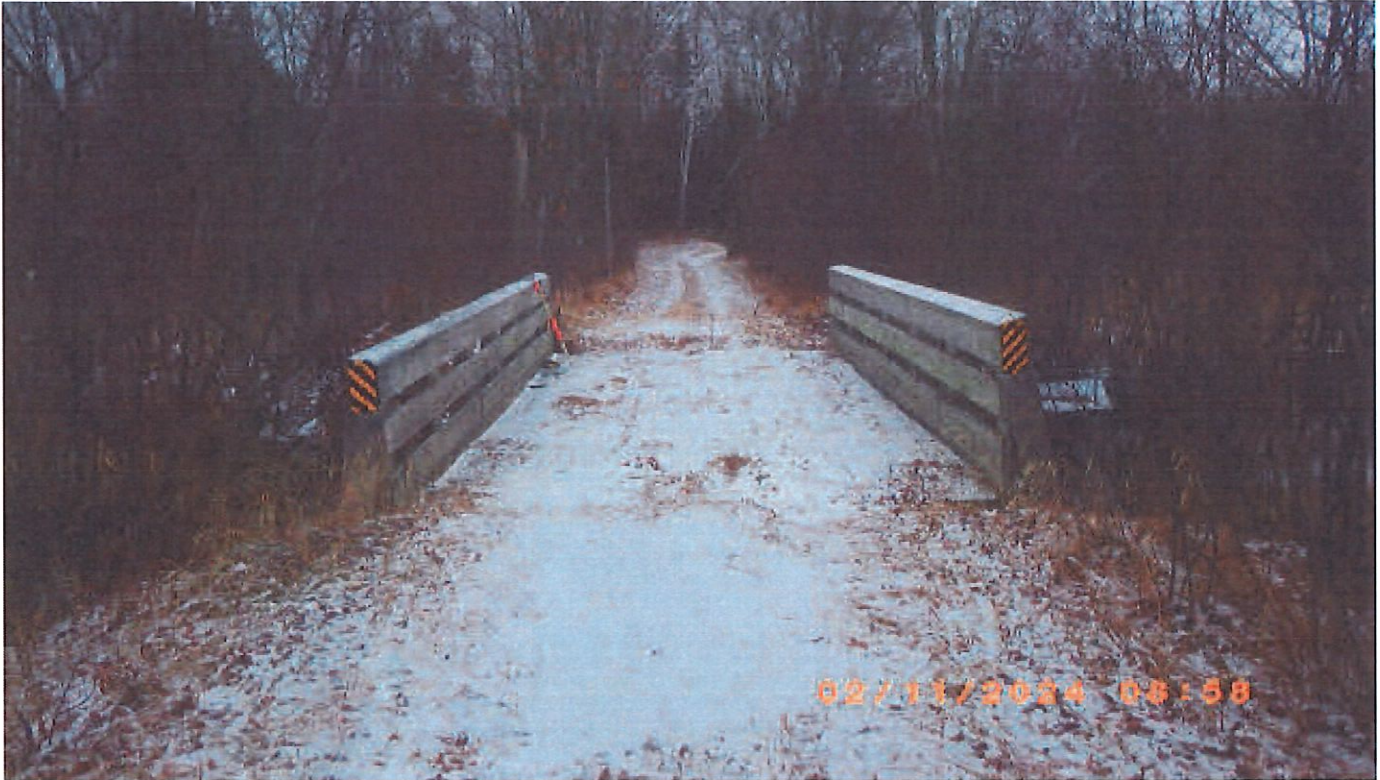
West approach

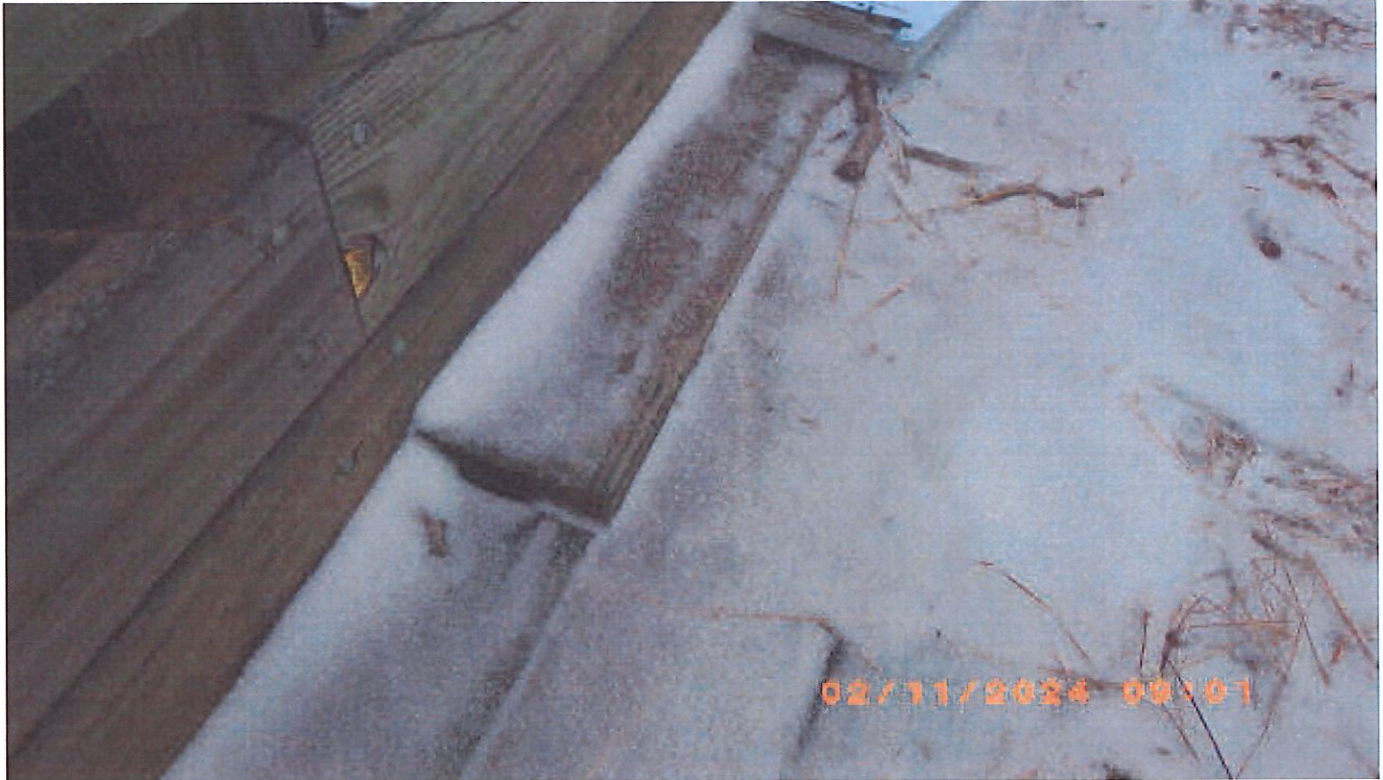
Timber wearing surface, 1 board is loose and coming up. Some areas covered in soil / vegetation. Fair.

Wear plank loose and coming up

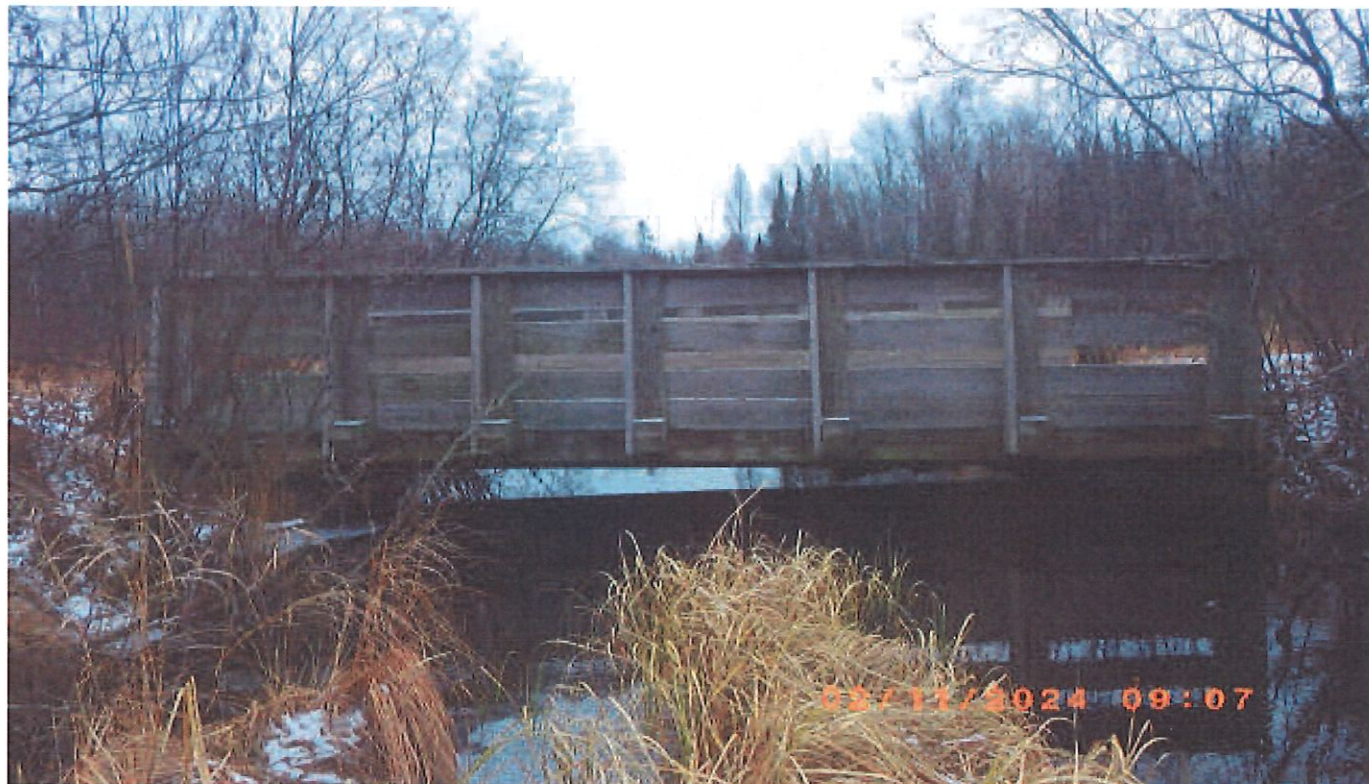
Elevation view from upstream

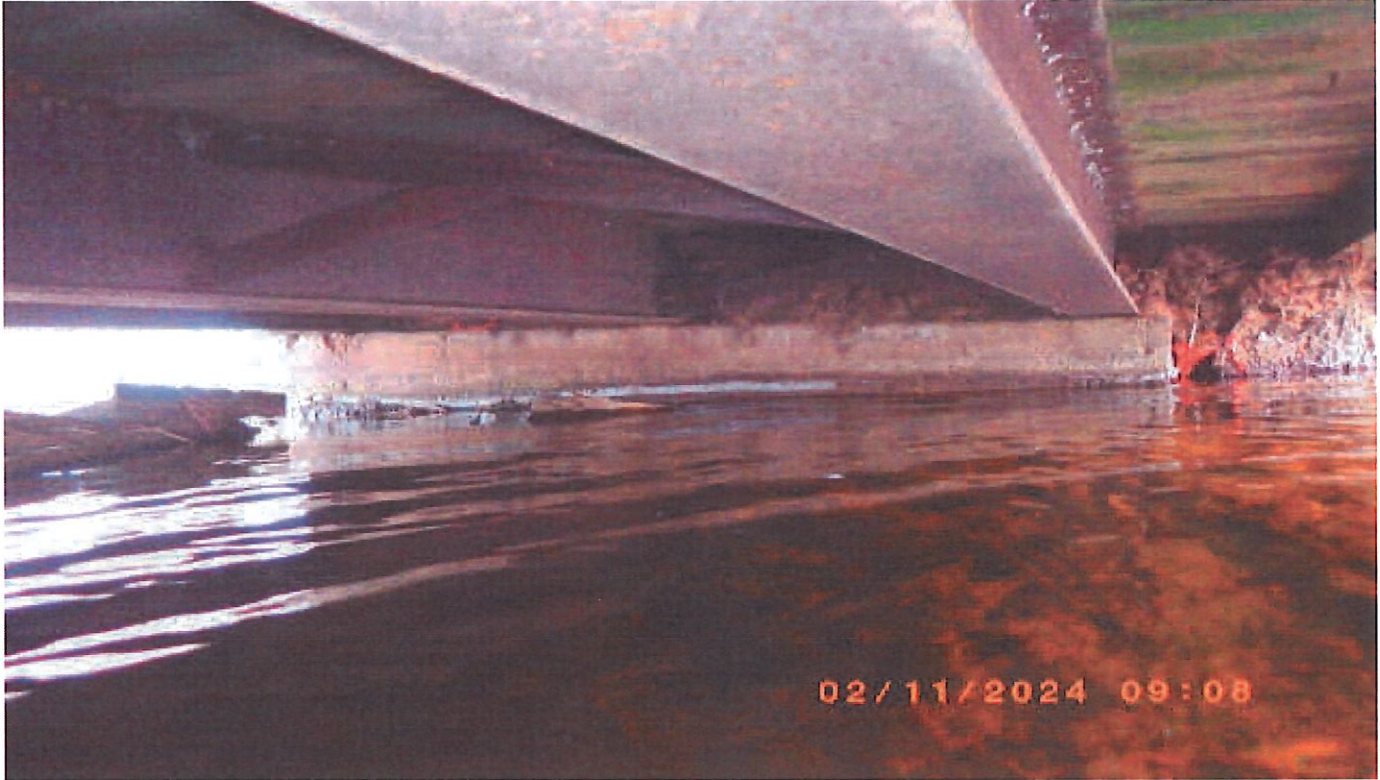
Concrete footings, scaling present and moderate spalling on west footing. Large crack in east sill. East sill undermined up to 12" deep at south end. NW corner is sinking and putting a twist in the bridge. Poor condition.

West footing

Level footings and add riprap to both abutments.

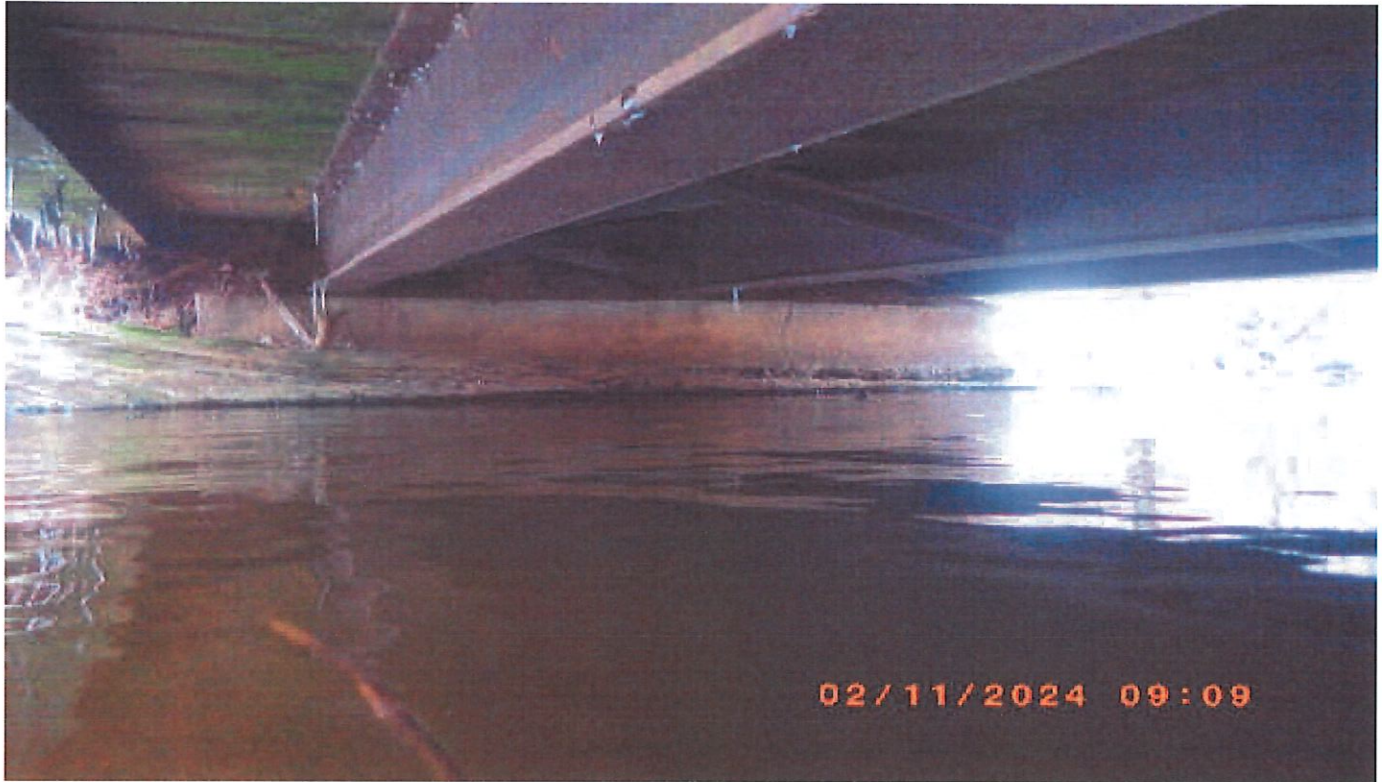
East footing

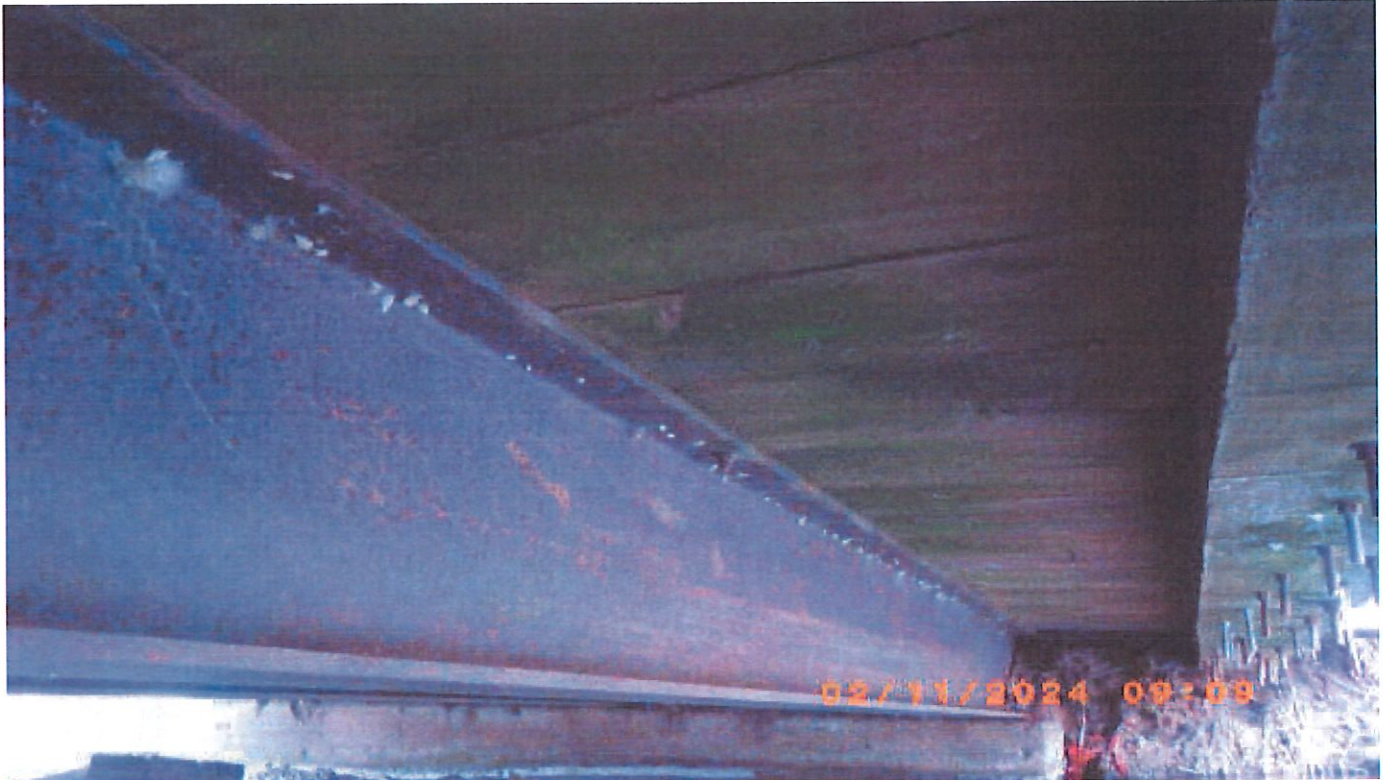
Deck is 4"x8" transverse planks, some decay, widespread green mold on underside. Fair.

Typical underside of deck / green mold

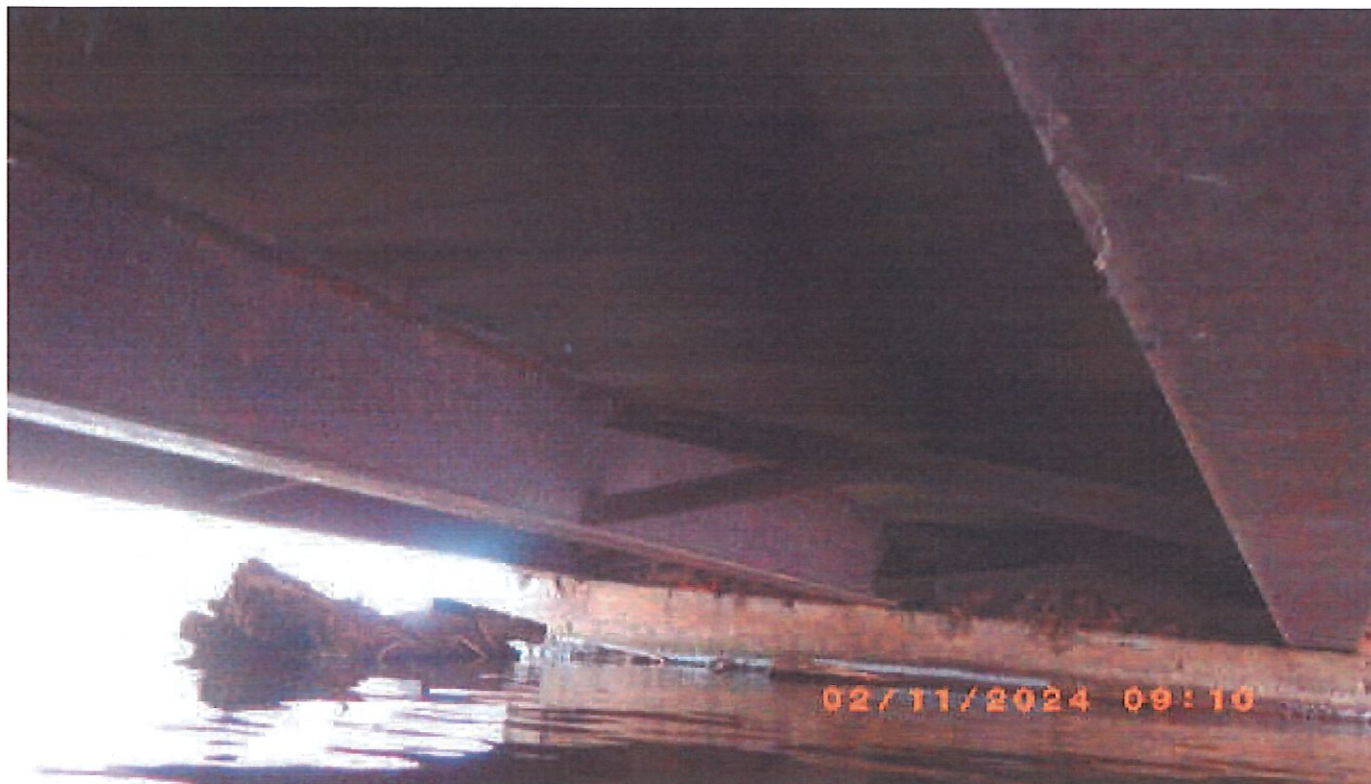
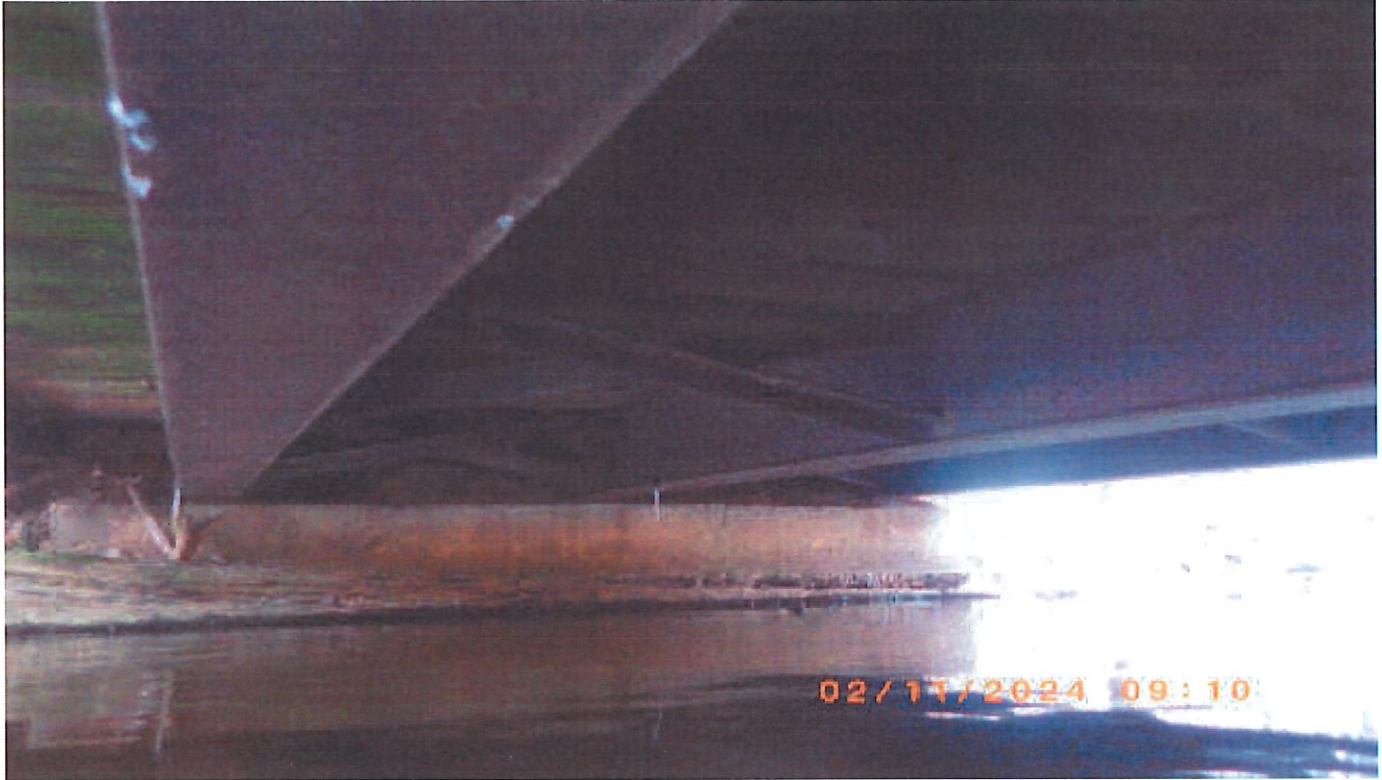
3 Steel girders, surface rust, welded splice near east 1/4 point of north girder. Fair.

Typical underside of superstructure / x bracing at ends plus 1/4 pts

*****High importance-Consider a load rating for base line. 3 girder system and the girders appear undersized and insufficient quantity.

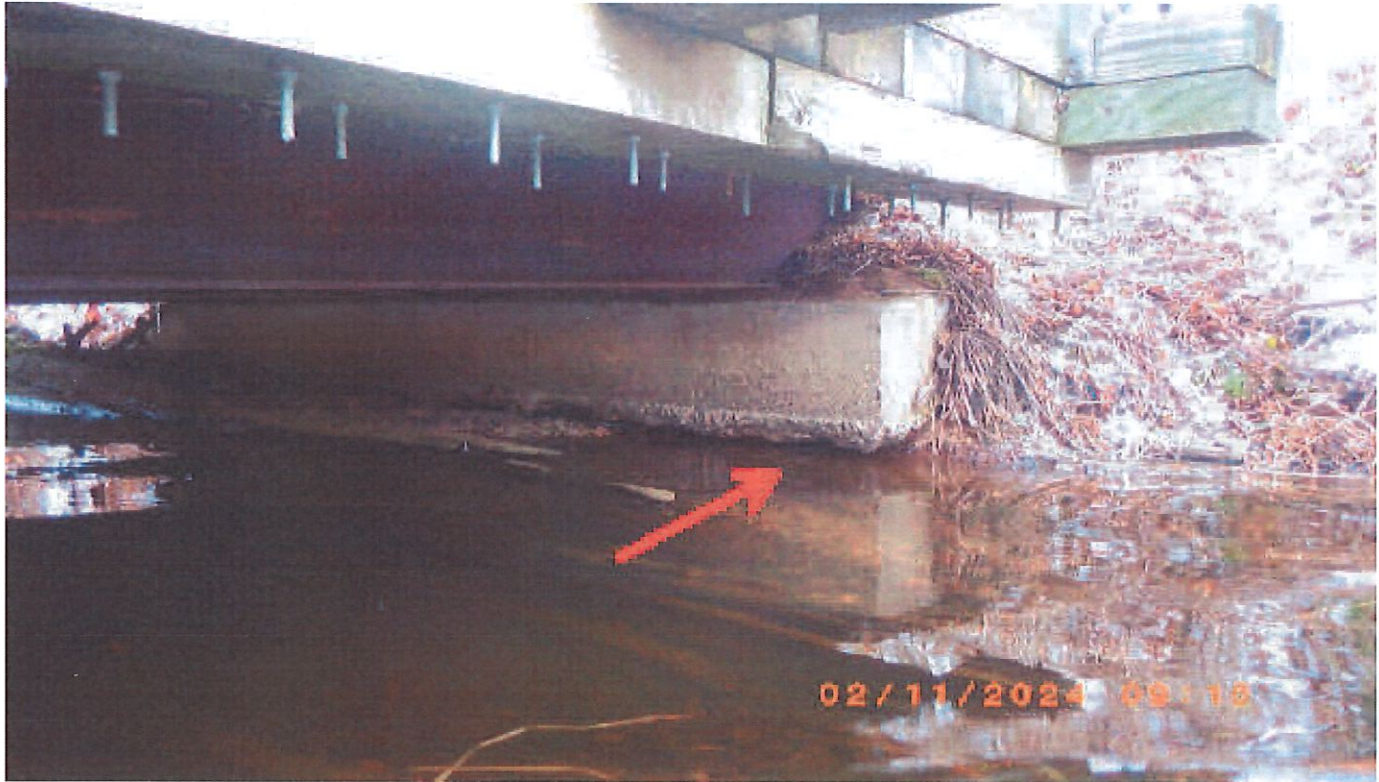
East sill undermined up to 12" deep at south end
