S-30 Cost Increase Request for Lynx Creek Bridge

Trail Bridge Inspection

Vilas 1

Bridge Inspection Report

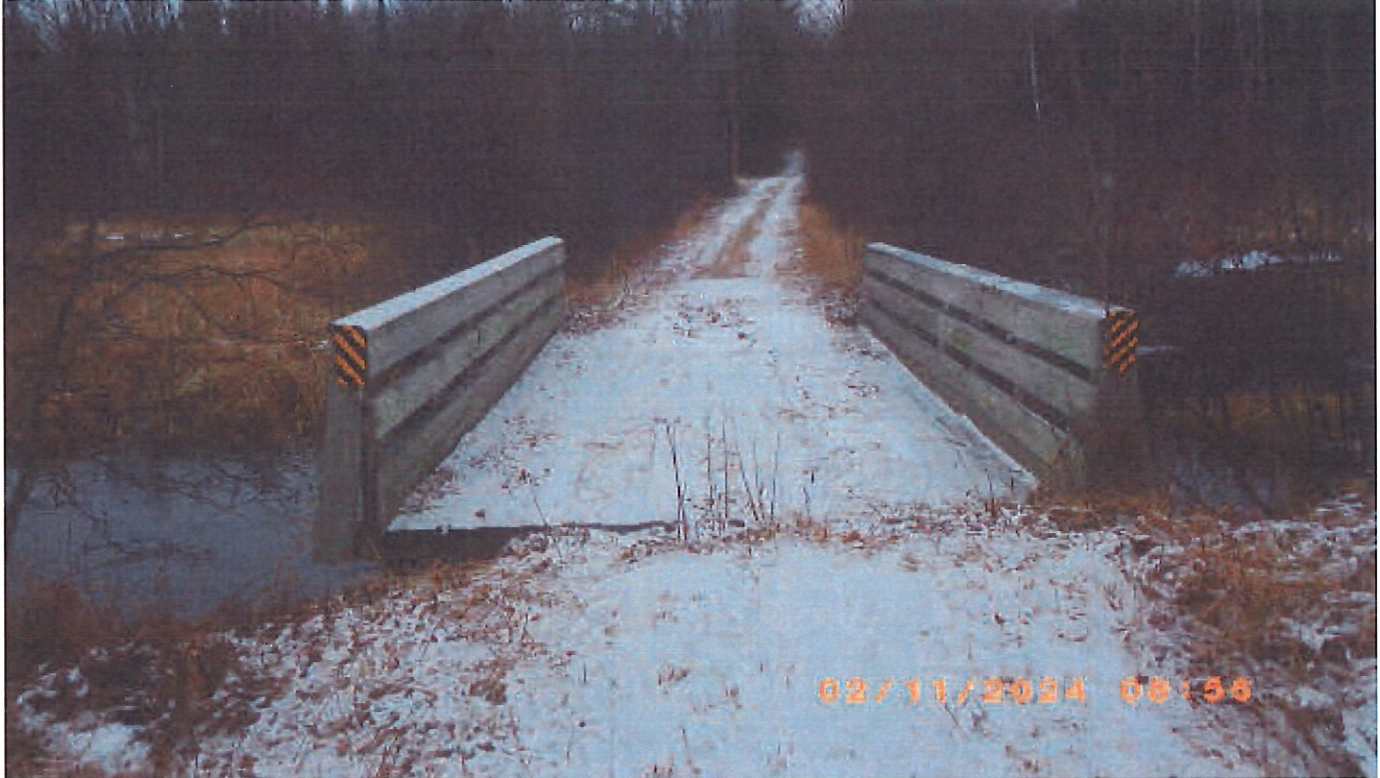
Approaches have a 3' x 3' hole in SE corner, 1' x 1' hole in SW corner, approaches are 6-12" higher than bridge. Poor condition.

East approach

Fill sinkholes / erosion in approaches.

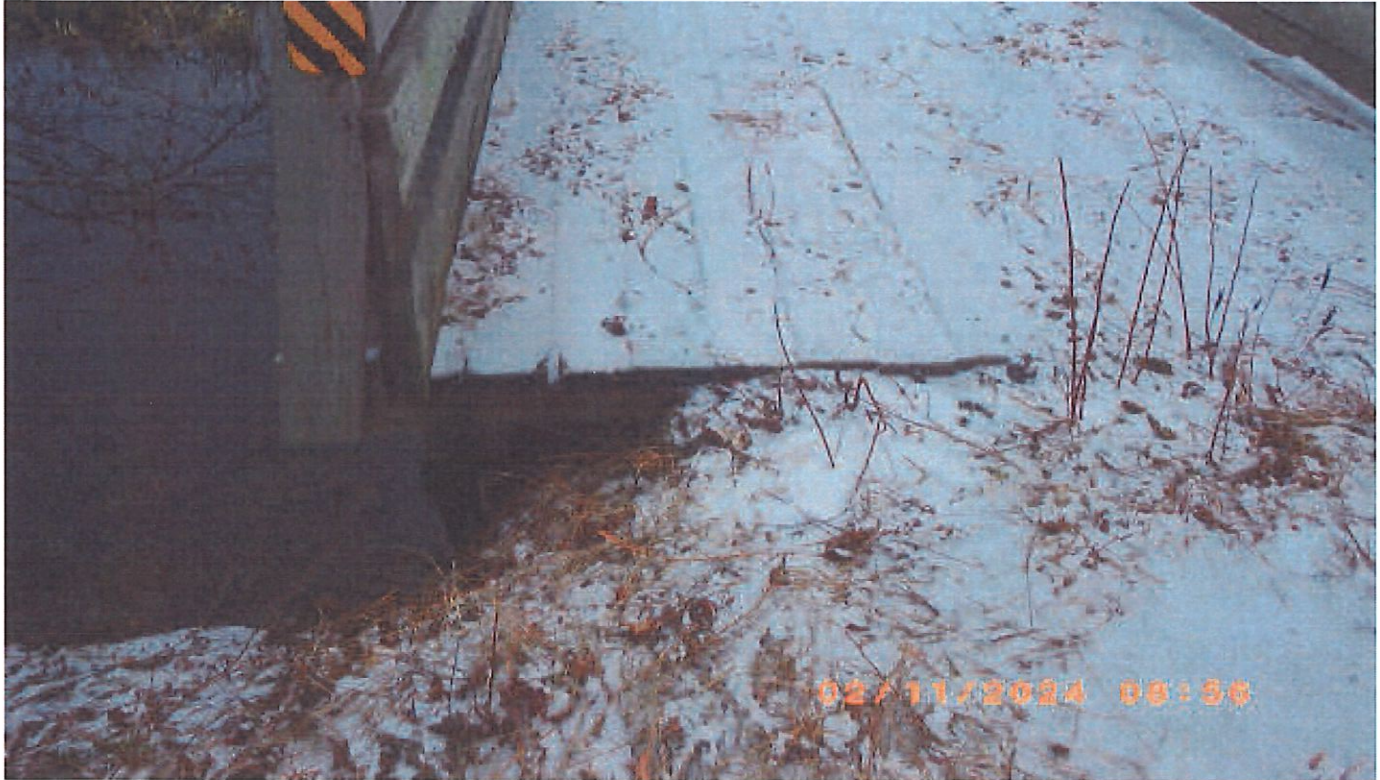
3' x 3' hole in SE corner

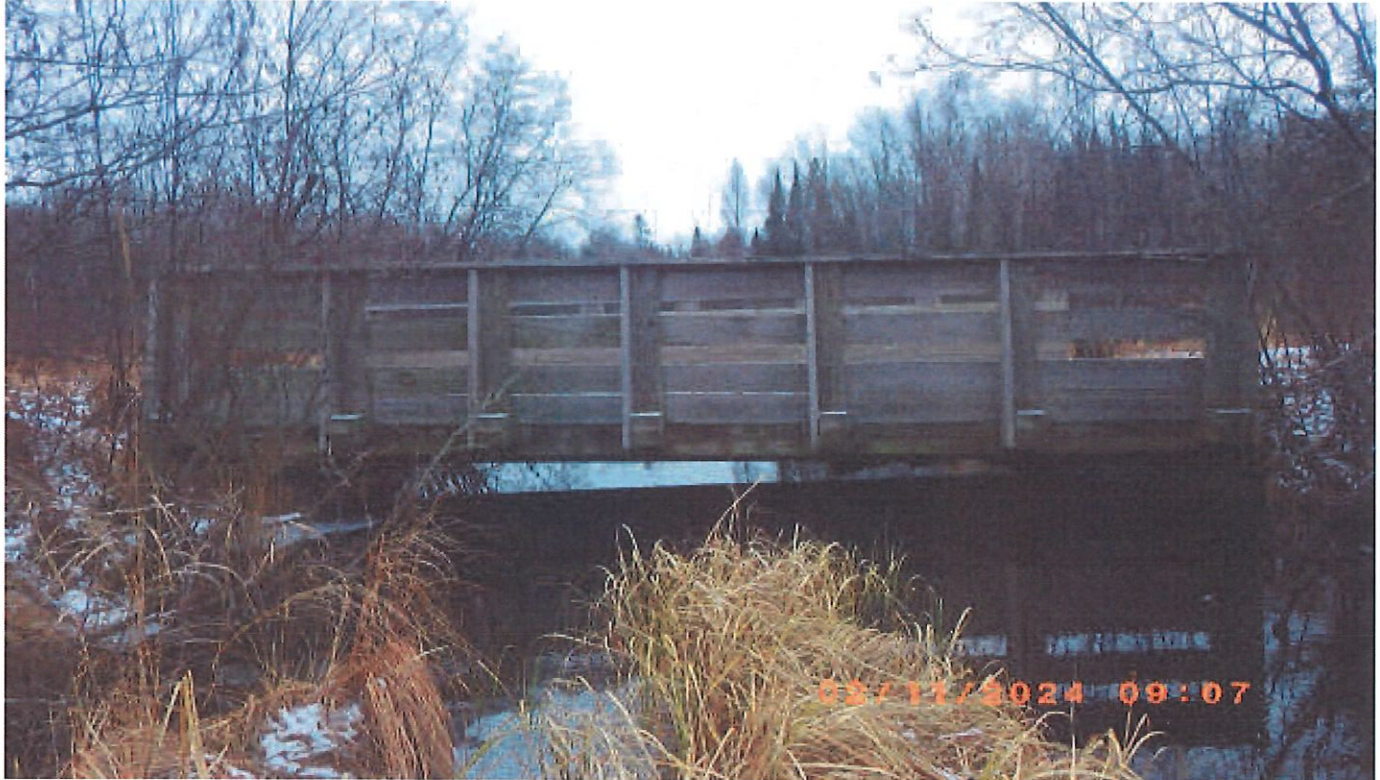
Elevation view from upstream

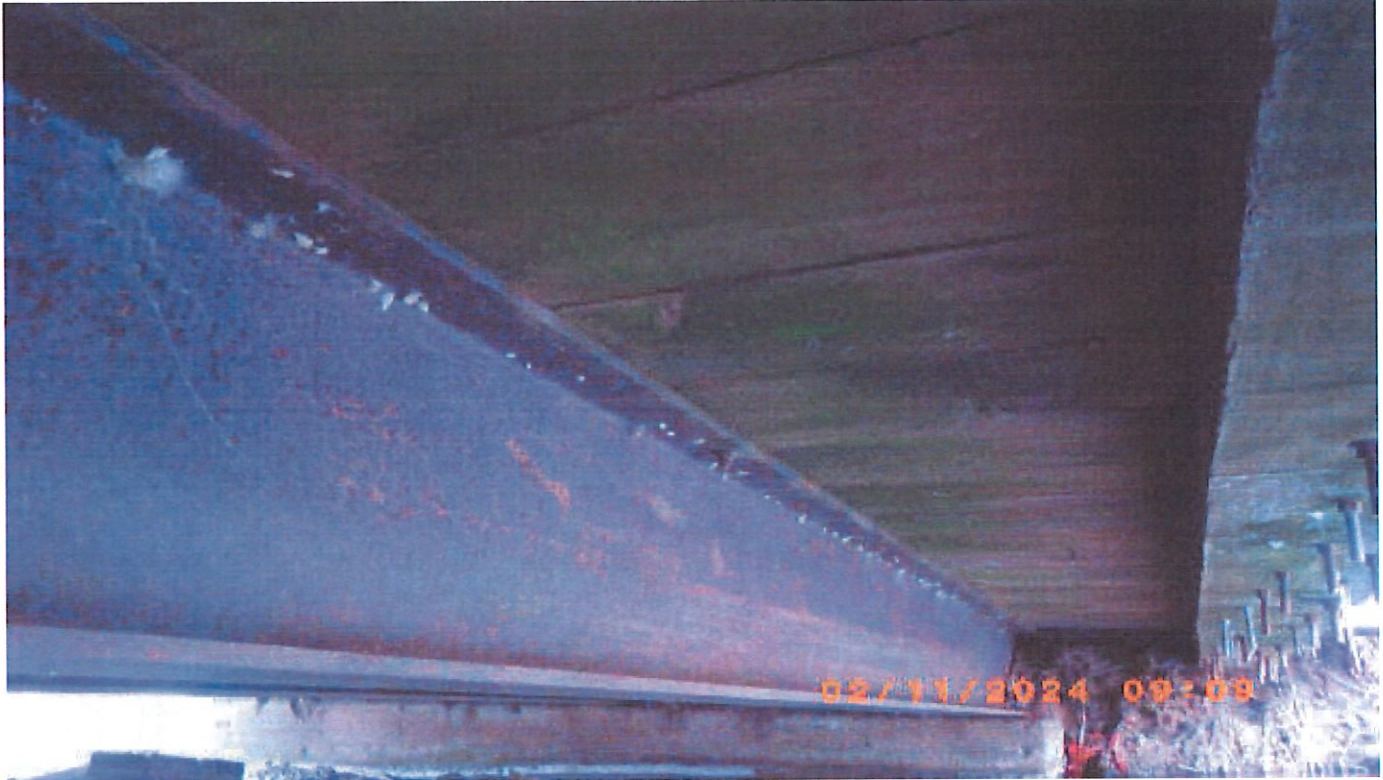
Deck is 4"x8" transverse planks, some decay, widespread green mold on underside. Fair.

Typical underside of deck / green mold

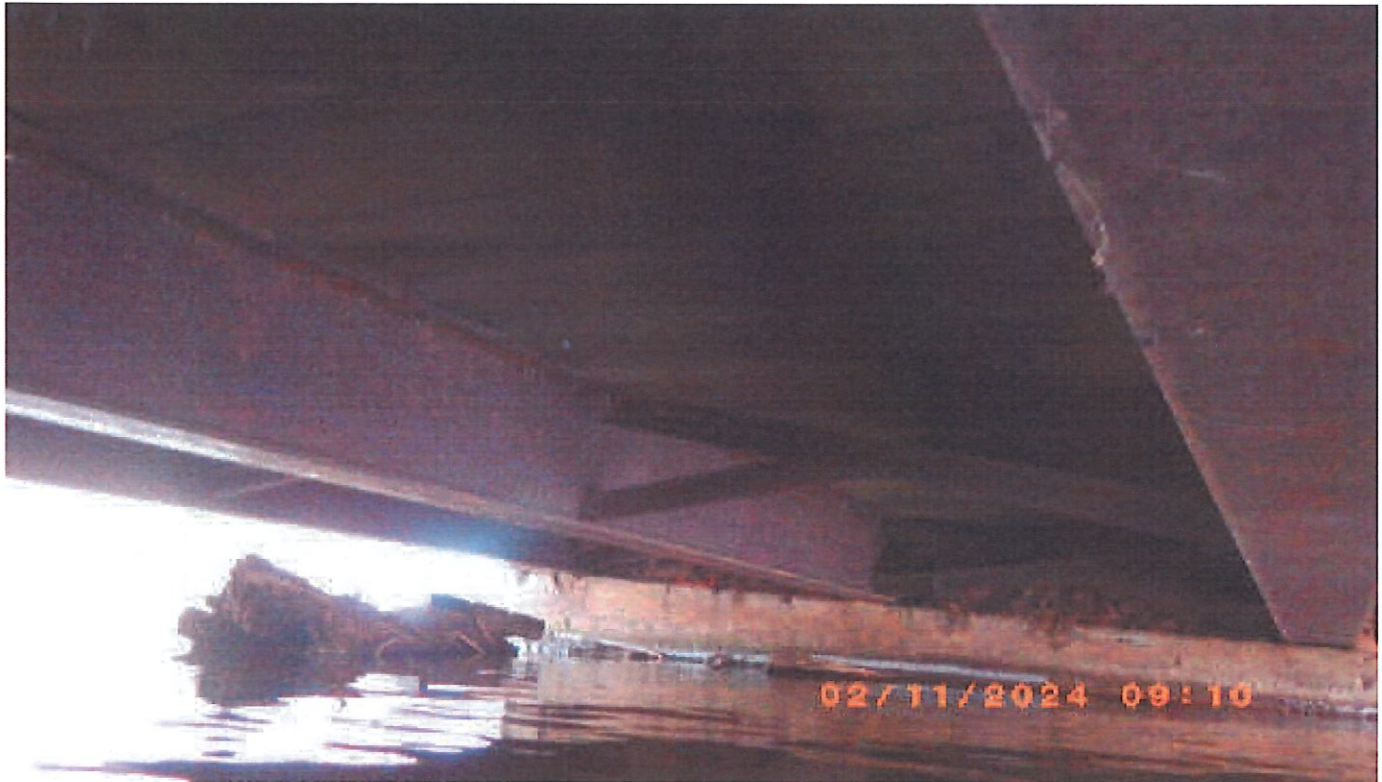
Typical underside of superstructure / x bracing at ends plus 1/4 pts

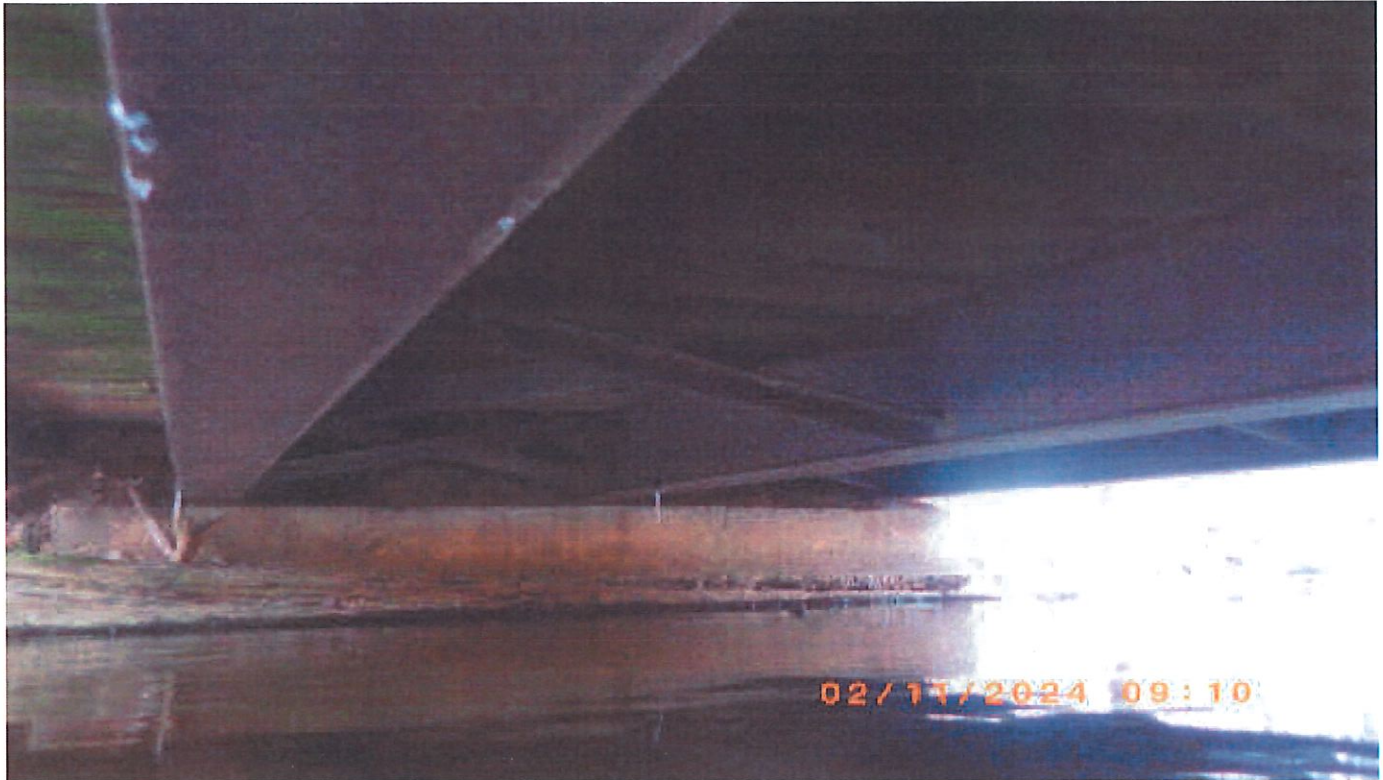
Typical underside of superstructure / x bracing at ends plus 1/4 pts

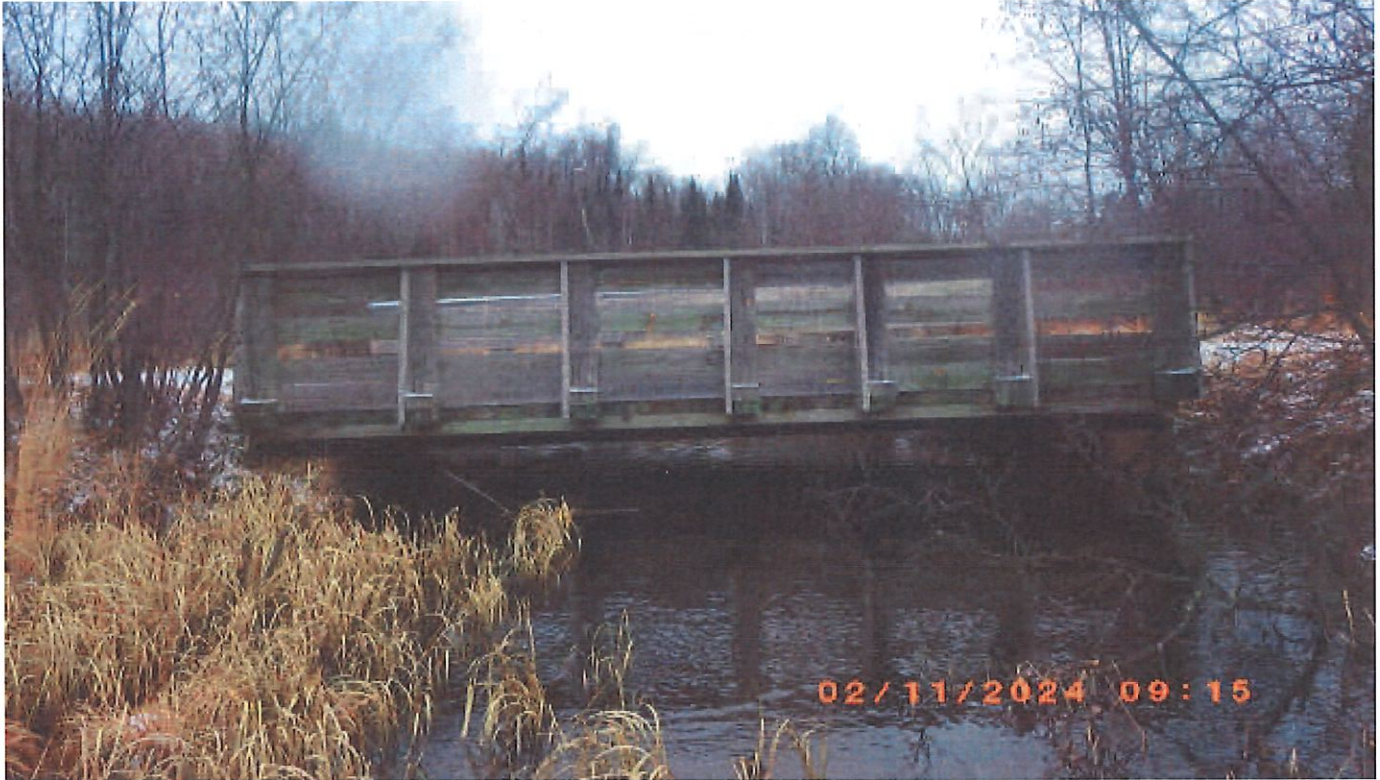
Elevation view from downstream
