**Project Subject/Title:** WRFA Buckthorn Treatment and Removal

**Contact Person:** Christopher Sand, WI DNR Fish Technician (715) 372-8539  
Report and data compiled by Alex Mertig- WDNR Forester

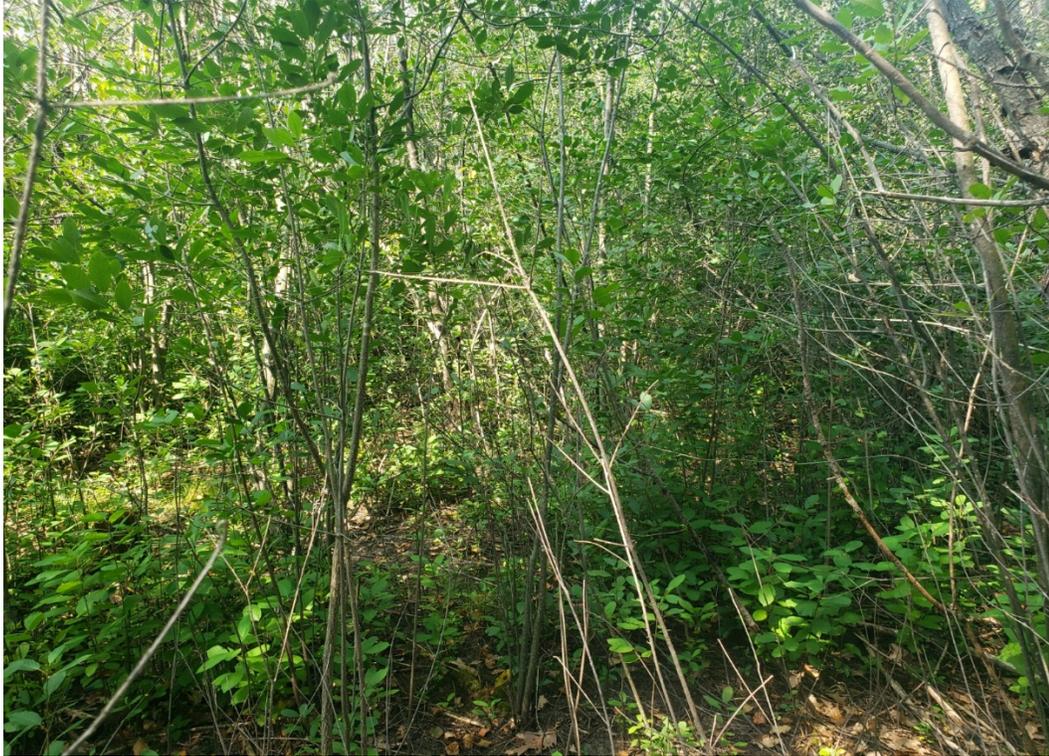
Fig. 4 Untreated Area

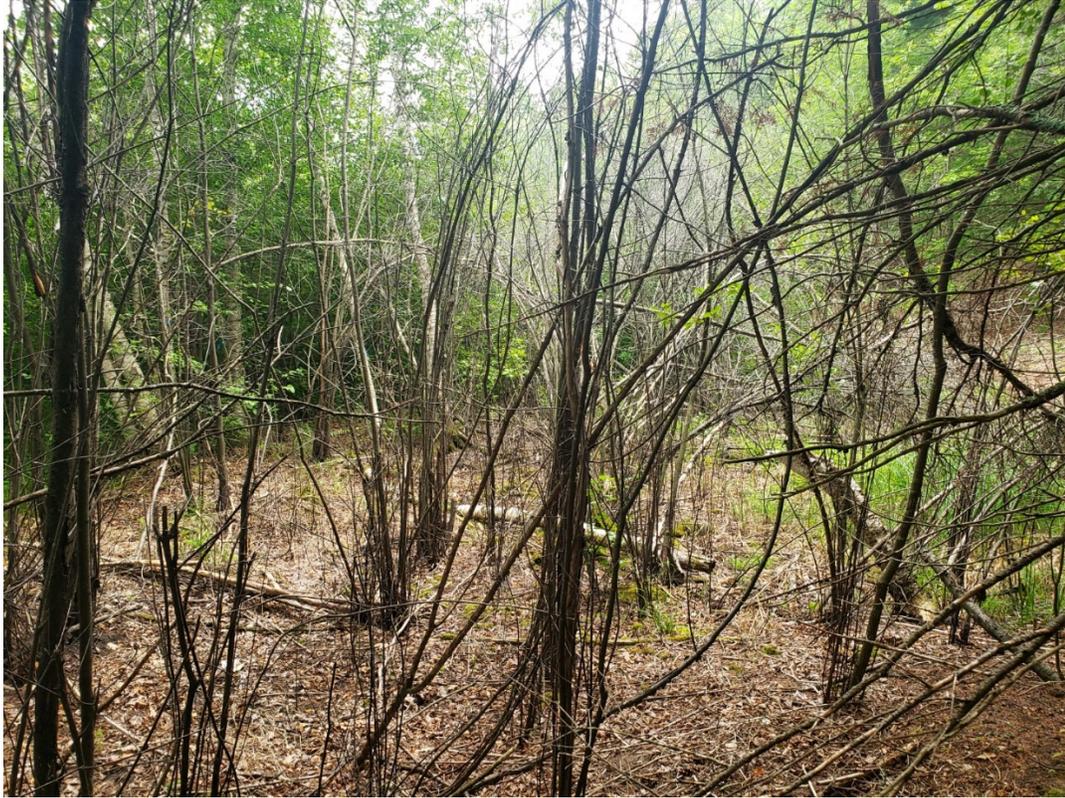
regeneration in the understory (Fig. 5). Bare soil was also a result of the dense buckthorn population and contributed to increased erosion.

Fig. 5. Recently treated via basal bark and foliar herbicide application

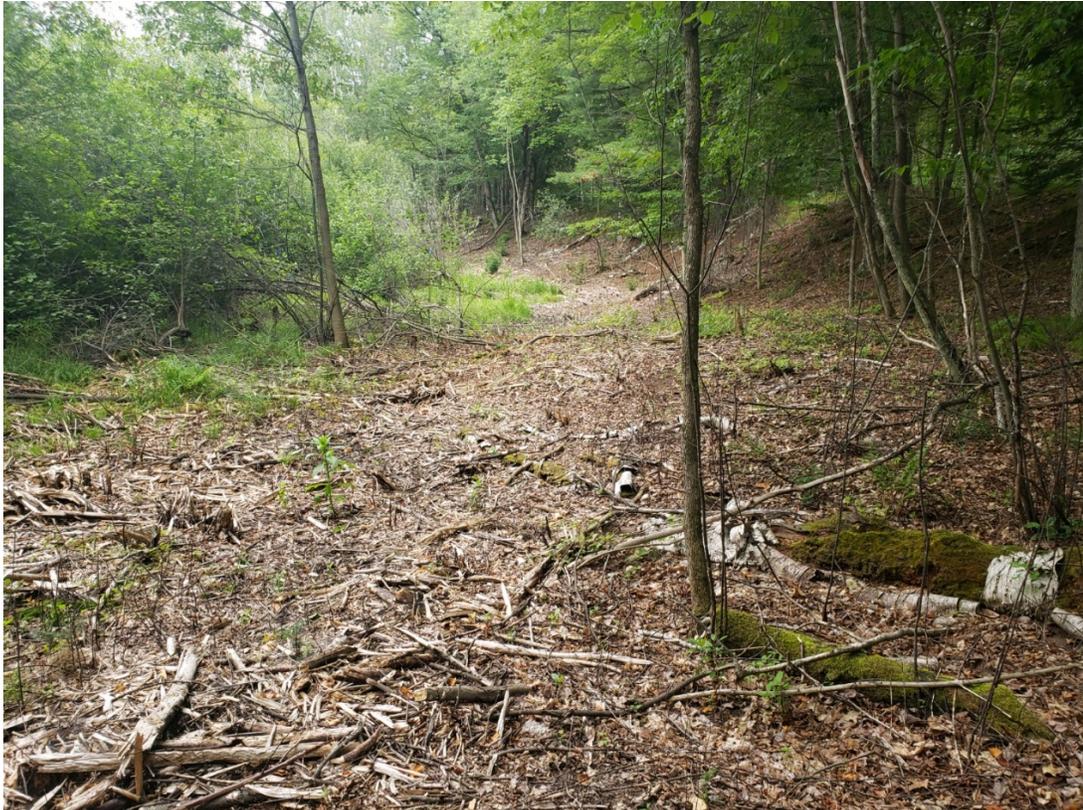
Fig. 6. Pre-treated with herbicide and recently mowed

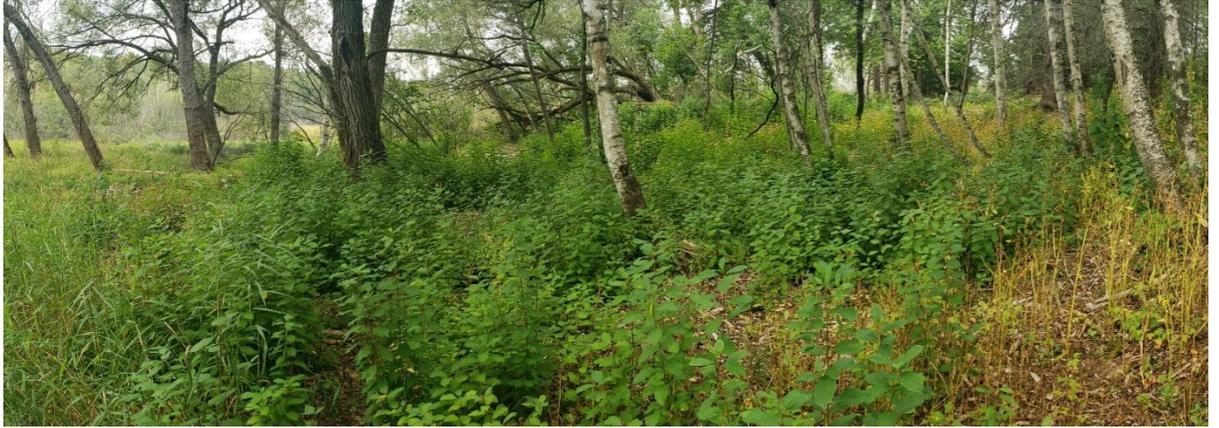
**Discussion:** There were several notable things that were discovered as a result of this project. First, the largest factor in controlling buckthorn on this site was repeated treatments. The areas that had successful tree regeneration and the least number of buckthorn had multiple treatment entries over many years. Second, the foliar treatments on stump sprouts are necessary when used in conjunction with other methods such as mowing or manual removal. If left untreated, the stumps will quickly resprout, creating multiple stems from what used to be one singular stem (Fig. 7). That area has since been treated with a foliar application of herbicide.

Fig. 7. Pre-treated with herbicide, mowed and left untreated for one growing season.

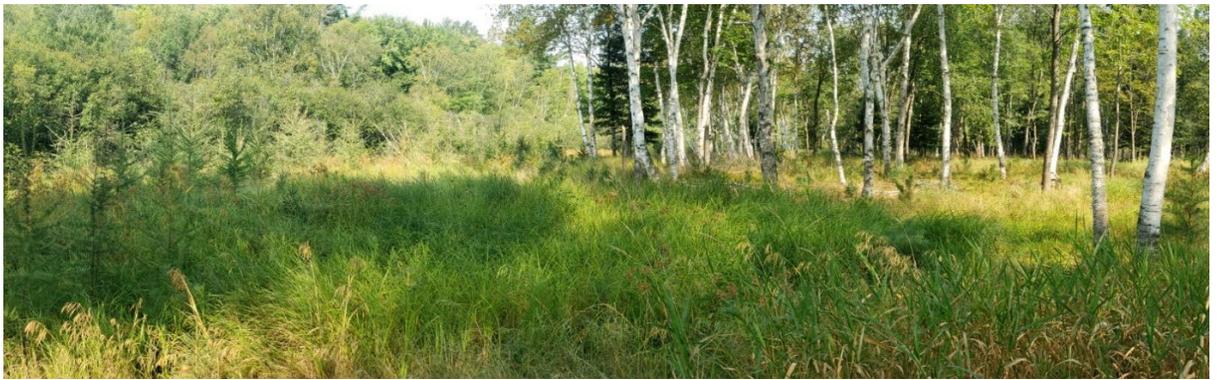
Fig. 8. Mechanically and manually cleared, followed by multiple follow-up treatments of herbicide application, as well as planting of multiple tree species.
